# PROTECTED TREE REPORT (TREE WORKS)

| Application number | HGY/2024/0712 |
| Site Address: | 18 Coolhurst Road, Hornsey, London, N8 8EL |

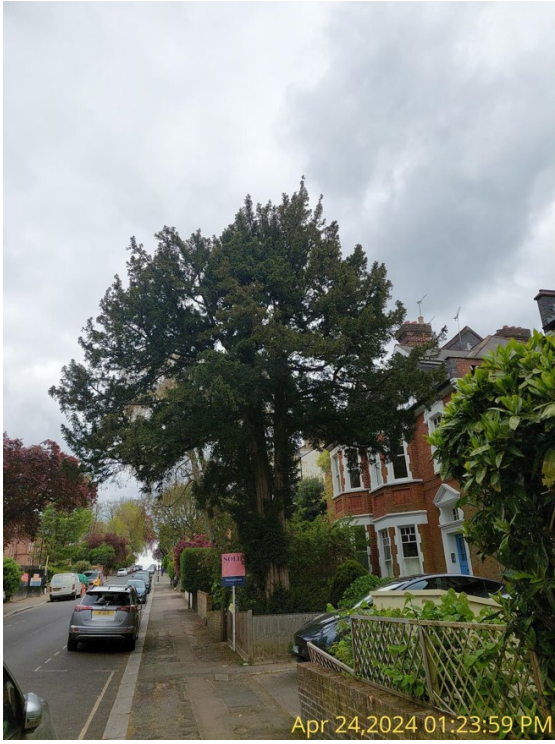
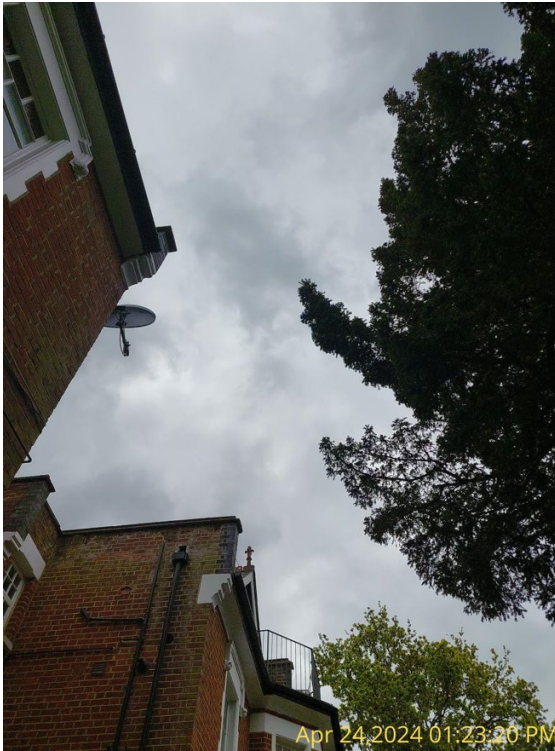
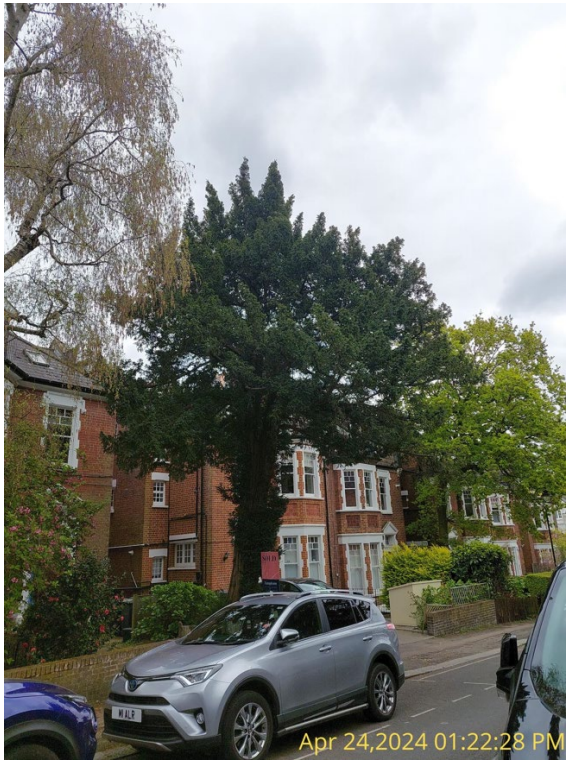
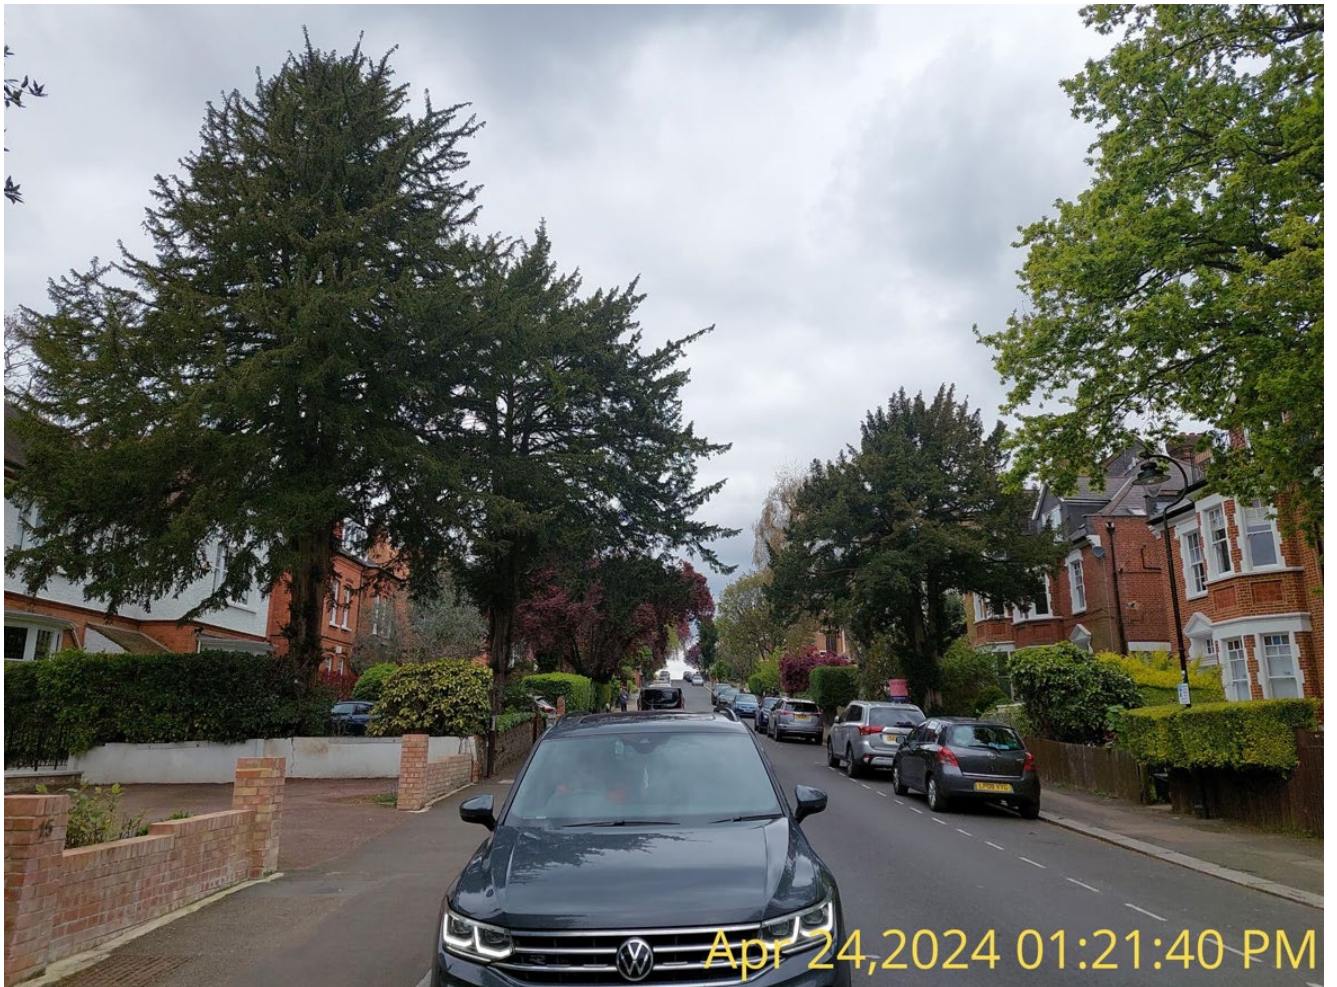
The mature large Yew *Taxus* spp. tree T1, as marked on the plan and seen in the photographs (see also below), is situated in the front garden of the property. It is publicly visible.

T1 has not had an overall reduction. There is some lower crown past works and pulling back from the structure.

At the time of inspection, the tree appeared to be in a fair condition.

There is also current adequate clearance from the structure.

The three Yew trees when viewed on approach complement each other and are in scale with the road and as such no tree works are seen as necessary.

I object to the proposed pruning works as stated above within the specification.

### **Objection**
