**ASBESTOS SURVEY  
REPORT NO: A-64869**

Stanhope Road Bridge  
Stanhope Road  
London N6 5ND

## ASBESTOS SURVEY REPORT

| MANAGEMENT | REFURBISHMENT | DEMOLITION ✓ |

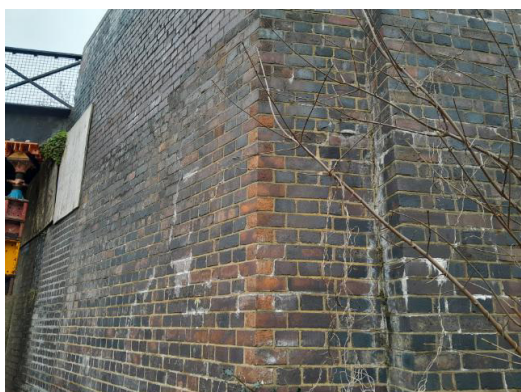
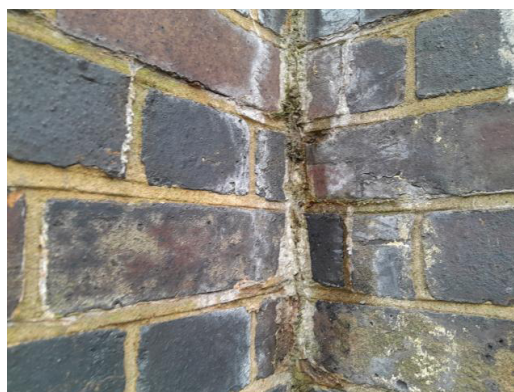
| Inspection no: | S1 | Type: | Sampled |

| Client | | | Property Address | | | Inspection Date | | | Ayerst Report Number | | | | | | | Inspection Types Included | | | |
|---|---|---|---|---|---|---|---|---|---|---|---|---|---|---|---|---|---|---|---|
| S1 | | S | Stanhope Road | Ground Floor | Ground level of bridge [001] | Front wall - Mastic Sealant<br>White mastic to brickwork work wall joint | Mastic Sealant | 0 | Low Damage | 0 | Composites, resins, vinyl tiles etc | 0 | NAD | 0 | 0 | 5 | lin m | No action required | |

| Room/Area | Ground Floor. Ground level of bridge [001] | | |
| Damage/Deterioration | n/a | Score: | n/a |
| Extent | 5lin m | | |

| Recommended Action | <b>No Further Action Required</b> | Total Score | 0 |

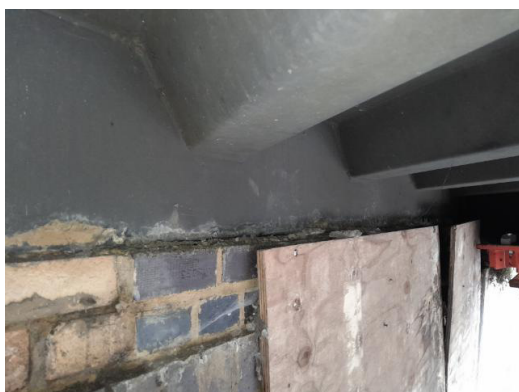
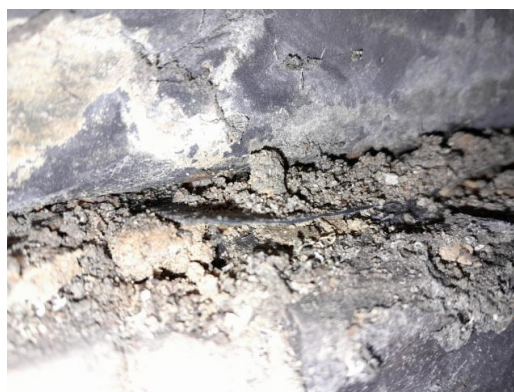
| Inspection no: | S3 | Type: | Sampled |

| Client | | | Property Address | | | Inspection Date | | | Ayerst Report Number | | | | | | | Inspection Types Included | | | |
|---|---|---|---|---|---|---|---|---|---|---|---|---|---|---|---|---|---|---|---|
| S3 | | S | Stanhope Road | Ground Floor | Ground level of bridge [001] | Top of wall<br>Damp Proof Course (Bitumen)<br>Damp proof course between brickwork wall and steel or bridge. | Damp Proof Course (Bitumen) | 0 | Low Damage | 0 | Composites, resins, vinyl tiles etc | 0 | NAD | 0 | 0 | 6 | lin m | No action required | |

| Room/Area | Ground Floor. Ground level of bridge [001] | | |
| Damage/Deterioration | n/a | Score: | n/a |
| Extent | 6lin m | | |

| Recommended Action | No Further Action Required | Total Score | 0 |

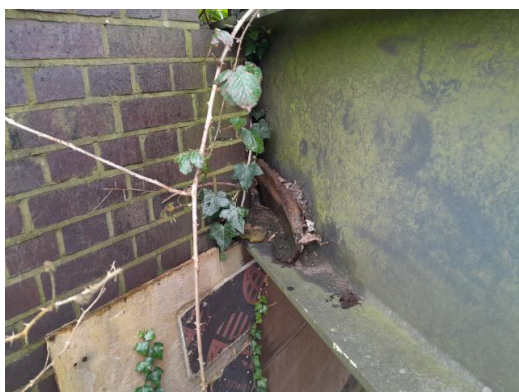
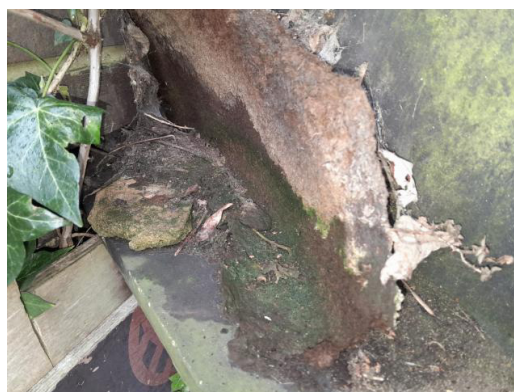
| Inspection no: | S5 | Type: | Sampled |

| Client | | | Property Address | | | Inspection Date | | | Ayerst Report Number | | | | | | | Inspection Types Included | | | |
|---|---|---|---|---|---|---|---|---|---|---|---|---|---|---|---|---|---|---|---|
| S5 | | S | Stanhope Road | Ground Floor | Ground level of bridge [001] | Back of bridge - Fibreboard<br>Fibreboard packing between bridge and brickwork wall | Fibreboard | 0 | High Damage | 0 | Unsealed AIB, encapsulated lagging & sprays | 0 | NAD | 0 | 0 | 0.5 | m² | No action required | |

| Room/Area | Ground Floor. Ground level of bridge [001] | | |
| Damage/Deterioration | n/a | Score: | n/a |
| Extent | 0.5m <sup>2</sup> | | |

| Recommended Action | No Further Action Required | Total Score | 0 |

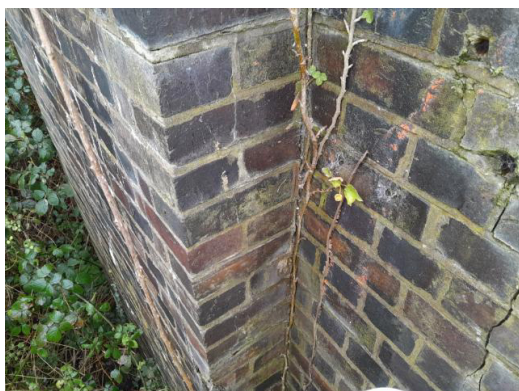
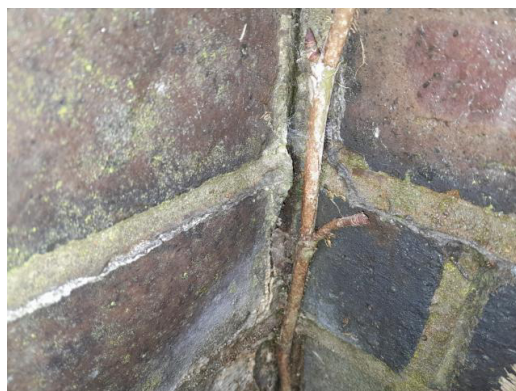
| Inspection no: | S6 | Type: | Sampled |

| Client | | | Property Address | | | Inspection Date | | | Ayerst Report Number | | | | | | | Inspection Types Included | | | |
|---|---|---|---|---|---|---|---|---|---|---|---|---|---|---|---|---|---|---|---|
| S6 | | S | Stanhope Road | Ground Floor | Ground level of bridge [001] | Back wall - Mastic Sealant<br>Mastic sealant to brickwork joint | Mastic Sealant | 0 | Low Damage | 0 | Composites, resins, vinyl tiles etc | 0 | NAD | 0 | 0 | 6 | lin m | No action required | |

| Room/Area | Ground Floor. Ground level of bridge [001] | | |
| Damage/Deterioration | n/a | Score: | n/a |
| Extent | 6lin m | | |

| Recommended Action | No Further Action Required | Total Score | 0 |

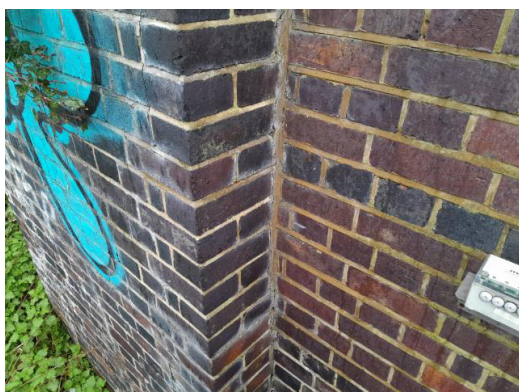
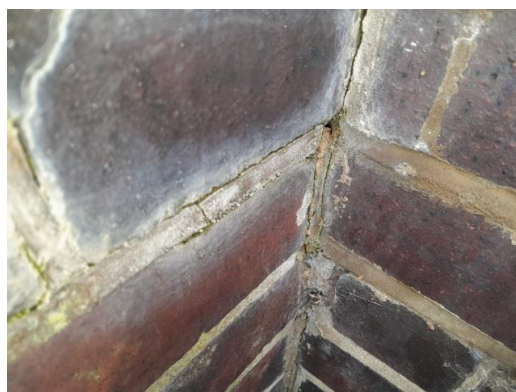
| Inspection no: | S7 | Type: | Sampled |

| Client | | | Property Address | | | Inspection Date | | | Ayerst Report Number | | | | | | | Inspection Types Included | | | |
|---|---|---|---|---|---|---|---|---|---|---|---|---|---|---|---|---|---|---|---|
| S7 | | S | Stanhope Road | Ground Floor | Ground level of bridge [001] | Front wall - Mastic Sealant<br>Mastic sealant to brickwork joint | Mastic Sealant | 0 | Low Damage | 0 | Composites, resins, vinyl tiles etc | 0 | NAD | 0 | 0 | 6 | lin m | No action required | |

| Room/Area | Ground Floor. Ground level of bridge [001] | | |
| Damage/Deterioration | n/a | Score: | n/a |
| Extent | 6lin m | | |

| Recommended Action | No Further Action Required | Total Score | 0 |

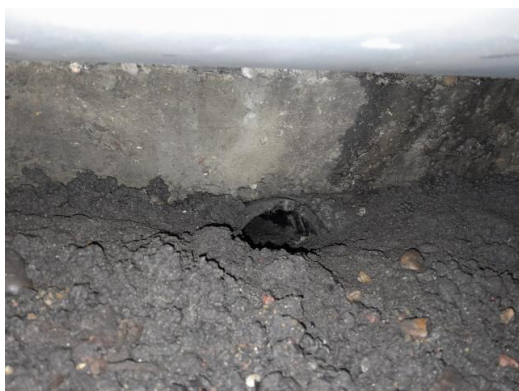
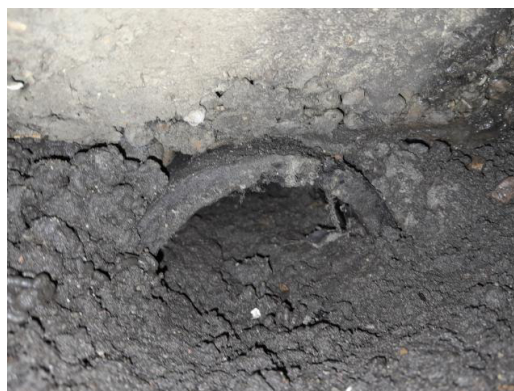
| Inspection no: | S8 | Type: | Sampled |

| Client | | | Property Address | | | Inspection Date | | | Ayerst Report Number | | | | | | | Inspection Types Included | | | |
|---|---|---|---|---|---|---|---|---|---|---|---|---|---|---|---|---|---|---|---|
| S8 | | S | Stanhope Road | Ground Floor | Ground level of bridge [001] | Pipe on shelf - Cement downpipe<br>Pipework at top of shelf | Cement downpipe | 0 | Low Damage | 0 | Composites, resins, vinyl tiles etc | 0 | NAD | 0 | 0 | 1 | lin m | No action required | |

| Room/Area | Ground Floor. Ground level of bridge [001] | | |
| Damage/Deterioration | n/a | Score: | n/a |
| Extent | 1lin m | | |

| Recommended Action | No Further Action Required | Total Score | 0 |
