52A, NORTH HILL,  
LONDON,  
N6 4RH

## HERITAGE NOTE:

Appendix I, Design & Access  
Report by ME Architects, April  
2024

Response to request for information for the above site ,  
a Grade II Listed former coach house in the Highgate  
Conservation Area, by the London Borough of Haringey

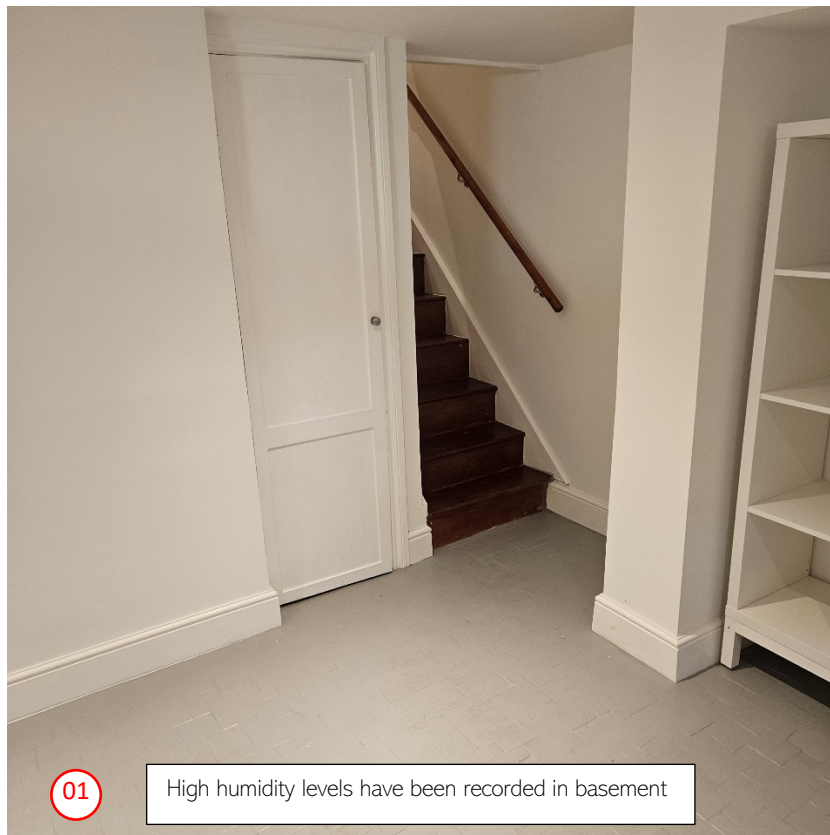
*Figure 2 – Damp Condition Survey : View 1*

View 01 is located within the basement which has high levels of damp although no visible staining to the walls or ceiling. It is assumed that a lot of the airborne damp to the floors above originates from the basement (except that associated with the (assumed / likely) building defects identified later.

High humidity levels have been recorded in basement

For additional protection (to ensure the building's fabric is preserved), a damp proof membrane with additional dry lining / finishes is proposed to the basement. This system is non-invasive and has been approved in Grade I buildings (evidence can be provided).

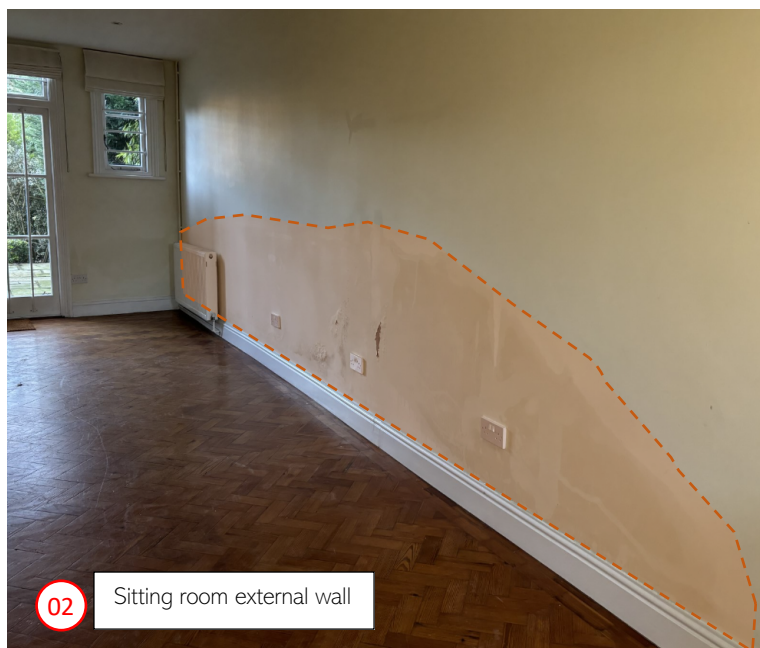
*Figure 3 – Damp Condition Survey : View 2*

View 02 is located within the ground floor sitting room on the south westerly wall.

Sitting room external wall

Damp is seen on the sitting room wall at the bottom of the wall. The levels of moisture appear to be much more than condensation.

Interestingly, this is an external wall (rear side). From the one site inspection that we attended, it appears to be penetrating damp either through capillary action upward from the ground or as a result of façade ingress, however, the behavioural response of the damp levels following rainfall has not been witnessed either from naturally occurring events of dye / flood-testing..

The damp appears to be a building defect. The exterior of the wall has not been viewed.

The proposed damp resolution methods are principally associated with rectification of the current (suspected) leaks and defects. These include rainwater, gutter and (assumed) external wall defects. The building pathology will be investigated to determine the exact sources of the damp and following fixing the defects, the building will be dried out and reviewed.

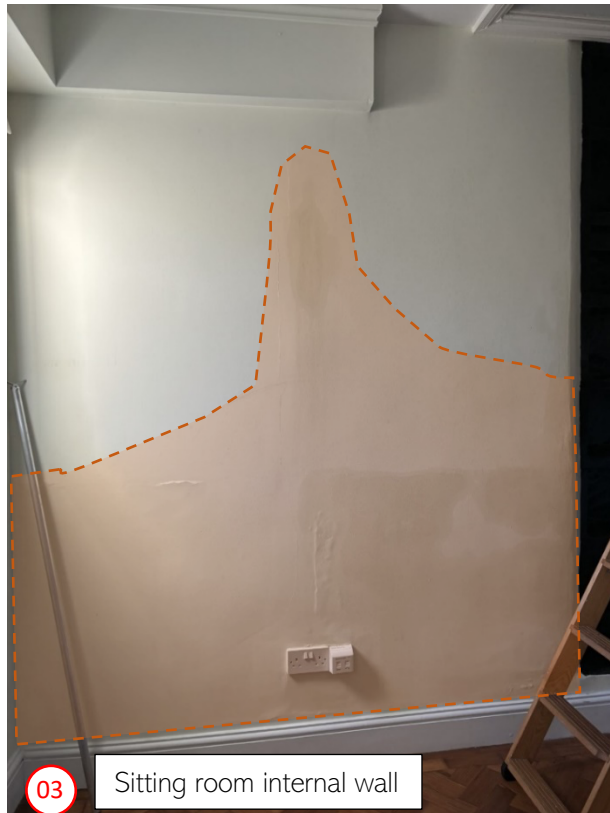
*Figure 4 – Damp Condition Survey : View 3*

View 03 is located within the ground floor sitting room on the easterly wall.

Historic damp is seen adjacent to the historic ladder to the wall. It is pooling.

It is assumed that the water is coming downwards and inwards and possibly is associated with failing / leaking rainwater goods, in particular gutterings, however, the behavioural response of the damp levels following rainfall has not been witnessed either from naturally occurring events or dye / flood-testing.

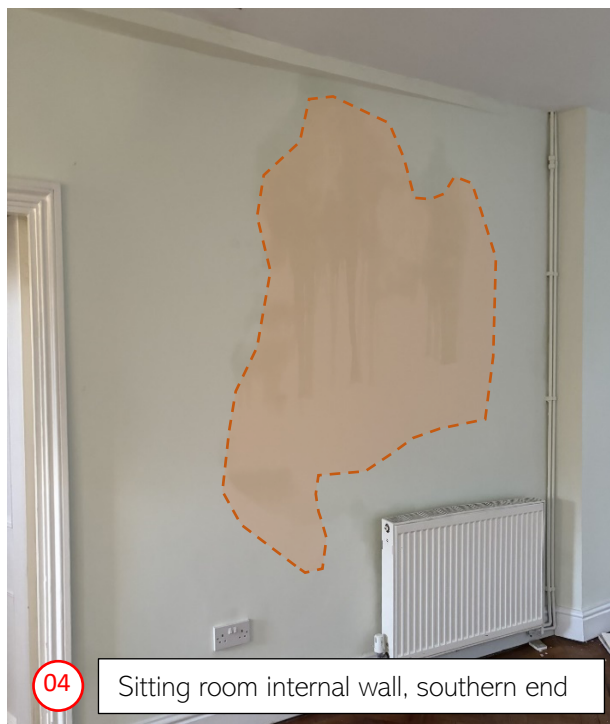
*Figure 5 – Damp Condition Survey : View 4*

View 04 is located within the ground floor sitting room on the south westerly wall.

Historic damp is seen at high level.

It is assumed that the water is coming downwards and inwards and possibly is associated with failing / leaking rainwater goods, in particular gutterings, however, the behavioural response of the damp levels following rainfall has not been witnessed either from naturally occurring events or dye / flood-testing.

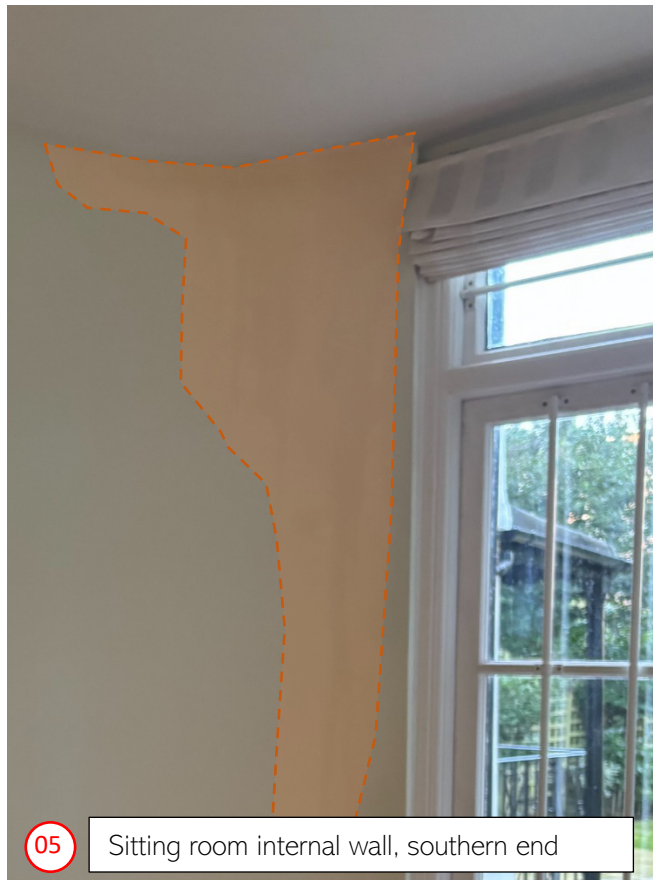
Figure 6 – Damp Condition Survey : View 5

View 05 is located within the ground floor sitting room on the south westerly wall.

Historic damp is seen at high level.

It is assumed that the water is coming downwards and inwards and possibly is associated with failing / leaking rainwater goods, in particular gutterings, however, the behavioural response of the damp levels following rainfall has not been witnessed either from naturally occurring events of dye / flood-testing.

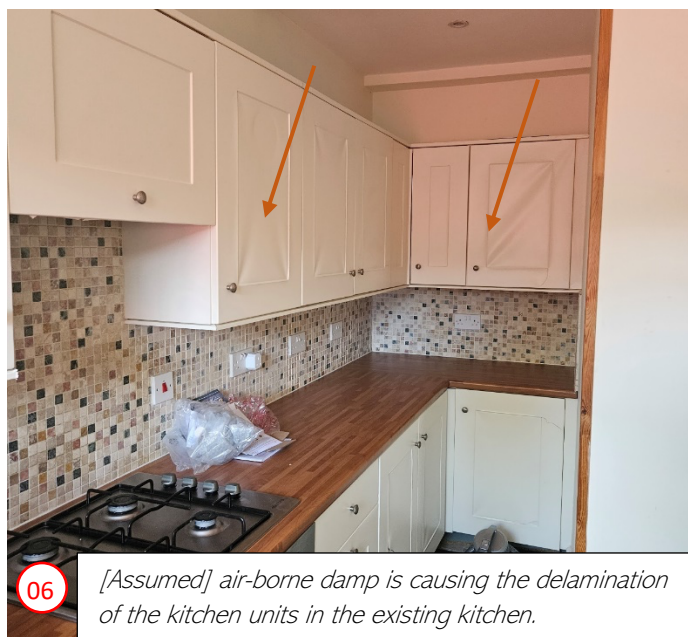
Figure 7 – Damp Condition Survey : View 6

View 06 is located within the ground floor kitchen.

*[Assumed] air-borne damp is causing the delamination of the kitchen units in the existing kitchen.*

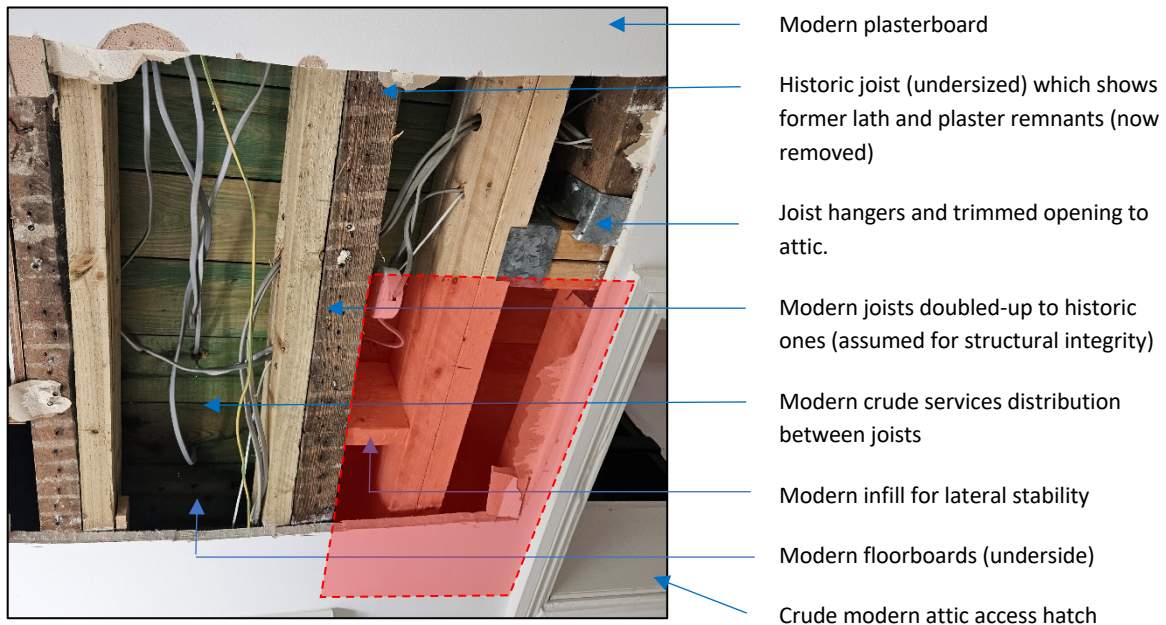
Figure 9 – Ceiling opening, recording

Targeted opening-up has been undertaken (from below) to the hayloft's floor. It has revealed extensive alteration and very little remaining historic fabric. The opening has been labelled on the photograph below. The proposals have been altered based on the pre-application feedback. The original hayloft ladder will be displayed and the kitchen arrangement has been altered accordingly.

The floor structure is no longer proposal for removal (see architect's drawings) – nor is the previously suggested extension of the roof hatch opening (see red area hatched, below).

Similarly, the posts mentioned are no longer proposed for removal. It is assumed that the revised proposals address the pre-application feedback concerns as the proposals have been altered to address each issue raised.

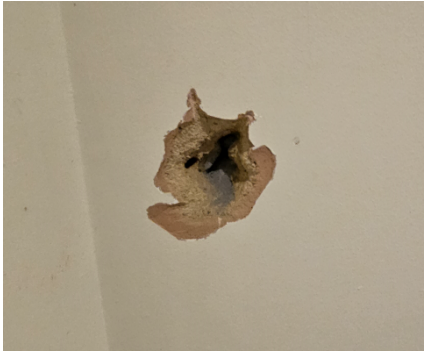
| W-02 | Ground floor hallway | | <p>Entirely modern masonry wall comprising blockwork with gypsum plaster 30mm approx and skim.</p> |

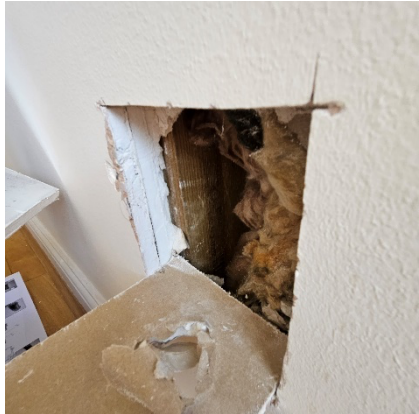
| W-03 | Bedroom 2 | | <p>Entirely modern studwork wall comprising 2 layers plasterboard / insulation board each side with rockwool between modern timber studs.</p> <p><u>Studwork is labelled with timber specification showing modern soft wood present as seen on photograph.</u></p> |

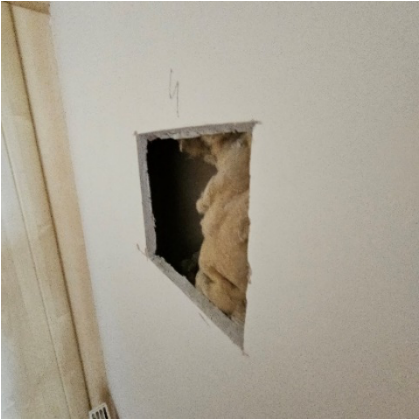
| W-04 | Bedroom 2 | | <p>A continuation of the wall above albeit that this hole does not reveal the studworks (hit and miss openings).</p> |

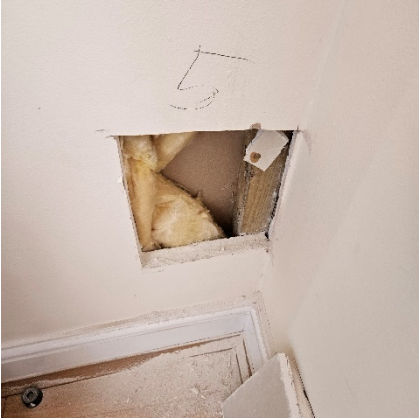
| W-05 | Bedroom 2 | | <p>Entirely modern studwork wall comprising 2 layers plasterboard / insulation board each side with rockwool between modern timber studs.</p> |

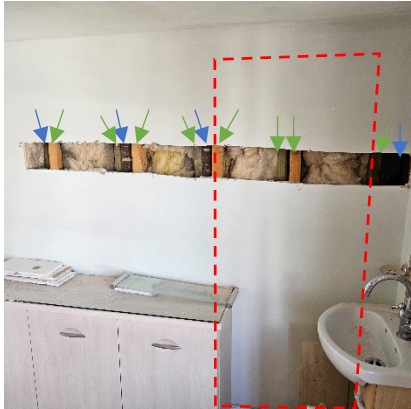
| W-06 | Bedroom 3 | | <p>Doubled-up timber studs (modern against historic) with rockwool insulation infill and plasterboard finish. The doorway will be made in the red section, no historically sensitive fabric will be removed. Studs shown within proposed doorway are modern.</p> <p>↓ indicates Historic joists</p> <p>↓ indicates Modern studs</p> |

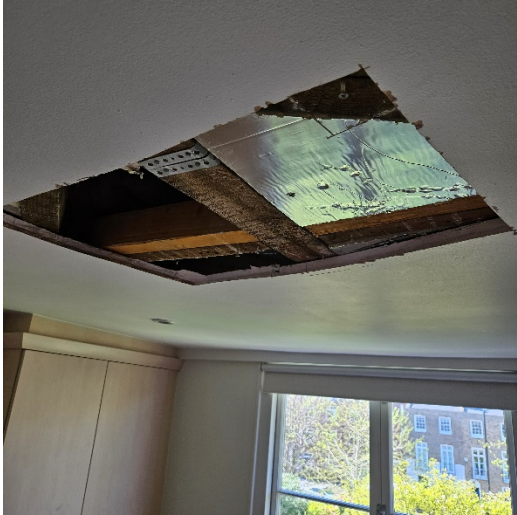
| C-03 | Bedroom 4 | | <p>2 layers plasterboard with insulation boards spanning between ceiling joists that have been adapted with hangers. New modern timbers doubled up to historic ones. See section 2.4</p> |

The opening-up has revealed a combination of modern and historic timbers that have been extensively adapted.

The proposal is for the plasterboard ceiling to be replaced – no historic timber will be removed.

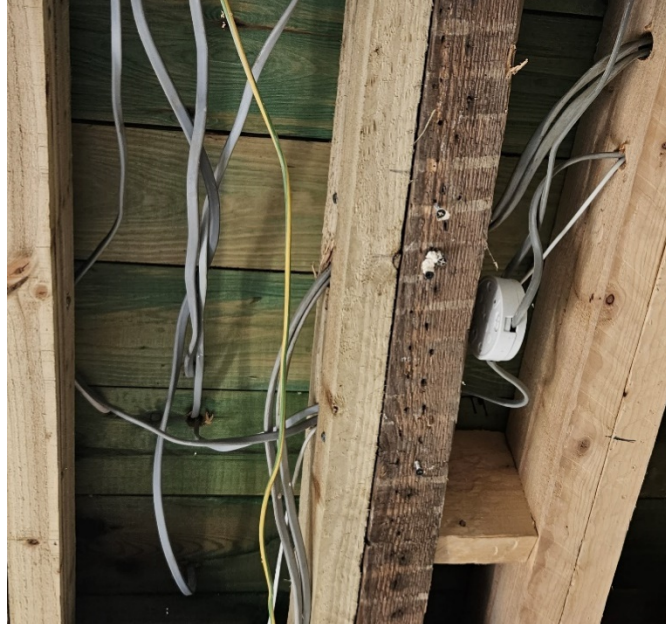
*Figure 10 – Typical Existing services distribution*

It is assumed that the more detailed physical distribution of services (ie smaller radiator pipework, waste pipes, cabling) currently travels between joists and within suspended ceilings or manifests within boxing-out. It is assumed that cabling is chased into plasterwork in the walls or runs between joists in the floors (as per the opening up undertaken to date). No lath and plaster has been found.

Distribution of services will use existing routes where possible but reverse the continued pattern of crude boxing-out. Surface-mounted wiring, conduits etc will be avoided.
