## Pre-Redevelopment Audit

For Planning

41 Sheldon Avenue

Mark Tognolini and Eva Stengaard

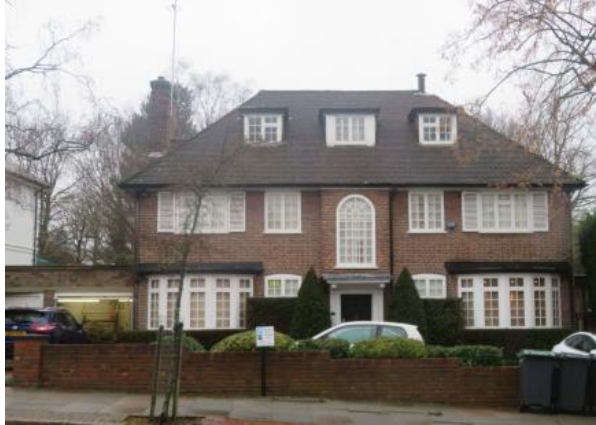
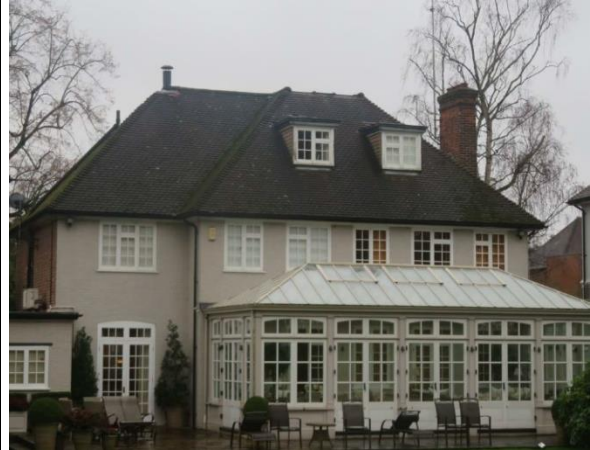
**Façade:** The main building consists of **uninsulated** brick wall (assumed is Cavity) with timber frames an single glazed windows – Garage is single solid brick wall and the roof is timber frame with felted finishes. One brick chimney and one metal flute on site.

**Condition:** The property is of age where lead paint could have been used.

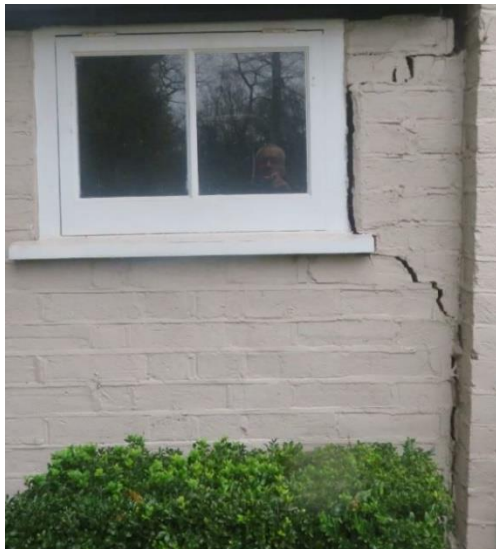
#### Brick Store

**Condition:** Not in good condition large crack observed

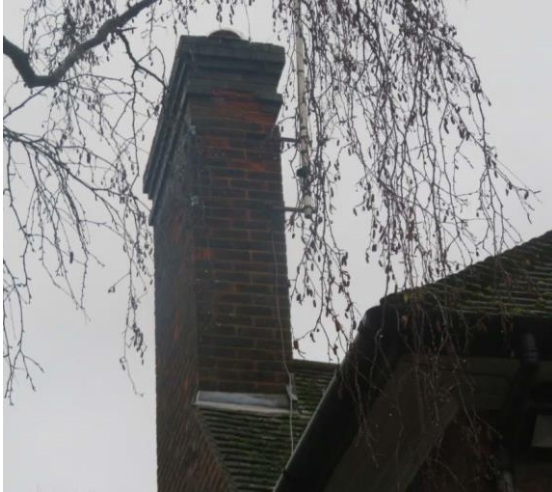
**Chimney**

**Condition:** Main chimney has some frost damage

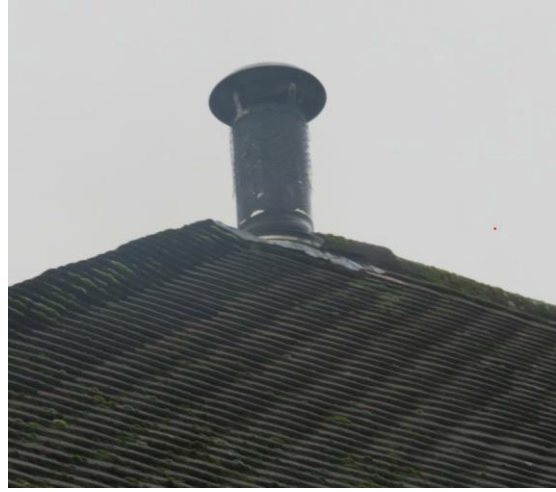
**Metal flue pipe**

**Condition:** Flashings around the flue are basic and could be prone to seepage.

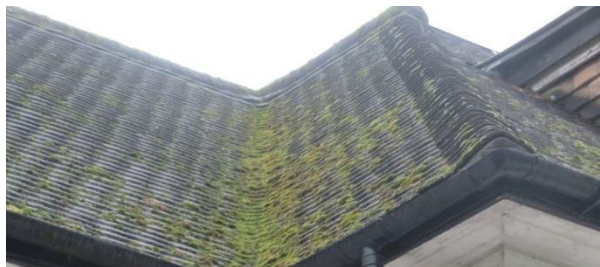
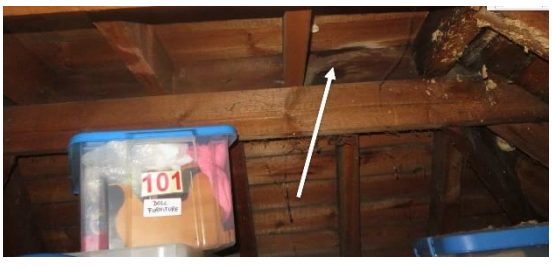
**Condition:** Poor condition with localised leaks

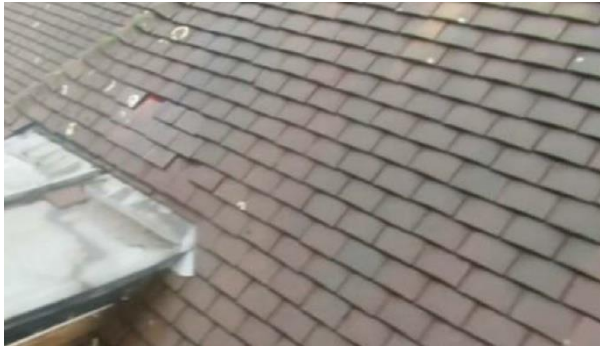
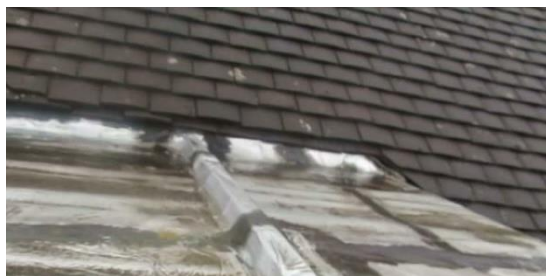
**Condition:** Poor condition with regular patching to stop water intrusion

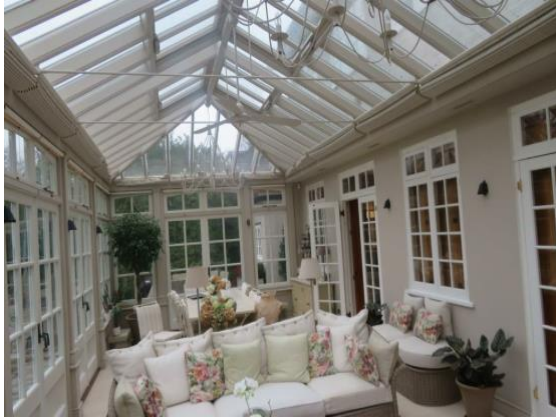
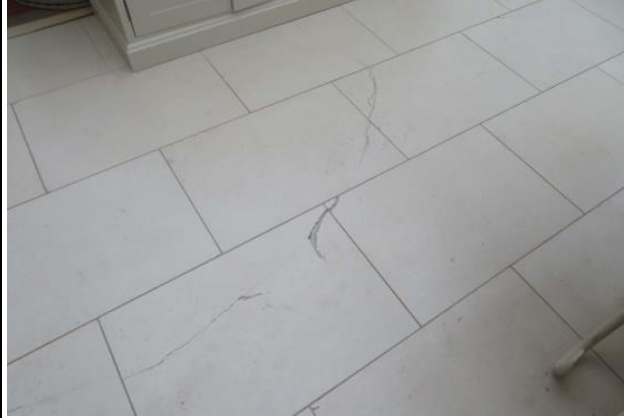
**Condition:** Floor tiling is quite bad with cracking.

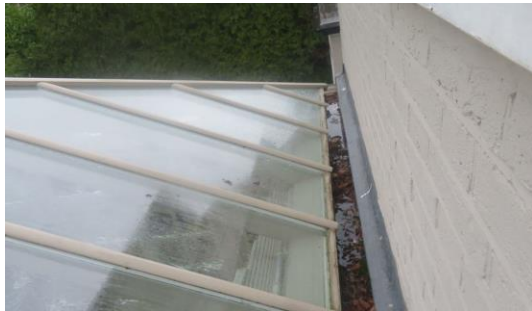
**Condition:** Average quality however patching would have to be done if the roof was retained.

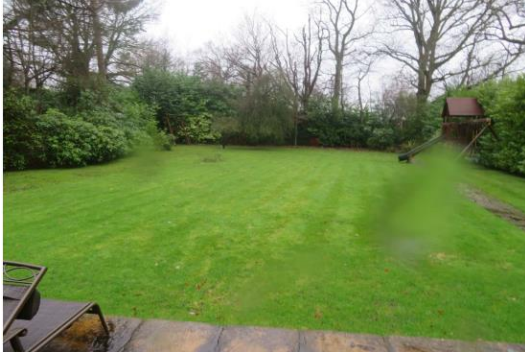
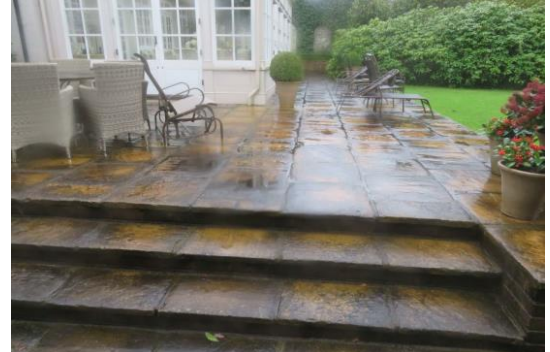
**Condition:** Adequate patio tiling but some minor cracks

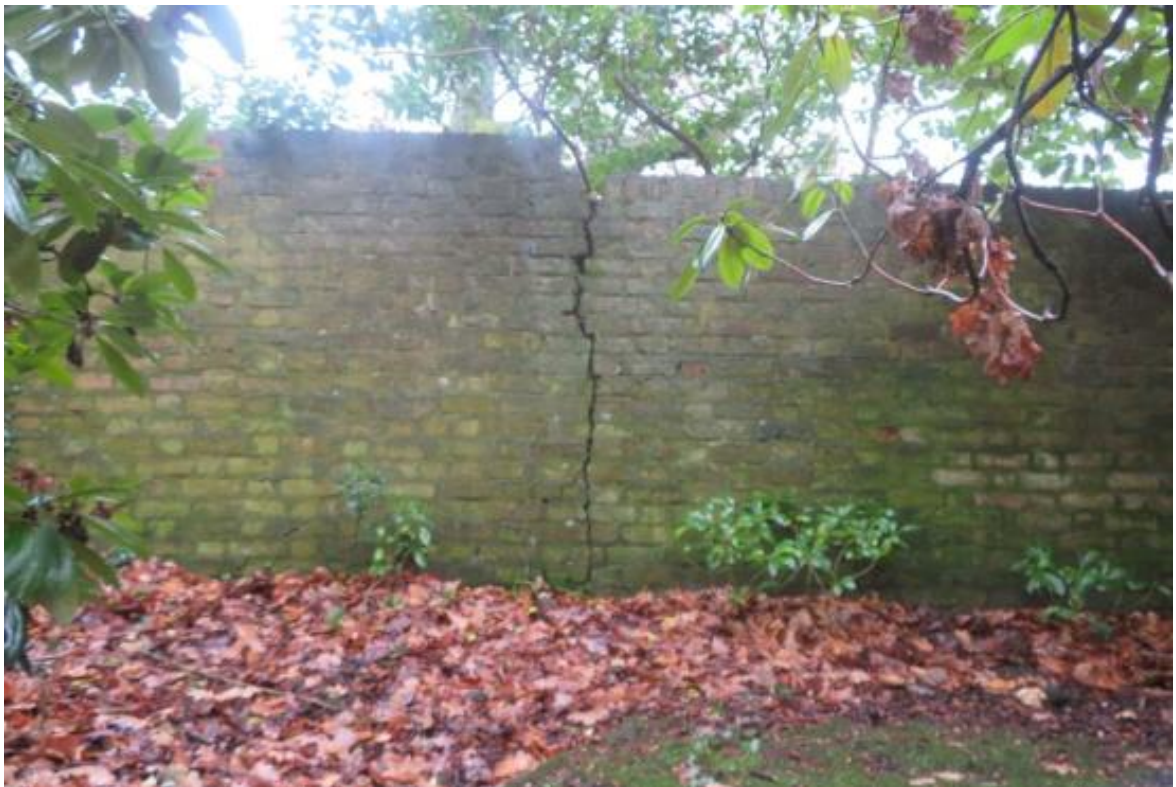
**Condition:** A large and noticeable crack that goes down the middle of the boundary wall.

The boundary walls of the property are in desperate need of repair which a major crack down the middle of the main boundary wall. The patio tiles are in adequate condition however minor cracks are beginning to form. The existing hard landscaping should therefore not be retained or re-used.
