Our Ref: 13998/AML

**Re: 23 Wolseley Road London, N8**

Derek Lofty and Associates were instructed to carry out an inspection of the above property and comment on the structural stability of the boundary wall.

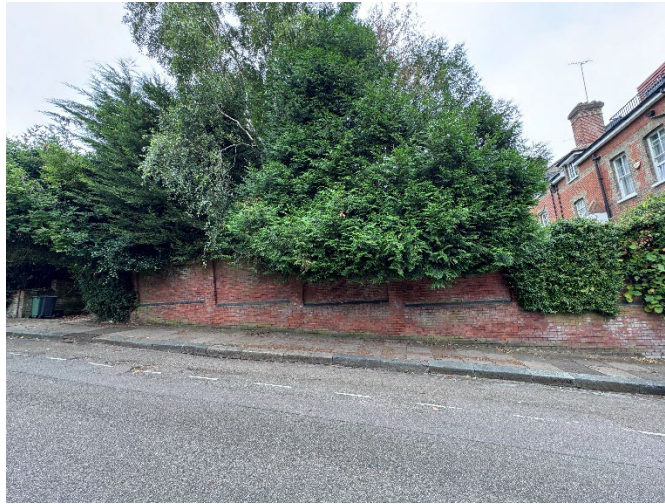
The east boundary wall on Birchington Road is a substantial masonry wall, retaining in part, and is at least 30 metres in length. The wall is constructed utilising standard format facing brick. The specific constructional details are not known, however it would seem the lower half of the wall is constructed at least 13 inches thick. The upper half of the wall reduces to 9 inches thick, with piers at regular centres of approximately 3.0 metres.

Figure 1 – Boundary Wall on Birchington Road

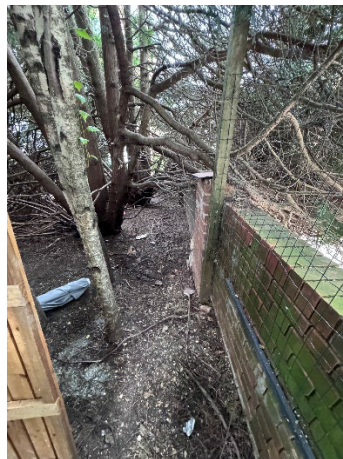
The rear most section of the garden wall within 23 Wolseley Road stands approximately 2.6 metres tall and retains approximately 1.6 metres of garden, above pavement level. A close boarded timber fence has been fixed to the head of the last section of wall too.

Figure 2 – Retained Garden and Trees Behind Wall

The rear garden of 23 Wolseley Road includes a series of mature conifer trees and bushes, most of which are in close proximity of the boundary wall.

It is recommended that the trees behind the wall are removed in a controlled manner.

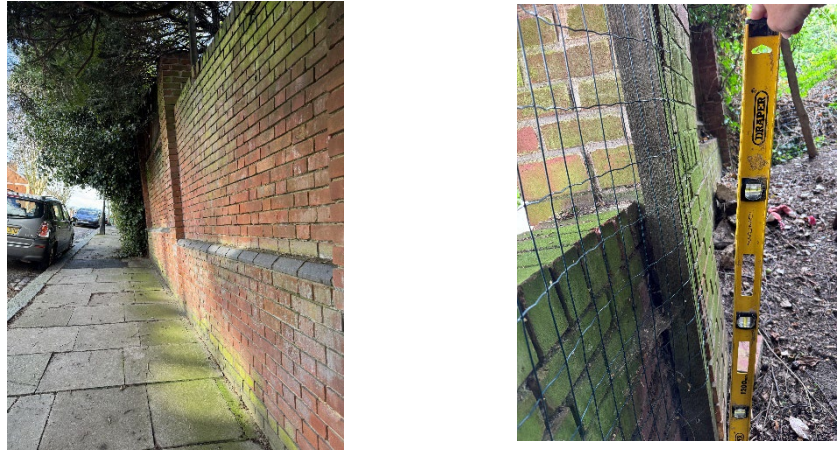
At the time of our inspection the section of wall believed to be within the demise of 42 Birchington Road was covered in vegetation and a close inspection was not possible. The wall forming the boundary wall for 23 Wolseley Road is leaning toward Birchington Road, significantly for the later 15 metres or so.

Figure 3 & 4 – Vertical lean for Later sections of Boundary Wall

A spirit level was used to determine the degree of misalignment. The lower section of wall, from pavement level to 1.2 metres above pavement level was noted to be out of vertical by 90mm. The section of wall above the retained ground was noted to be in excess of 200mm out of vertical alignment.

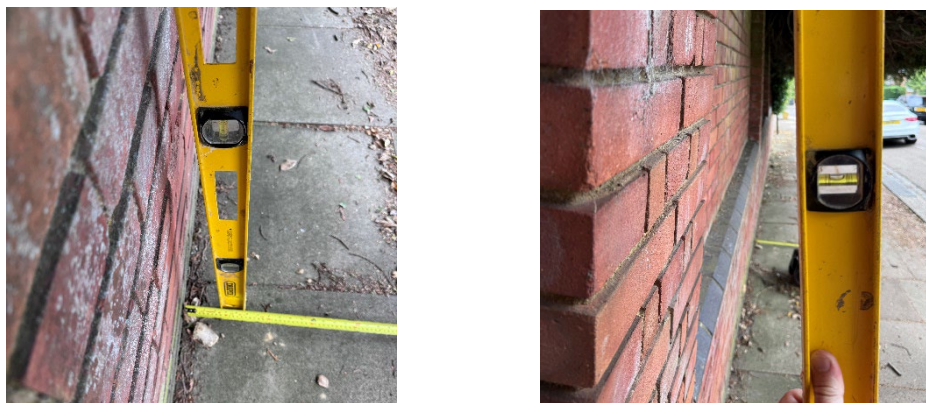
Figure 4 & 5 – Base of Wall Misalignment

At the time of our inspection vertical cracks were evident to the upper sections of the wall, between the piers of the last two bays, where the most significant misalignment is.

The wall is considered to have failed and could not be justified by calculation. Remedial works are required to either stabilise or reconstruct the wall. It is very likely that the defect is progressive. The wall is not stable and liable to collapse.

The cause of the defects to the wall are not immediately obvious, and possibly complex. It is likely that the cause is a combination of unintentional levels of retained garden coupled with pressures from the mature trees that have grown immediately behind the wall.

The retained ground can then be reduced and the upper sections of the wall that are particularly responsive removed before they fail and while the permanent solution is considered.
