## **Project**

**Project Name:** CTS-MC 0129 20-21 Cranwood House  
**Project Description:** CCTV Survey Route Inspection  
**Project Status:** On Site  
**Project Date:** 08/06/2021  
**Inspection Standard:** MSCC5 Sewers & Drainage GB (SRM5 Scoring)

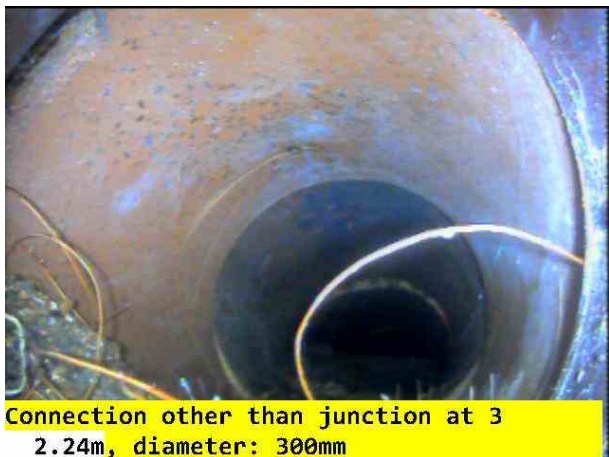
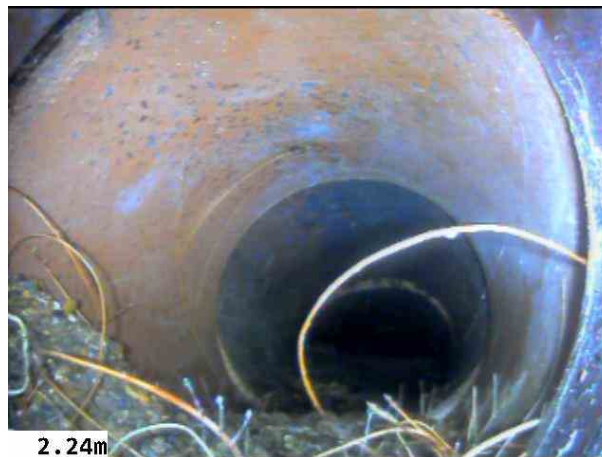
Garden  
1X\_d04540f9-b93c-4312-8144-1464a774e2c5\_20210608\_215  
200\_630.jpg, 00:01:29, 2.24 m  
Connection other than junction at 3 o'clock, diameter: 300mm,  
connection

Garden  
1X\_dd4cb79b-82fb-4b5c-800c-06b83d48be8d\_20210608\_215  
203\_709.jpg, 00:01:29, 2.24 m  
Connection other than junction at 3 o'clock, diameter: 300mm,  
connection

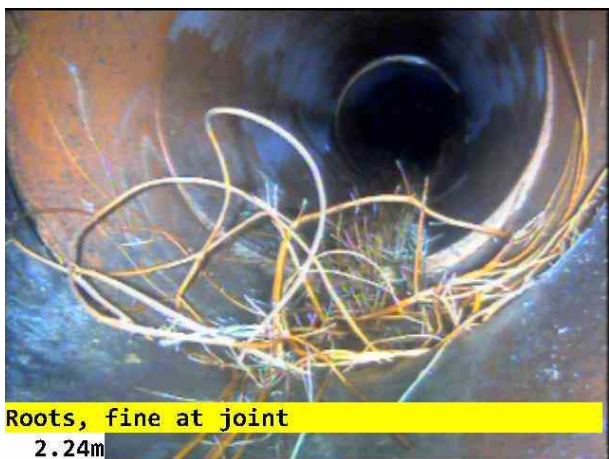
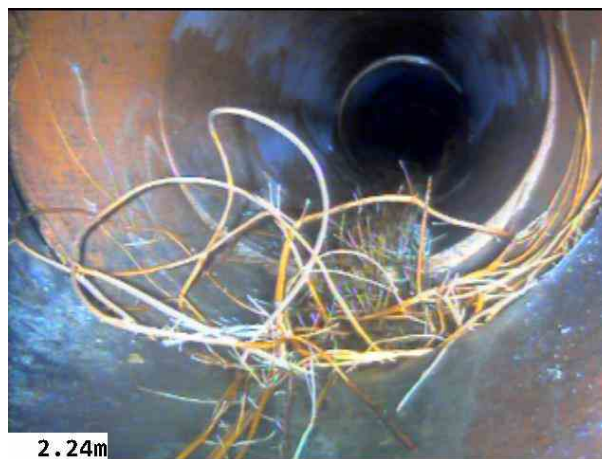
| Scale: 1:79 | Position [m] | Code | Observation | MPEG | Photo | Grade |
|---|---|---|---|---|---|---|
| 2.24 | RFJ | Roots, fine at joint: fine roots in joint | 00:01:45 | Garden 1X_bfc166f0-2869-4c | | 2 |

Garden  
1X\_bfc166f0-2869-4cab-ba87-cd3921366bdd\_20210608\_2152  
51\_765.jpg, 00:01:45, 2.24 m  
Roots, fine at joint, fine roots in joint

Garden  
1X\_4517b416-12e5-4861-985b-eae0c8bead6b\_20210608\_215  
255\_277.jpg, 00:01:45, 2.24 m  
Roots, fine at joint, fine roots in joint

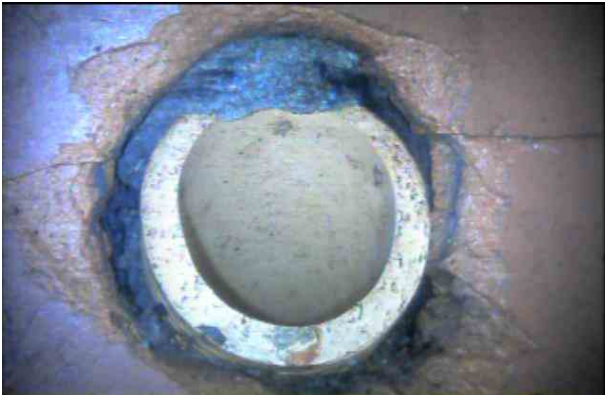
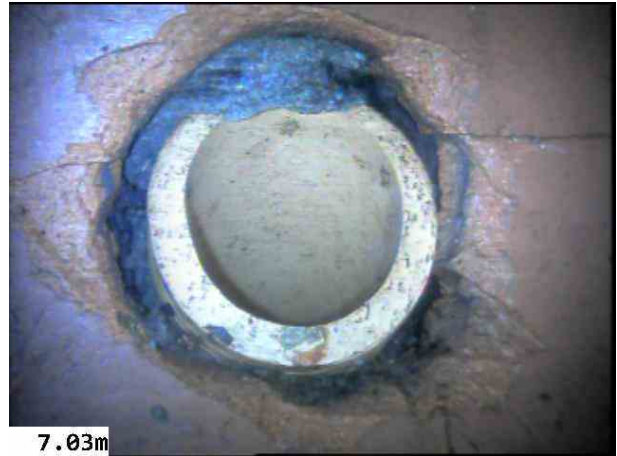
Garden  
1X\_37f0d21a-f97c-4cae-b499-1213055a06a0\_20210608\_2154  
23\_530.jpg, 00:03:01, 7.03 m  
Connection other than junction at 12 o'clock, diameter: 100mm,  
connection

Garden  
1X\_077501f0-4d3e-4c4e-886b-704c87fc9377\_20210608\_2154  
26\_358.jpg, 00:03:01, 7.03 m  
Connection other than junction at 12 o'clock, diameter: 100mm,  
connection

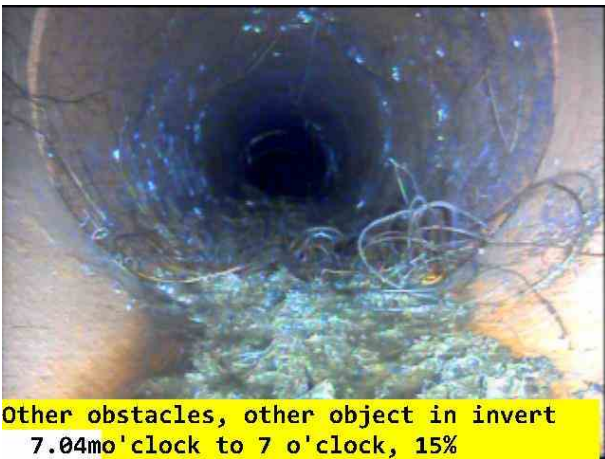
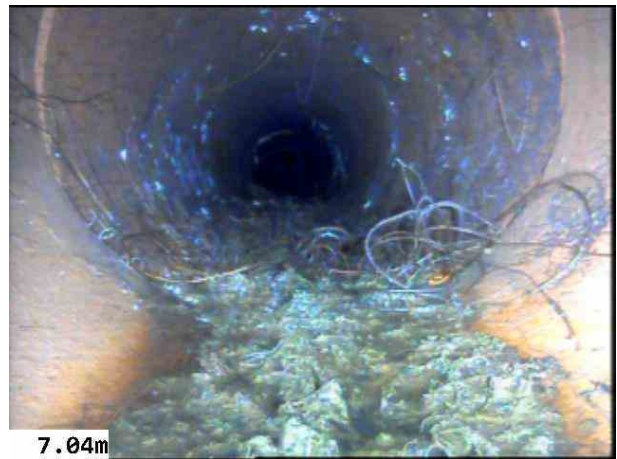
| Scale: 1:79 | Position [m] | Code | Observation | MPEG | Photo | Grade |
|---|---|---|---|---|---|---|
| 7.04 | S01 | OBX Other obstacles, other object in invert from 5 o'clock to 7 o'clock, 15% cross-sectional area loss, start: debris in pipe | 00:03:19 | Garden 1X_bf916249-7f9a-47 | | 5 |

Garden  
1X\_bf916249-7f9a-4707-bdb8-e101dd684cdd\_20210608\_2155  
03\_862.jpg, 00:03:19, 7.04 m  
Other obstacles, other object in invert from 5 o'clock to 7  
o'clock, 15% cross-sectional area loss, start, debris in pipe

Garden  
1X\_32862a37-9c63-4a7d-aa82-10fe5cc42024\_20210608\_215  
507\_136.jpg, 00:03:19, 7.04 m  
Other obstacles, other object in invert from 5 o'clock to 7  
o'clock, 15% cross-sectional area loss, start, debris in pipe

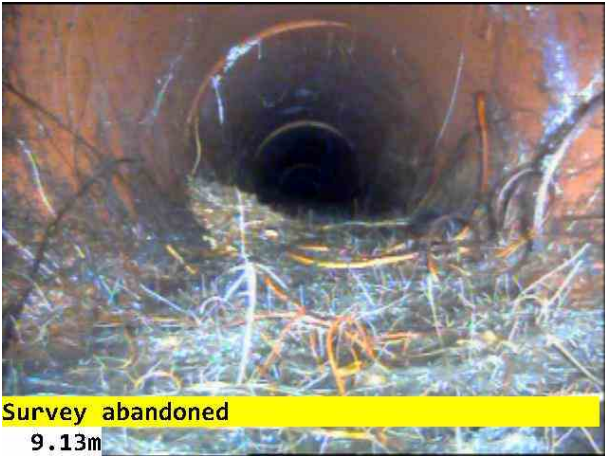
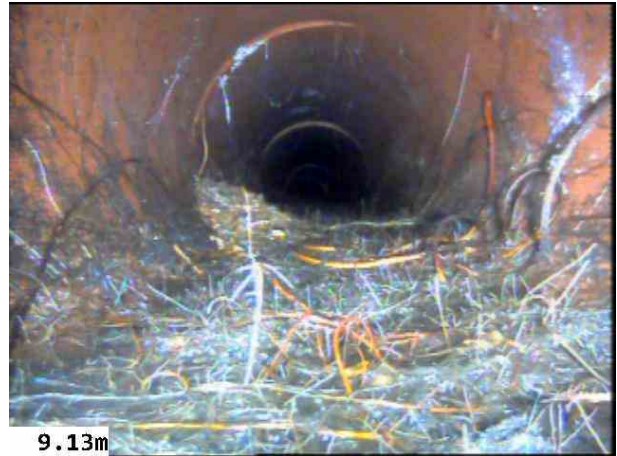
Garden  
1X\_fc882bd2-6db1-48c2-99b8-78ec3c304a44\_20210608\_220154\_280.jpg, 00:08:25, 9.13 m  
Survey abandoned, survey abandoned due to crawler unable to get pass debris

Garden  
1X\_a6664f8a-d5d2-485e-9306-ae7d85adfb9a\_20210608\_220203\_442.jpg, 00:08:25, 9.13 m  
Survey abandoned, survey abandoned due to crawler unable to get pass debris

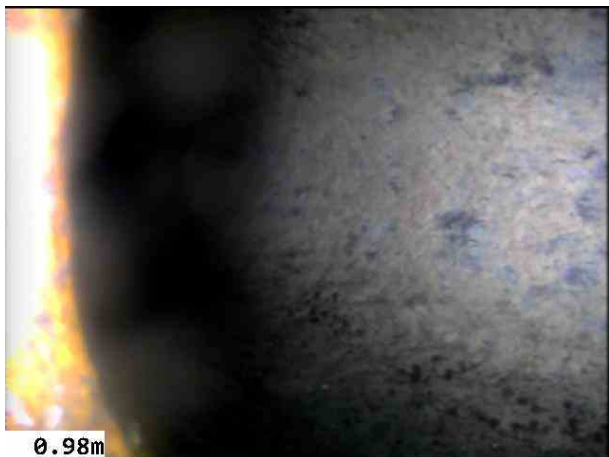
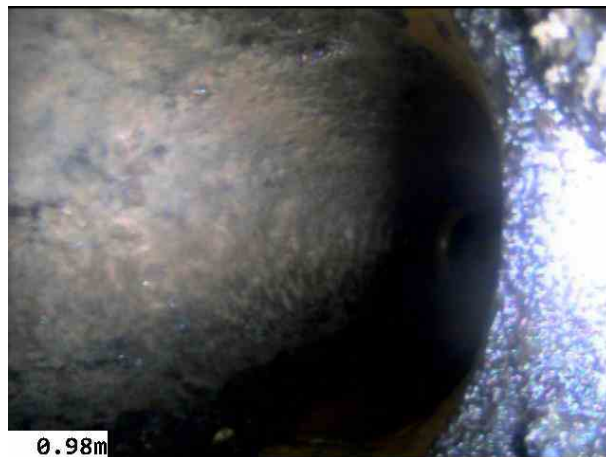
Prop  
MH2X\_5242af46-9029-4e30-9d06-4533e935abaf\_20210608\_2  
23903\_454.jpg, 00:01:15, 0.98 m  
General photograph taken at this point, Poss backdrop in pipe

Prop  
MH2X\_b69b6607-2d40-46c7-aa44-2af71f9207bb\_20210608\_2  
23918\_244.jpg, 00:01:15, 0.98 m  
General photograph taken at this point, Poss backdrop in pipe
