# **Hornsey Town Hall**

## **Planning Report – Heritage Areas**

### **January 2025**

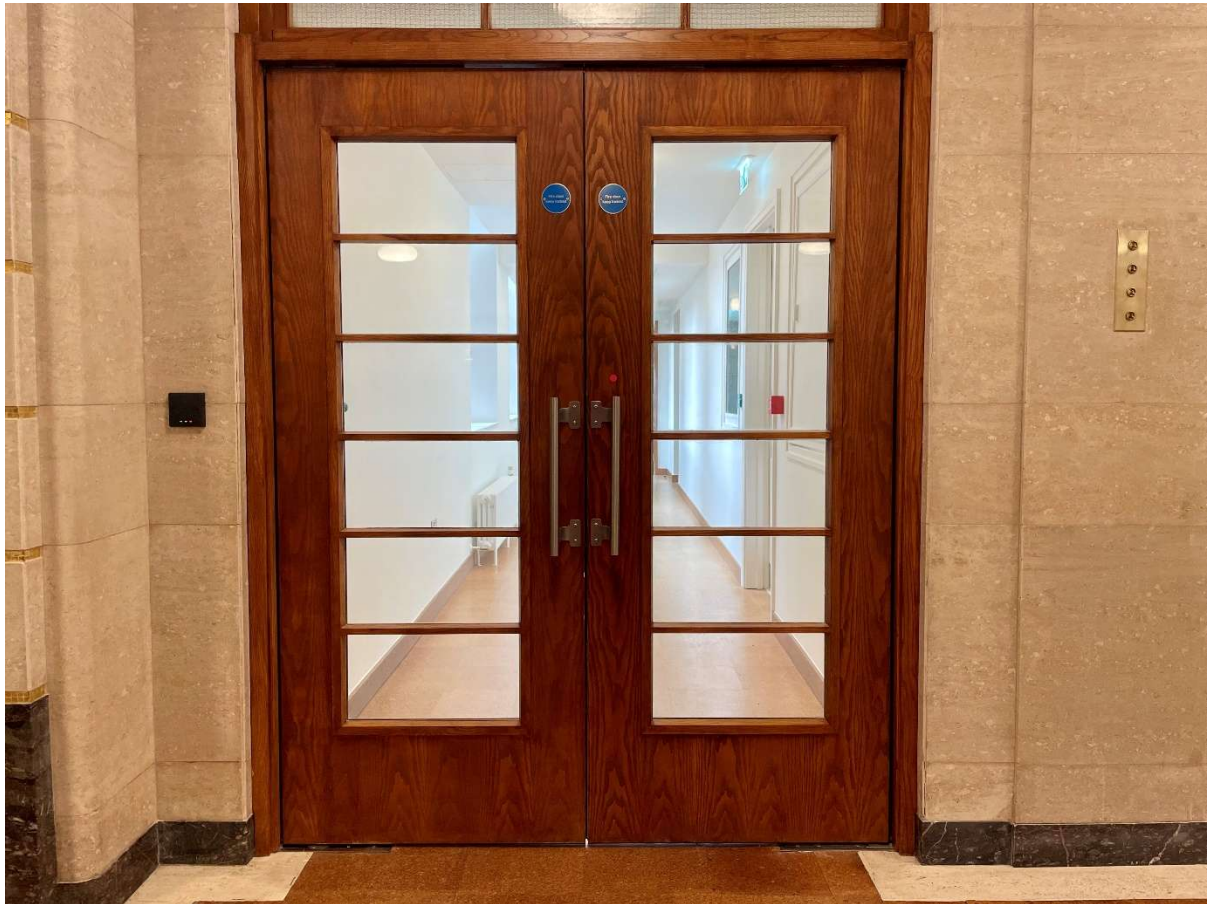
New door to level 1 corridor with existing overhead glazed panel
