**Project Name:** BRUNEL\_WALK\_14\_5\_24

**Project Description:** WinCan Import in Miraculix Standard

**Project Date:** 14/05/2024

**Company:** Selsdon Bulders  
**Street:** Brunel Walk  
**Town or City:** London  
**County:** N155HG

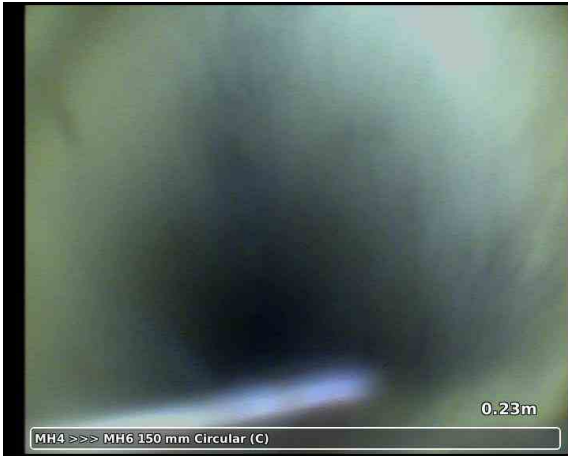
20240514-113734-snap0000.jpg, 00:00:05, 0.00 m  
Roots, ROTS

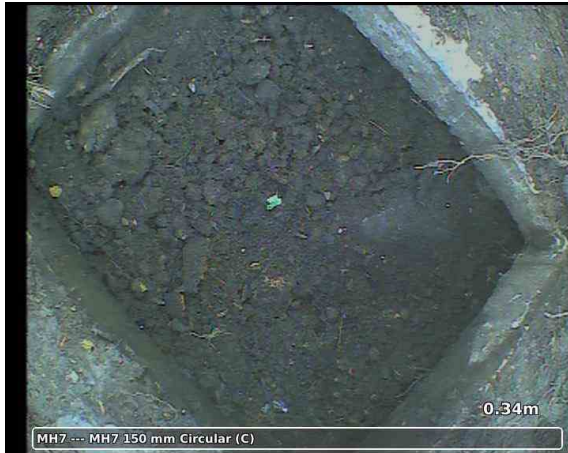
| Scale: | 1:50 | Position [m] | Code | Observation | MPEG | Photo | Grade |
|---|---|---|---|---|---|---|---|
| | | 0.34 | SA | Survey abandoned: BLOCKED | 00:00:22 | 20240514-114626-sn ap0000.jpg | A |

20240514-114626-snap0000.jpg, 00:00:22, 0.34 m  
Survey abandoned, BLOCKED

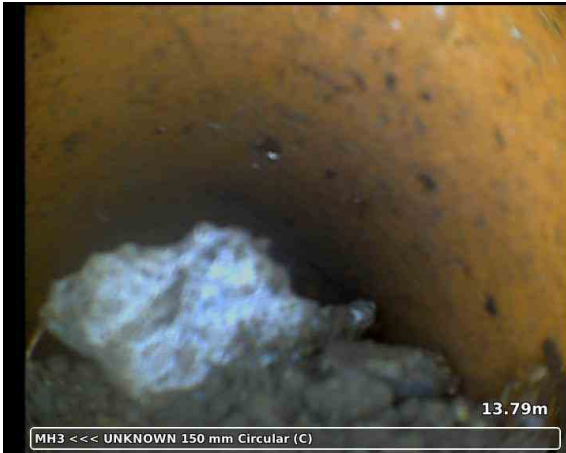
| Scale: 1:115 | Position [m] | Code | Observation | MPEG | Photo | Grade |
|---|---|---|---|---|---|---|
| | 13.79 | SA | Survey abandoned: DEBRIS/REDUNDANT | 00:01:47 | 20240514-120030-sn<br>ap0000.jpg | A |

20240514-120030-snap0000.jpg, 00:01:47, 13.79 m  
Survey abandoned, DEBRIS/REDUNDANT
