## Arboricultural Impact Assessment

The Mallinson Sports Centre  
Bishopswood Road  
Highgate  
London  
N6 4NY

Highgate School  
North Road  
London  
N6 4AY

Survey Date: 21<sup>st</sup> February 2025  
Report Date: 25<sup>th</sup> March 2025  
Project no: 380.1

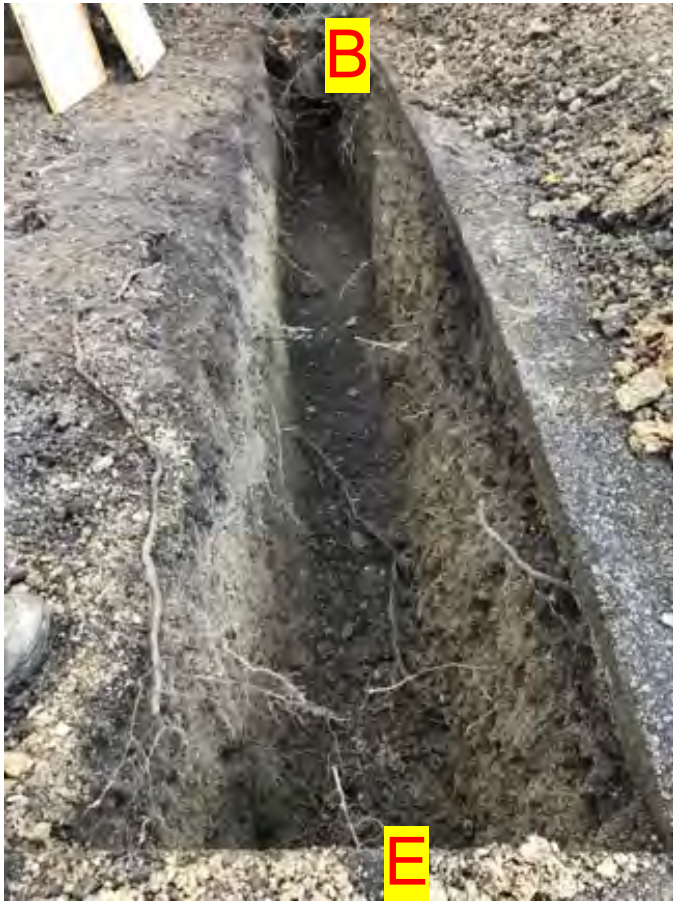
### Trench E to B

- 0.9m below asphalt surface
- 60mm asphalt, 200mm sub-base
- very few roots, largest 9mm, approx. 20 others <5mm (some dead)

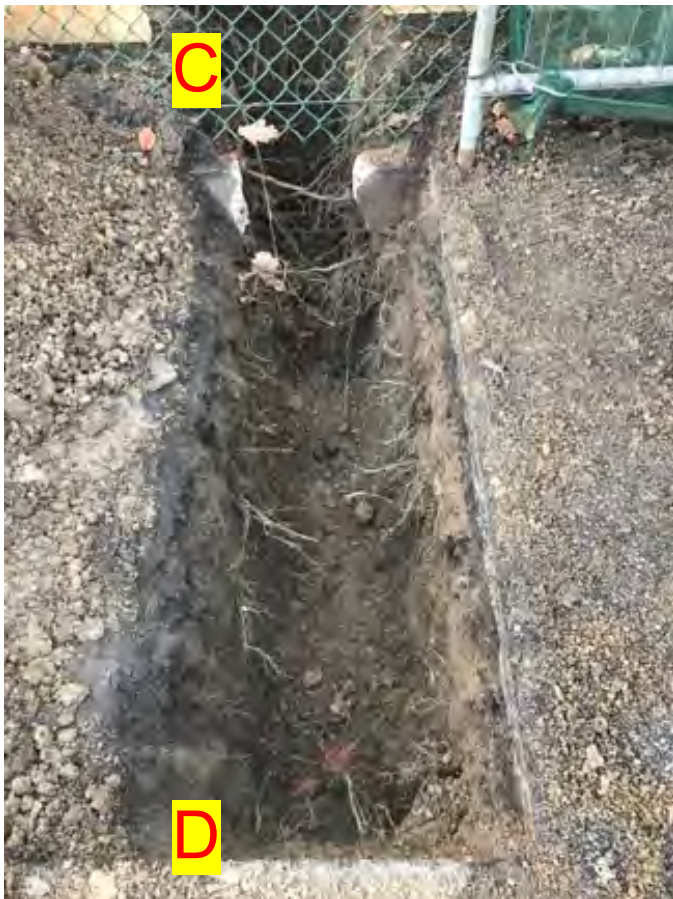
### Trench C to D

- 0.7m below asphalt surface
- 60mm asphalt, 200mm sub-base
- largest root 7mm, approx. 20 others <5mm
- with a mass of roots at C

VERY LITTLE ROOT GROWTH SEEN UNDER THE ASPHALT COURTS, BUT EXTENSIVE ROOT GROWTH JUST OUTSIDE. IF LINE OF EXCAVATION FOR FOUNDATIONS CAN BE KEPT 1m BACK FROM THE EDGE OF THE COURTS THERE WILL BE MINIMAL ROOT DAMAGE

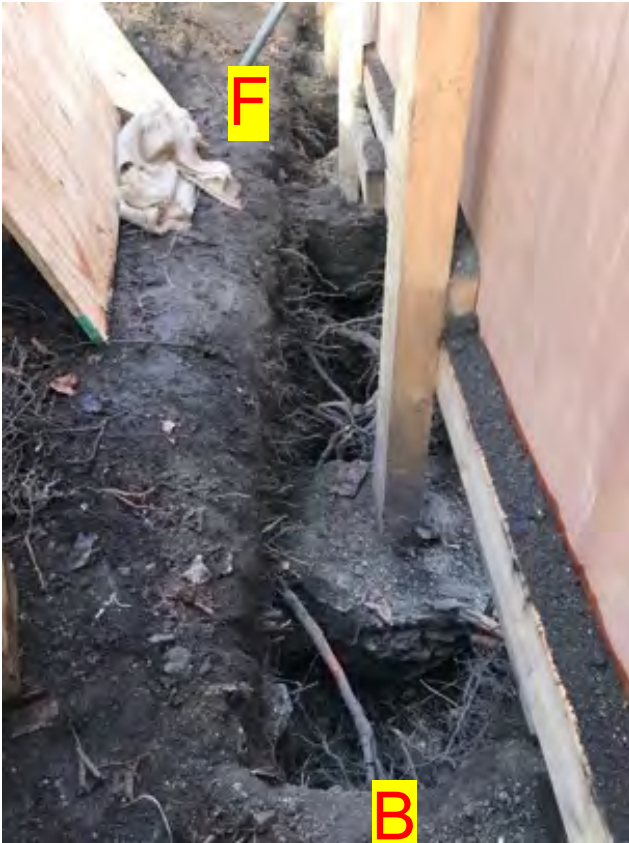
### Trench B to F

-dug to 0.8m

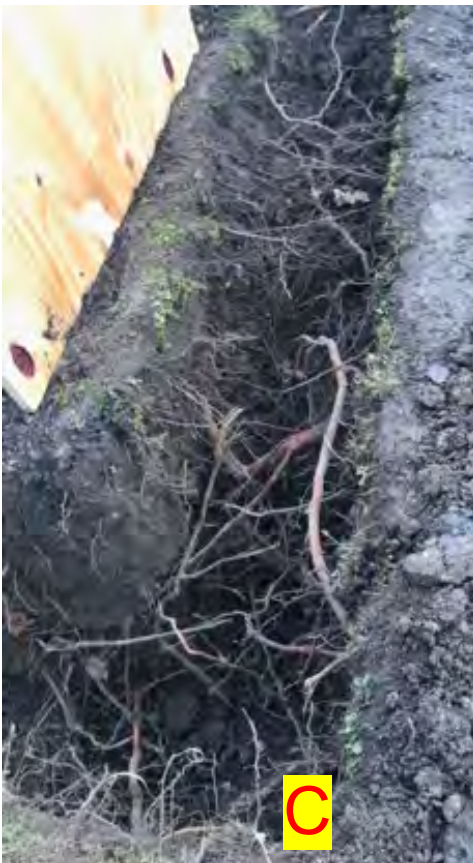
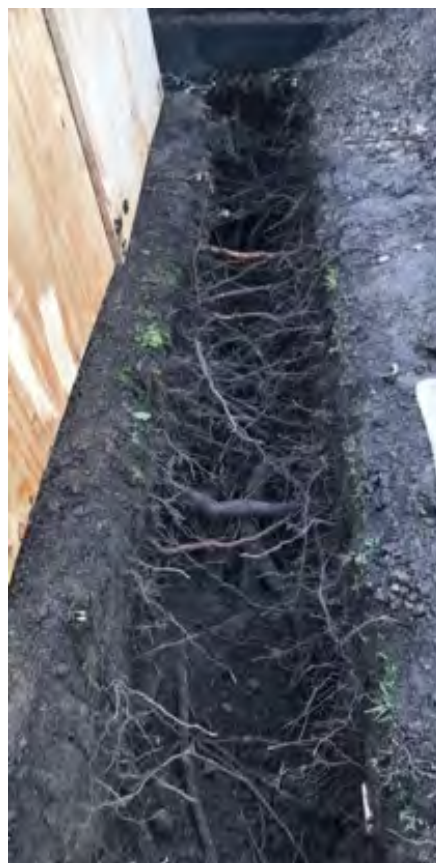
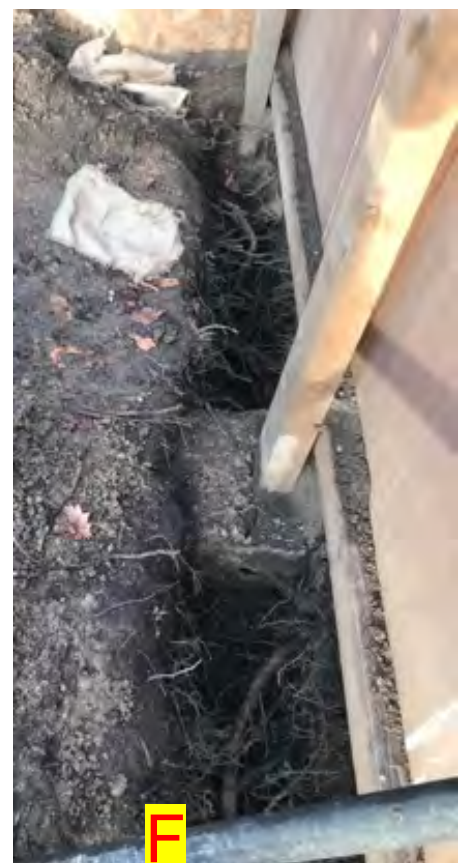
-dug 0.3m to 0.8m depth

- a mass of fibrous roots in top 250mm, then number reducing with depth.
- roots 12, 13, 20, 22, 28, 30, 35 and 38mm
- 23no roots c10mm
- 34no roots 5-10mm
- numerous roots < 5mm

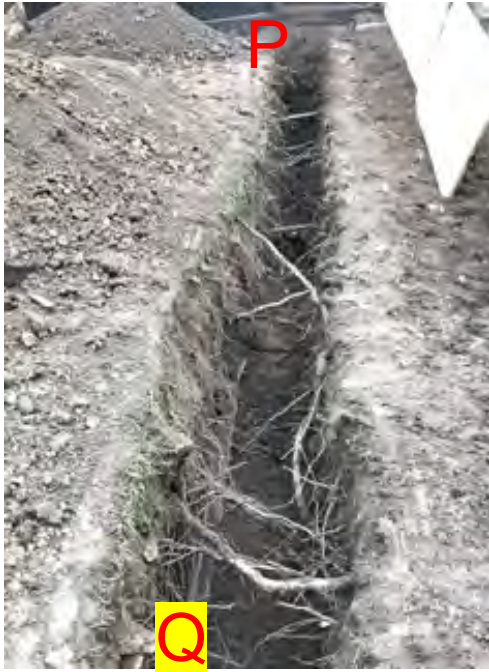
### Trench P to Q

-dug 0.8m to 0.9m depth

- a reasonable number of roots: none of great size
- roots 12, 15, 20, 20 and 26mm
- 3no roots c10mm
- 11no roots 5-10mm
- a reasonable number of roots < 5mm in top 300mm

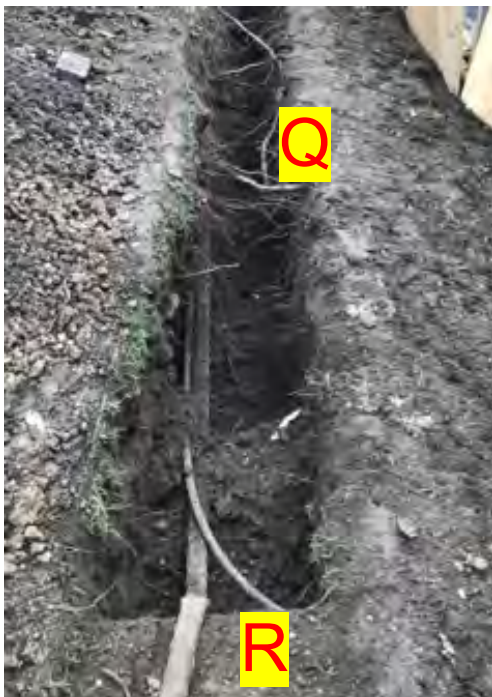
### Trench Q to R

-dug 0.8m to 0.9m depth

- very few roots
- no roots over 10mm
- 2no roots 5-10mm
- a minimal number of roots < 5mm

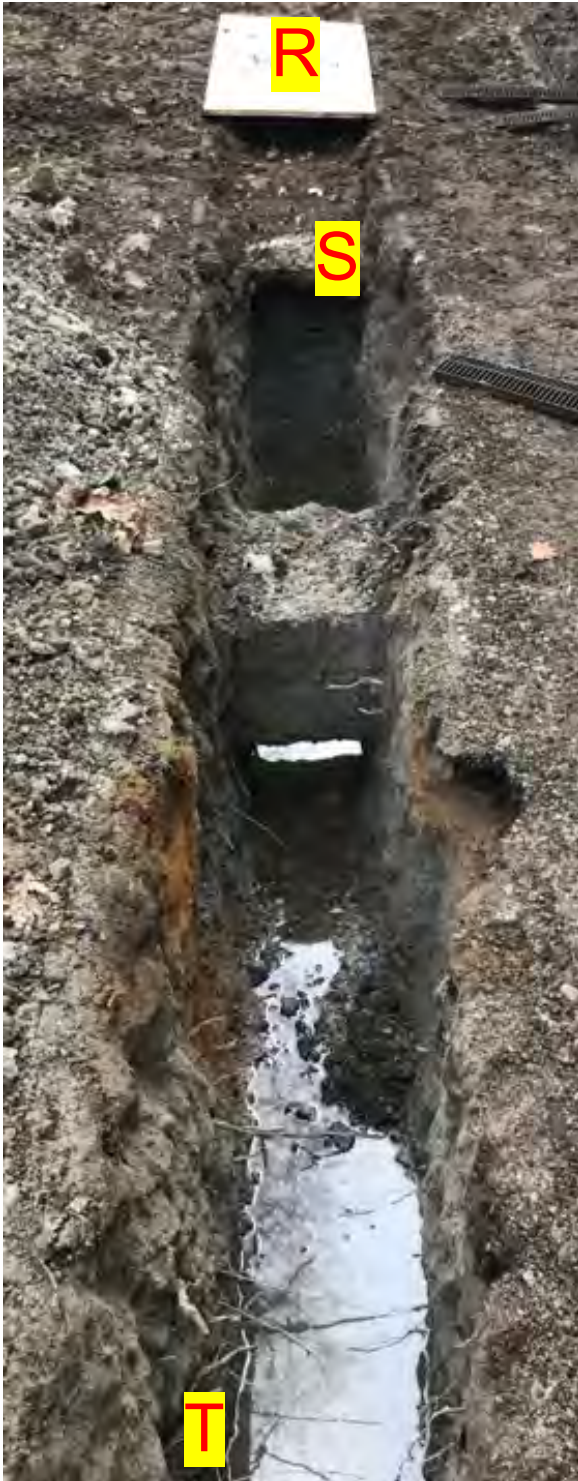
R to S

- solid concrete 75mm below surface and approx. 250mm deep
- little sign of root growth underneath

- 300 by 300mm concrete "bridge"
- very minimal root growth
- no roots over 5mm
- minimal roots <5mm

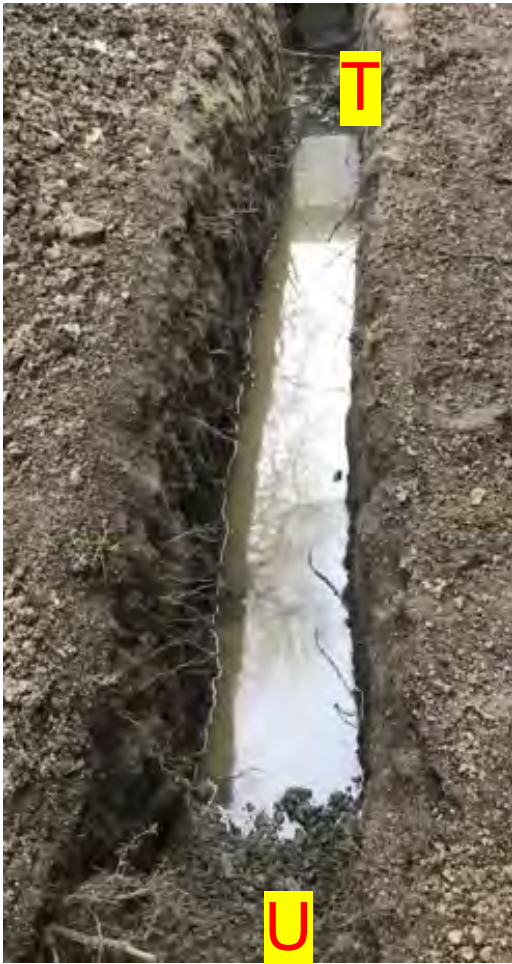
### Trench T to U

- dug to 0.9m depth
- very few roots found
- No roots > 10mm
- 3no roots 5-10mm
- approx 20 roots < 5mm

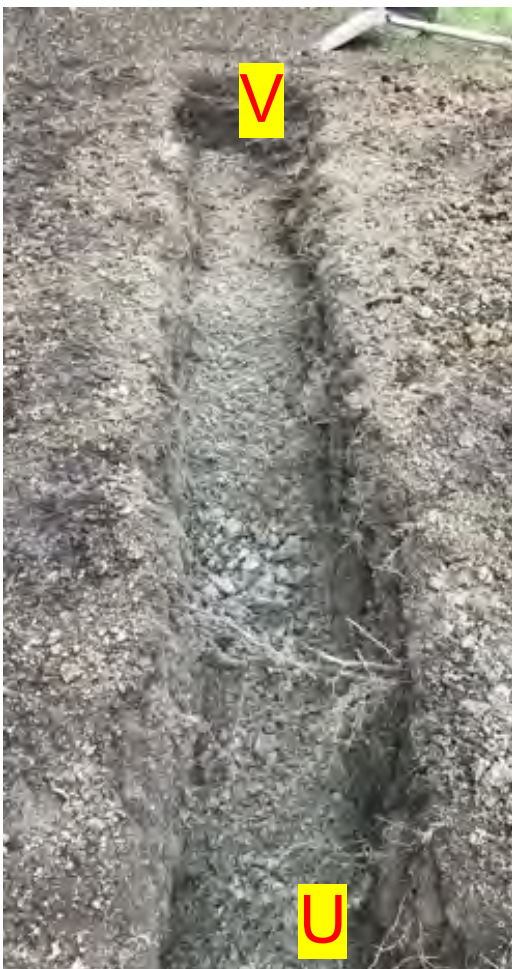
### Trench U to V

- dug to 0.3m -0.5m depth when inspected
- fibrous root found, but few larger roots
- no roots > 10mm
- 1no roots 5-10mm
- many roots < 5mm close to surface

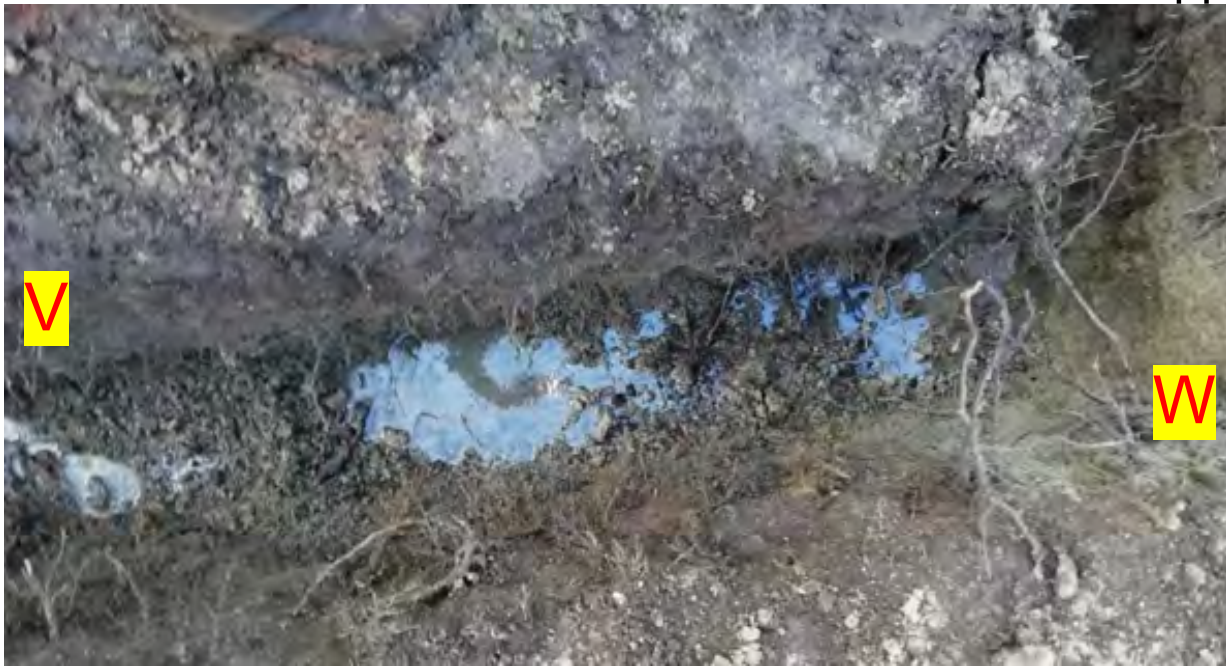
Trench V to W

-dug to 0.9m depth, 1 root c5mm. Many small fibrous roots but all <5mm

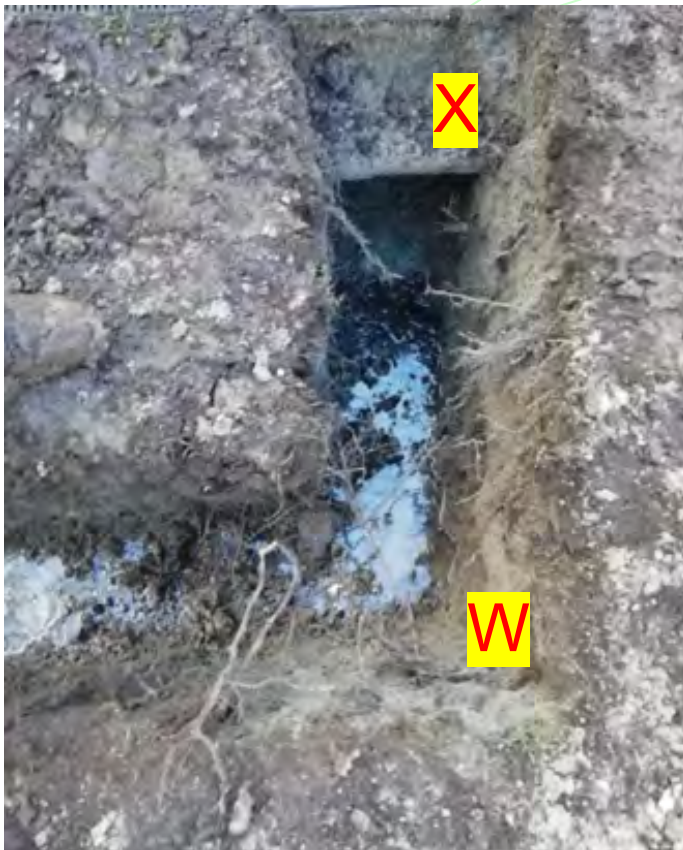
Trench W to X

- dug to 0.9m
- 2no roots c5mm
- fibrous roots < 5mm

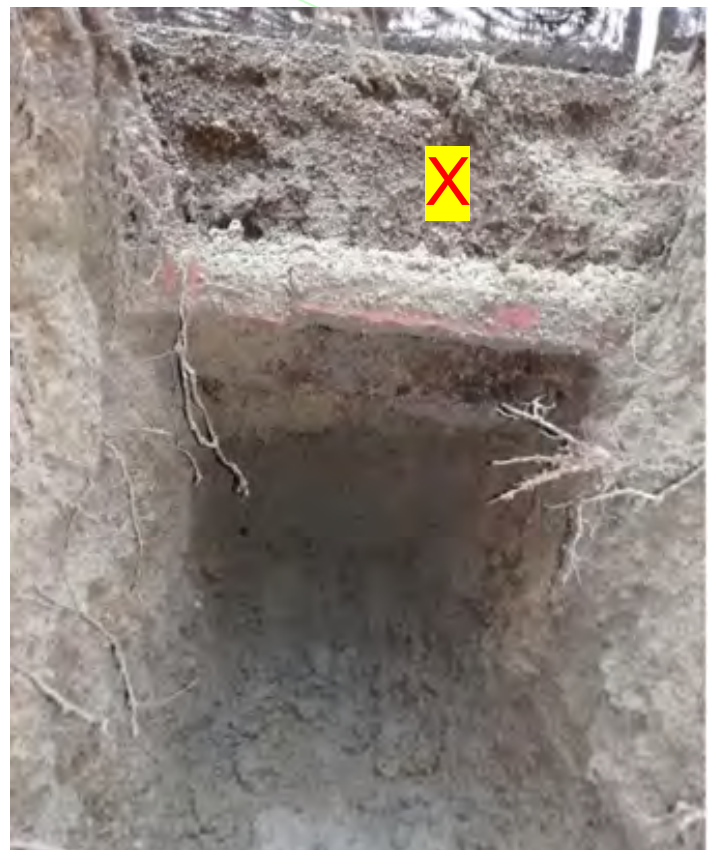
At X, burrowed under  
playground: almost no roots  
Found underneath
