**BRAEMAR AVENUE BAPTIST CHURCH AND CHURCH HALL**

**BRAEMAR AVENUE  
WOOD GREEN  
LONDON N22**

**PRELIMINARY ROOST ASSESSMENT**

**CLIVE HERBERT**

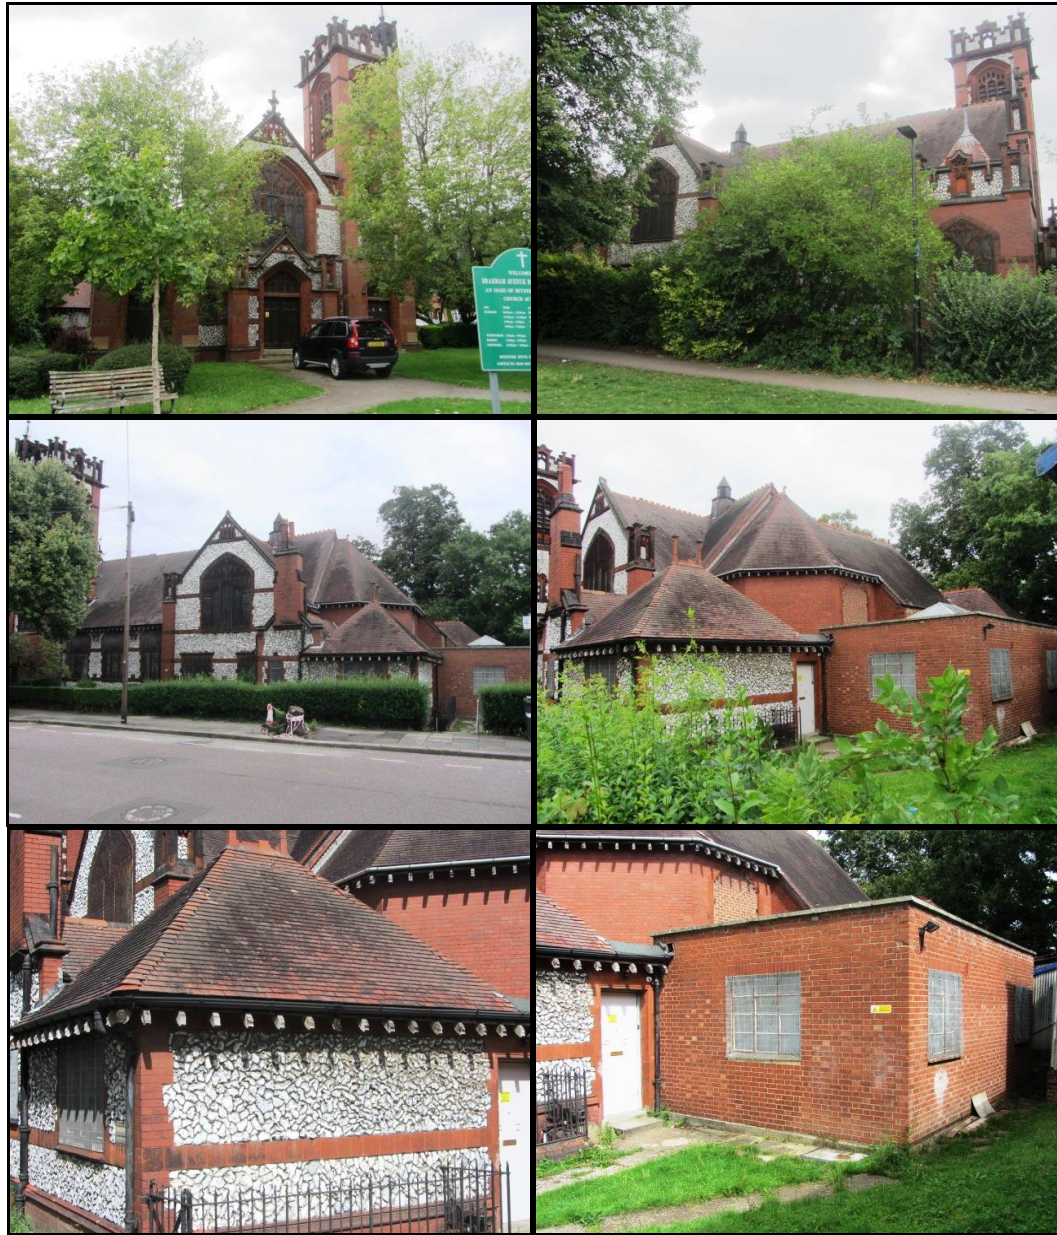
The proposed development footprint comprises a brick-built church, with a tower on the front elevation, located on the south side of Bounds Green Road (A109) between Braemar Avenue and Nightingale Gardens parkland (see photographs 1 - 6 below).

As a result of the structure of the building, with no potential bat access points or roost features identified, it was assessed to be of 'negligible potential' as a roost site for bats.

Photographs 1 - 6: Braemar Avenue Baptist Church - front, rear & side elevations

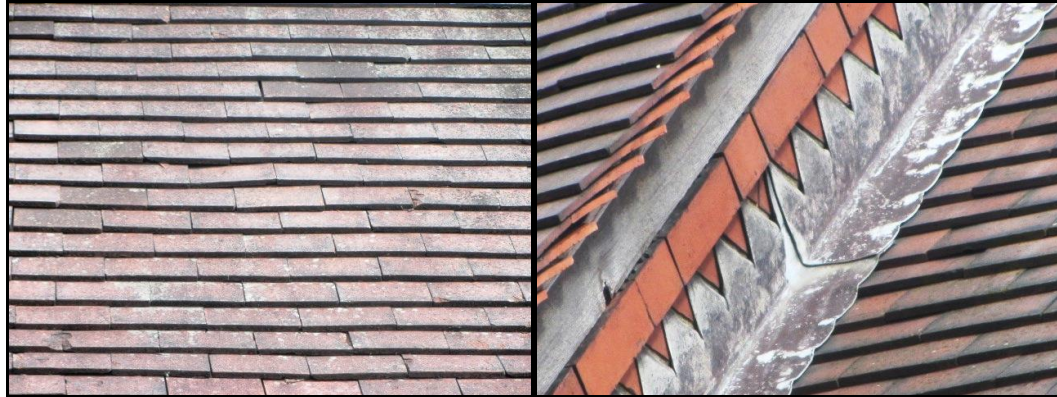
The main church building has a suite of tile-covered roofs at different levels that are all in reasonable condition with only minor damage to the tiles and no missing mortar or other gaps visible that could act as potential bat ingress points (see photograph 7 below).

The valleys and associated flashings also appeared to be tight-fitting with no obvious gaps for bat access (see photograph 8 below). There are no chimneys present.

Photographs 7 - 8: Close-fitting roof tiles & valley flashing

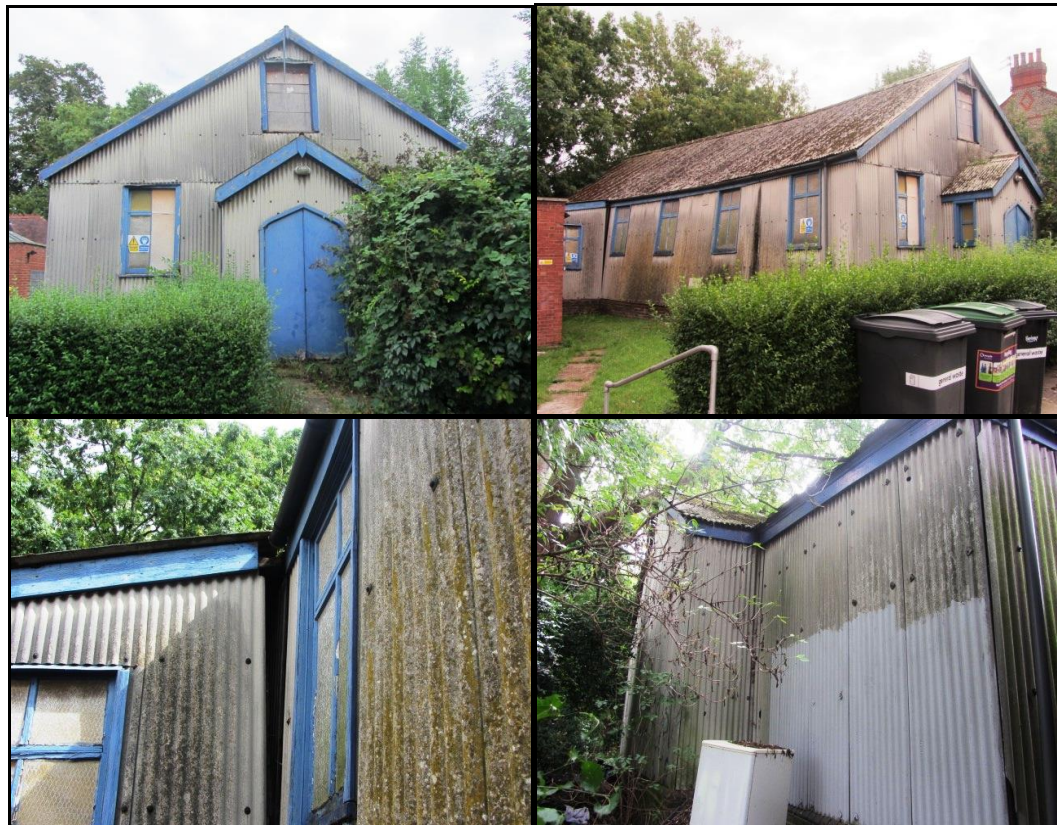
The proposed development footprint comprises an adjacent church hall, located to the south of the main church (see photographs 9 - 12 below). The building is derelict and has not been used for many years. It shows signs of obvious decay and the walls are bowing and separating in places.

Photographs 9 - 12: Church Hall

As a result of the structure of the building, materials used and the complete lack of potential roost features, the church hall was assessed to be of 'negligible potential' as a roost site for bats.

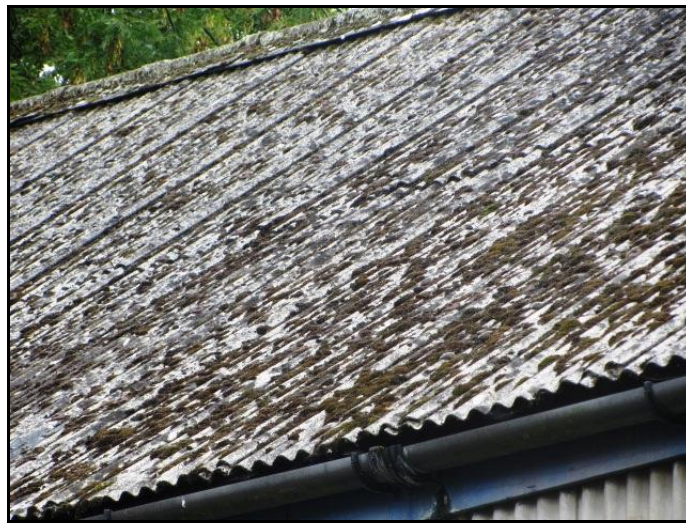
The building has a pitched, sloping roof corrugated iron roof (see photograph 13 below) and asbestos walls. There is no loft void present and no chimneys. The structure and materials used for the roof covering were considered to provide no suitable roosting opportunities for bats.

Photograph 13: Roof sheeting
