Existing Building

Key Internal Spaces - Registrar and North Wing Offices

External Fabric Condition

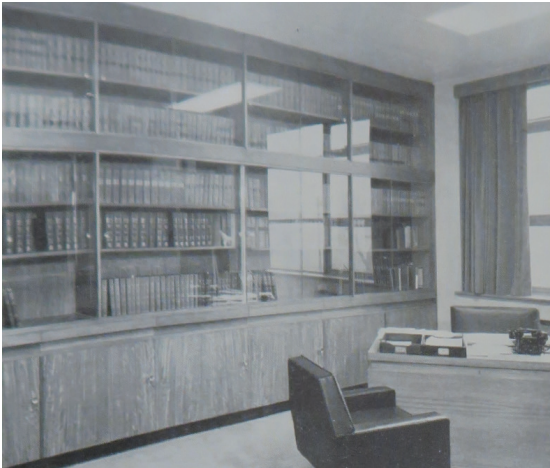
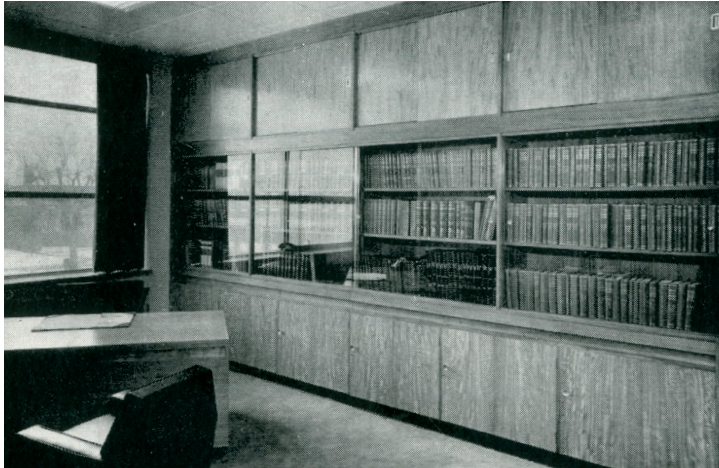
North Wing Meeting Room

- Features
- Frenger Ceiling

Timber panelling & cupboards
- Pre-Enabling Works Condition
- Asbestos above ceilings

Non-Original carpet

Vertical Blinds

Original brass clocks removed

Scratched joinery
- Post-Enabling Works Condition
- Asbestos ceiling removed

Carpet Removed & Blinds Removed (Curtain track retained)

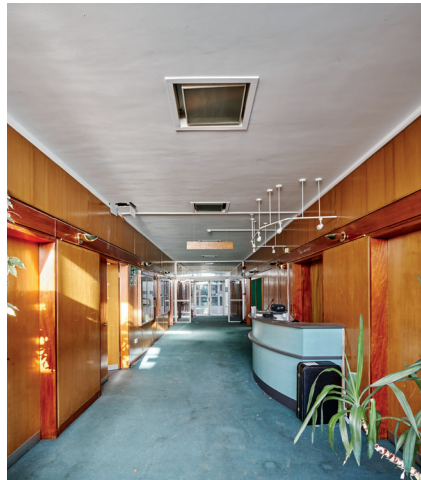
Registrars

- Features
- Plaster ceiling

Barrel vaulted in main wedding room

Timber panelling & cupboards
- Pre-Enabling Works Condition
- Asbestos above ceilings

Non-Original carpet

Vertical Blinds

Original brass clocks removed

Scratched joinery
- Post-Enabling Works Condition
- Asbestos removed

Carpets & Blinds Removed (Curtain track retained)

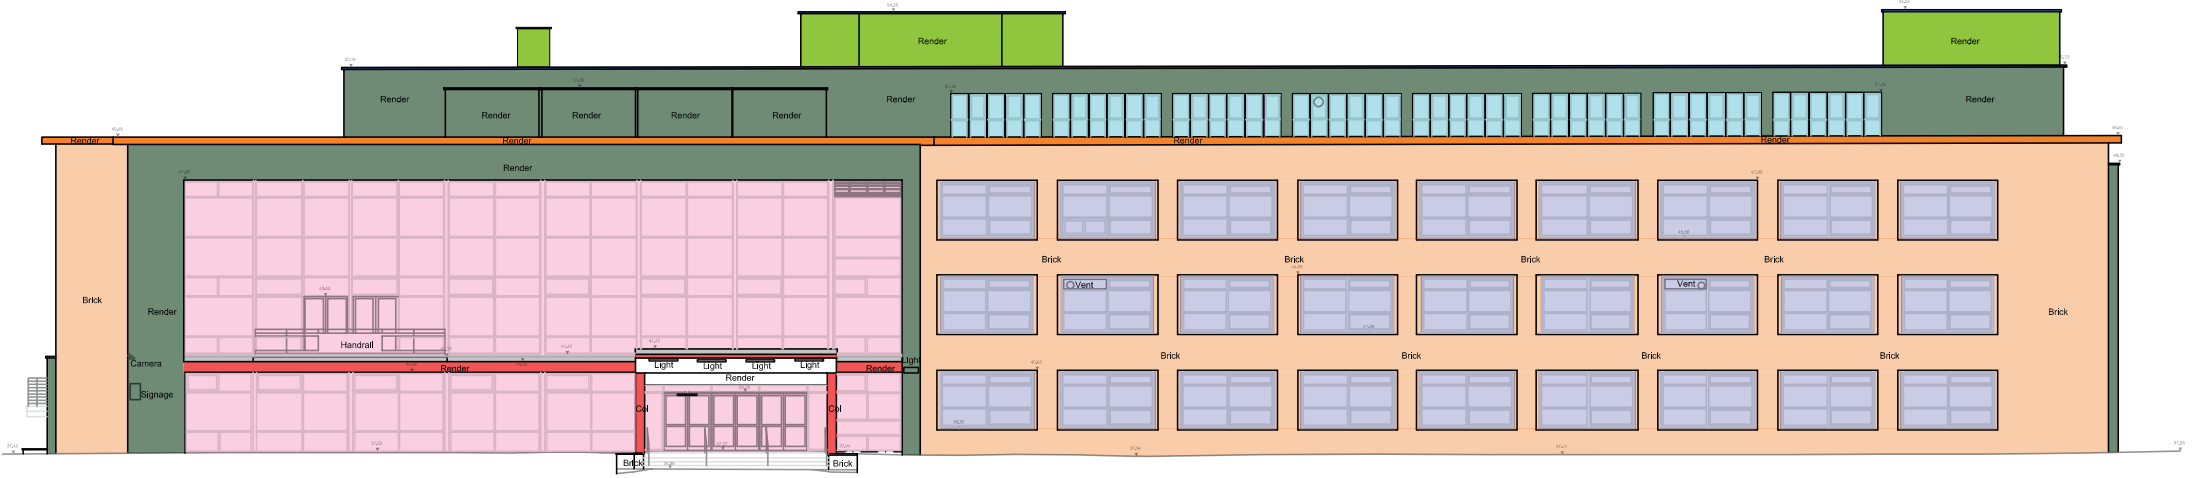
East Facade (Front)

Facing brickwork to all elevations is in fair condition, and cleaning, local re-pointing and minimal crack repairs will be implemented as part of the refurbishment works. Within certain locations there is more extensive visible cracking which will require further structural investigation to assess the cause of movement and propose remedial works.

The pre-cast cladding at levels 0 to 2 are generally in poor condition. The cladding at level 3 is in a more advanced state of disrepair.

A small band of travertine stone cladding to the East elevation fascia and canopy appears in fair condition: some cracked tiles require replacement and a general cleaning is recommended as well as possible re-fixing of the larger cladding stones at the canopy columns which appear dislodged.

The rendered areas of the facade to the West wing are in poor condition with cracking in areas which require further structural investigation. New render should take into account any movement joints required in the façade of the West wing to minimise the risk of future cracking.

All existing glazed areas, both the aluminium curtain walling and steel windows all levels are in poor condition. The glazing is generally single ply: glazed areas account for a large portion of the façade surface and therefore it is expected that the overall thermal performance of the building will be poor unless replaced. In addition to this, there is evidence of previously perceived glare discomfort and heath gain (solar film was applied to the majority of the windows).
