# J. B. WARD & SONS

**37 North Road, Highgate**

**REPORT**

**T 75001**

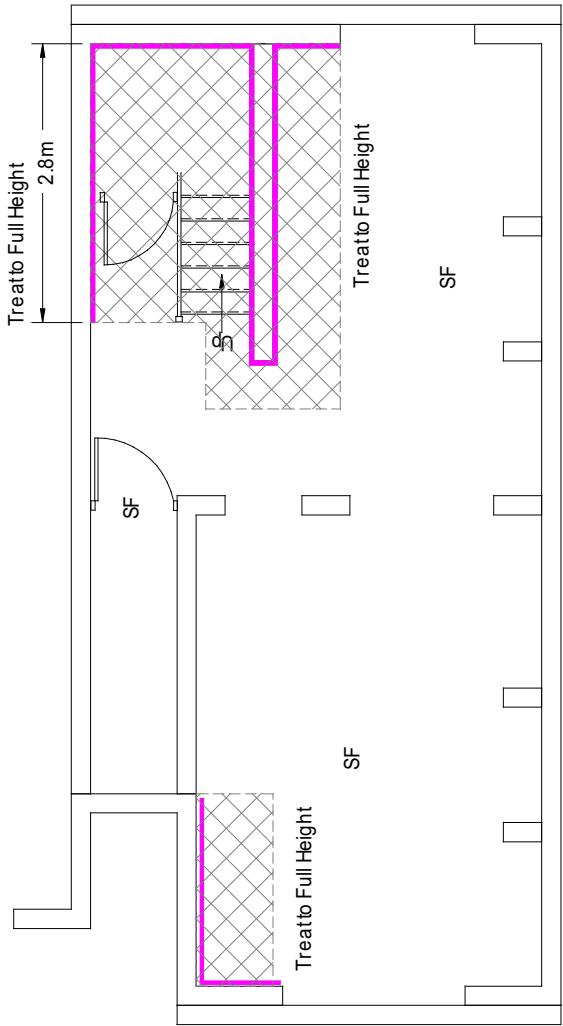
37 North Road  
( LOWER GROUND FLOOR )  
London N6 4BE

- Dry Rot noted to Wall Plaster, Staircase and Adjacent Timbers/Floor Joists as present etc. within the areas indicated on the attached plan.
- Others to:
- Remove all obstructions from the indicated area in conjunction with JB Wards to determine the full extent of Rot. THE AREA INDICATED MAY NOT BE THE FULL EXTENT OF THE ROT.
- JB Wards to:
- Remove and dispose of Rot
  - Sanitize areas indicated..
- Others to:
- Reinstate with pre treated timbers.

- SF
- Solid Floor
- Remove Wall Render to Full Height & Sanitize. 28sm approx
- Ceiling Joists to be removed by other Contractors.

WE RECOMMEND A 2ND INSPECTION FOLLOWING EXPOSURES BY OTHER CONTRACTORS TO FURTHER DETERMINE EXTENT OF ROT.

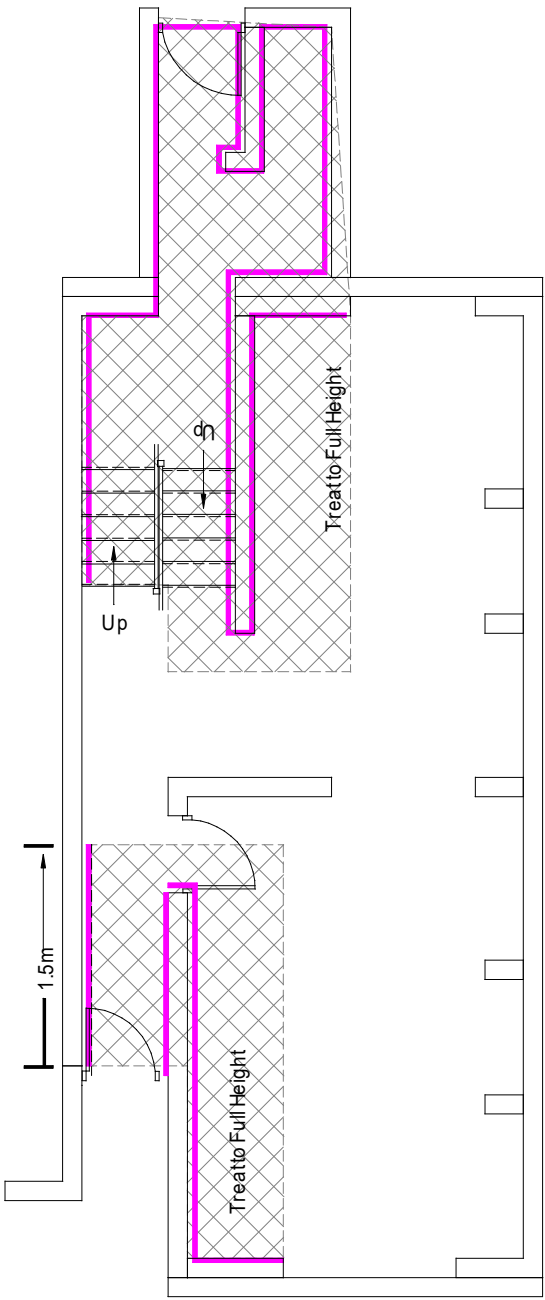
37 North Road  
(GROUND FLOOR )  
London N6 4BE

Dry Rot noted to Wall Plaster, Staircase and Adjacent Timbers/Floor Joists as present etc. within the areas indicated on the attached plan.

Others to:  
Remove all obstructions from the indicated area in conjunction with JB Wards to determine the full extent of Rot. THE AREA INDICATED MAY NOT BE THE FULL EXTENT OF THE ROT.

JB Wards to:  
Remove and dispose of Rot  
Sanitize areas indicated..

Others to:  
Reinstate with pre treated timbers.

SF  
Solid Floor  
Remove Wall Render to Full Height & Sterilise. (50sm approx)  
Ceiling Joists to be removed by other Contractors.

WE RECOMMEND A 2ND INSPECTION FOLLOWING EXPOSURES BY OTHER CONTRACTORS TO FURTHER DETERMINE EXTENT OF ROT.

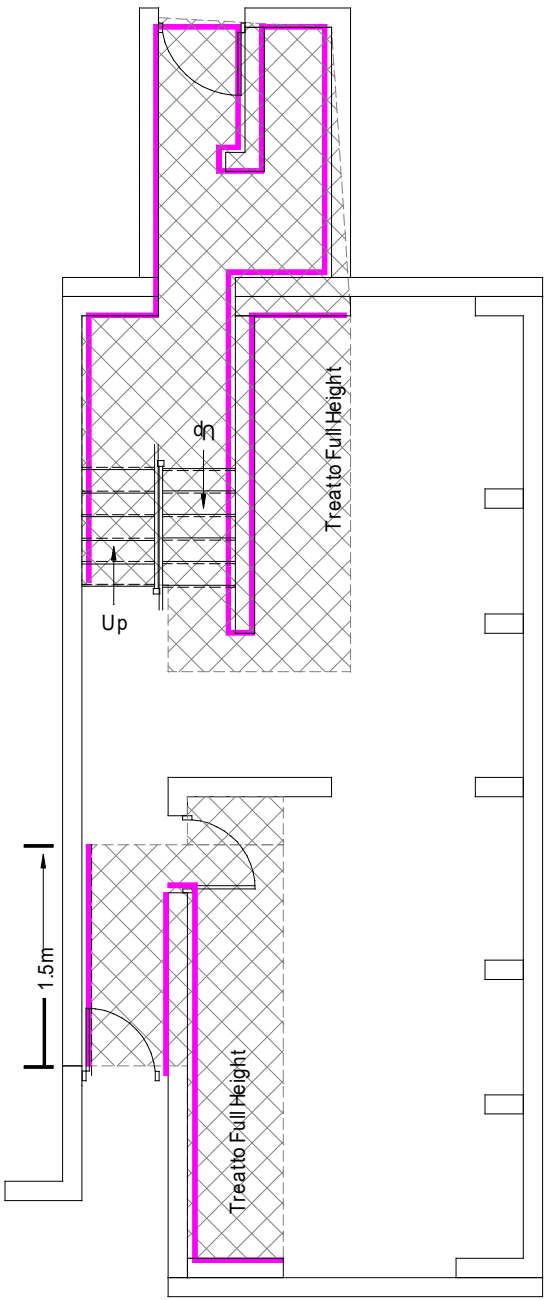
37 North Road  
(1ST FLOOR)  
London N6 4BE

- Dry Rot noted to Wall Plaster, Staircase and Adjacent Timbers/Joists as present etc. within the areas indicated on the attached plan.
- Others to:  
Remove all obstructions from the indicated area in conjunction with JB Wards to determine the full extent of Rot. THE AREA INDICATED MAY NOT BE THE FULL EXTENT OF THE ROT.
- JB Wards to:  
Remove and dispose of Rot  
Sanitize areas indicated..
- Others to:  
Reinstate with pre treated timbers.

Remove Wall Render to Full Height & Sterilise. (67sm approx)

Joists to be removed by other Contractors.
