# CONDITION REPORT

**FOR**  
THE EXISTING TIMBER PORCH TO BE REBUILT LIKE FOR  
LIKE AND THE WINDOW AND TIMBER PORCH  
REPAIR/REDECORATION WORKS

**AT**  
MOUNTFORD HOUSE,  
7 TOTTENHAM GREEN EAST,  
LONDON,  
N15 4UU

November 2024  
JB/24176

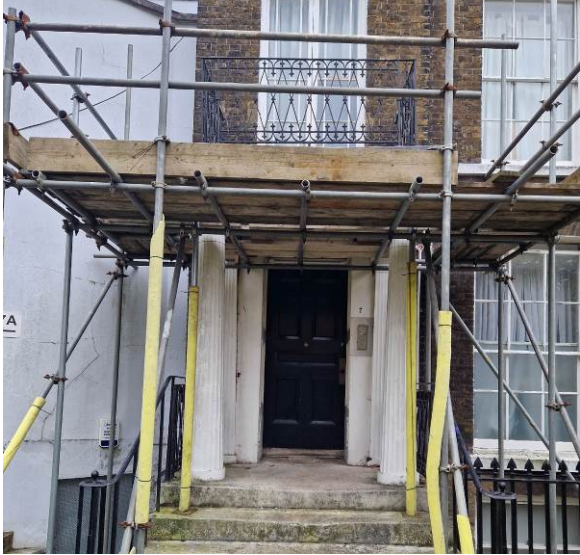
| <u>Item</u> | <u>Condition Notes</u> | <u>Picture</u> |
|---|---|---|
| Right Porch | <p>A supporting scaffold has been installed.</p> <p>Both bowing and leaning are more severe now. The extent is covered by the scaffold support securing the porch in place.</p> | |

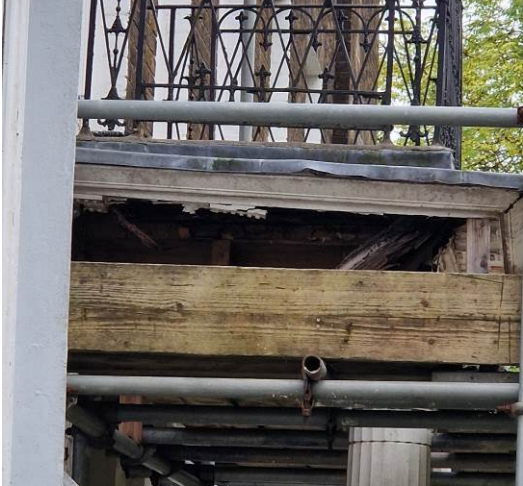
| <u>Item</u> | <u>Condition Notes</u> | <u>Picture</u> |
|---|---|---|
| Left Architrave | <p>The left side of the architrave is completely removed and internal timber rot and decay are now visible.</p> | |

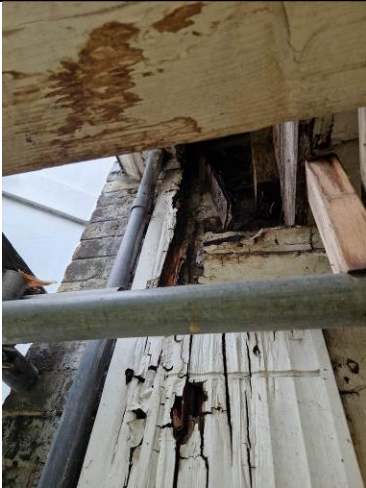
| <p>Timber door surround and underside of architrave</p> | <p>The underside of the architrave has been removed.</p> <p>Shows severe internal timber rot and decay.</p> <p>Large chips in the timber.</p> <p>Horizontal splits and flaking paint</p> | |

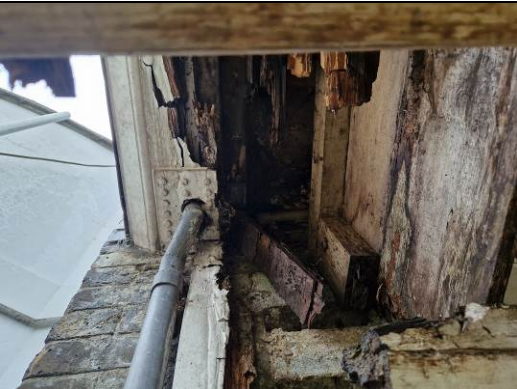
| <p>View of the underside of the cornice</p> | <p>Shows severe internal timber rot and decay.</p> <p>Some timber battens, supports, side and underside of the architrave are removed.</p> <p>Cornice damage from timber rot and decay also.</p> | |

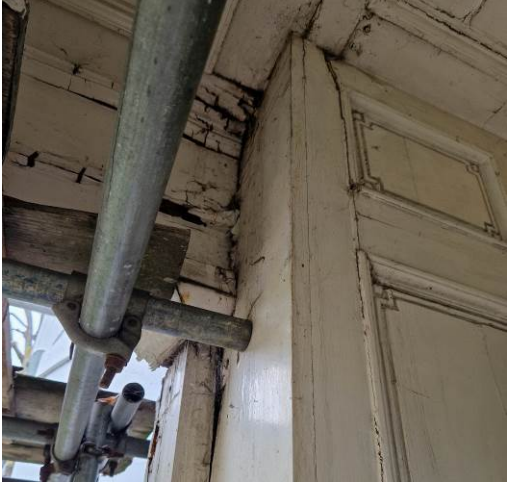
| <p>Internal side of architrave</p> | <p>Timber rot and decay running horizontally.</p> <p>Vertical and horizontal splits.</p> | |

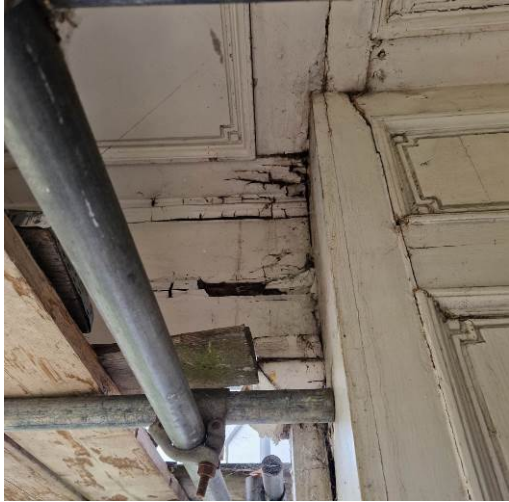
| Internal side of the architrave | <p>Timber rot and decay running horizontally.</p> <p>Vertical and horizontal splits.</p> | |

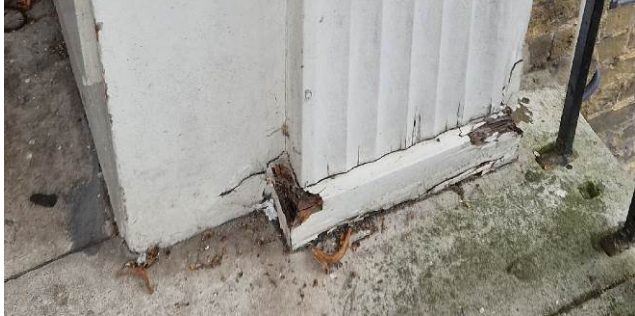
| Timber base | <p>Areas of rot and decay, causing the timber to chip off.</p> <p>Horizontal splits.</p> | |

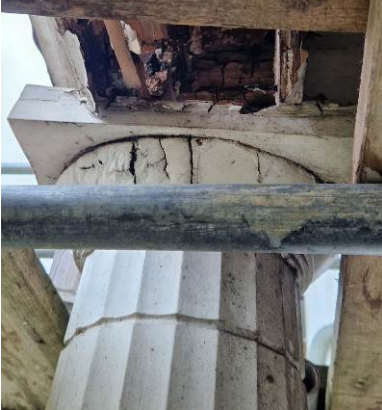
| Fluted Column, Capital and underside of architrave | Shows severe internal timber rot and decay. | |

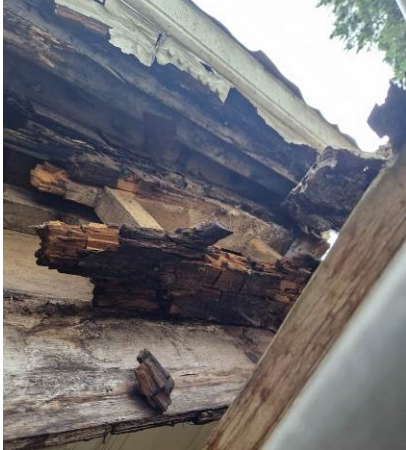
| Potential timber lintels. | <p>The majority of the timber now missing.</p> <p>Severely decayed timbers, potentially used as a lintel. Clearly failed.</p> | |

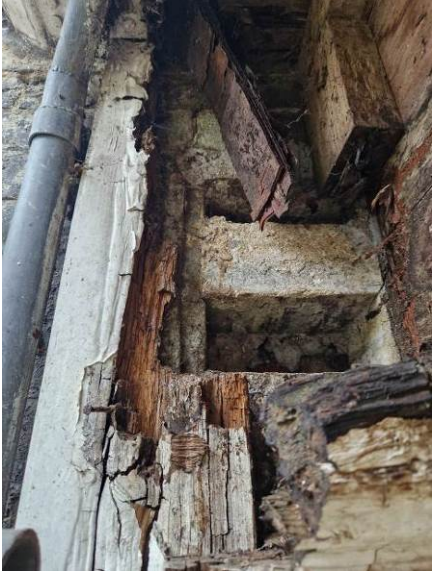
| <p>External wall</p> | <p>Assumed timber lintels removed.</p> <p>Timber battens dropped lower.</p> <p>Severe decay and rot to all timbers.</p> | |

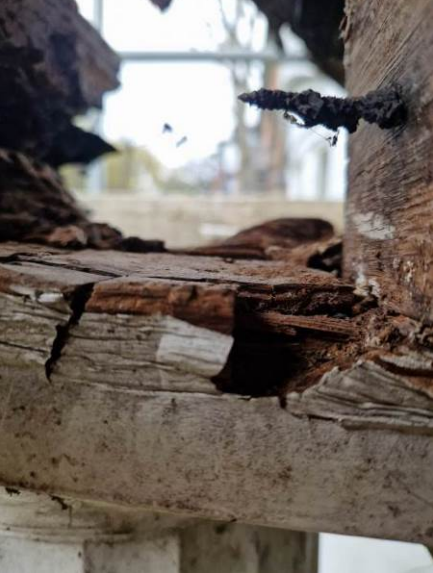
| <p>Above column capital</p> | <p>Removed timbers, clear signs of rot and decay.</p> <p>Peeling paintwork and discoloration.</p> | |

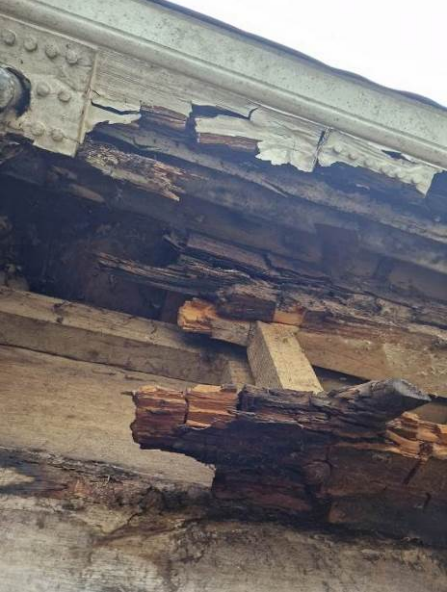
| <p>Underside of cornice and timber lintel.</p> | <p>Shows severe internal timber rot and decay.</p> <p>Some timber battens, supports, side and underside of the architrave are removed.</p> <p>Cornice damage from timber rot and decay also.</p> <p>Majority of the timber now missing.</p> <p>Severely decayed timbers, potentially used as a lintel. Clearly failed.</p> | |

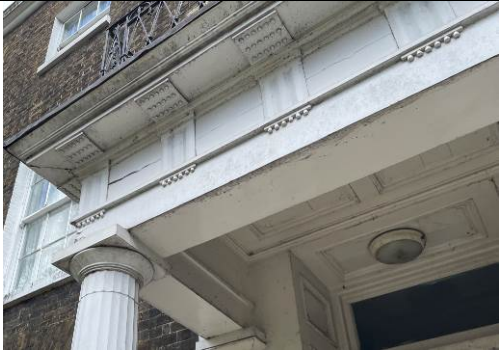
| <p>Frieze</p> | <p>Cracks and splits at the midpoint between the triglyphs.</p> | |

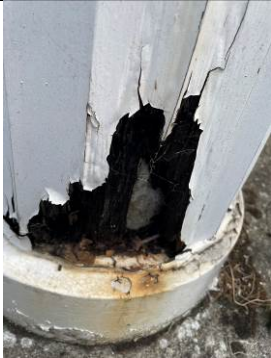
| <p>Right column and base.</p> | <p>Exposed concrete column.</p> <p>Exposed timber shows rot and decay.</p> <p>Concrete base paint flaking and discolouration through oxidation.</p> | |

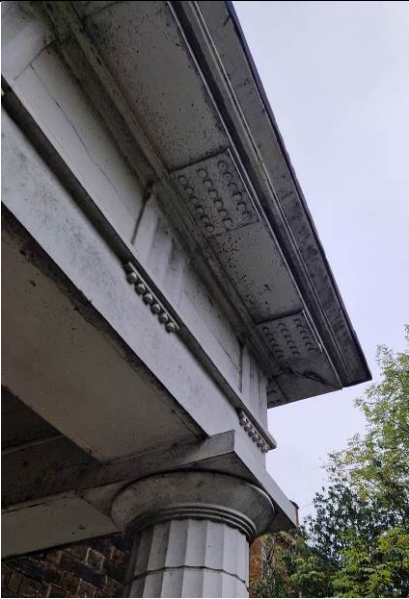
| <p>Entablature front and underside areas. Column capital and fluted shaft.</p> | <p>Weathered timber has caused the timber to fade and discolour.</p> <p>There are signs of mould and mildew.</p> <p>The underside of the architrave has a split from one side to the other.</p> | |

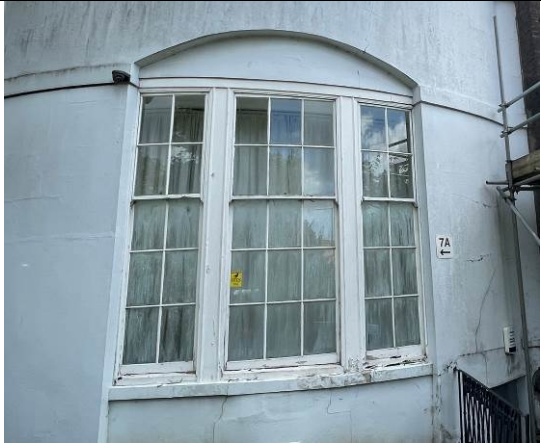
| <p><b><u>Bow window</u></b></p> | <p>Timber sash bow window</p> <p>Single pane glass</p> <p>White paint finish which is in general poor condition and has significant discolouration.</p> | |

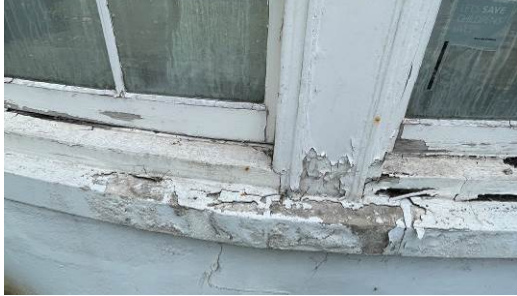
| <p>Timber and concrete window cill</p> | <p>Further examples of cracks peeling and discoloration.</p> | |
