37 NORTH ROAD

DRY ROT AND TIMBER CONDITION INVESTIGATION

JOB NO. 162-58

01 NOVEMBER 2024

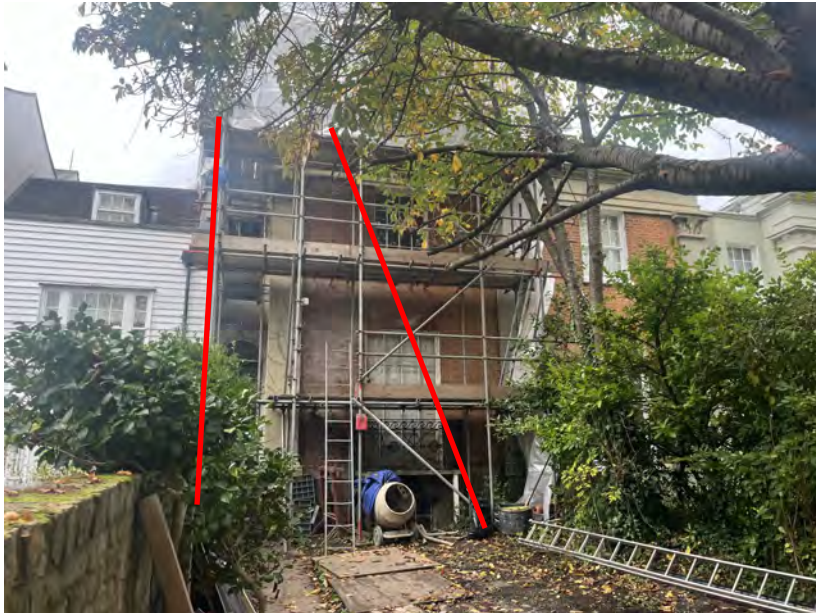
**Fig 1:**

East elevation; showing a general view to the principal front façade. Note general spread or dry rot 'zone' identified as a cone emanating from roof level and widening substantially down towards ground level

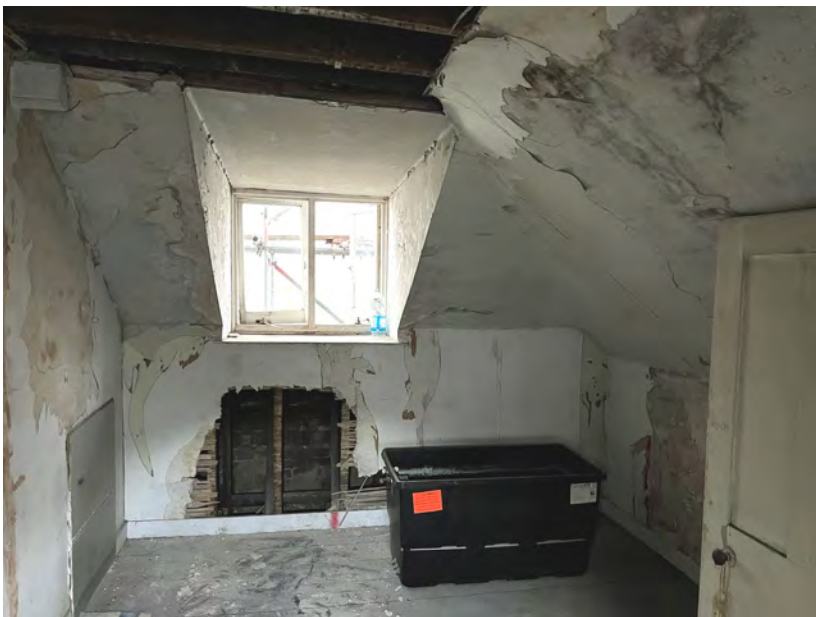
**Fig 2:**

Roof structures; showing a general internal view looking towards the east pitch. Note the majority of historic plaster linings remaining

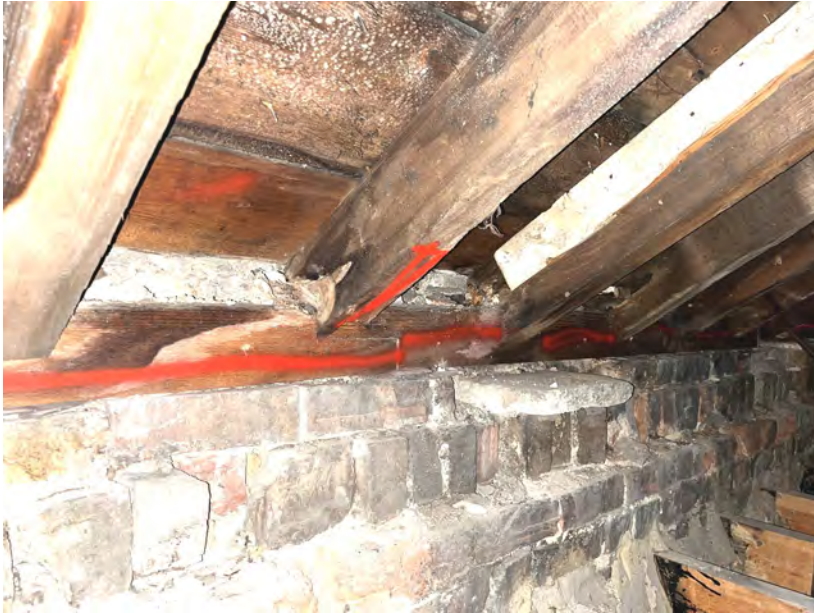
**Fig 3:**

Roof structures, east pitch; showing structural decay to the rafter plate for almost its entire length at ~4m as well as 1 no. common rafter for ~250mm to its bearing end. All structurally decayed items identified on-site via water soluble red spray paint

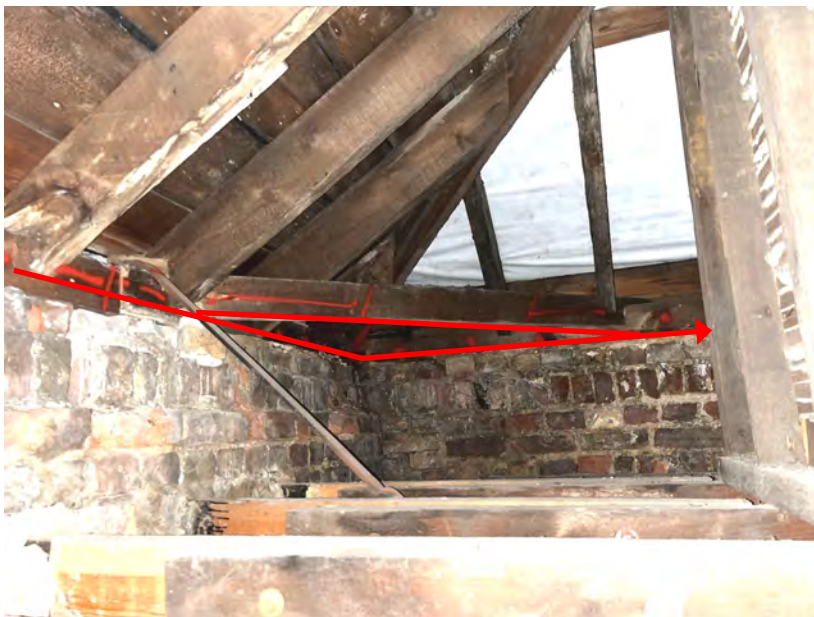
**Fig 4:**

Roof structures, east pitch; showing structural decay to the south-east corner including to the corner tie, the hip rafter for ~400mm and to the south rafter plate return for ~2m

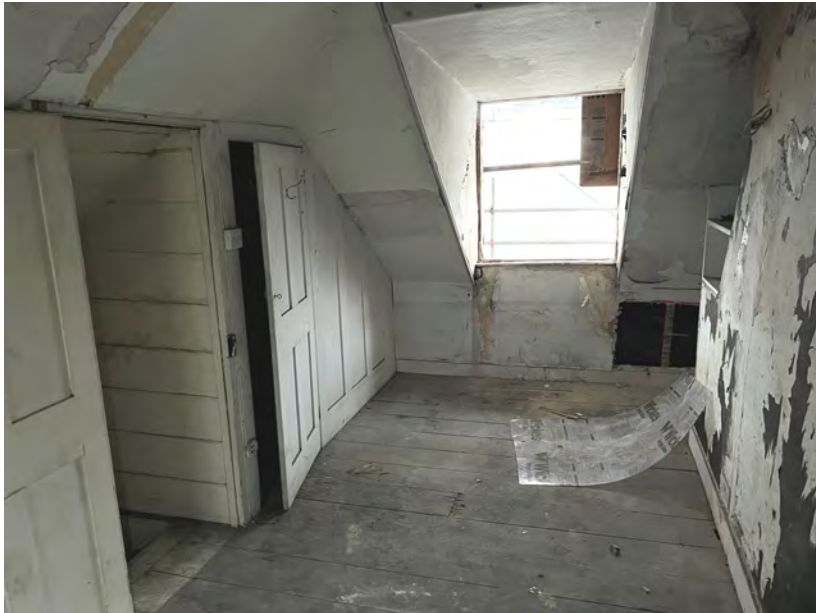
**Fig 5:**

Roof structures; showing a general internal view looking towards the west pitch. Note limited access to roof structures at the time of survey

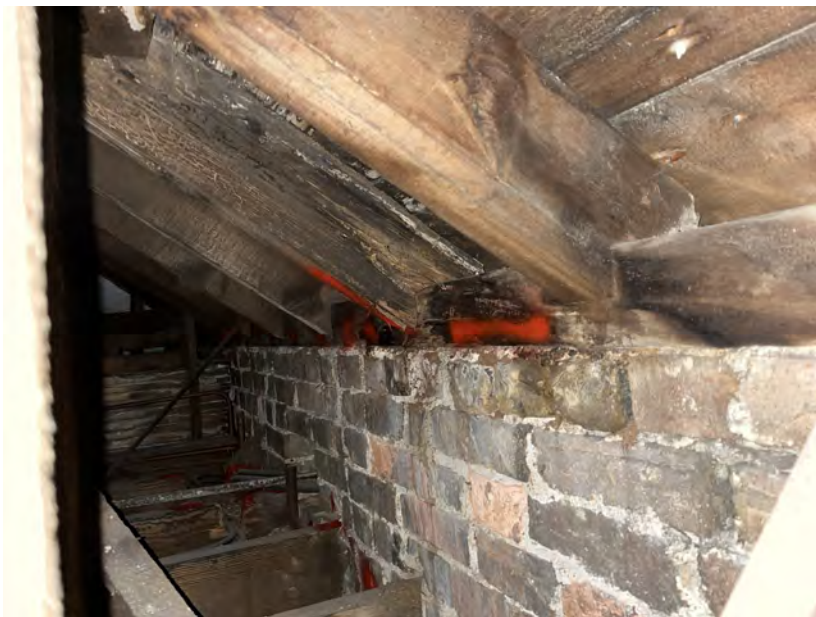
**Fig 6:**

Roof structures, west pitch; showing structural decay to the rafter plate for ~2m as well as 1no. common rafter for ~100mm to its bearing end only. All structurally decayed items identified on-site via water soluble red spray paint

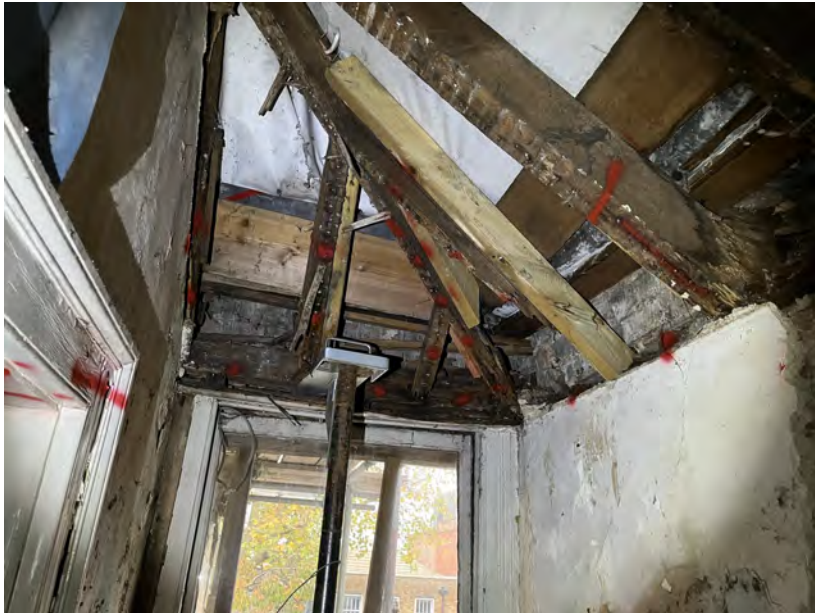
**Fig 7:**

Roof structures, south catslide; showing severe structural decay to the majority of timber components to the south-east corner, including the east rafter plate, 5no. Jack rafters and the south rafter plate (for its full length extending beyond this image. See fig.8)

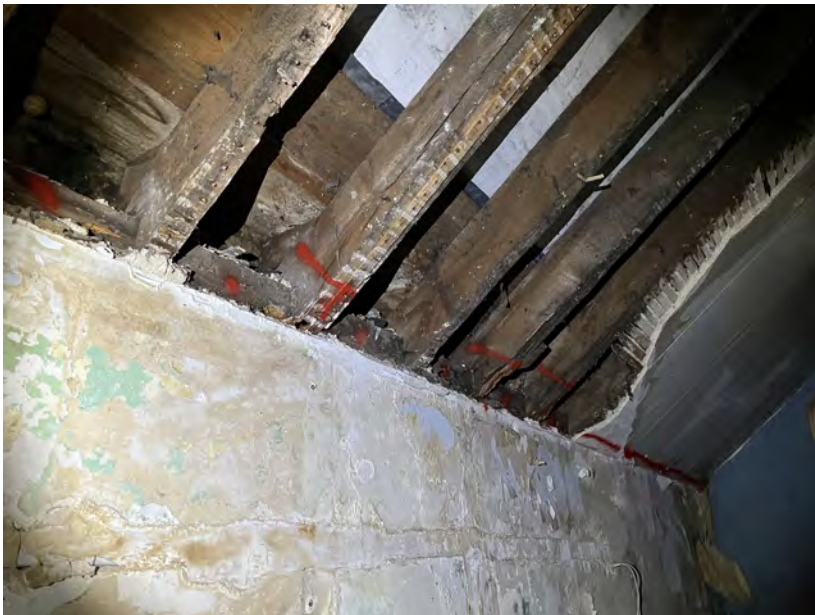
**Fig 8:**

Roof structures, south catslide; showing continuance of structural decay to the south rafter plate for its full length (although access limited to the west end due to remaining plaster finishes). Also, decay detected to ~5no. Common rafters

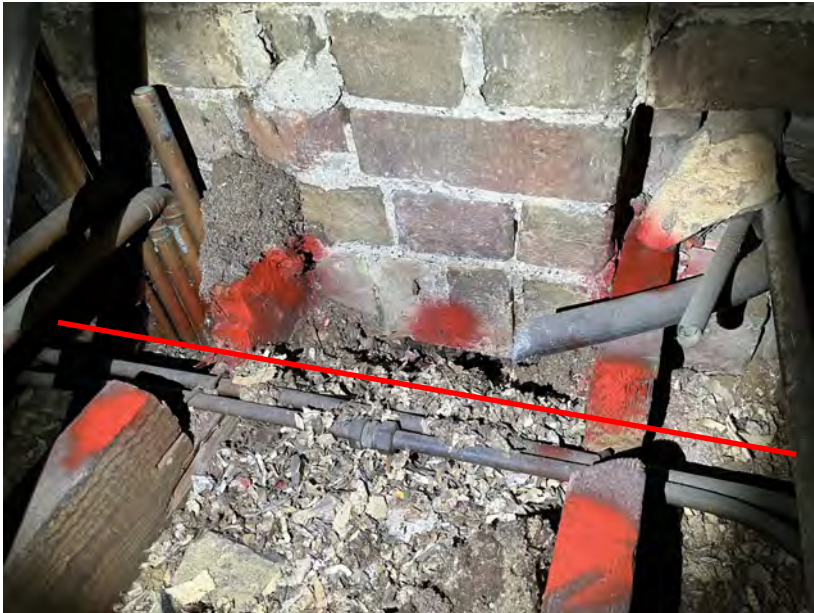
**Fig 9:**

Second (attic) floor; showing structural decay, as well as excessive service notching to 2no. West perimeter floor joists. Also note no visible access to the embedded wall plate beneath but this was deep resistance drilled and subject to structural decay at ~2m (indicated via red line)

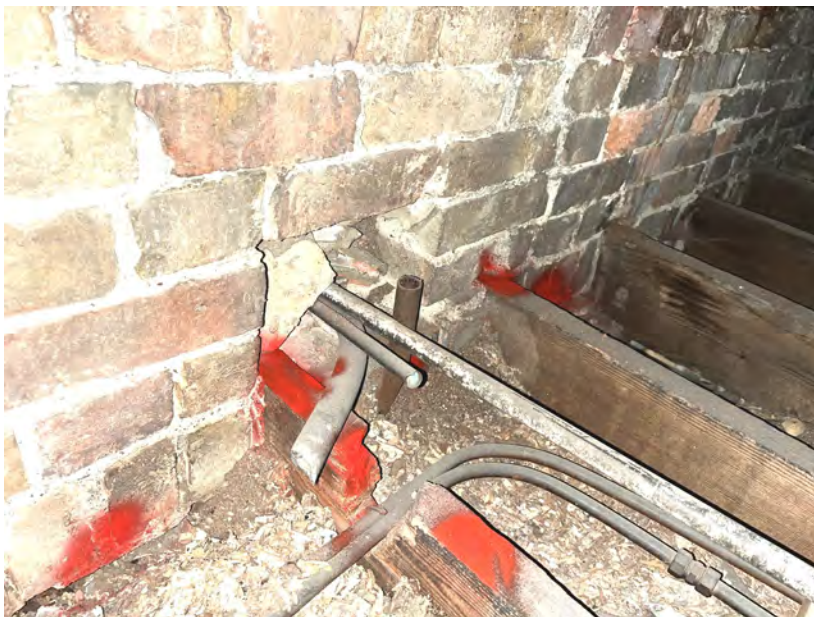
**Fig 10:**

Second (attic) floor; showing a further view along the west perimeter wall where structural decay was detected to 5no. Embedded floor joists as well as 2m of wall plate

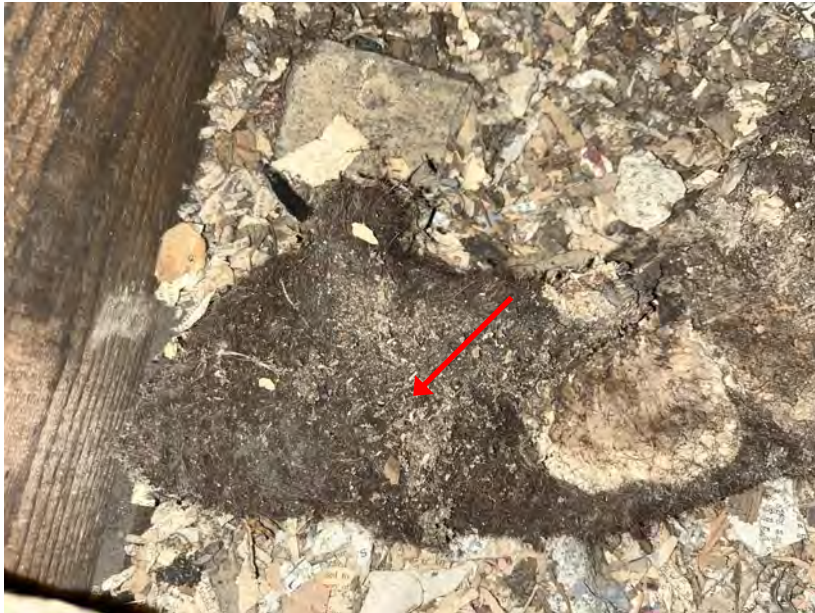
**Fig 11:**

Second (attic) floor; showing what appeared to be an asbestos containing material (ACM) debris within the ashlar roof void

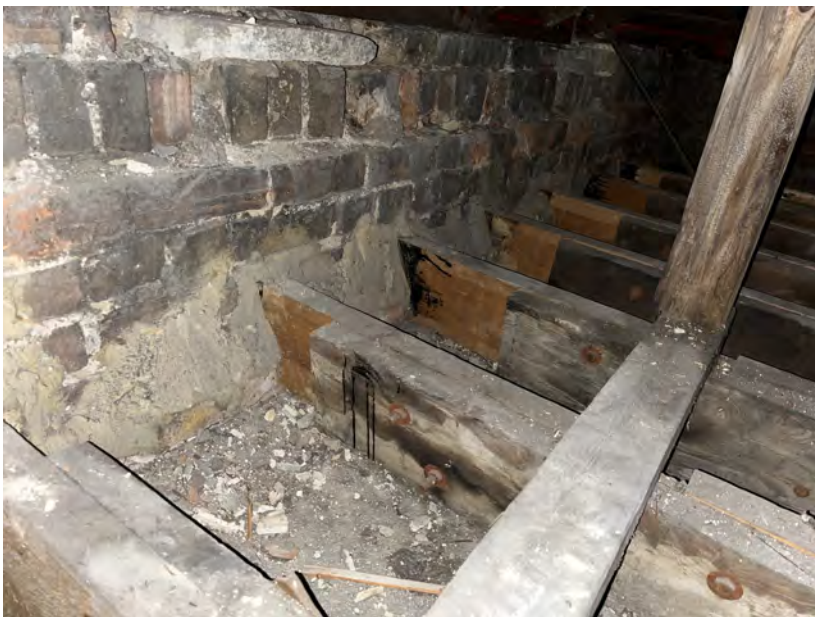
**Fig 12:**

Second (attic) floor; showing a general view towards the east perimeter wall. Note all historic floor joists had been previously remedially cut short and partnered with new softwood members which were improperly embedded into the masonry. Partners were deep drilled and moisture probed. No decay detected although historic underlying plate subject to total structural decay. See fig.13

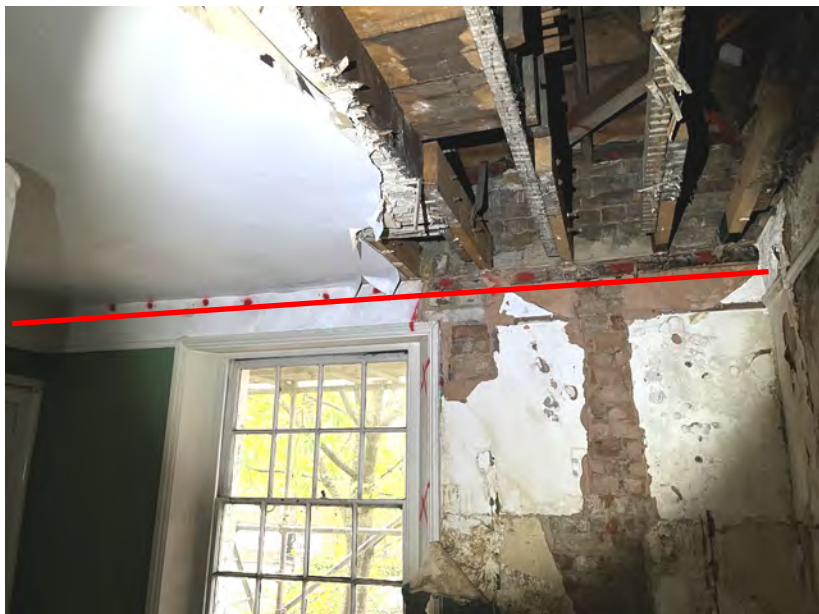
**Fig 13:**

Second (attic) floor; showing a general view towards the east perimeter wall from first floor level. Note total structural decay detected to the historic embedded wall plate

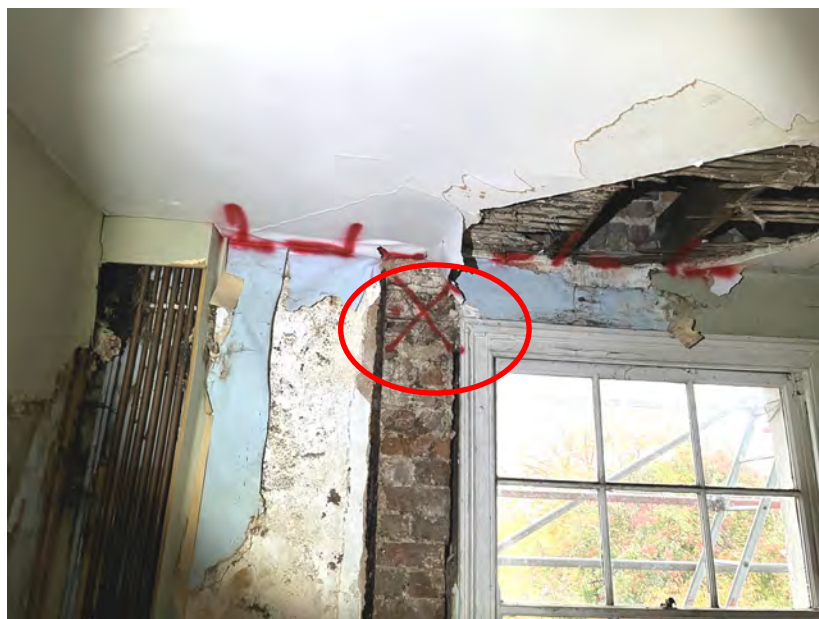
**Fig 14:**

Second (attic) floor; showing a view towards the west perimeter wall. Structural decay detected to 5no. floor joists and up to ~2m of wall plate (see also fig10). Also note structural decay detected to the window timber lintels south bearing end

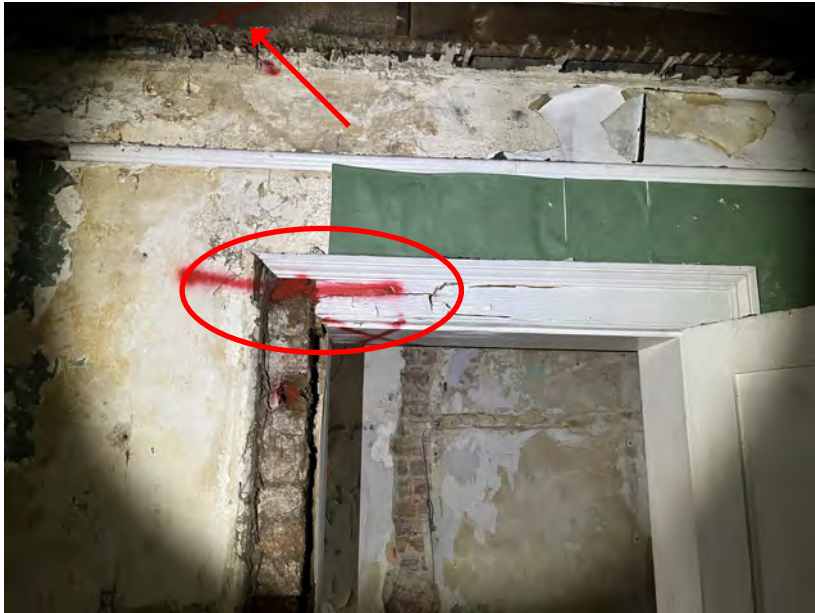
**Fig 15:**

First floor; showing structural decay to the internal lintel between the principal east room and the south passageway (embedded timber grounds also decayed). Also total decay to the 1no. perimeter ceiling joist above

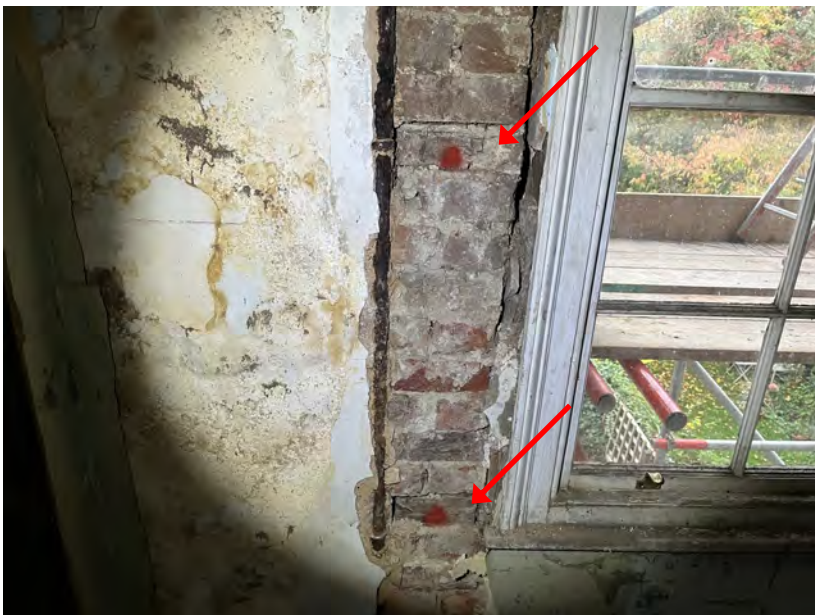
**Fig 16:**

First floor; showing representative decay to timber grounds forming fixing locations for windows and doors within the designated dry rot zones

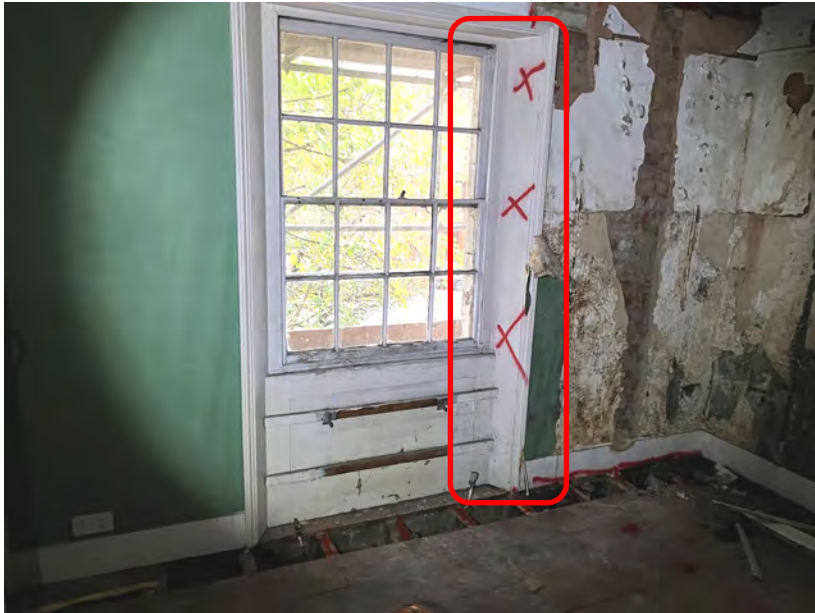
**Fig 17:**

First floor, east room; showing non-structural decay issues to the historic window joinery in contact to the south dry rot affected masonry. Lintel over of solid construction

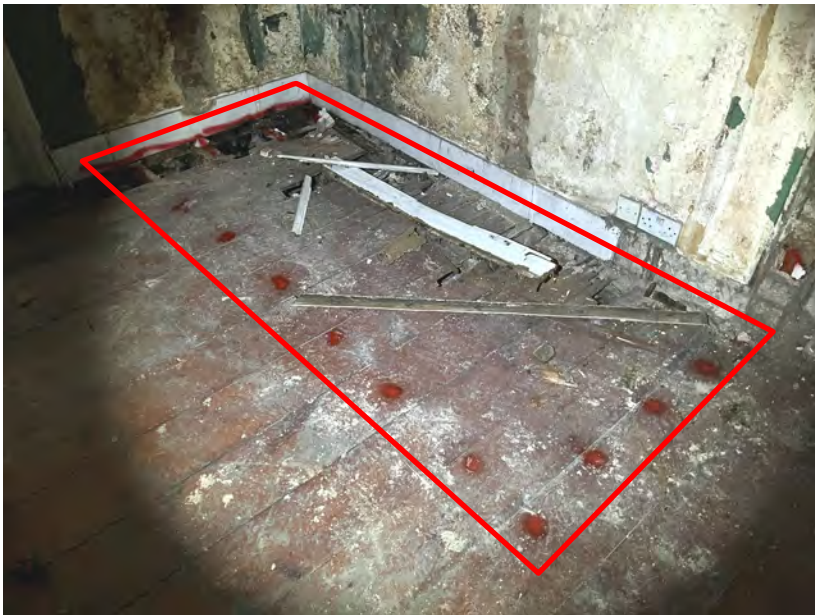
**Fig 18:**

First floor, east room; showing approximate area of structurally unsound floor structures marked on-site with water soluble spray paint. Allow for cordoning off and propping from beneath

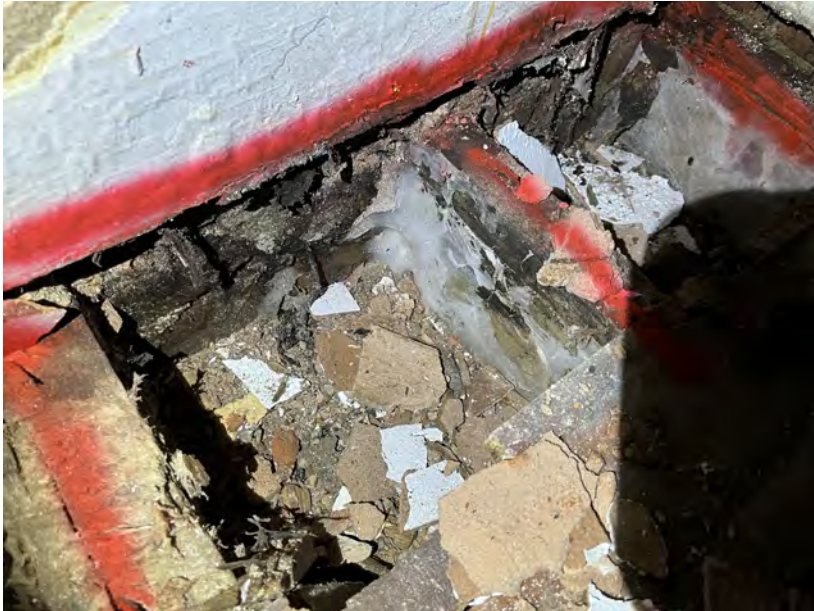
**Fig 19:**

First floor, east room; showing active dry rot mycelium decay to embedded east perimeter floor joists

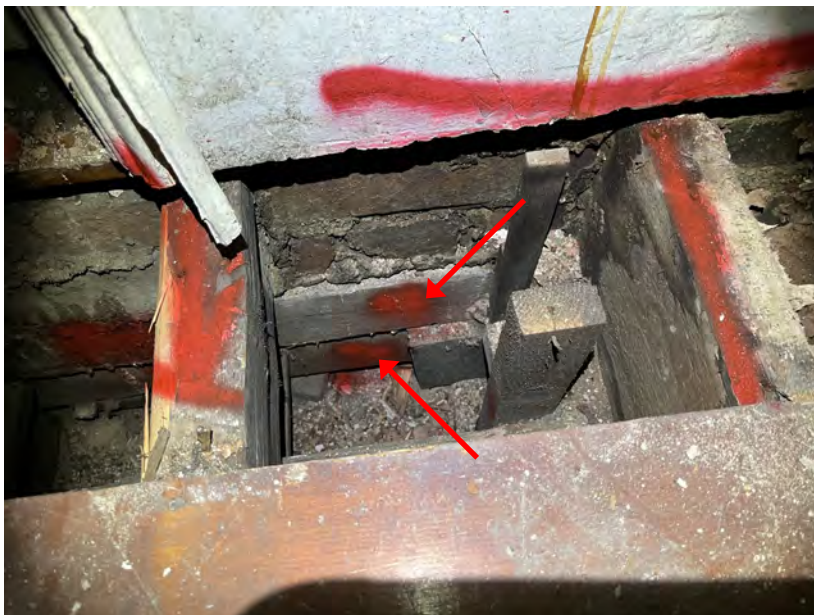
**Fig 20:**

First floor, east room; showing structural decay to most timber elements in contact to the dry rot infected east elevation masonry. Including the double timber lintel build-up beneath (over the ground floor window) which also served as a wall/joist plate to first floor structures

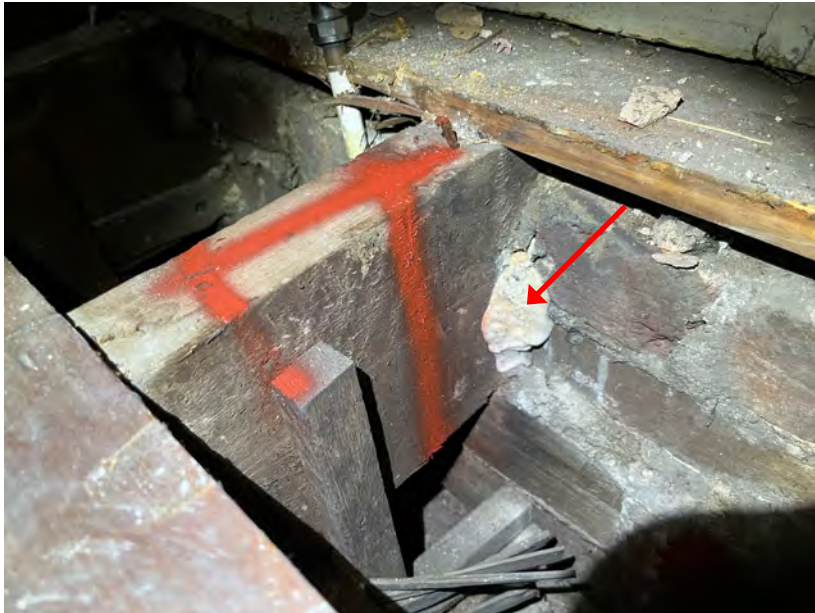
**Fig 21:**

First floor, east room; showing active dry rot fungus to embedded east perimeter floor joists sat directly over the ground floor lintel

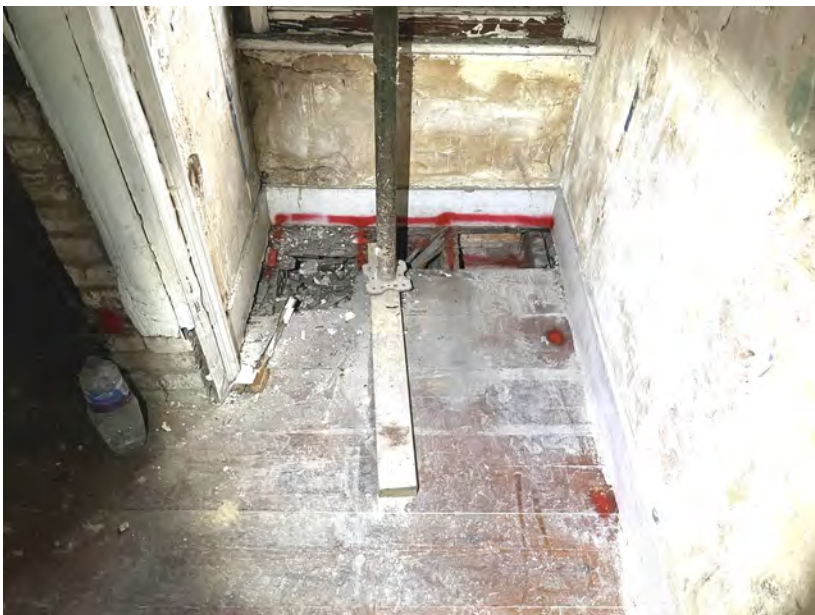
**Fig 22:**

First floor, south passage; showing a view looking east. Note total decay to all timbers in contact to the historically dry rot infected masonry, including the total wall plate and 4no. joists

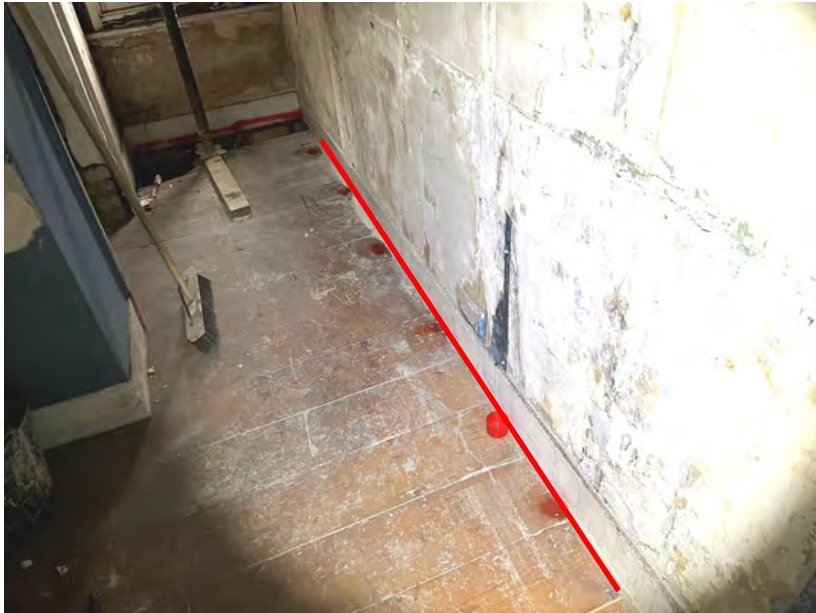
**Fig 23:**

First floor, south passage; showing decay detected to the south perimeter floor joist, presumably due to a lack of a ventilated air gap between it and the party masonry wall

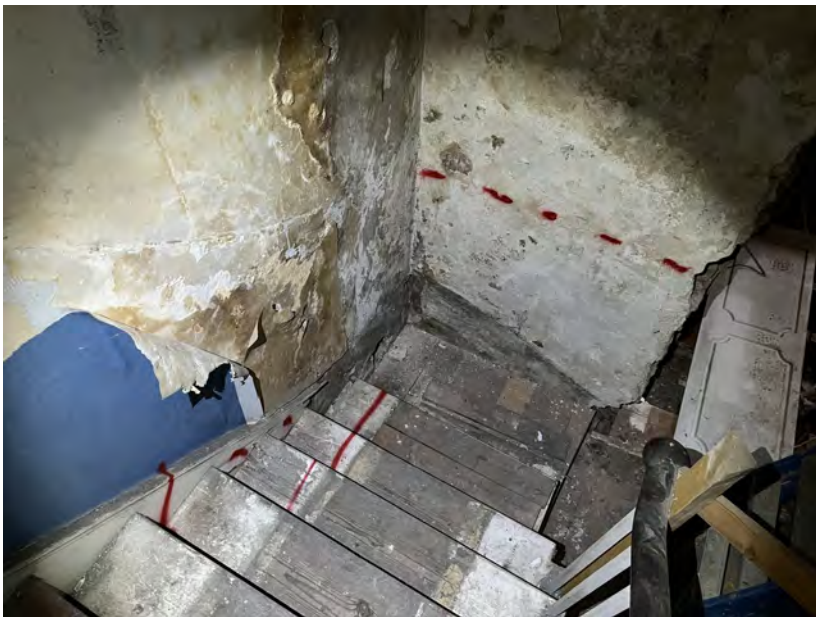
**Fig 24:**

First floor, stairs; showing structural decay to most stair elements in contact to the west and south perimeter walls. Including stair treads, outside string, landing floorboards and landing beams/joists

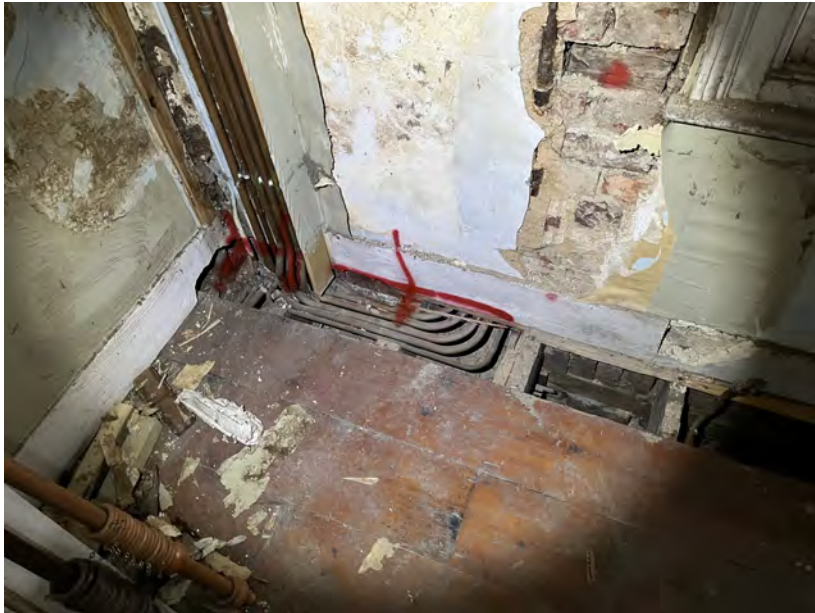
**Fig 25:**

First floor, west room; showing historic structural dry rot decay to structures in contact to the south-west corner. Including the wall plate at ~1m and 3no. floor joists

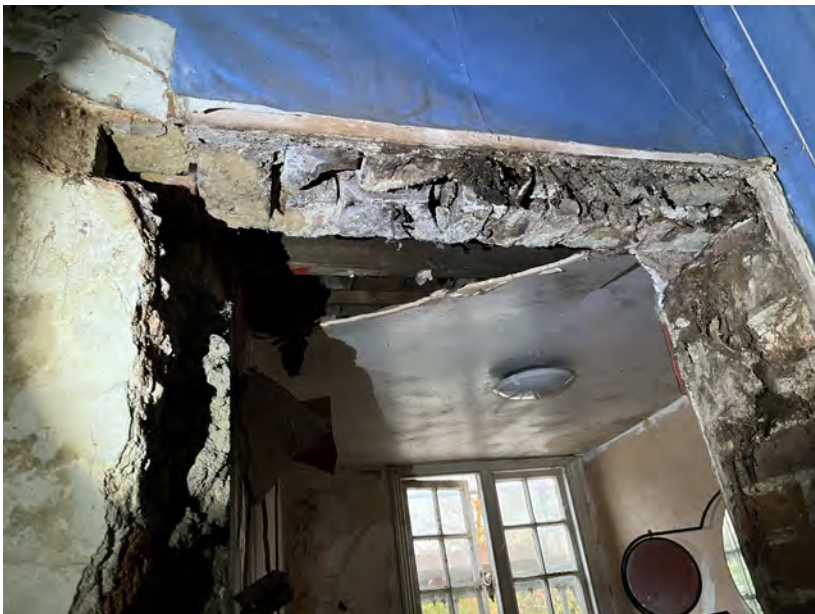
**Fig 26:**

First floor, W/C mezzanine; showing complete structural decay/loss to the timber lintel between the W/C and the stair landing. Allow for expedient remedial shoring

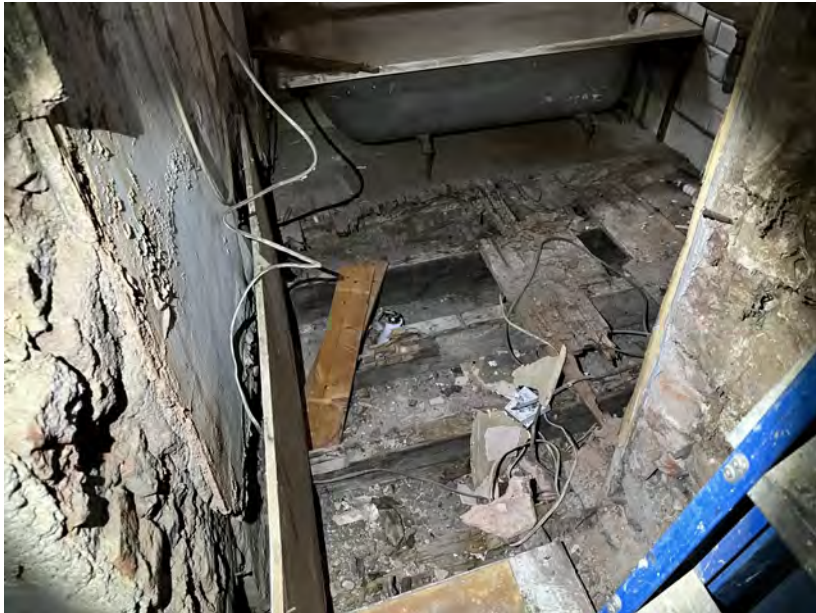
**Fig 27:**

First floor, W/C mezzanine; showing comprehensive structural decay to floor joists in contact to the south perimeter wall

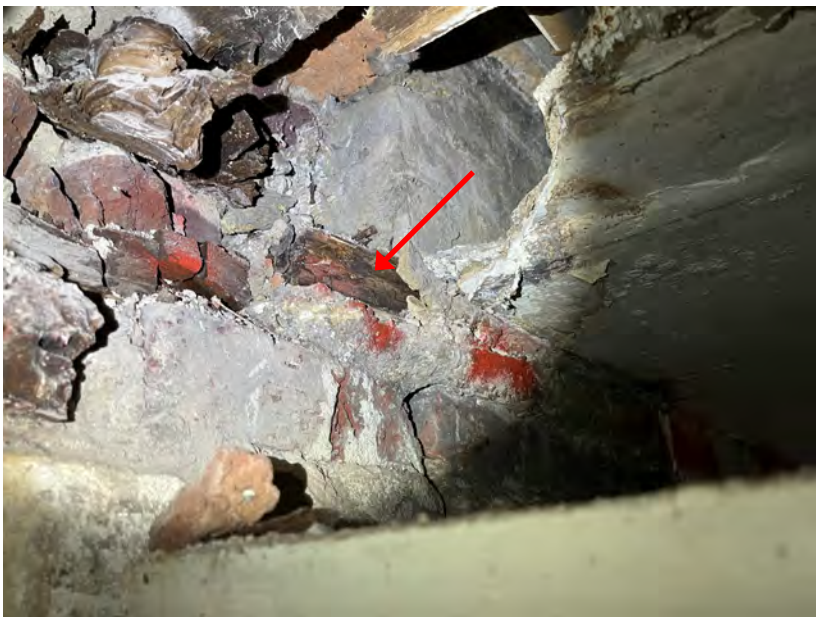
**Fig 28:**

First floor, W/C mezzanine; showing south perimeter wall plate partially visible and subject to decay (presumably for its entire length– TBC)

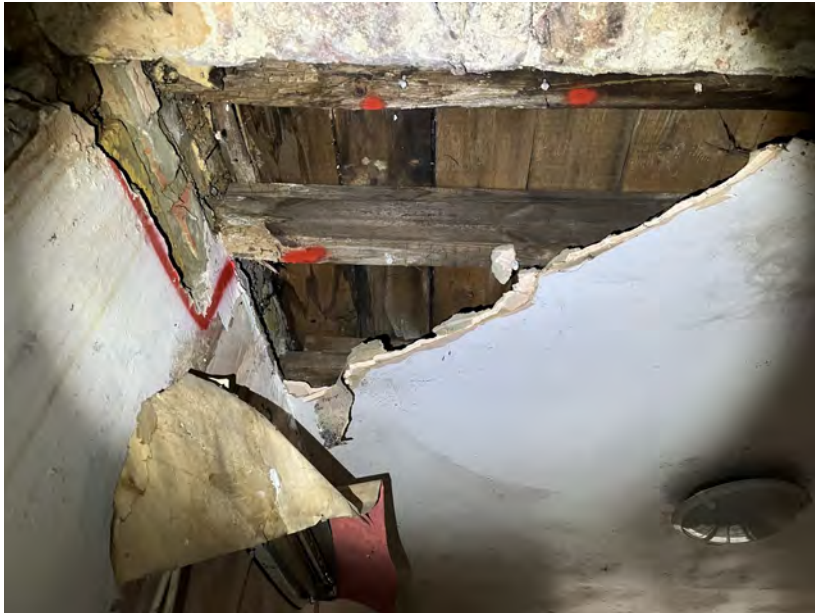
**Fig 29:**

W/C mezzanine flat roof; showing structural decay to 2no. Flat roof joists in contact to the south perimeter wall. Limited access to remaining flat roof joists due to collapsing floor below and remaining ceilings. Further decay presumed. No plate suspected

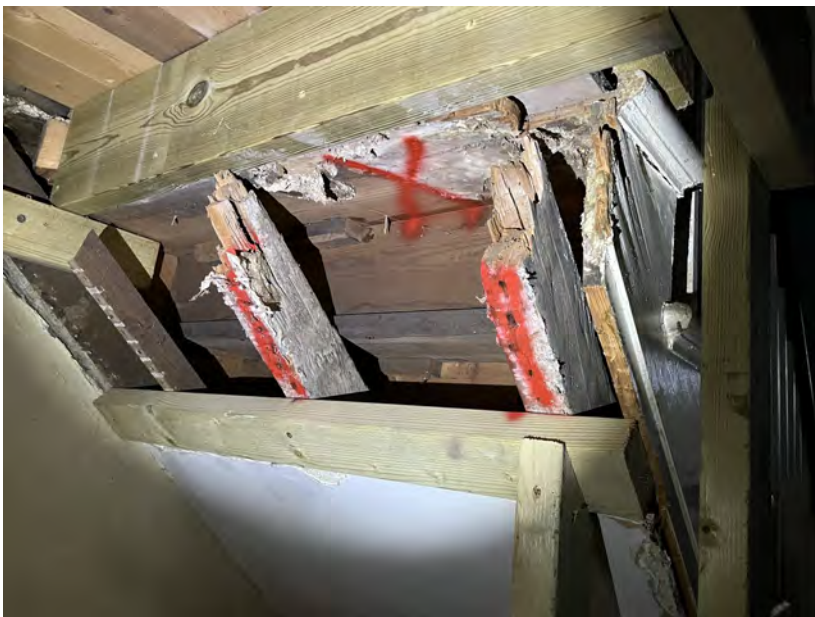
**Fig 30:**

First floor, lower flight of stairs; showing structural decay to the 2no. innermost carriage beams and local treads

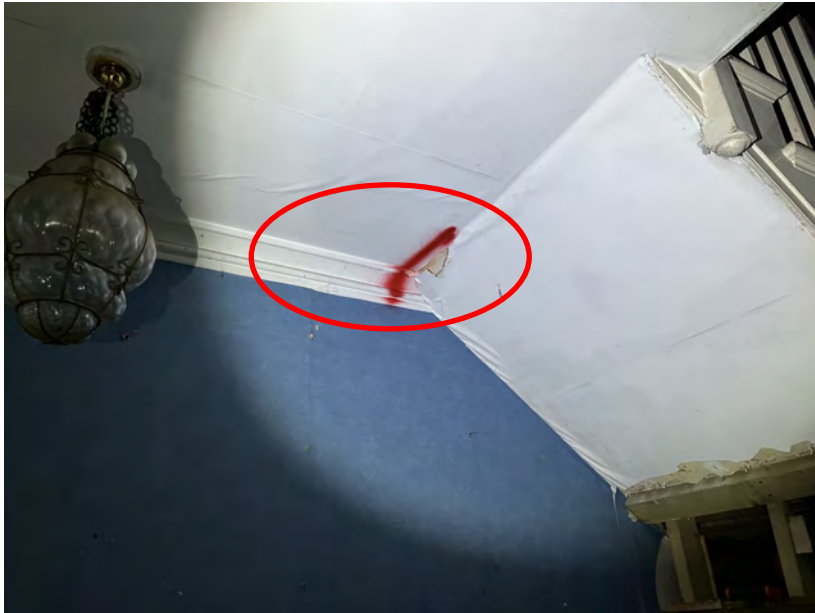
**Fig 31:**

Ground floor; showing view to the underside of the first floor stair landing. Note structural decay identified to the landing trimmer beam where it embeds into the south perimeter wall

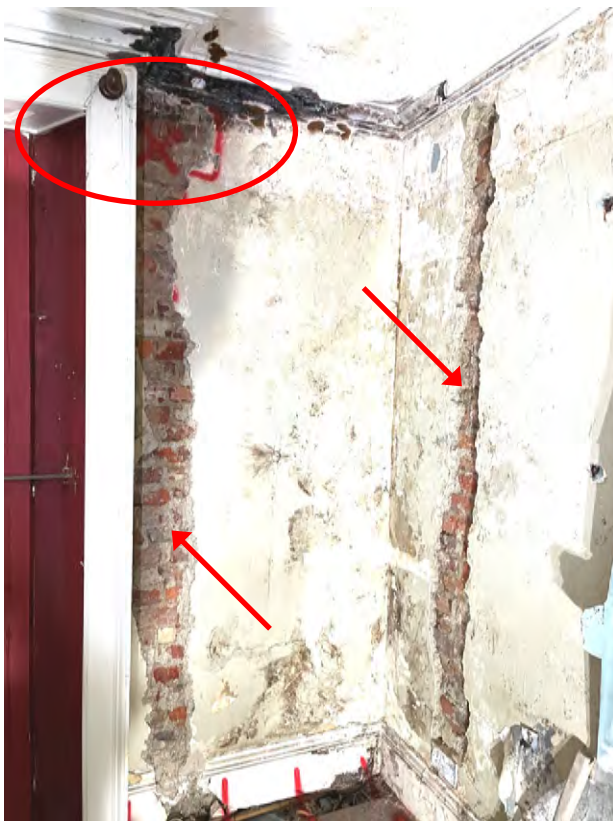
**Fig 32:**

Ground floor, east room; showing structural decay to the east window lintel. Also note localised openings to wall plasters showed no evidence for embedded bonding timbers to this area

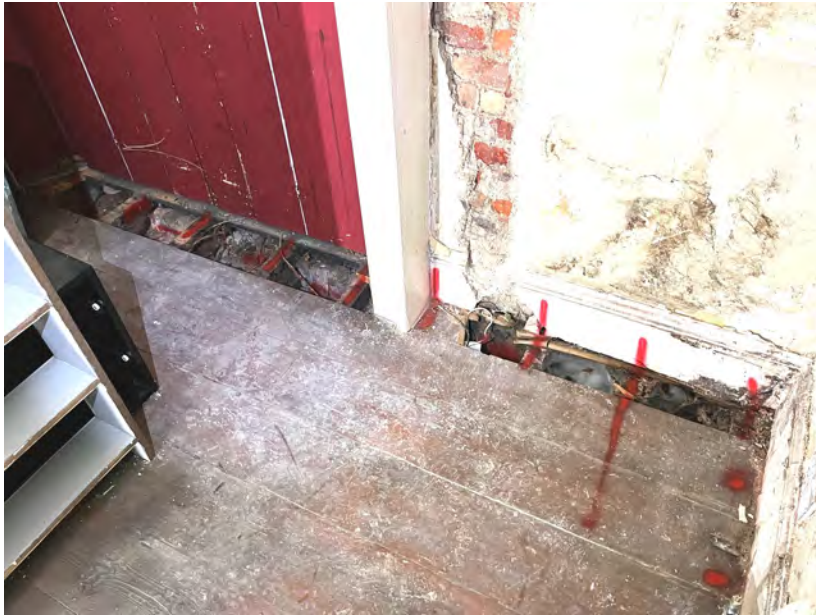
**Fig 33:**

Ground floor, east room; showing structural decay to all accessible structural and non-structural timbers in contact to the active dry rot infected east perimeter façade masonry

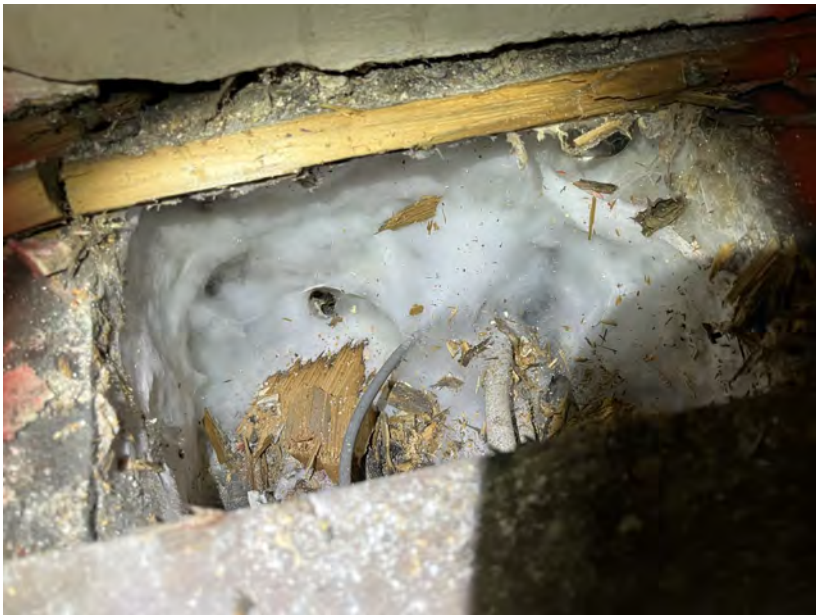
**Fig 34:**

Ground floor, east room; showing active dry rot mycelium decay to embedded east perimeter floor joists

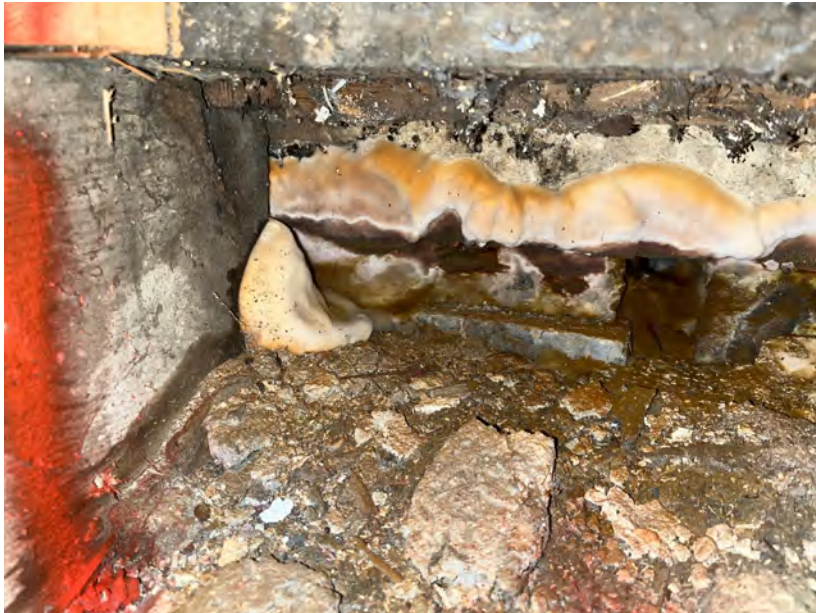
**Fig 35:**

Ground floor, east room; showing further evidence for active dry rot fungus to embedded east perimeter floor joists

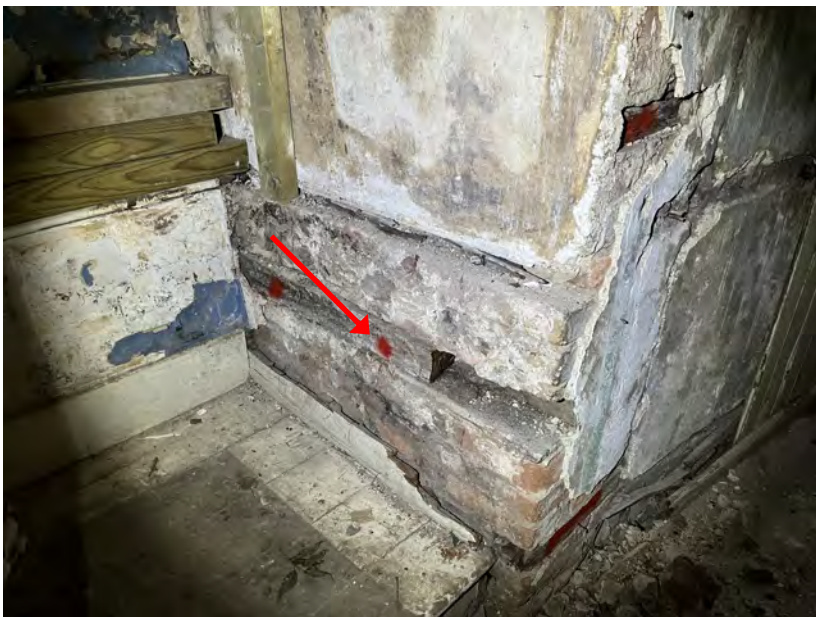
**Fig 36:**

Ground floor, stair landing; showing representative structural decay to embedded bonding timbers within the east perimeter wall. This elevation showed the only bonding timbers identified at the time of investigation

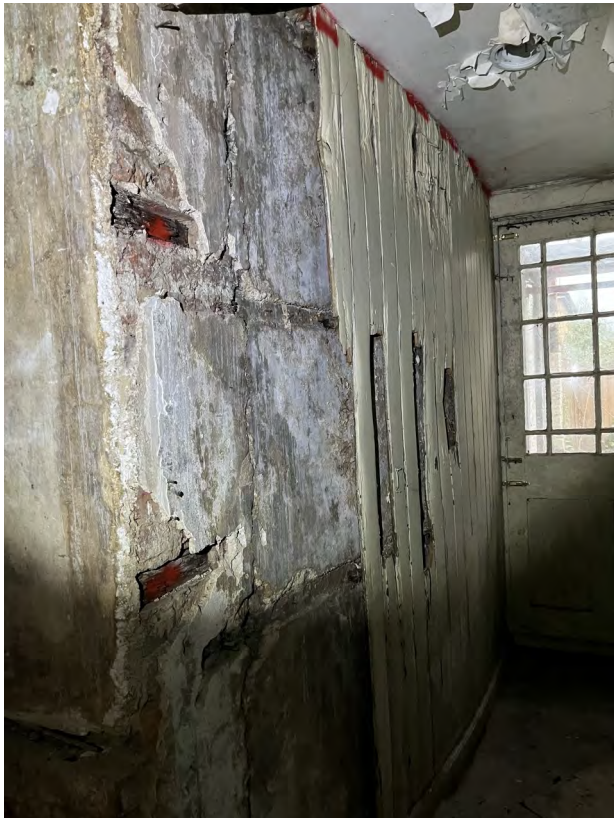
**Fig 37:**

Ground floor, west passageway; showing severe dry rot issues to the south wall panneling. Note that the partially embedded decayed panel slats were not considered bonding timbers and therefore are not considered a structural decay issue

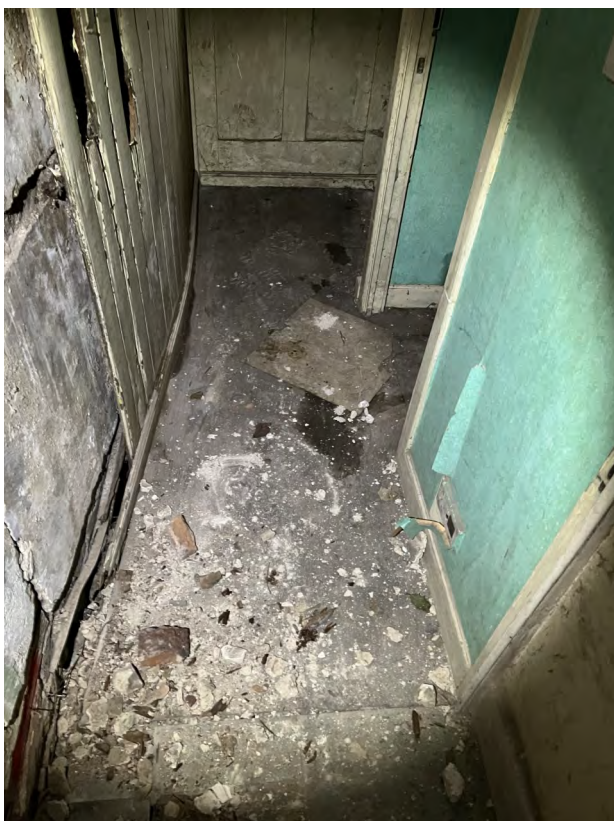
**Fig 38:**

Ground floor; showing general view to the south extension floor structures of suspended timber construction with joists spanning north-south. Limited access at time of investigation, although widespread decay issues suspected

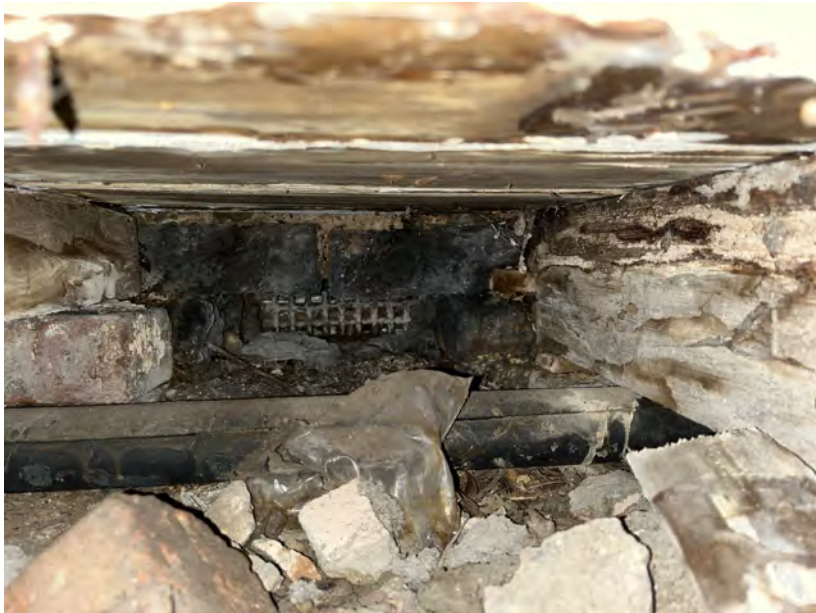
**Fig 39:**

Ground floor, west extension; showing a representative view of the subfloor void. Note timbers in visibly very poor state likely due to close proximity to the damp earth and without provision for a damp proof membrane/course and/or due to long term escape of water for the plumbing goods above. Widespread decay issues suspected

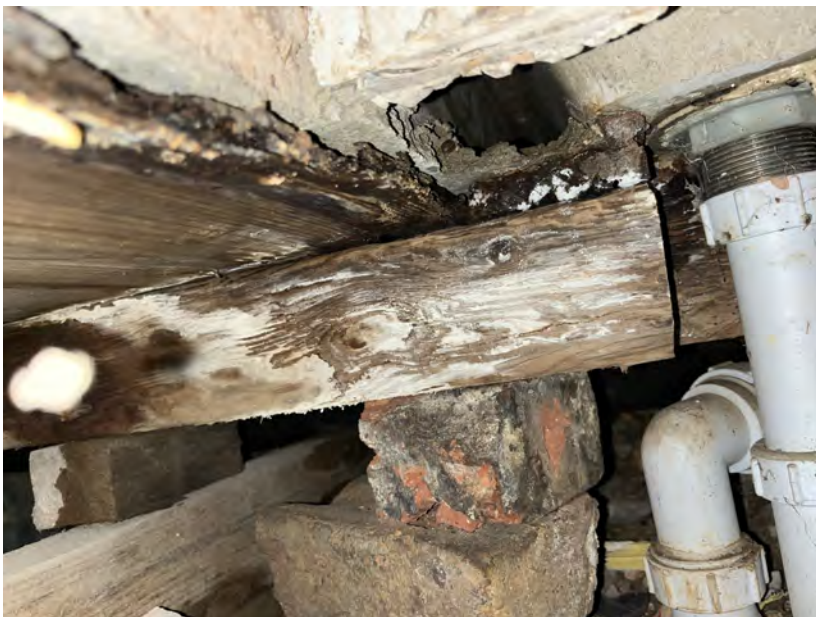
**Fig 40:**

Ground floor, west extension; showing a representative view of the subfloor void. Note timbers in visibly very poor state. Also note structurally inappropriate brickwork supporting floor joists. Widespread decay issues suspected

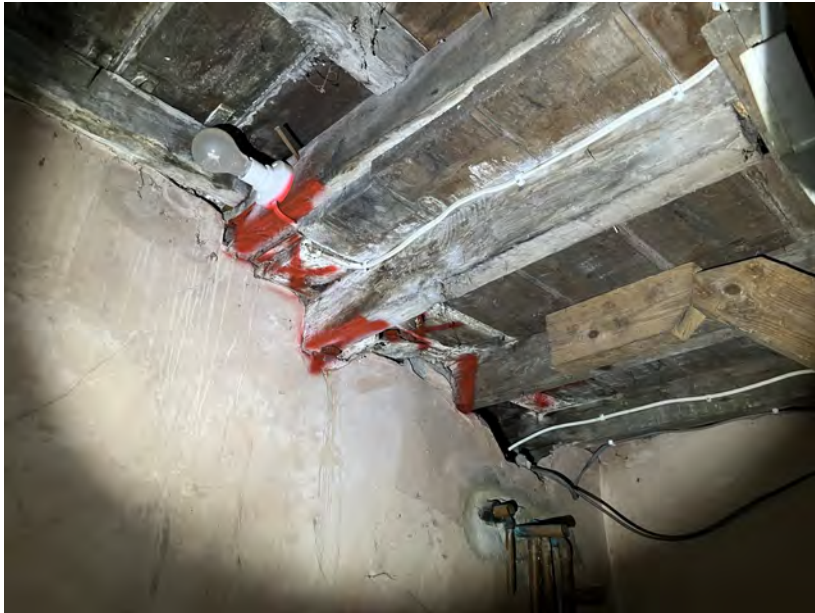
**Fig 41:**

Ground floor, stairs; showing structural decay to the stair landing trimmers and 2no. joists where they embed into the west internal masonry wall
