37 NORTH ROAD

DRY ROT AND TIMBER CONDITION INVESTIGATION

JOB NO. 162-58

01 NOVEMBER 2024

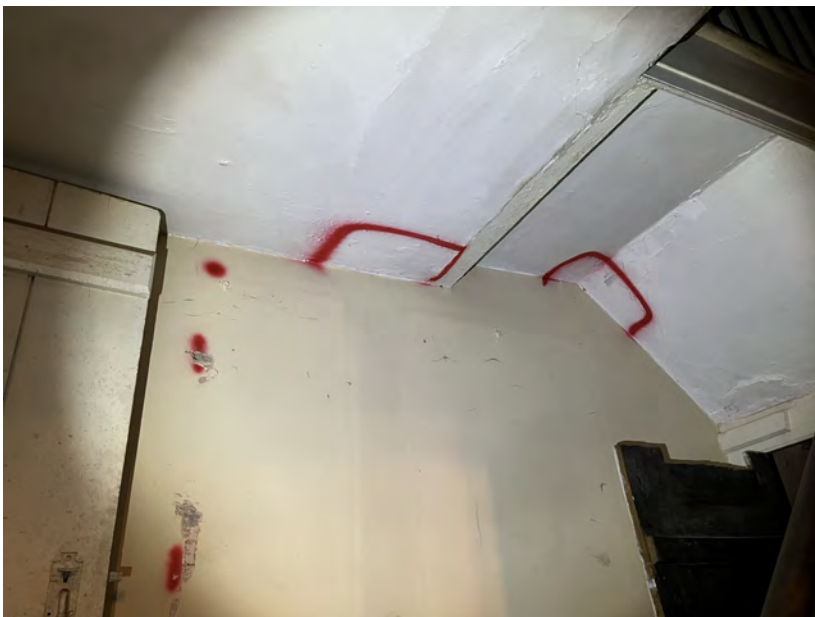
**Fig 42:**

Ground floor, stairs; showing no access to determine position and condition to the main east passage stair landing beams and trimmers. Allow for further exposure as per red marked areas

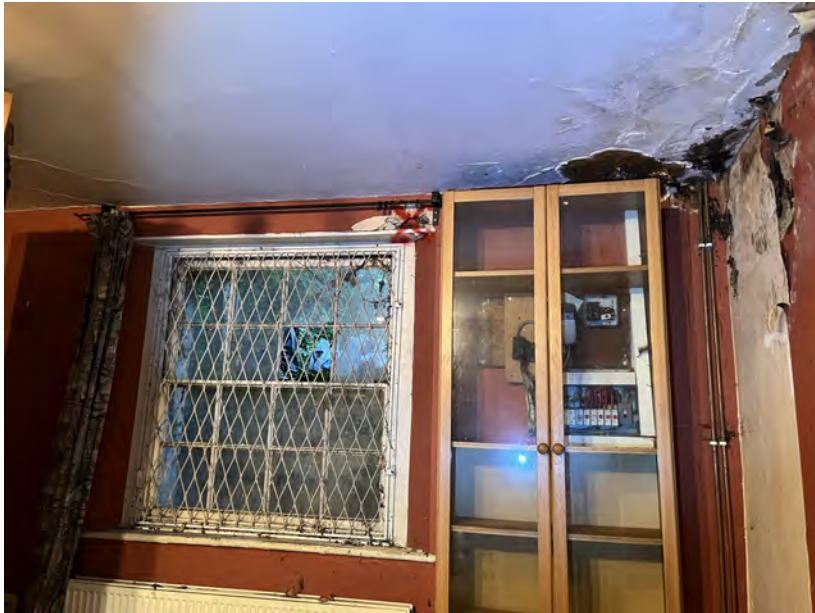
**Fig 43:**

Basement, east room, showing structural decay to the window lintel

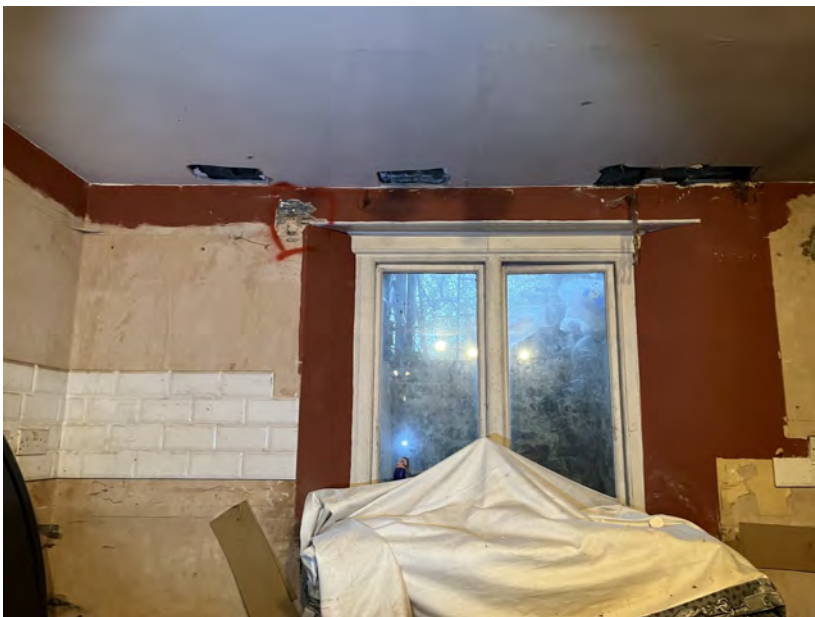
**Fig 44:**

Basement, west room, showing a view to the west window lintel where no decay was detected

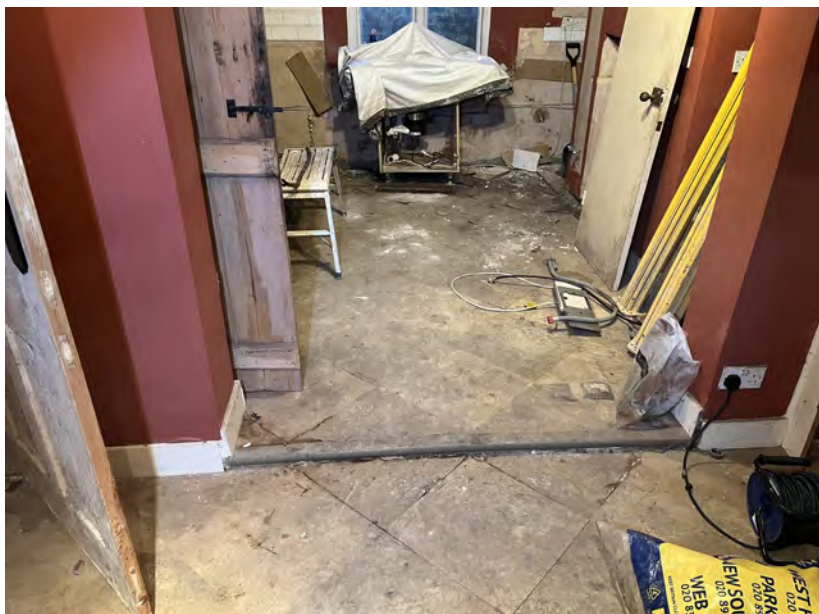
**Fig 45:**

Basement, central area, showing a general view to the floor structures which were of solid construction, apparently of York stone laid directly onto the earth substrate. Note a slight elevation to the west room apparently due to a poured asphalt type surface over, presumably for improved thermal performance in the past. Note historic linoleum tiles as well as any poured asphalts may contains ACMs

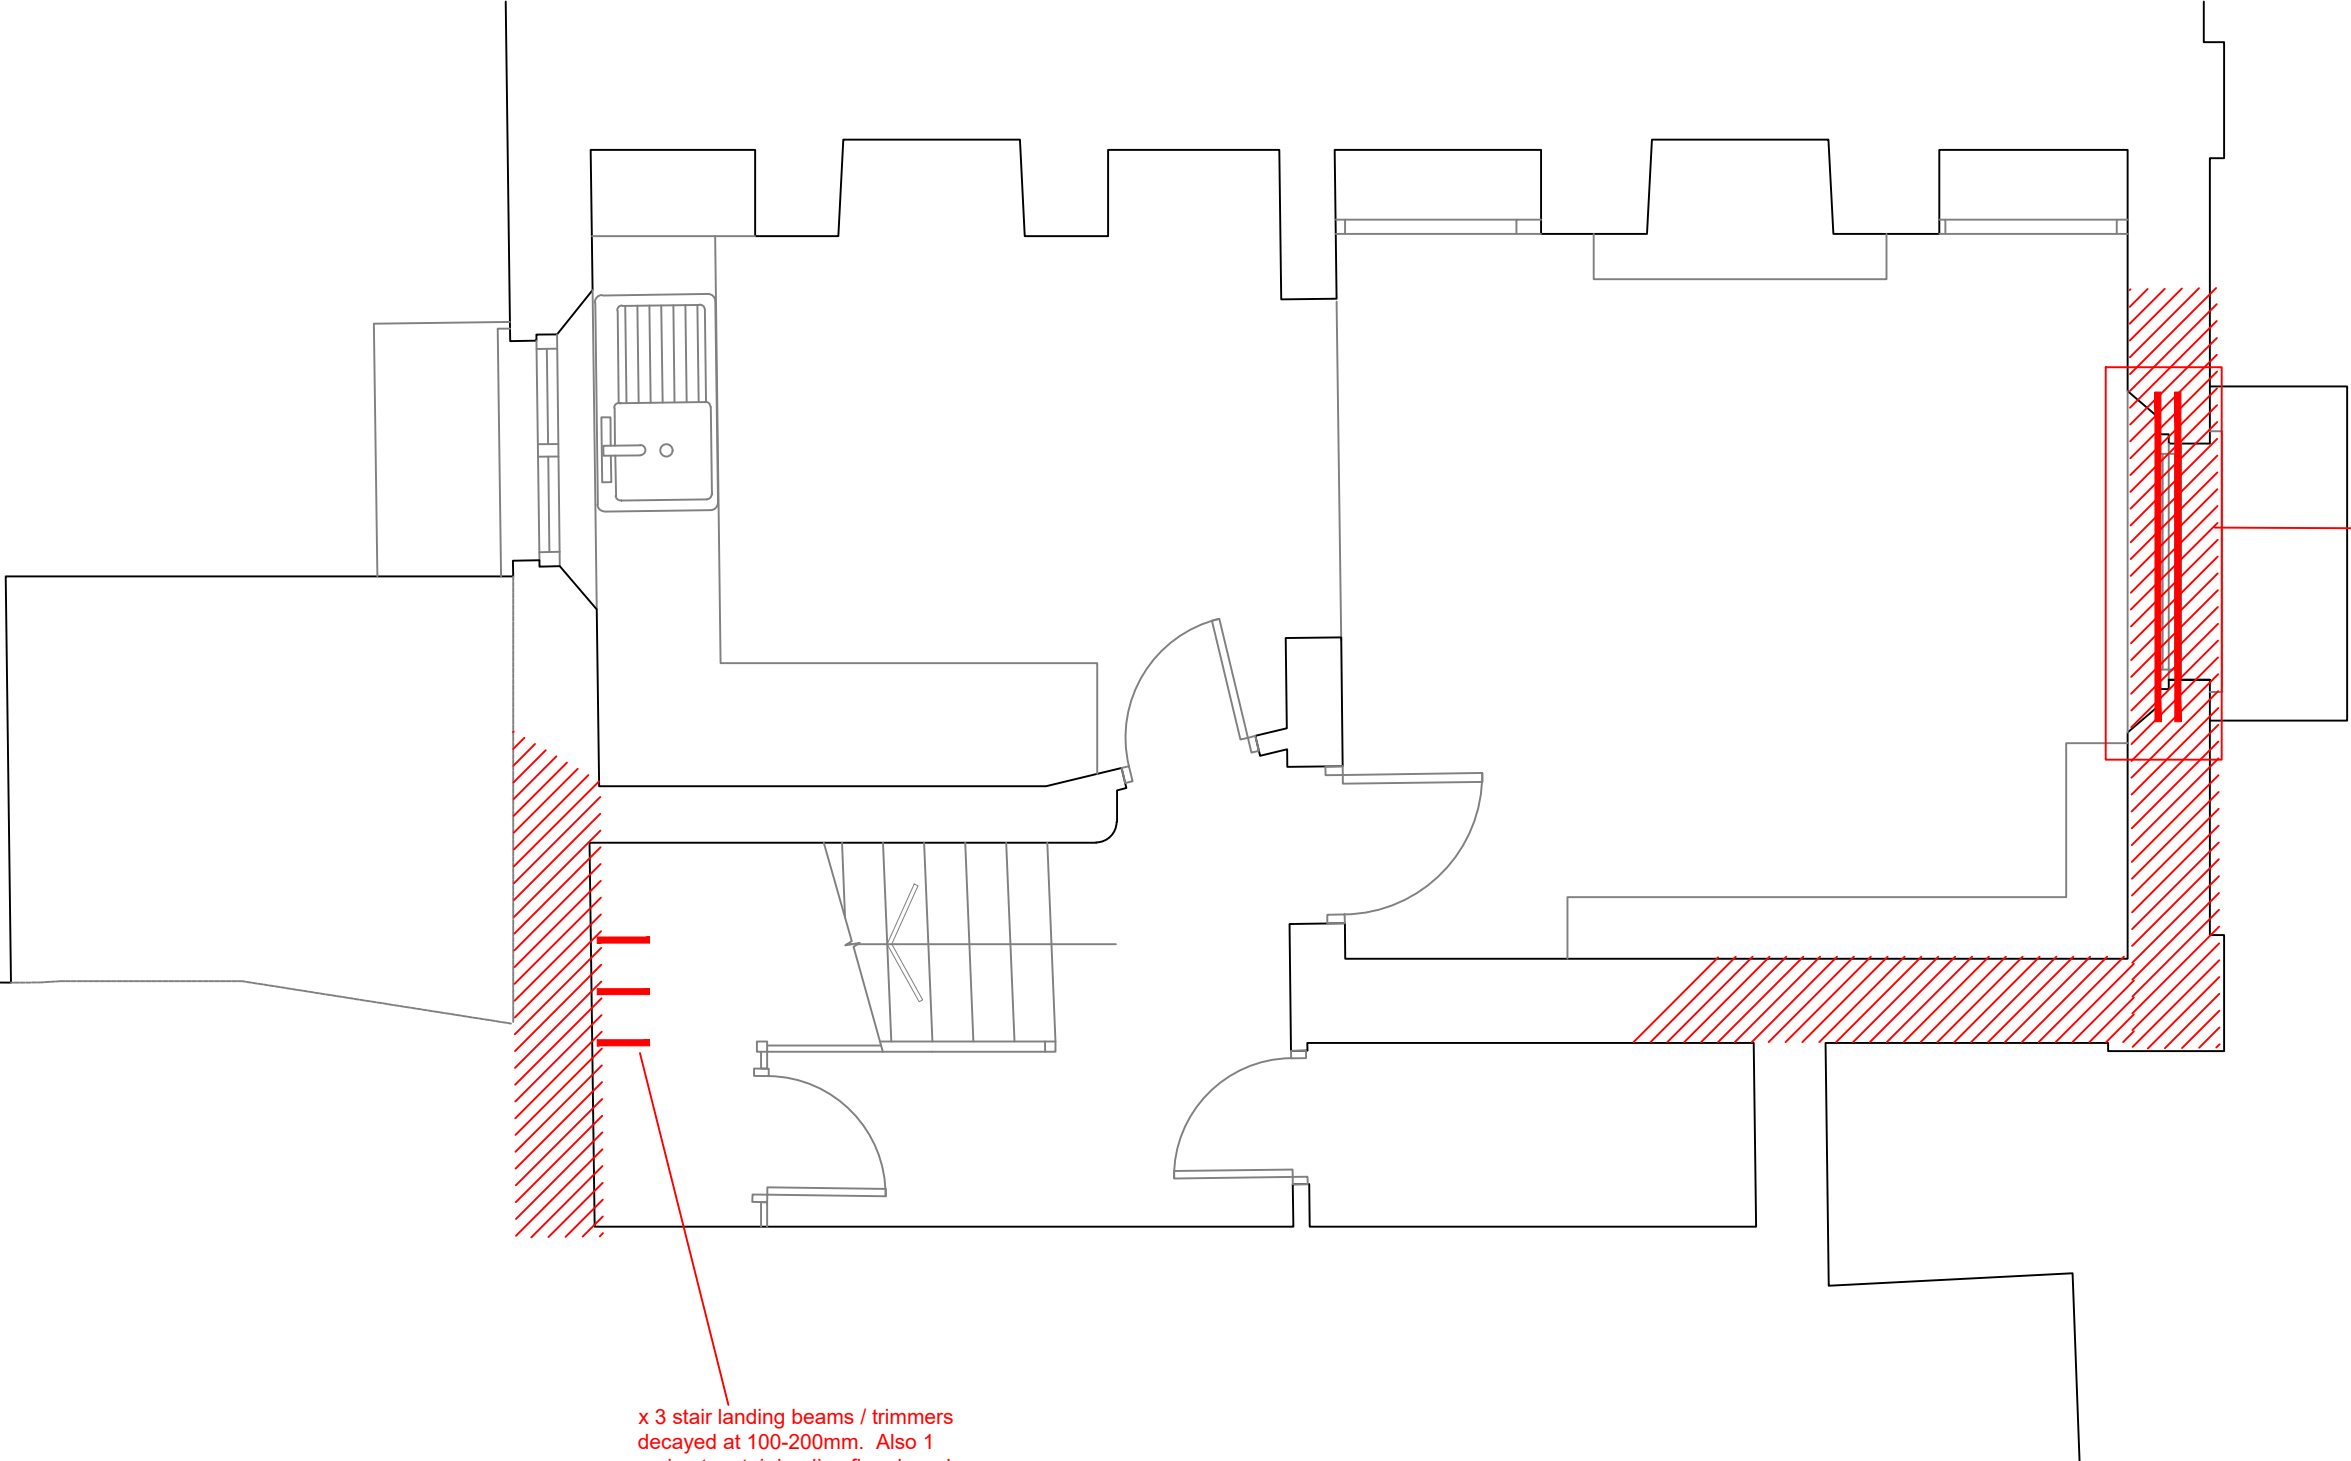
**e**  
Lintel also forming ground  
floor joist plate (doubled up)  
structurally decay

x 3 stair landing beams / trimmers  
decayed at 100-200mm. Also 1  
perimeter stair landing floor board
