Notes

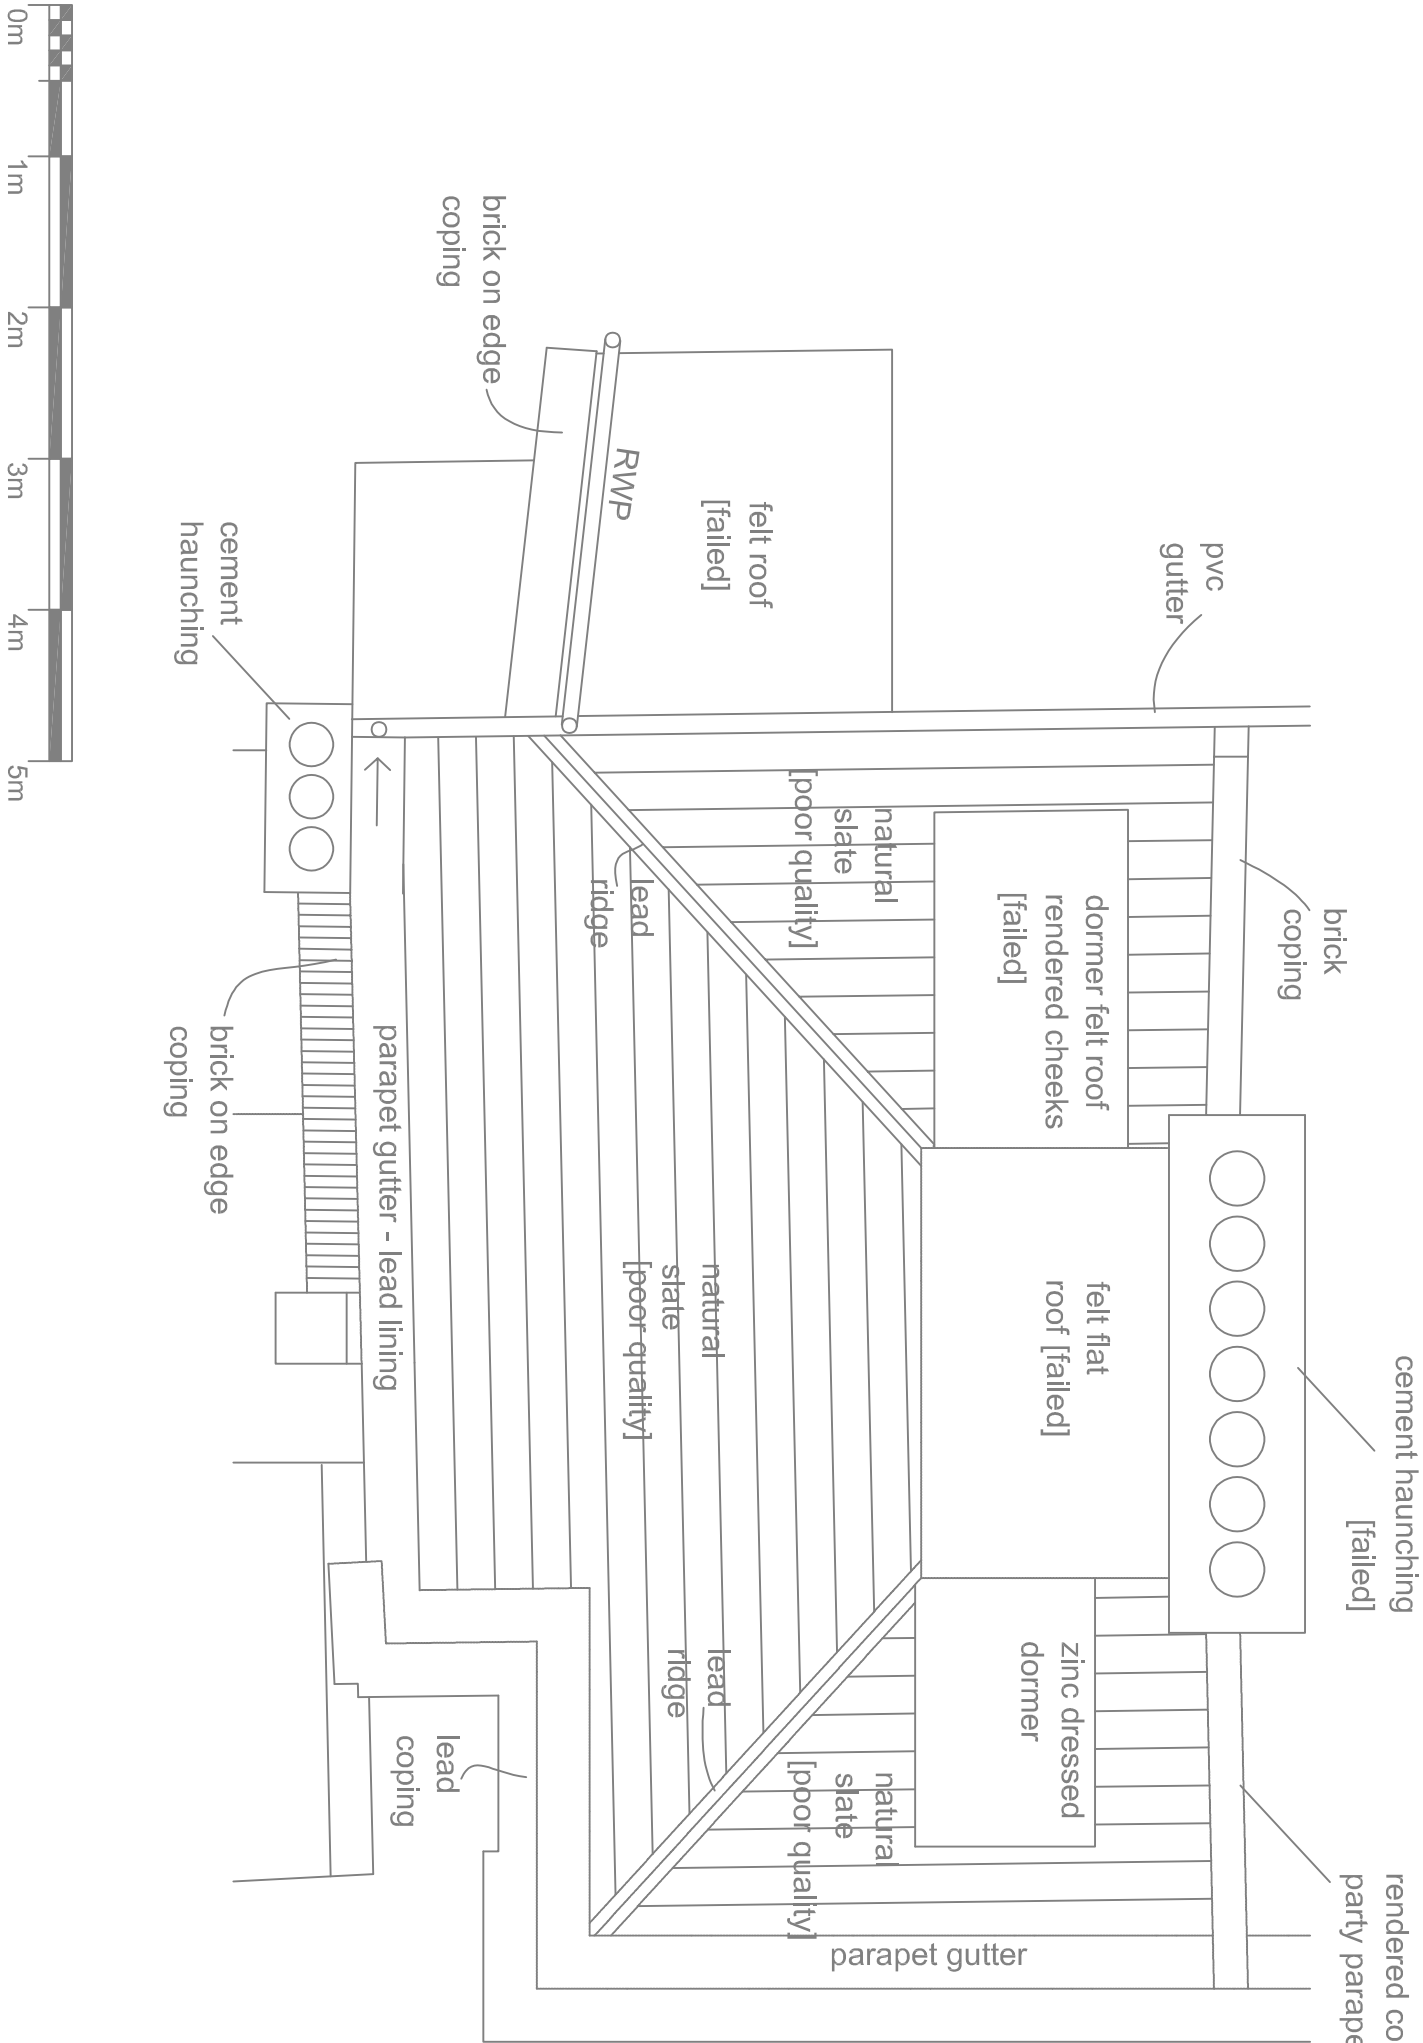
Roof: overhauled in 2013  
Extensive use of flash band  
Poor quality Spanish slate [probably second hand]  
Lead 3 core  
Most areas failed  
Rainwater dispersal overloaded [one outlet]
