37 NORTH ROAD

FAÇADE MASONRY CONDITION INVESTIGATION

JOB NO. 162-58

28 NOVEMBER 2024

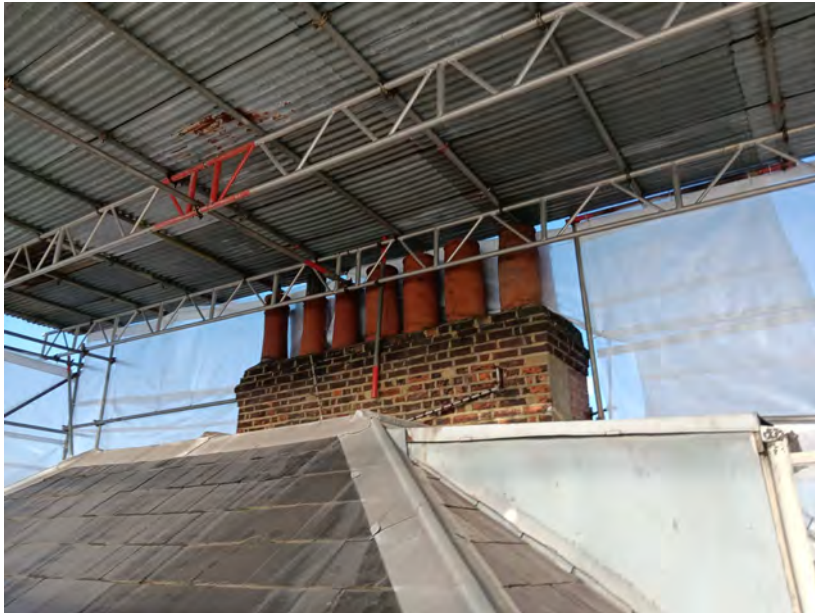
**Fig 1:**

| REFERENCE | ITEM | OBSERVATIONS | RECOMMENDATIONS | CLIENT COMMENTS |
|---|---|---|---|---|
| RPT.1.1 | Chimneystack | <p>There were a total of 7no. pots which connected to the fireplaces indicated on drawings. The flues would not be safe to use without certification by a heating engineer or similar</p> <p>The east pot has suffered clay failure</p> <p>All flaunching mortar was in a state of failure</p> <p>The west 3no. pots were modern replacements which did not closely match the historic original pots</p> <p>One of the 3no. modern pots appeared to have an asbestos-cement cowl (and the flue riser itself may be lined/lagged with asbestos materials, tbc)</p> <p>The upper courses of the stack had been replaced as part of a previous refurbishment and all brickwork in the stack had been re-pointed (rather crudely) using modern cement mortar. There were at least 12no. spalled brick faces</p> | <p><i>Consideration could be given to re-lining flues. In any case, H+R recommend trickle-ventilation is provided up all flues</i></p> <p><i>Pot to be carefully removed and sent to specialist terracotta workshop for fabrication of replica (at which time, the modern three pots could also be replaced in a more sensitive historic design)</i></p> <p><i>All pots to be lifted and re-laid into a replacement flaunching of NHL5 lime mortar (with a party wall agreement, it would be optimal to do this for the neighbouring pots too)</i></p> <p><i>Ideally these would be replaced in historic replicas (see other commentary)</i></p> <p><i>Asbestos containing materials should be inspected by a specialist and carefully removed under controlled conditions</i></p> <p><i>Allow to rake-out and re-point all brickwork on the chimneystack using NHL5 lime mortar. Bricks with spalled faces should be cut-out and replaced in a brick of matching type and imperial size</i></p> | |

Chimneystack

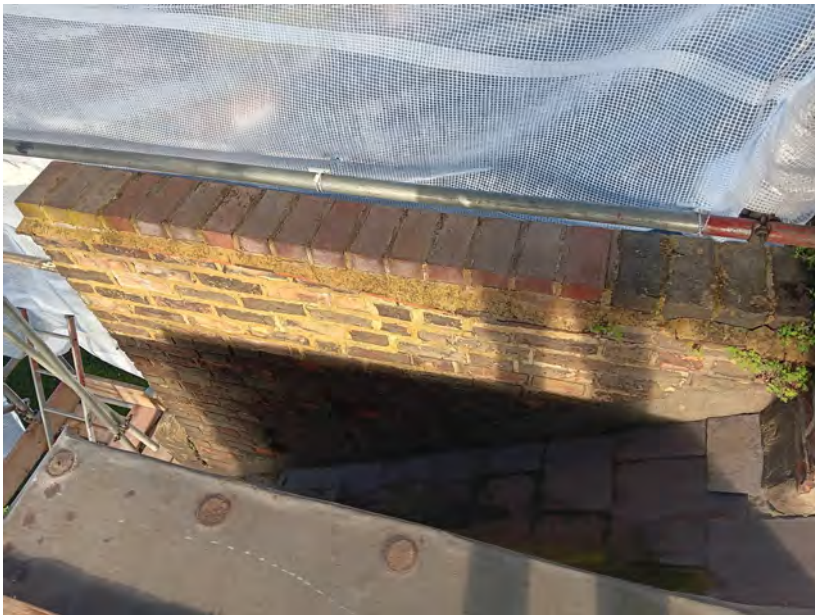
**Fig 2:**

| REFERENCE | ITEM | OBSERVATIONS | RECOMMENDATIONS | CLIENT COMMENTS |
|---|---|---|---|---|
| RPT.1.3 | Rear slope of party wall | <p>The wallhead in this area has been extended and re-built in several previous phases of work. There were at least 18no. spalled brick faces</p> | <p><i>Allow to rake-out and re-point all brickwork on the chimneystack using NHL5 lime mortar. Bricks with spalled faces should be cut-out and replaced in a brick of matching type and imperial size</i></p> <p><i>The flashing at the roof line should be replaced in lead</i></p> | |

Party wall, rear slope

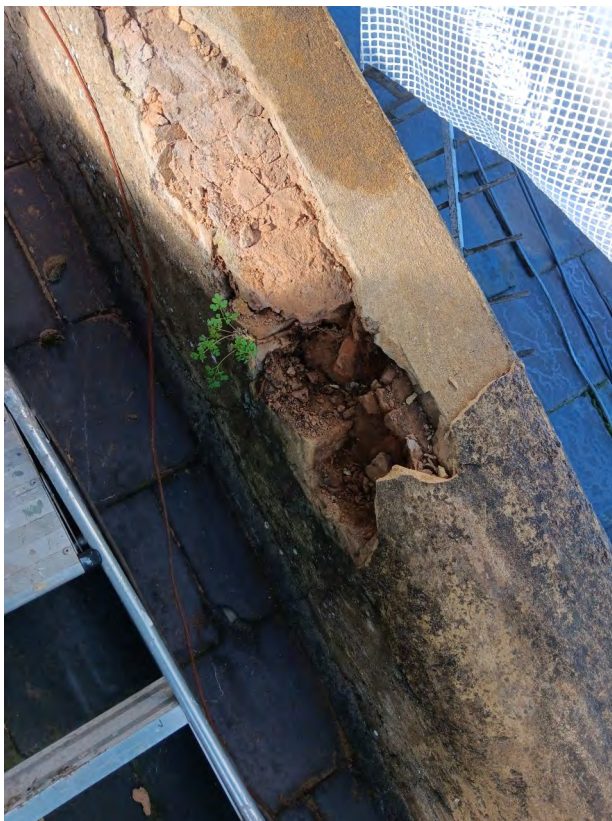
**Fig 3:**

| REFERENCE | ITEM | OBSERVATIONS | RECOMMENDATIONS | CLIENT COMMENTS |
|---|---|---|---|---|
| RPT.1.2 | Front slope of party wall | <p>The original weathering had been 'roman cement' which was in poor condition, exacerbated by modern Portland cement re-surfacing. The flashing onto the slate roof finish was poor. Note - render sample 1 was taken from this location</p> | <p><i>With a party wall agreement, it would be optimal to remove and replace the entire wallhead (new lead flashing onto roof slates, partial repair/rebuild of brick substrate, new 'Roman cement' render finish)</i></p> <p><i>The modern equivalent of 'Roman cement' is a product known as 'Prompt'. As per the original, the setting time of this product is very fast so application is a specialist task</i></p> | |

Party wall, front slope

'H+R render sample 1' taken from this location

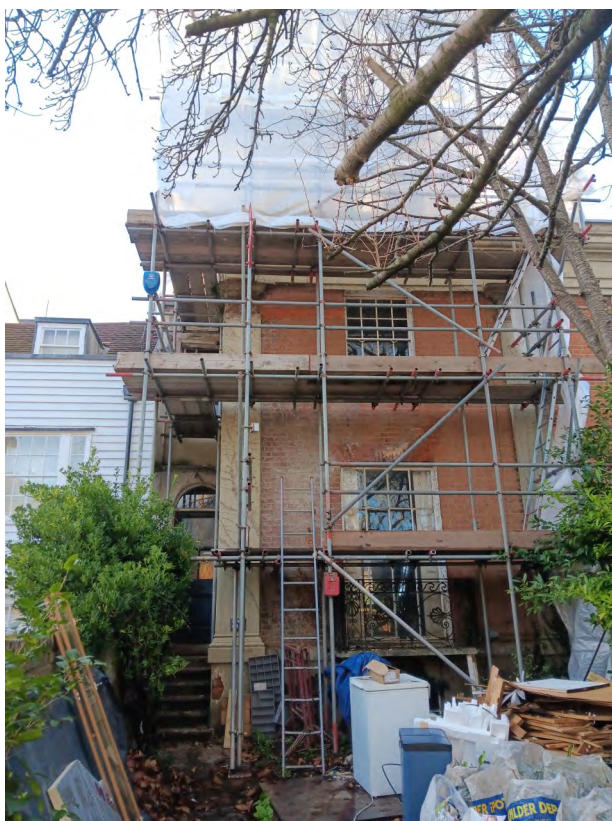
**Fig 4:**

Front (east) elevation

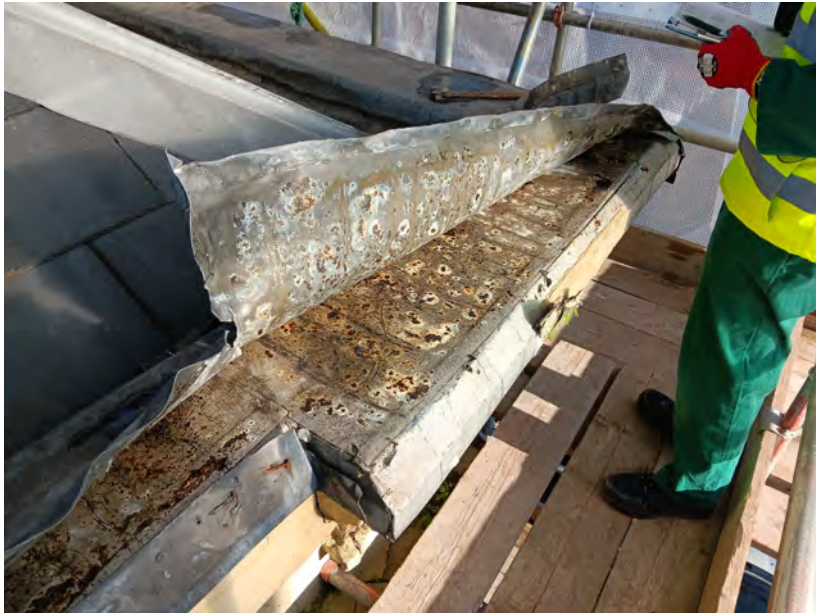
**Fig 5:**

Front (east) elevation, showing modern flashband repairs to wallhead

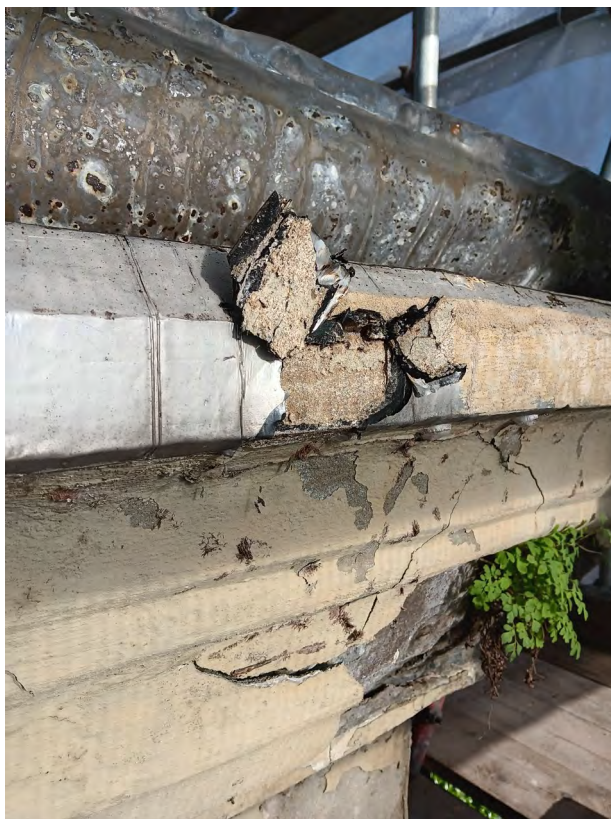
**Fig 6:**

Front (east) elevation, showing modern flashband repairs to wallhead

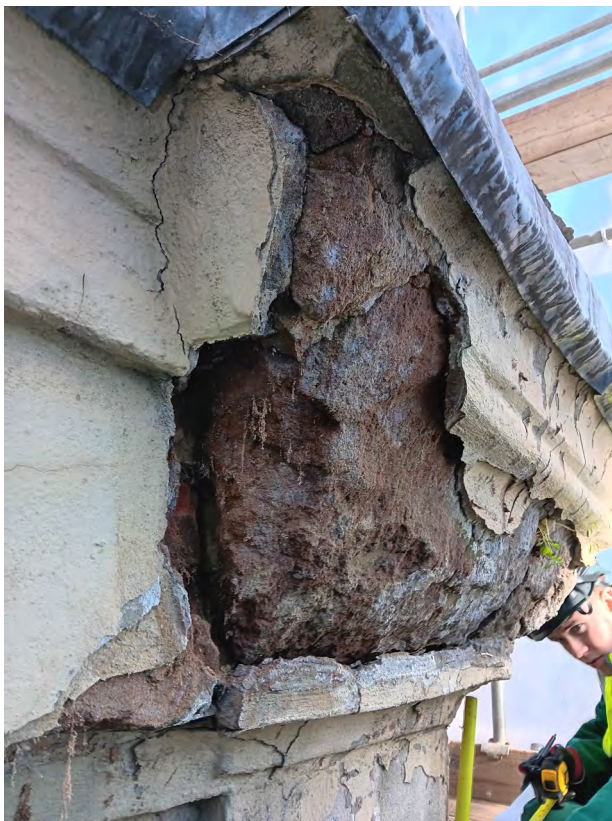
**Fig 7:**

Front (east) elevation, showing modern Portland cement re-surfacing of original 'Roman cement' render feature

The paint finish was a modern acrylic type

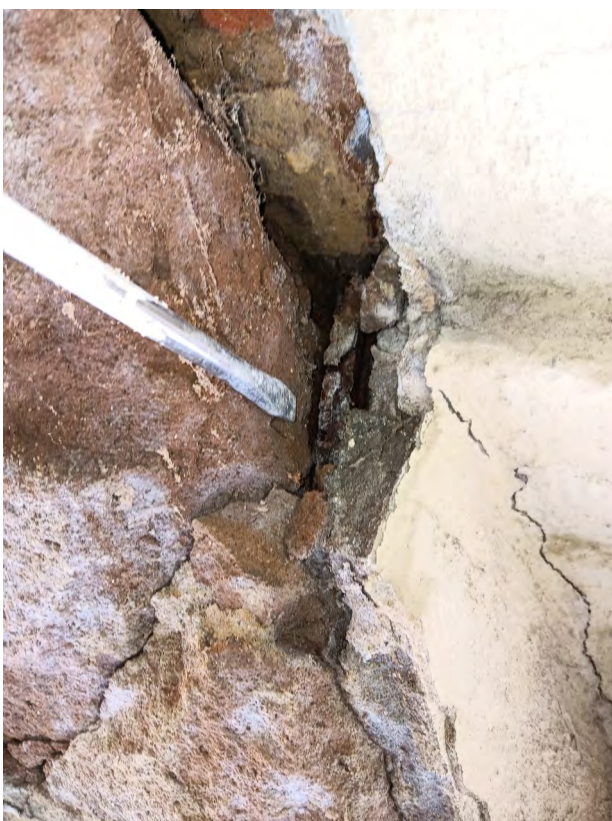
**Fig 8:**

Front (east) elevation, showing modern Portland cement re-surfacing of original 'Roman cement' render feature

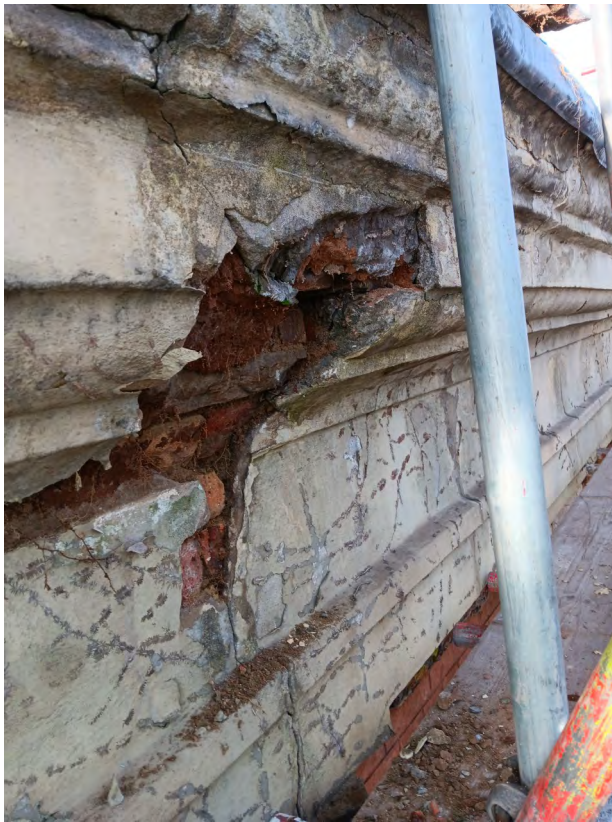
**Fig 9:**

Front (east) elevation, showing area of failed render cladding to corbelled cornice

The view of the substrate allowed H+R to determine the construction using sandstone slabs and corbeled-out brick courses

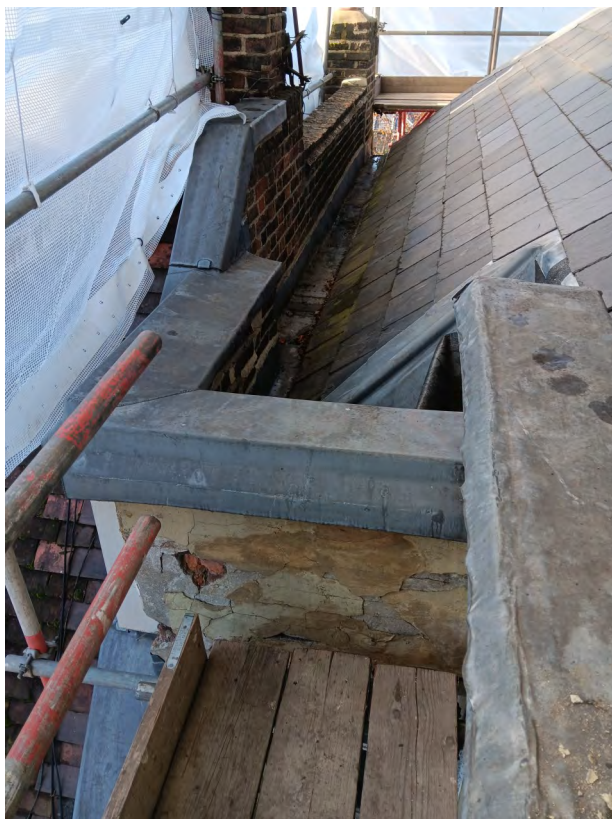
**Fig 10:**

Front (east) elevation, showing poor state of render at flank/return junction with an older neighbouring property

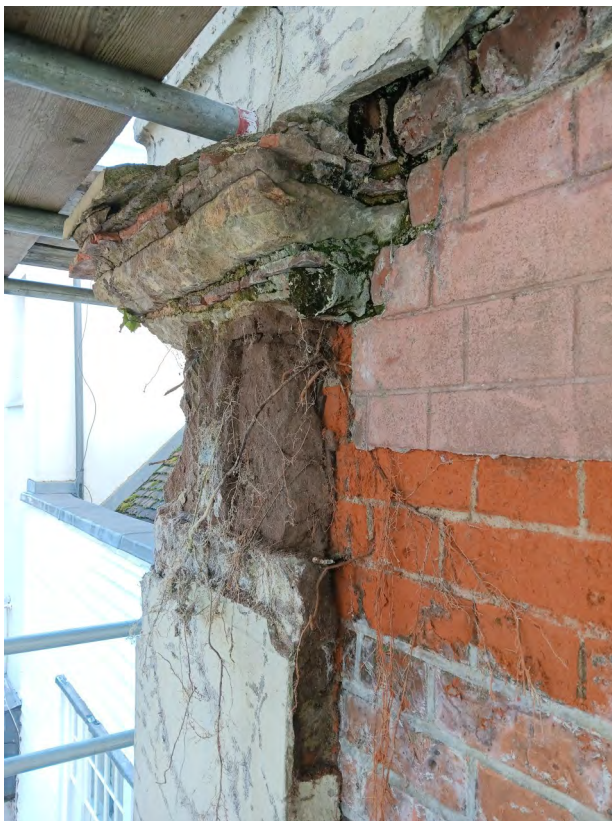
**Fig 11:**

Front (east) elevation, showing disintegration of render column capital feature

Note corbeled brick, tile and sandstone formwork

Note pilaster formed by considerable thickness of the render itself (rather than a step in the substrate)

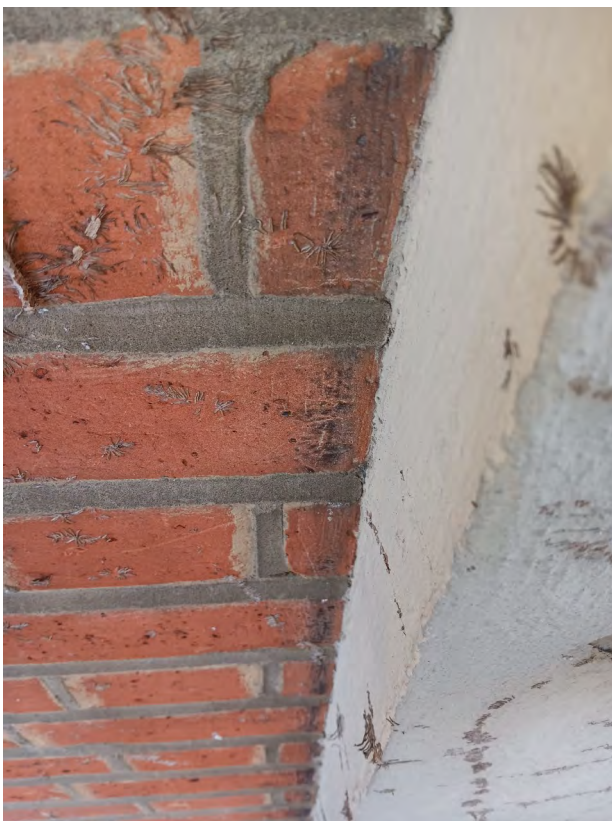
**Fig 12:**

Front (east) elevation, showing detail of cement re-pointing (note smears onto brick faces)

Also note residue to black pollution staining which appears to have been scoured-off brick faces (resulting in loss of brick material but luckily this has not affected weathering performance)

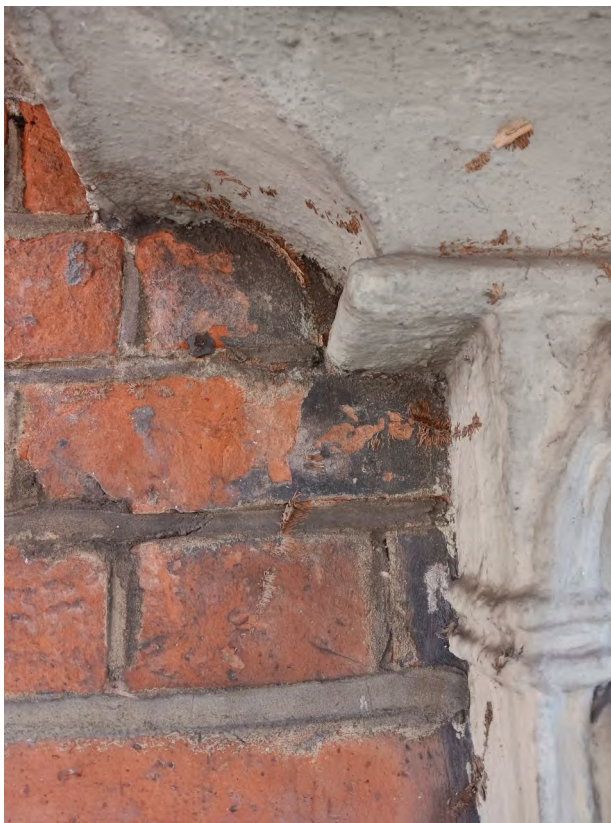
**Fig 13:**

Front (east) elevation, showing residue to black pollution staining which appears to have been scoured-off brick faces (resulting in loss of brick material but luckily this has not affected weathering performance)

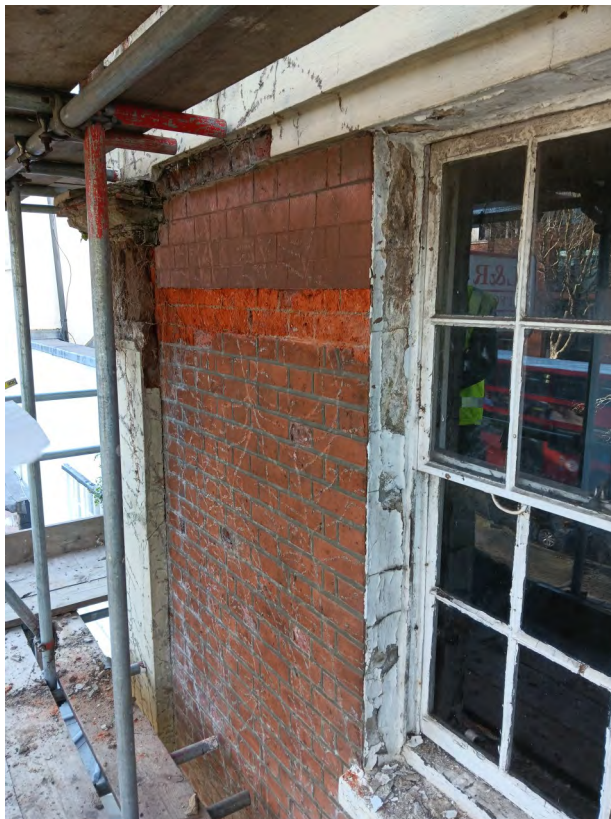
**Fig 14:**

Front (east) elevation, showing debonding failure of mortar repair to brick faces

Also note soiling by moisture/salts from parapet leakage

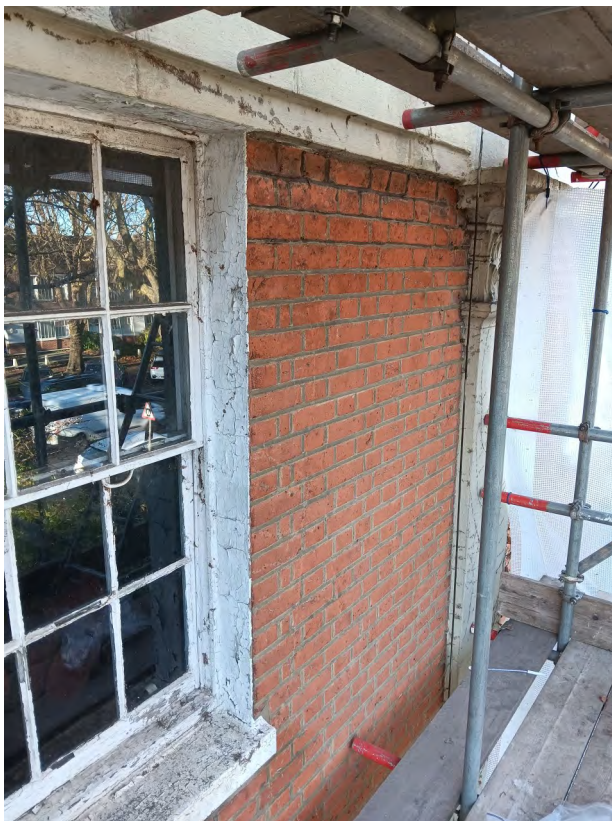
**Fig 15:**

Front (east) elevation, showing north side of first floor in fairly good condition

Note rendered window reveal largely intact despite paint failure

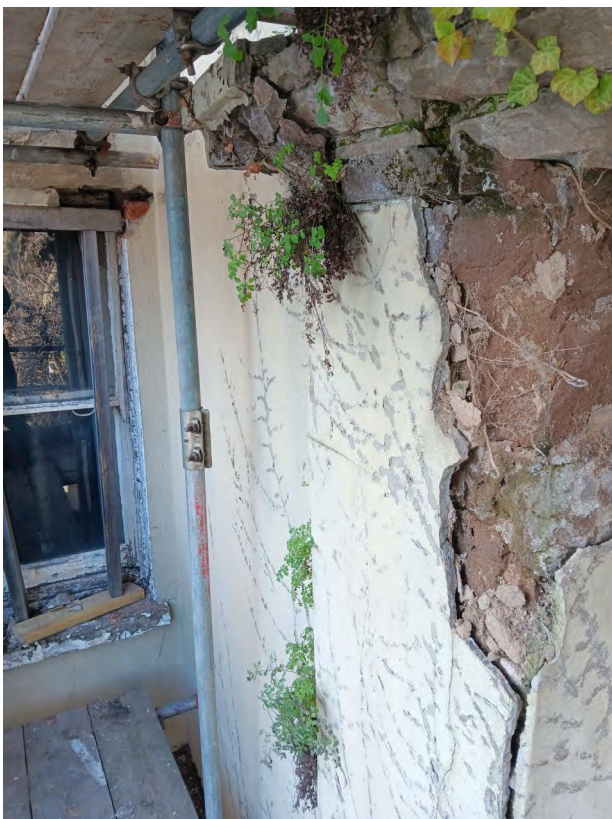
**Fig 16:**

Front (east) elevation, showing disintegration of modern cement render applied over original plaster render

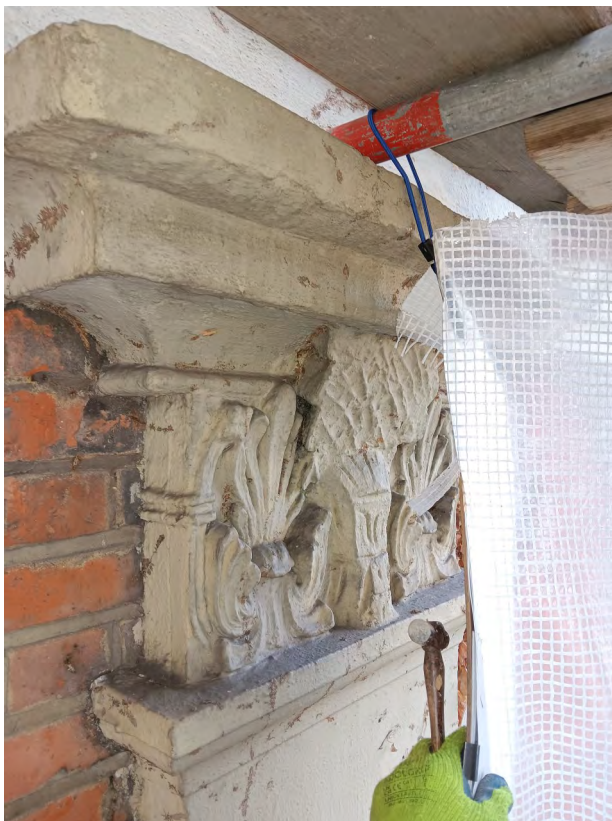
**Fig 17:**

Front (east) elevation, showing detail of pilaster capital at party wall

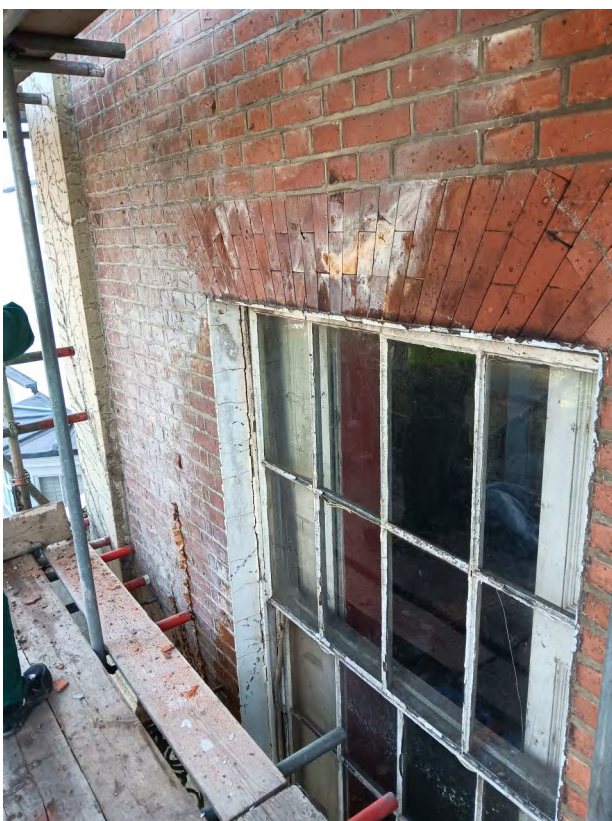
**Fig 18:**

Front (east) elevation, showing detail of moisture/salt staining from roof leak

Note salt staining was worst at the 'drying band' where moisture content fluctuated from wet to dry (which brings -out salts)

Also note some damage to gauged brick arch lintel and loss of pointing

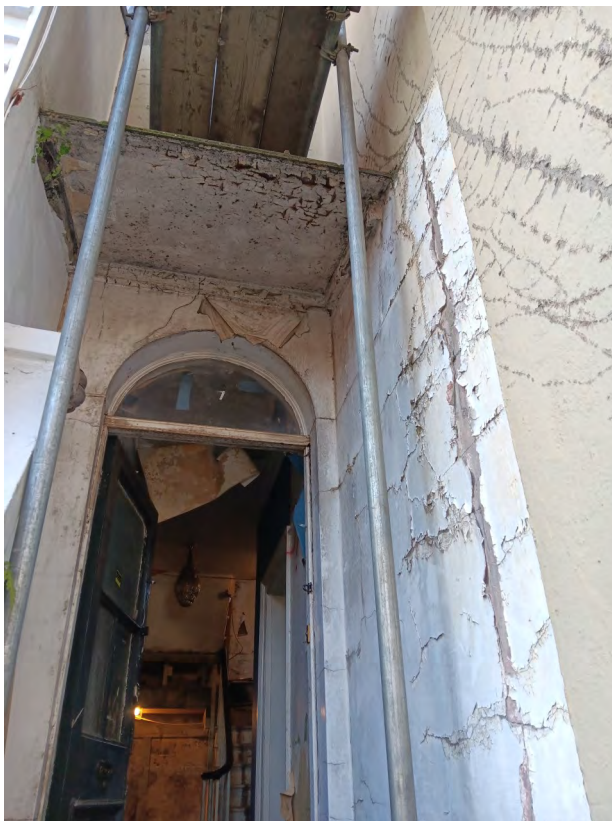
**Fig 19:**

Front (east) elevation, showing flank elevation subject to cracking and paint failure

Note slate slab canopy

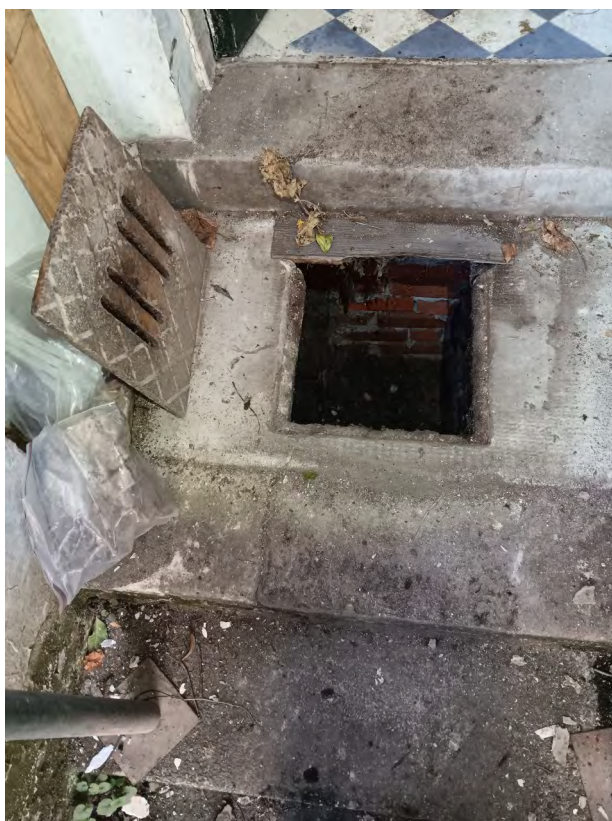
**Fig 20:**

Front (east) elevation, showing coal delivery chute (latterly bricked-up internally)

A lead water supply pipe was noted (this could be a health hazard if it is still the source of drinking water to the property, tbc)

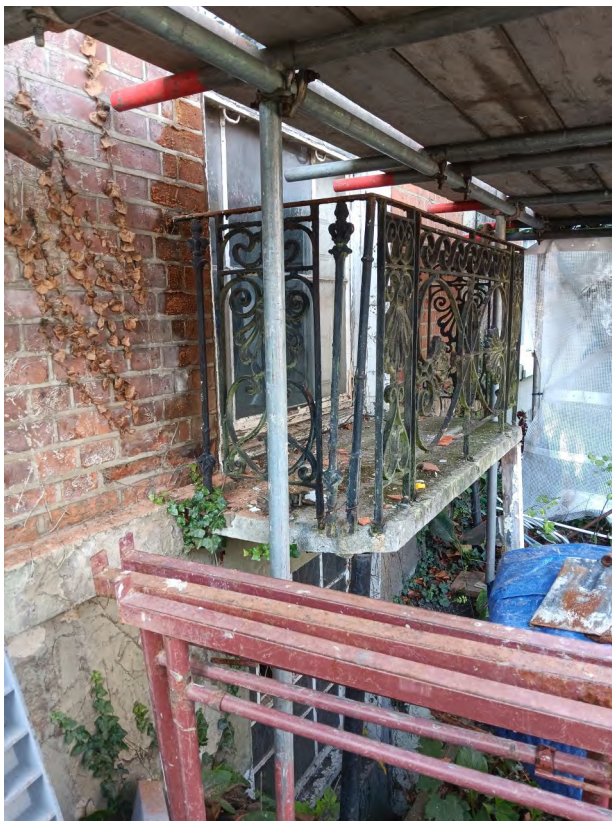
**Fig 21:**

Front (east) elevation, showing detail of balcony

Note minor damage to stone corners at corroded railing feet

Note modern and fairly crude props at leading edge of balcony (appeared to be loose and unclear if they are structurally essential)

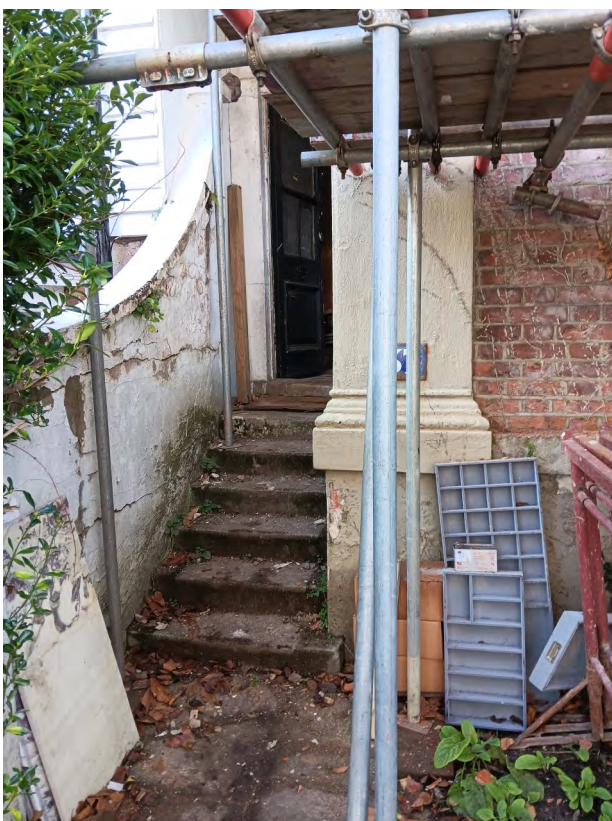
**Fig 22:**

| REFERENCE | ITEM | OBSERVATIONS | RECOMMENDATIONS | CLIENT COMMENTS |
|---|---|---|---|---|
| RPT.2.4 | East elevation<br>Boundary walls etc. | <p>The historic boundary wall alongside the entrance steps was rendered brickwork. This was badly cracked and subject to general debonding of the render</p> <p>Further down the south boundary to the front garden was a modern brick wall which appeared intact</p> <p>The pavement boundary may have originally been iron railings fixed into a stone plinth but this appeared to have been lost many years ago</p> <p>The north boundary of the front garden was not reviewed, it was potentially missing/absent</p> | <p><i>This section of wall is likely to require replacement of the render and structural repair of cracks by helibar</i></p> <p>-</p> <p><i>Consider restoring a historically appropriate boundary</i></p> <p>-</p> | |

Front (east) elevation, showing entrance steps and boundary wall in poor condition

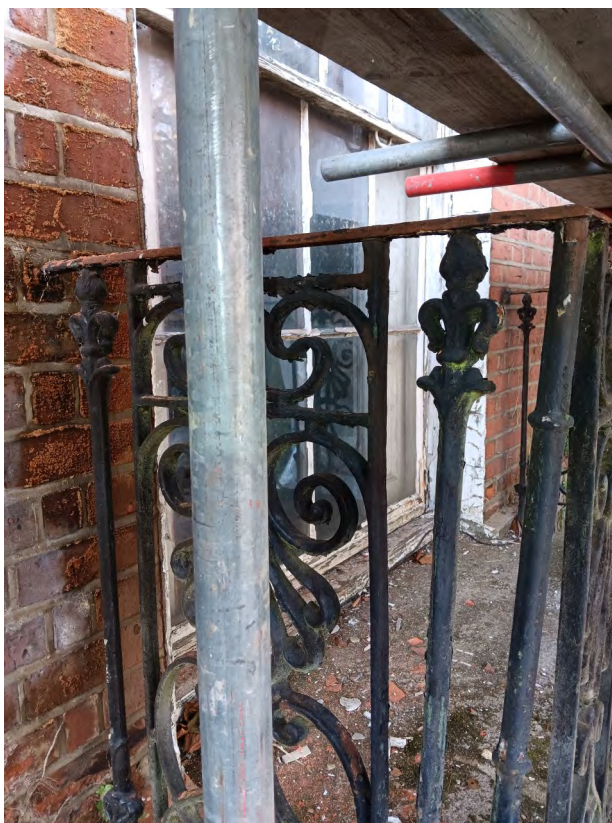
**Fig 23:**

Front (east) elevation, showing detail of balcony railing

The balusters are of cast iron whereas the handrail is of wrought iron

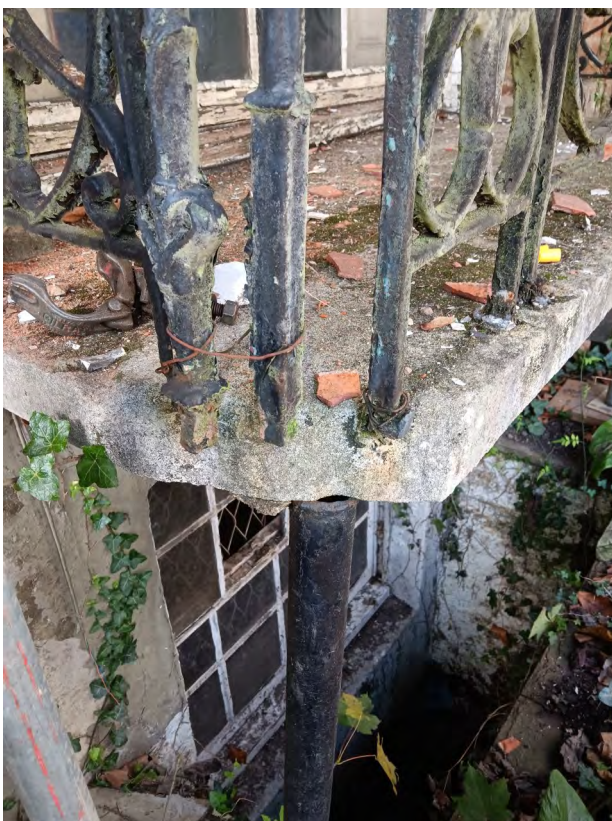
**Fig 24:**

Front (east) elevation, showing detail of balcony stone damage at corroded railing feet

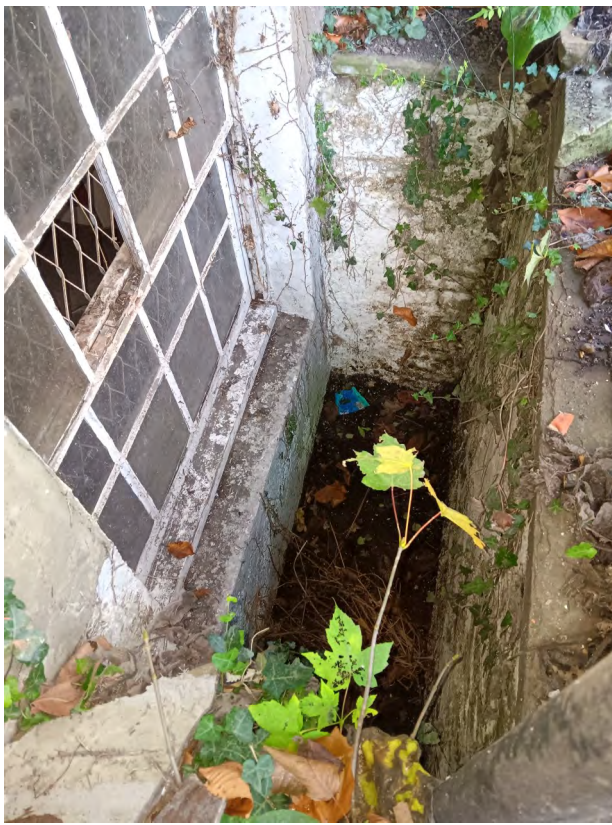
**Fig 25:**

Front (east) elevation, showing detail of basement lightwell

It appeared that there was no drainage in this area (tbc)

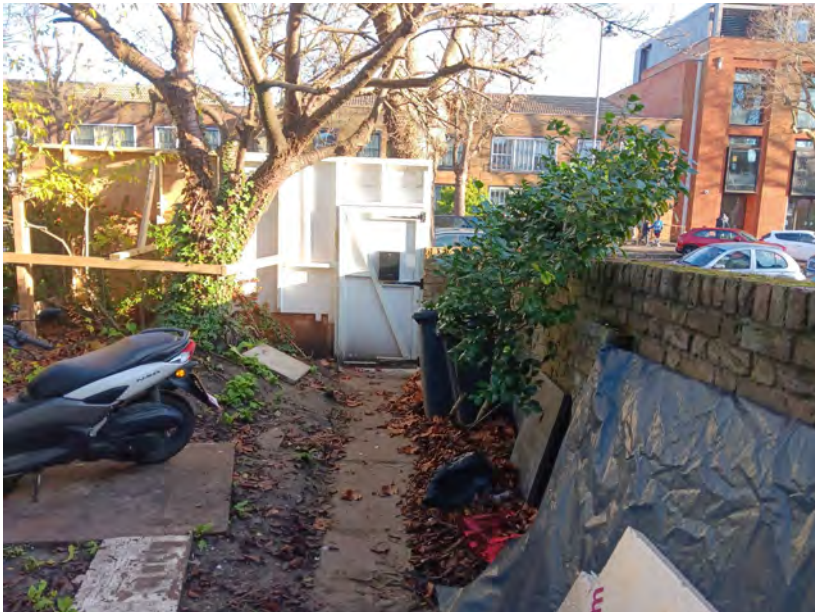
**Fig 26:**

Front garden; showing modern boundary wall and loss of original metal railings along the pavement

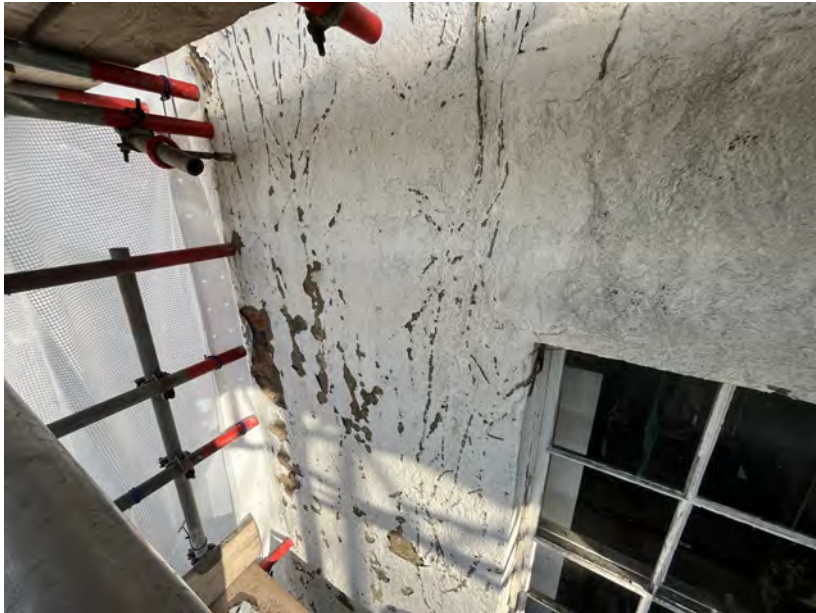
**Fig 27:**

Rear (west) elevation, showing north side at first floor level

Note render was poor quality (thin) and subject to delamination

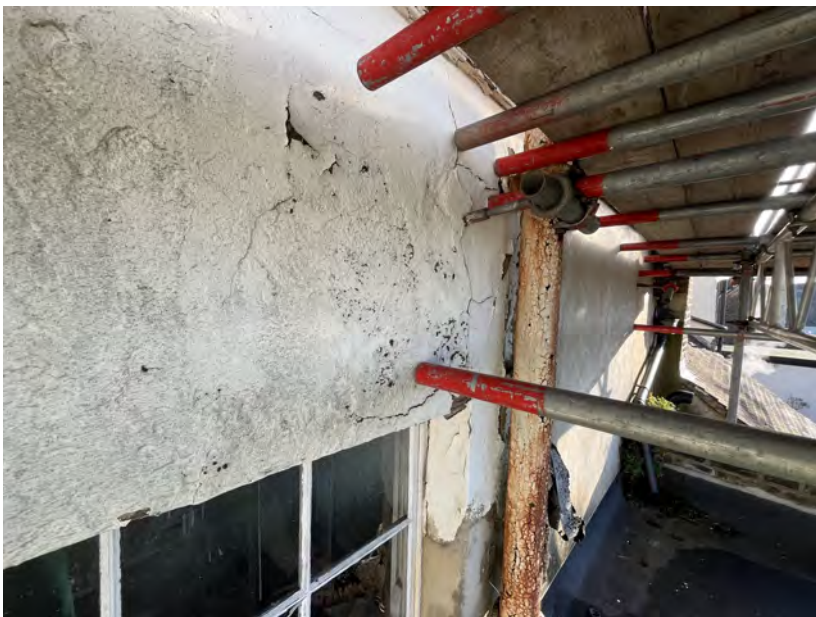
**Fig 28:**

Rear (west) elevation, showing south side at first floor level

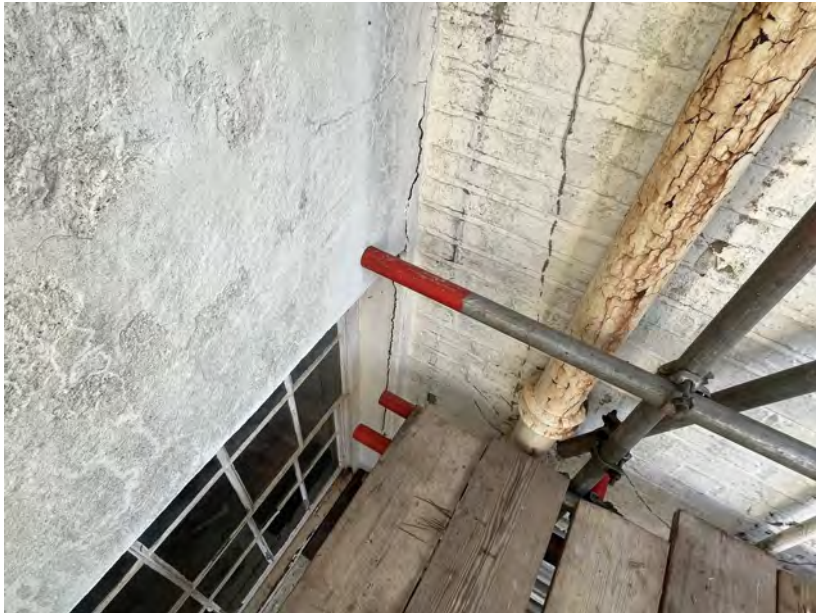
**Fig 29:**

| REFERENCE | ITEM | OBSERVATIONS | RECOMMENDATIONS | CLIENT COMMENTS |
|---|---|---|---|---|
| RPT.3.1 | General | <p>Vertical cracking at construction joint between modern closet wing extension and original rear elevation, crack opened-up by ~20mm</p> <p>Upper south corner has been re-rendered in modern Portland cement (appears to be associated with flying freehold area?)</p> <p>General failure of original render which appears to have always been a low quality (thin) coat of render and vulnerable to the effects of prevailing weather. Modern application of acrylic paint was likely deleterious to render. Render subject to various areas of collapse and widespread debonding</p> <p>Various redundant fixings and service runs/penetrations</p> <p>The rear garden boundaries were not reviewed, they appeared to be simple modern timber fencing</p> | <p><i>Structural Engineer to review this and other areas of cracking generally. It may be necessary to provide corner-ties using helibar or similar</i></p> <p><i>As a minimum, it is suggested that this area is decorated using Keim mineral paint for weathering protection</i></p> <p><i>Total replacement of this render is recommended using an NHL5 mortar</i></p> <p><i>To be made good using matching materials, following removal of all redundant items</i></p> <p>-</p> | |

Rear (west) elevation, showing crack at junction with modern closet wing

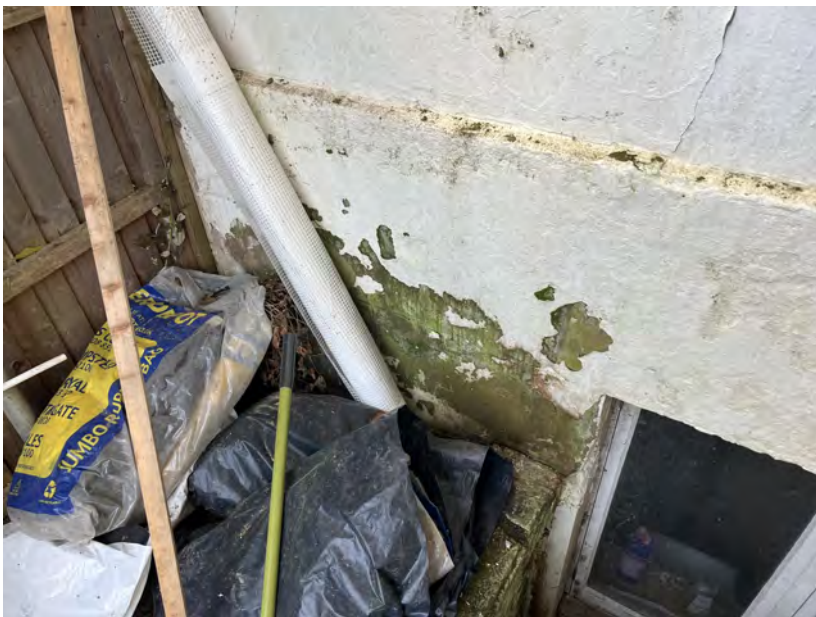
**Fig 30:**

Rear (west) elevation, showing north side at ground floor level

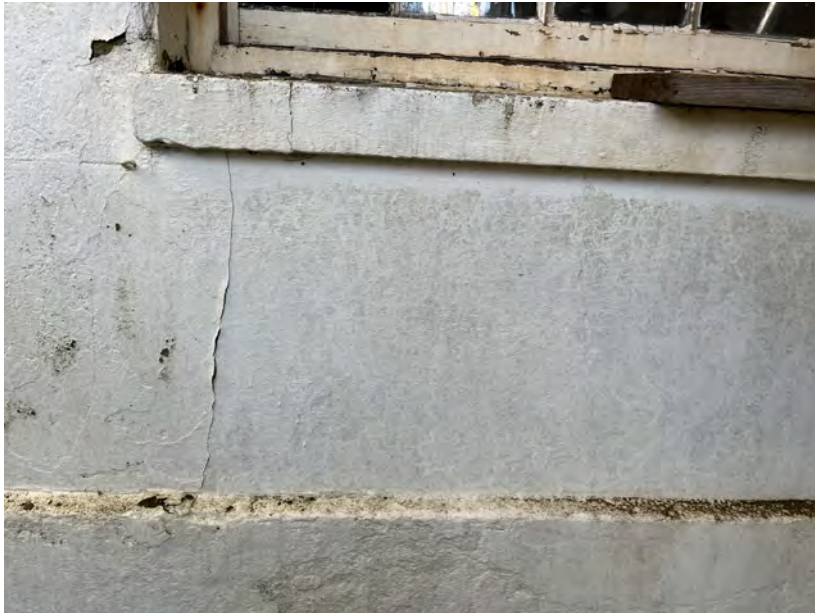
**Fig 31:**

Rear (west) elevation, showing crack below ground floor window aperture

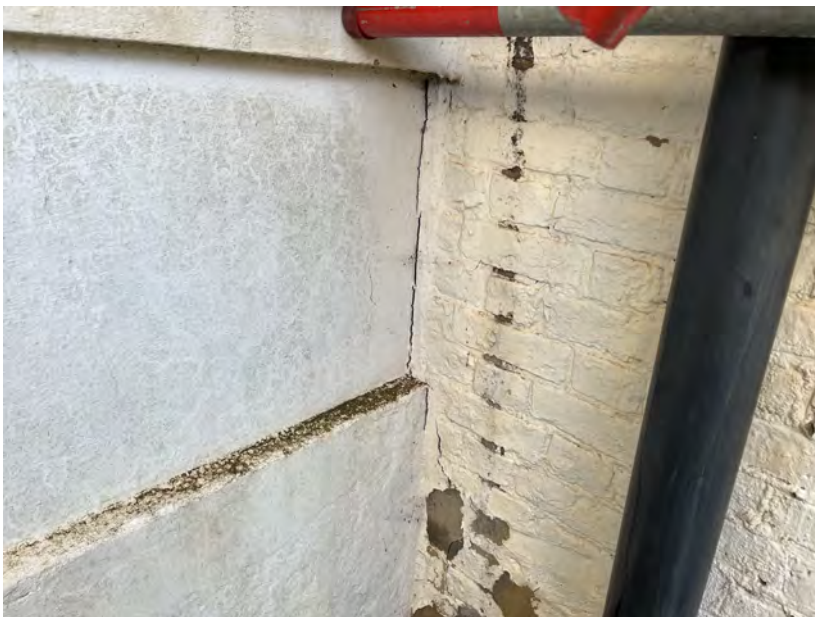
**Fig 32:**

Rear (west) elevation, showing crack at junction with closet wing

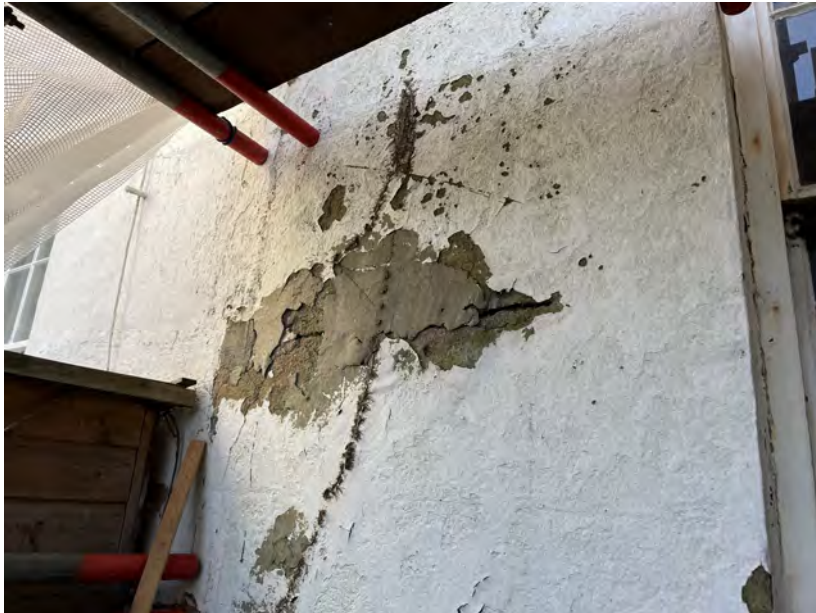
**Fig 33:**

Rear (west) elevation, showing poor previous patch repair to render at ground level

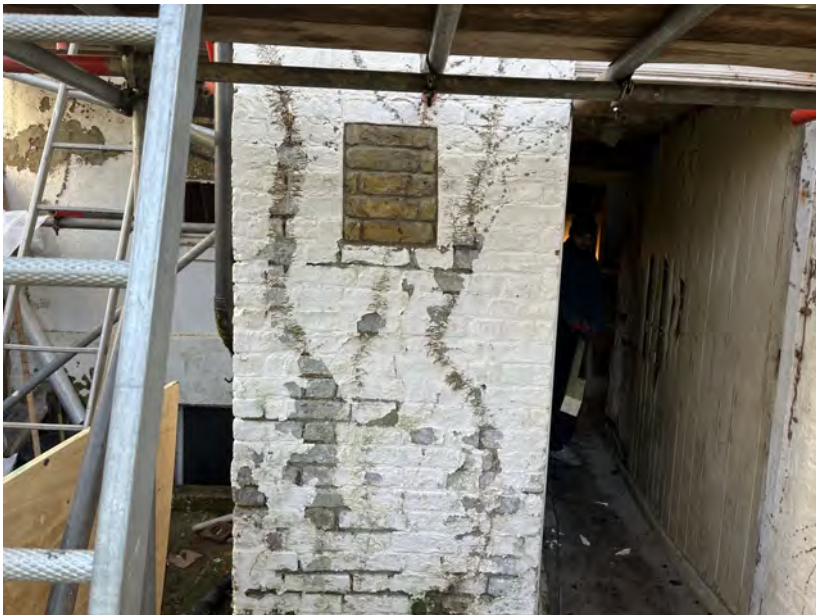
**Fig 34:**

Rear (west) elevation, showing ivy soiling, paint loss and infill repair to modern closet wing

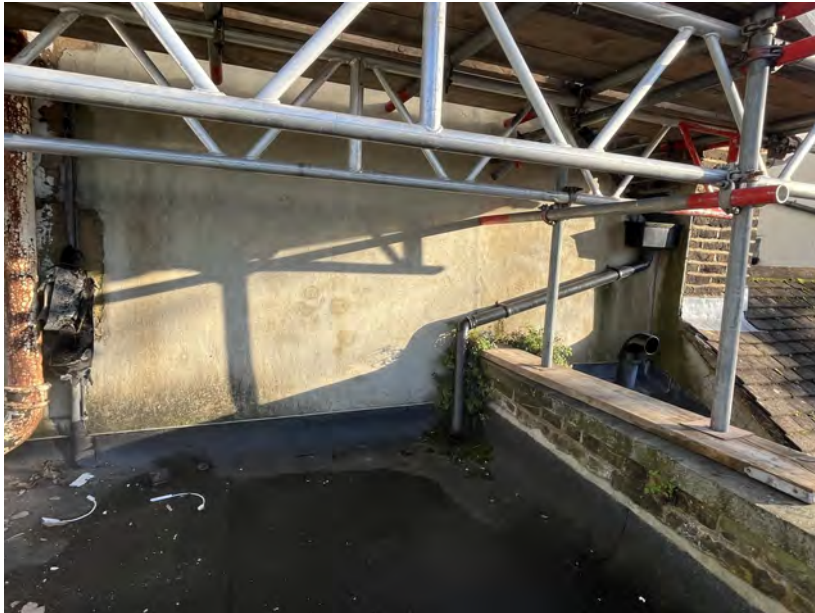
**Fig 35:**

Rear (west) elevation, showing modern cement render cladding at upper south side

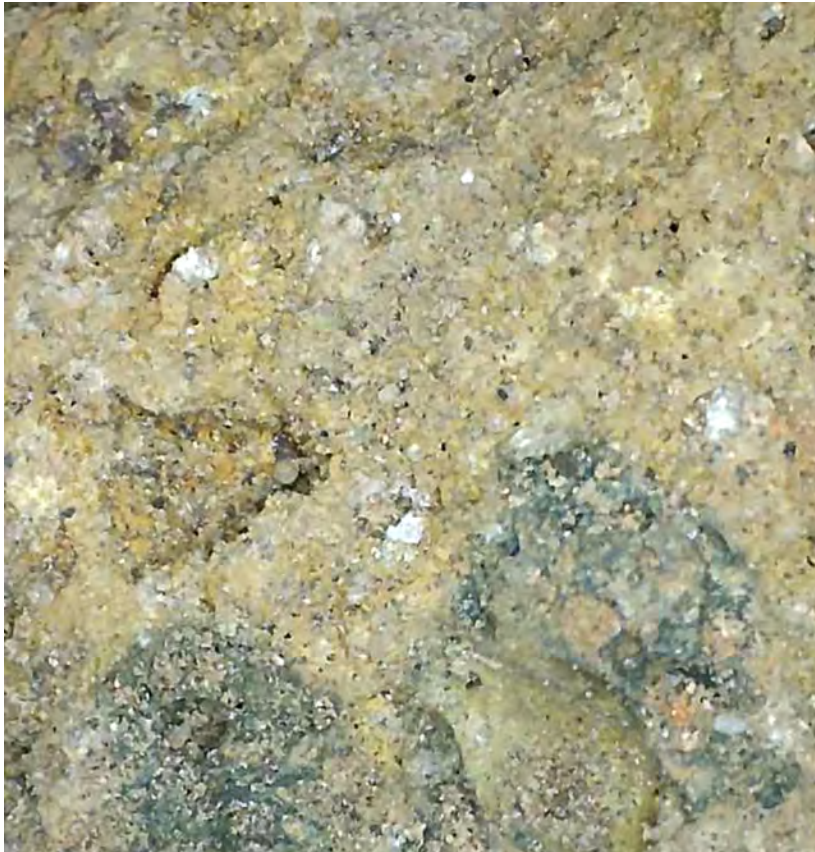
**Fig A:**

Sample 1, microscopic view

Note very well bonded aggregate matrix

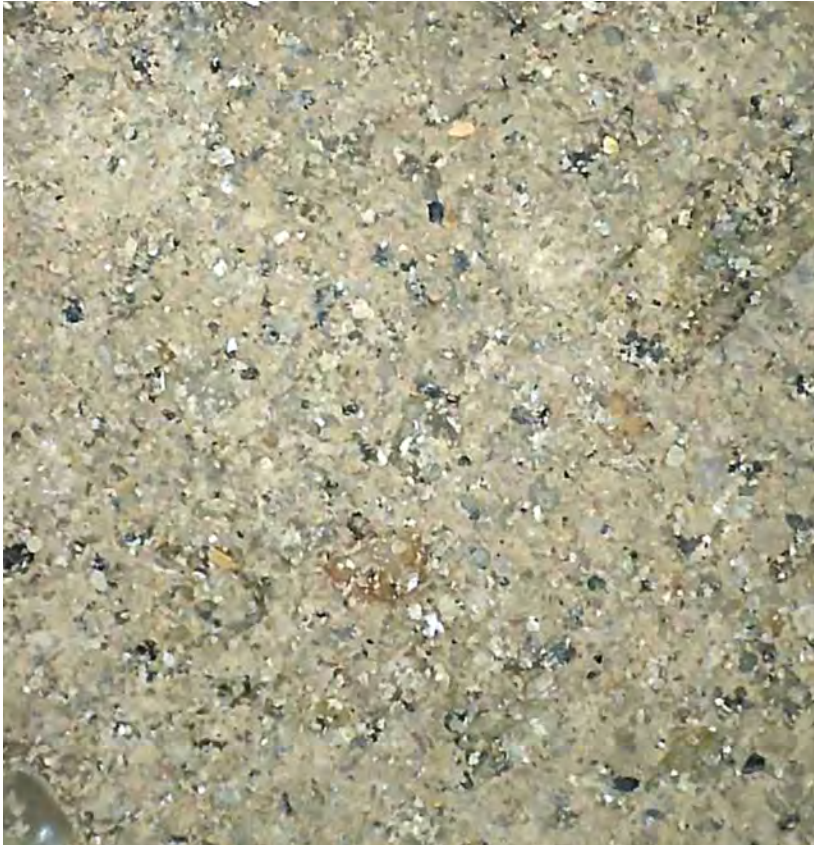
**Fig C:**

Sample 1, microscopic view

Note reasonable variation in aggregate size grading

Variation in aggregate colour suggested some mica inclusions (tbc)

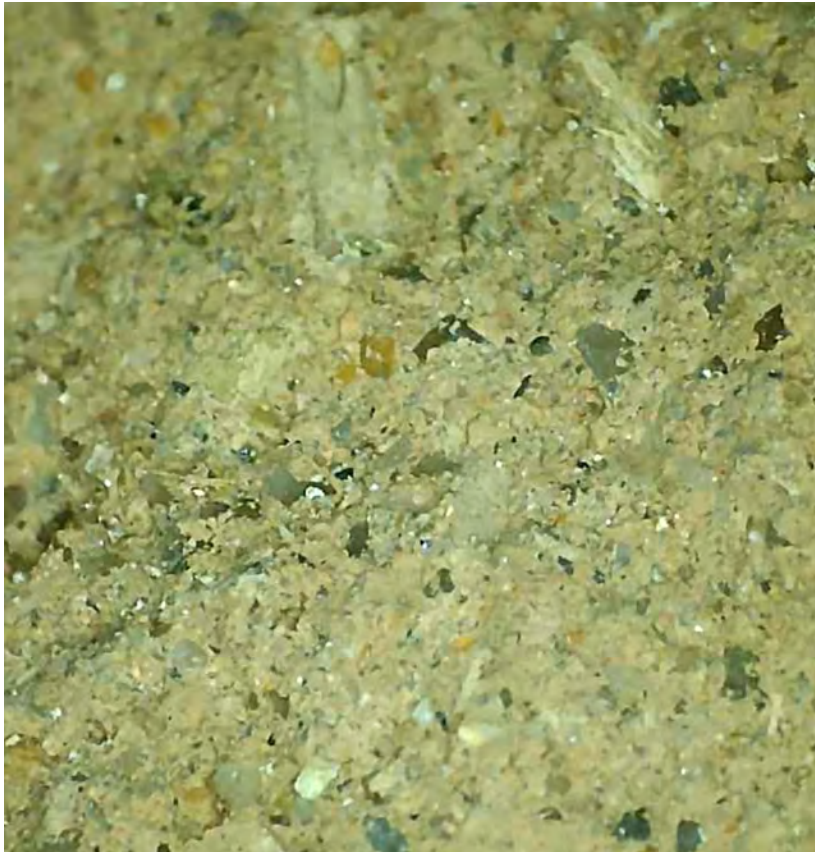
**Fig E:**

Sample 2, microscopic view

Note very well bonded aggregate matrix

There were no significant voids, pores or microcracks. This was consistent with what is understood of 'roman cement' (that it is a hard and fairly impervious material)
