37 NORTH ROAD

FAÇADE MASONRY CONDITION INVESTIGATION

JOB NO. 162-58

28 NOVEMBER 2024

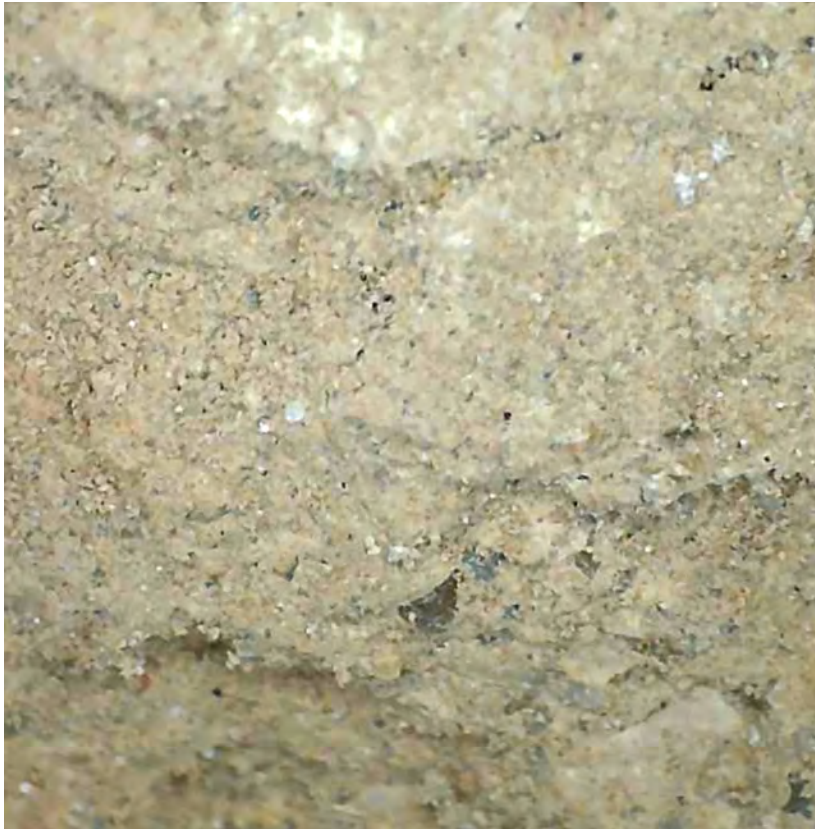
**Fig G:**

Sample 2, microscopic view

Note area of excessive fines associated with debonding failure
