# CONDITION REPORT

**FOR**  
THE EXISTING TIMBER PORCH TO BE REBUILT LIKE FOR  
LIKE AND THE WINDOW AND TIMBER PORCH  
REPAIR/REDECORATION WORKS

**AT**  
MOUNTFORD HOUSE,  
7 TOTTENHAM GREEN EAST,  
LONDON,  
N15 4UU

November 2024  
JB/24176

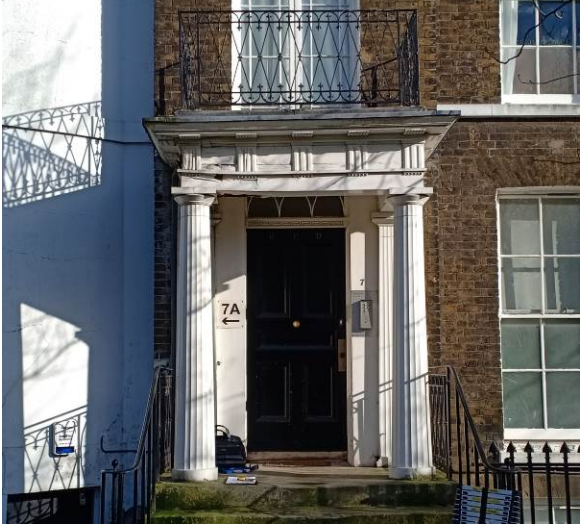
| <u>Item</u> | <u>Condition Notes</u> | <u>Picture</u> |
|---|---|---|
| <p><b><u>Right Porch</u></b></p> <p>Photo 1</p> | <p>Photo taken in January 2020 before the scaffold was installed.</p> <p>Shows clear signs of bowing at the bottom of the architrave.</p> <p>The whole entablature is leaning and dropping to the left side.</p> | |

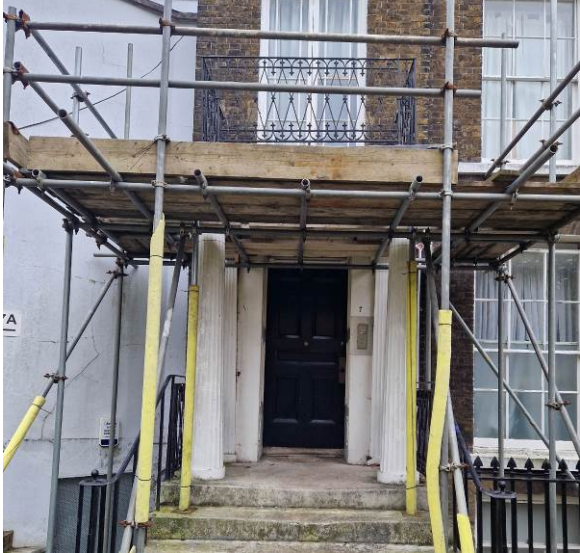
| <u>Item</u> | <u>Condition Notes</u> | <u>Picture</u> |
|---|---|---|
| <p>Right Porch</p> <p>Photo 2</p> | <p>A supporting scaffold has been installed.</p> <p>Both bowing and leaning are more severe now. The extent is covered by the scaffold support securing the porch in place.</p> | |

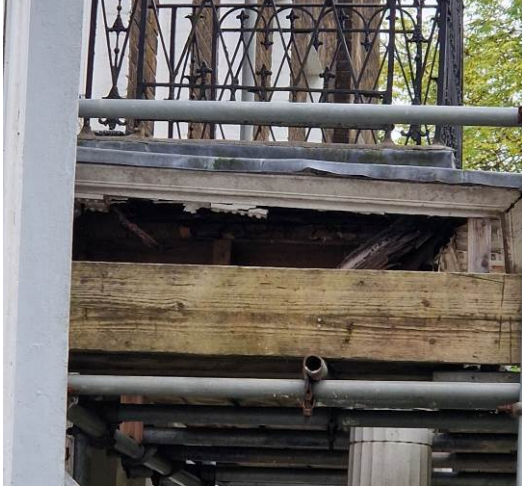
| <u>Item</u> | <u>Condition Notes</u> | <u>Picture</u> |
|---|---|---|
| <p>Left Architrave</p> <p>Photo 3</p> | <p>The left side of the architrave is completely removed and internal timber rot and decay are now visible.</p> | |

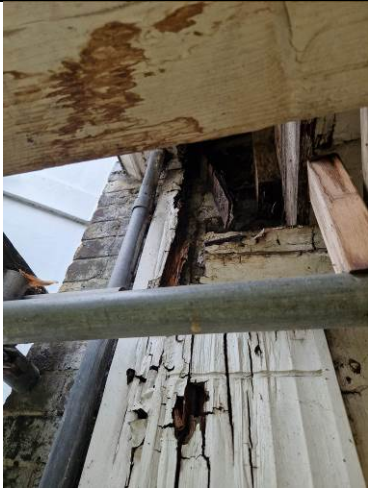
| <p>Timber door surround and underside of architrave</p> <p>Photo 4</p> | <p>The underside of the architrave has been removed.</p> <p>Shows severe internal timber rot and decay.</p> <p>Large chips in the timber.</p> <p>Horizontal splits and flaking paint</p> | |

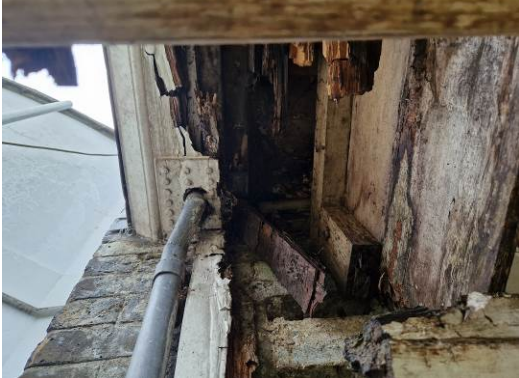
| <p>View of the underside of the cornice</p> <p>Photo 5</p> | <p>Shows severe internal timber rot and decay.</p> <p>Some timber battens, supports, side and underside of the architrave are removed.</p> <p>Cornice damage from timber rot and decay also.</p> | |

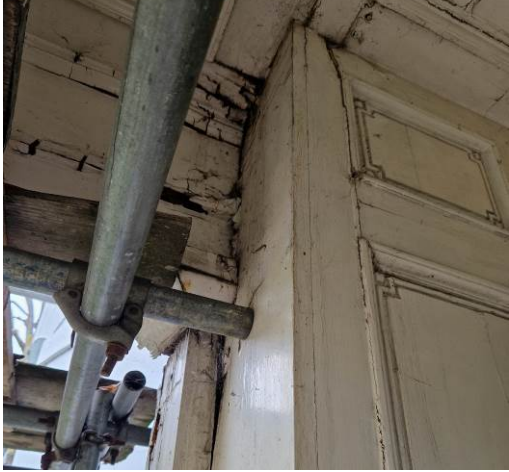
| <p>Internal side of architrave</p> <p>Photo 6</p> | <p>Timber rot and decay running horizontally.</p> <p>Vertical and horizontal splits.</p> | |

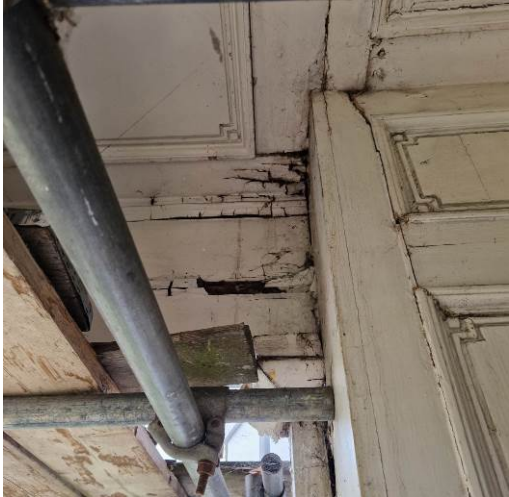
| <p>Internal side of the architrave</p> <p>Photo 7</p> | <p>Timber rot and decay running horizontally.</p> <p>Vertical and horizontal splits.</p> | |

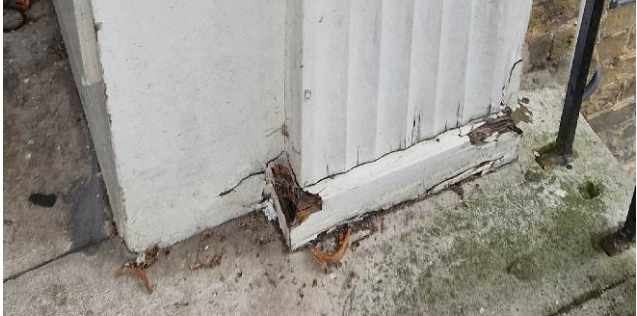
| <p>Timber base</p> <p>Photo 8</p> | <p>Areas of rot and decay, causing the timber to chip off.</p> <p>Horizontal splits.</p> | |

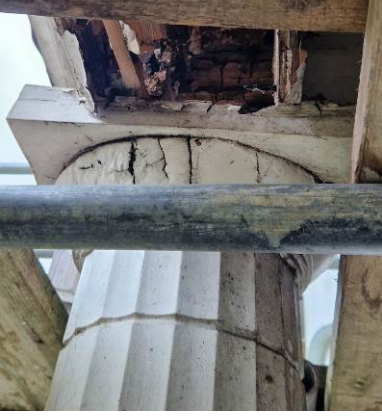
| <p>Fluted Column, Capital and underside of architrave</p> <p>Photo 9</p> | <p>Shows severe internal timber rot and decay.</p> | |

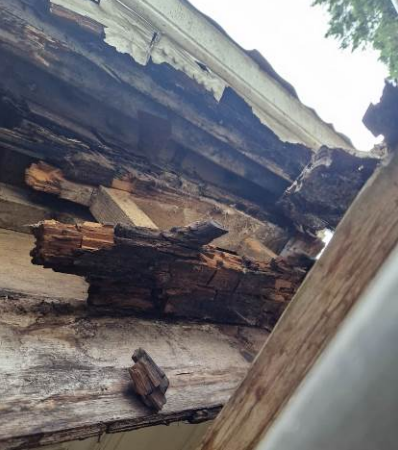
| <p>Potential timber lintels.</p> <p>Photo 10</p> | <p>The majority of the timber now missing.</p> <p>Severely decayed timbers, potentially used as a lintel. Clearly failed.</p> | |

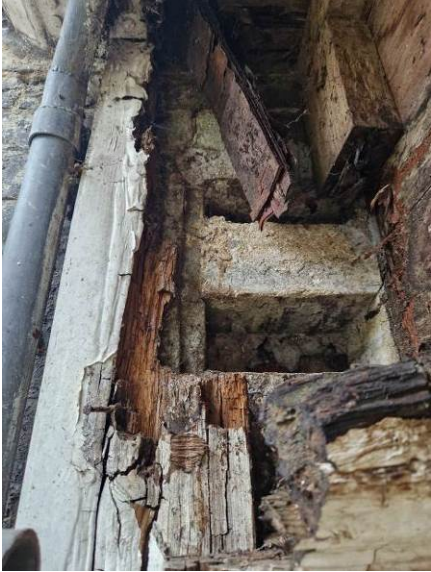
| <p>External wall</p> <p>Photo 11</p> | <p>Assumed timber lintels removed.</p> <p>Timber battens dropped lower.</p> <p>Severe decay and rot to all timbers.</p> | |

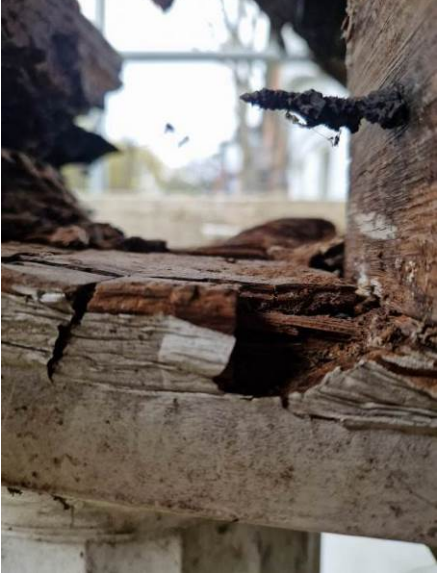
| <p>Above column capital</p> <p>Photo 12</p> | <p>Removed timbers, clear signs of rot and decay.</p> <p>Peeling paintwork and discoloration.</p> | |

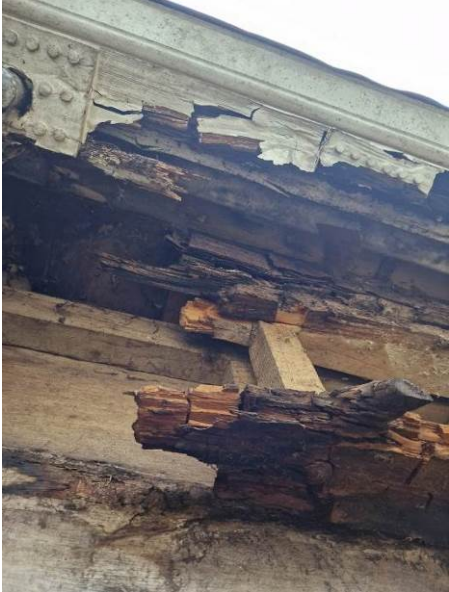
| <p>Underside of cornice and timber lintel.</p> <p>Photo 13</p> | <p>Shows severe internal timber rot and decay.</p> <p>Some timber battens, supports, side and underside of the architrave are removed.</p> <p>Cornice damage from timber rot and decay also.</p> <p>Majority of the timber now missing.</p> <p>Severely decayed timbers, potentially used as a lintel. Clearly failed.</p> | |

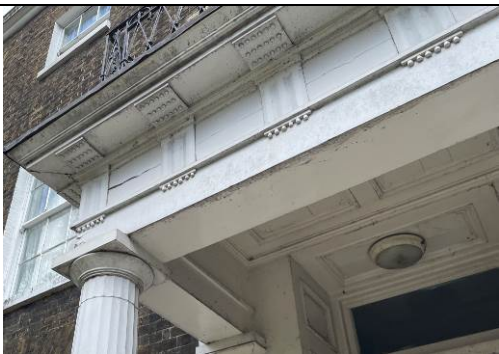
| <p>Frieze</p> <p>Photo 15</p> | <p>Cracks and splits at the midpoint between the triglyphs.</p> | |

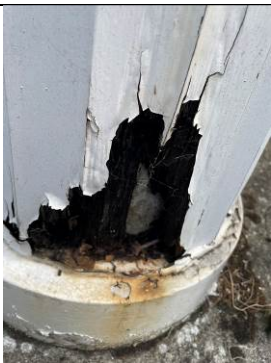
| <p>Right column and base.</p> <p>Photo 16</p> | <p>Exposed concrete column.</p> <p>Exposed timber shows rot and decay.</p> <p>Concrete base paint flaking and discolouration through oxidation.</p> | |

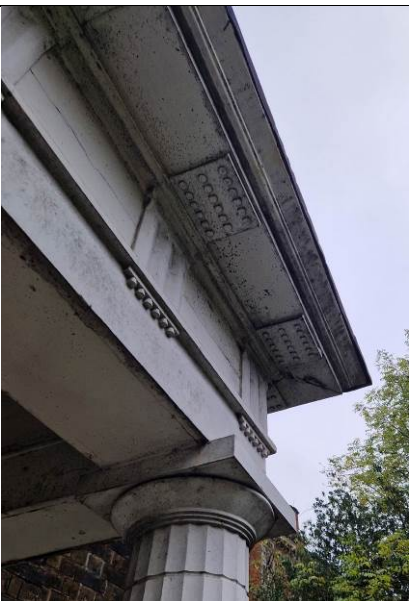
| <p>Entablature front and underside areas. Column capital and fluted shaft.</p> <p>Photo 17</p> | <p>Weathered timber has caused the timber to fade and discolour.</p> <p>There are signs of mould and mildew.</p> <p>The underside of the architrave has a split from one side to the other.</p> | |

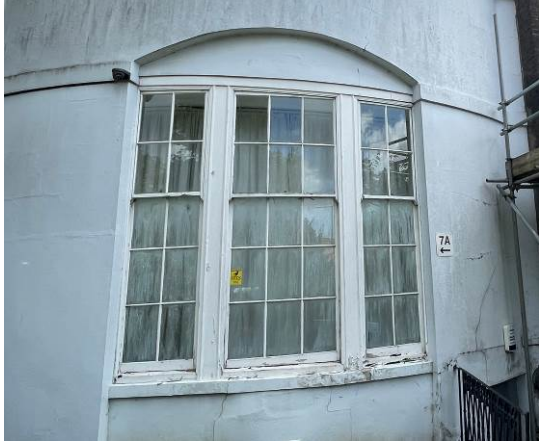
| <p><b><u>Bow window</u></b></p> <p>Photo 18</p> | <p>Timber sash bow window</p> <p>Single pane glass</p> <p>White paint finish which is in general poor condition and has significant discolouration.</p> | |

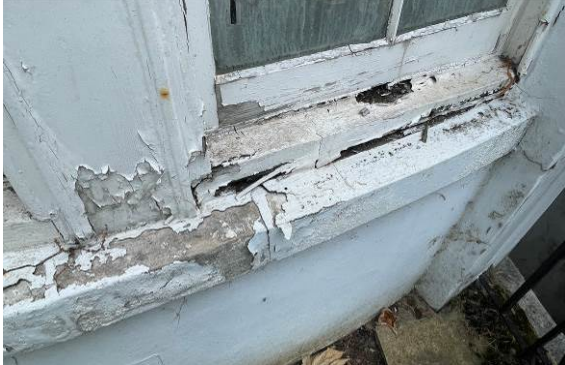
| <p>Timber and concrete window cill</p> <p>Photo 19</p> | <p>Clear signs of rot on the timber cill.</p> <p>Paint failure has led to cracks and peeling. Discoloration to the white paint.</p> <p>Cracks and peeling on the paint to the concrete cill. Small signs of mildew.</p> | |

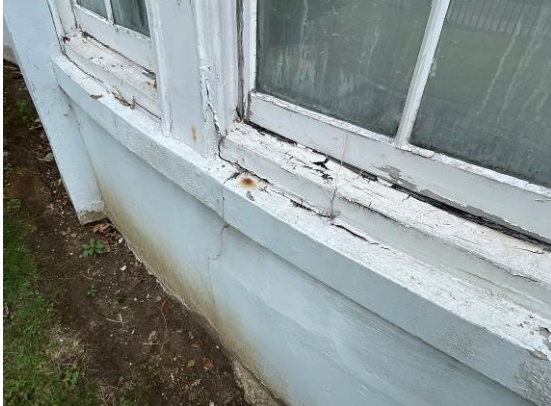
| <p>Timber and concrete window cill</p> <p>Photo 20</p> | <p>Further examples of cracks peeling and discoloration.</p> | |

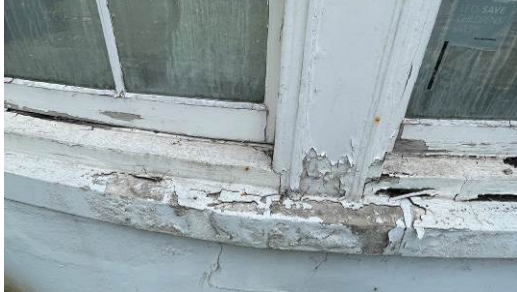
| <p>Timber and concrete window cill</p> <p>Photo 21</p> | <p>Further examples of cracks peeling and discoloration.</p> | |
