HERITAGE STATEMENT FOR 37 NORTH ROAD, HIGHGATE FOR REMEDIATION  
OF DECAYED AND DRY ROT INFECTED TIMBERS AND REPAIRS TO EXTERIOR

JOB NO: 162-58

V.3 REPORT 18 JUNE 2025

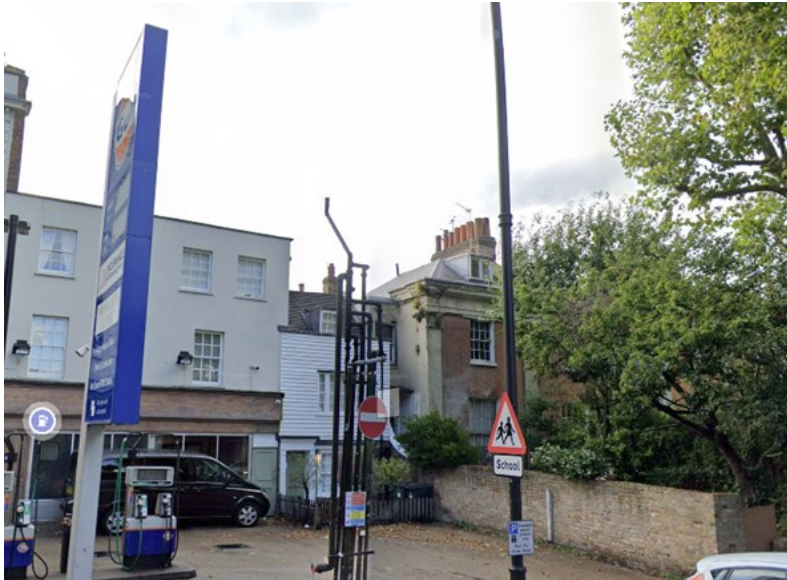
**Fig 1:**

**2024:** Google street view image., showing 37 North Road. The south frontage and south side of the building showing significant damp staining, presence of vegetation (indicative of dampness) and damage. The trees have been removed from the boundary so the building is more visible.

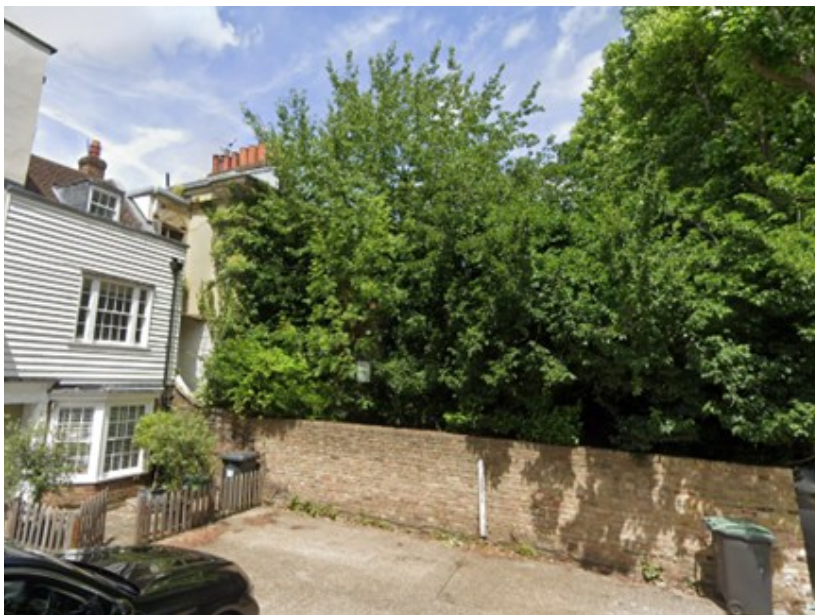
**Fig 2:**

**2022:** Google street view image., showing 37 North Road. The south frontage and south side of the building are concealed by vegetation with evidence of damage remaining to landing window and surrounding masonry as well as ivy growth on the façade.

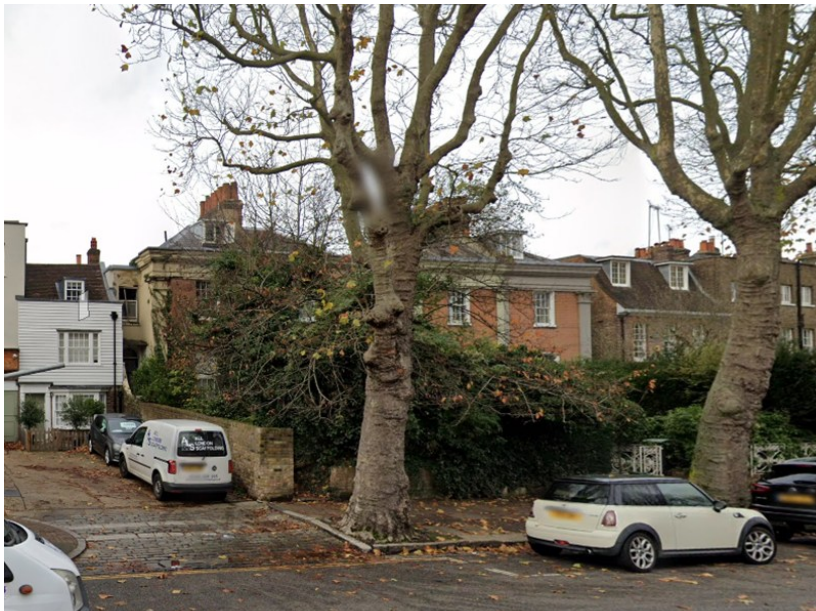
**Fig 3:**

**2020:** Google street view image., showing 37 North Road. The south frontage and south side of the building show deteriorating in condition with the landing window propped and damp staining across the façade.

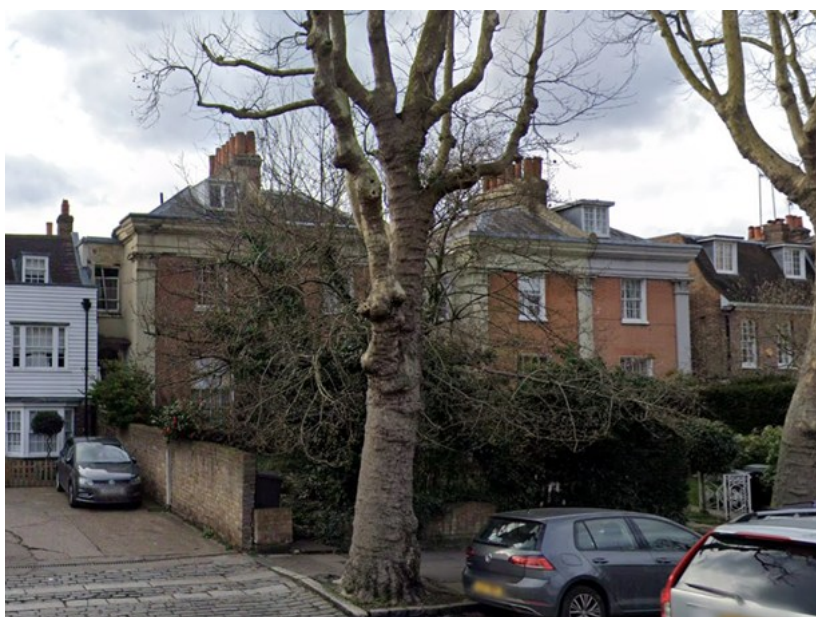
**Fig 4:**

**2018:** Google street view image., showing 37 North Road. The south frontage and south side of the building show deteriorating in condition with the landing window propped and damp staining across the façade.

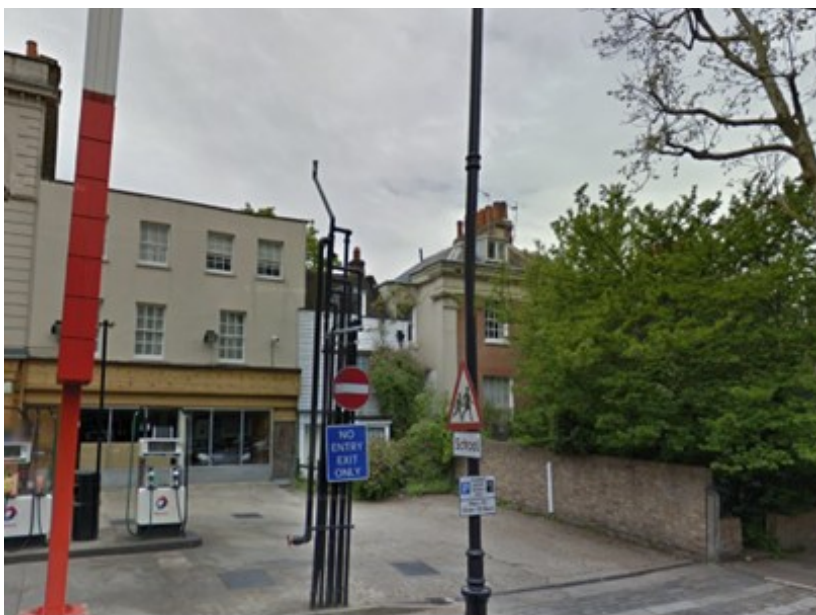
**Fig 6:**

**2012:** Google street view image., showing 37 North Road. The south frontage and south side of the building appear to be in reasonable condition although some damp staining is evident to the parapet in this image.

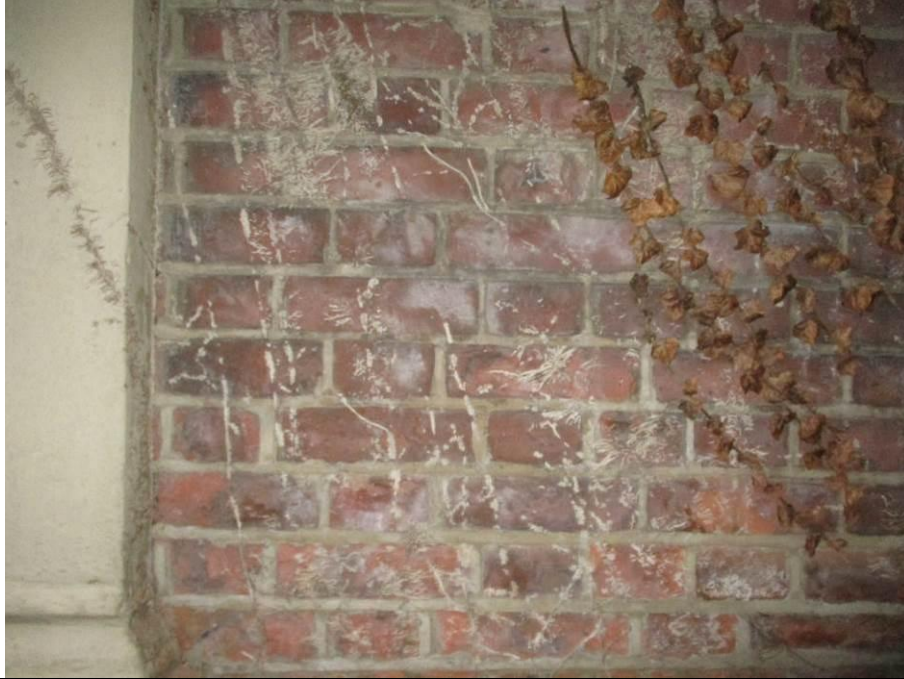
Front elevation, showing red brick laid to a bastardized Flemish bond with later cement repointing.

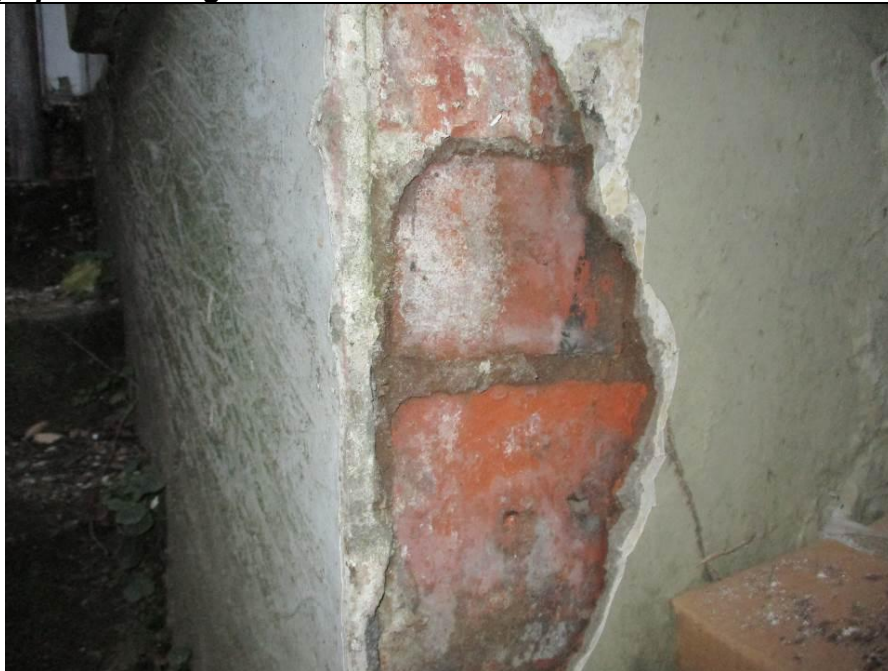
Front elevation, showing damage to render which forms the pilaster detail that has been applied over brickwork. Pilaster render is formed of a cement-based render.

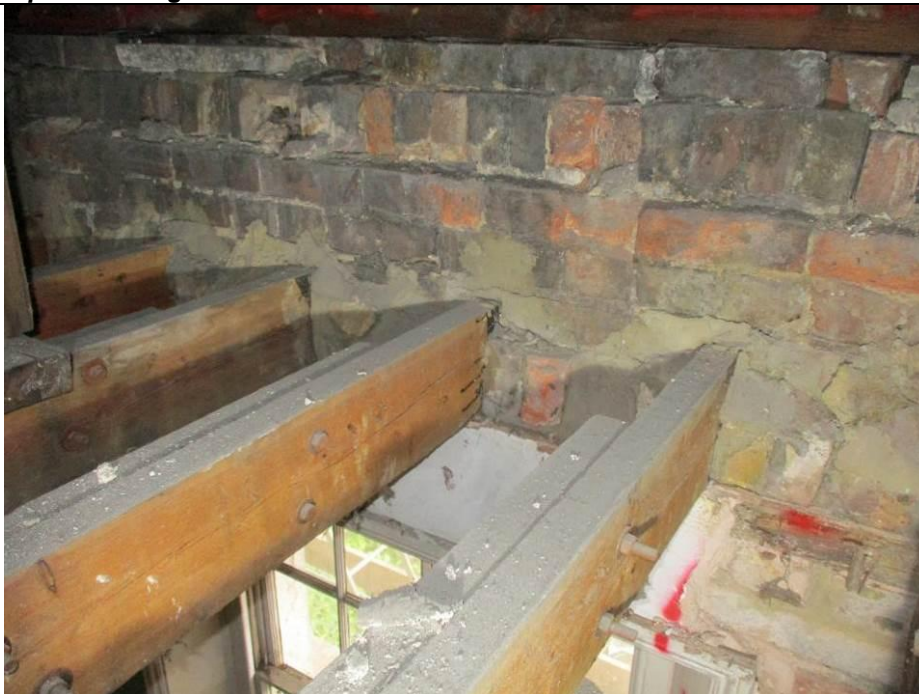
Room S1, showing evidence of previous structural repairs along the east wall. Partnering

timbers with bituminous painted ends set in cement mortars are present along east masonry.

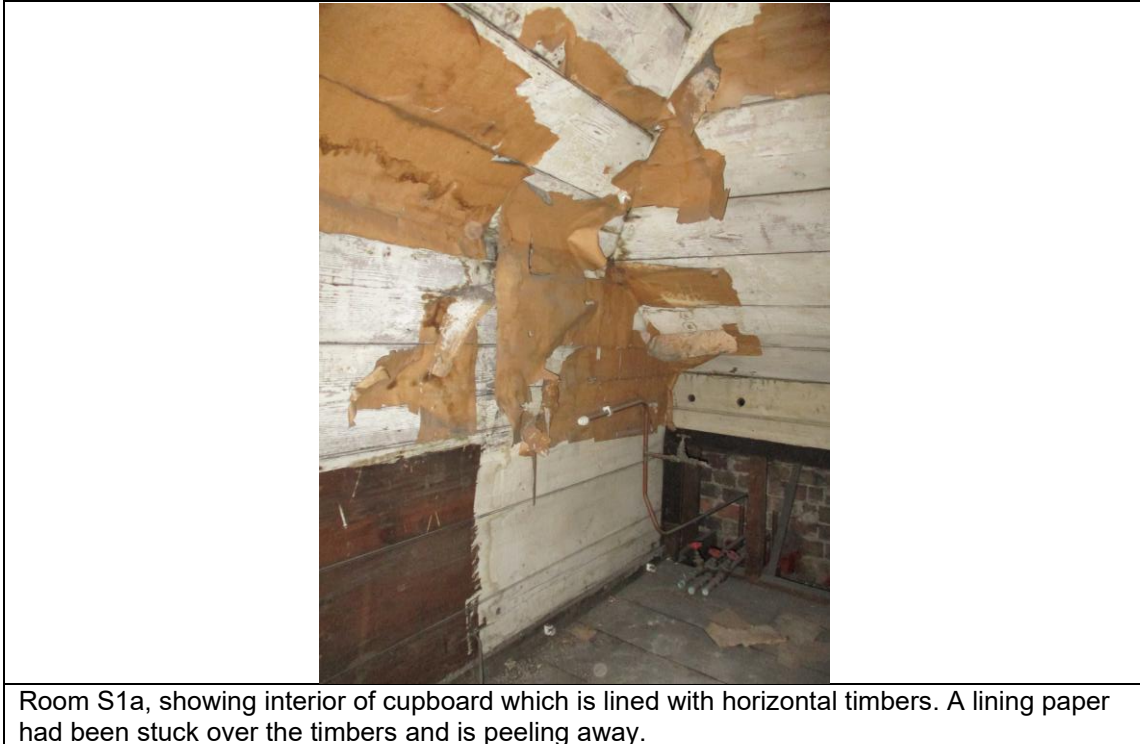
Room S1a, showing interior of cupboard which is lined with horizontal timbers. A lining paper had been stuck over the timbers and is peeling away.
