Project Number: 306

37 North Road, N6 4BE

## STRUCTURAL SURVEY REPORT

Document Reference: 306-SR-01

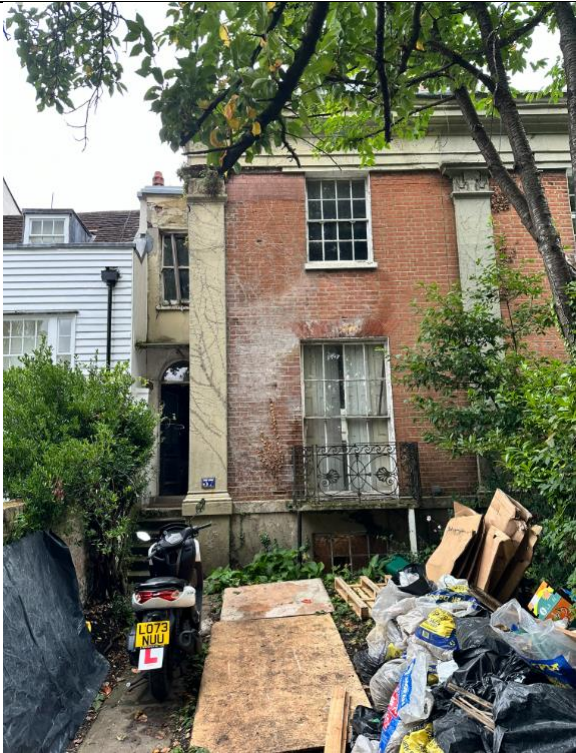
| 1.0 | <p>Overall view from the front.</p> <p>The building is set back from the road with a large tree adjacent to the pavement.</p> <p>Vegetation has been recently cleared from the façade exposing moisture / damp staining to the brick masonry.</p> | |

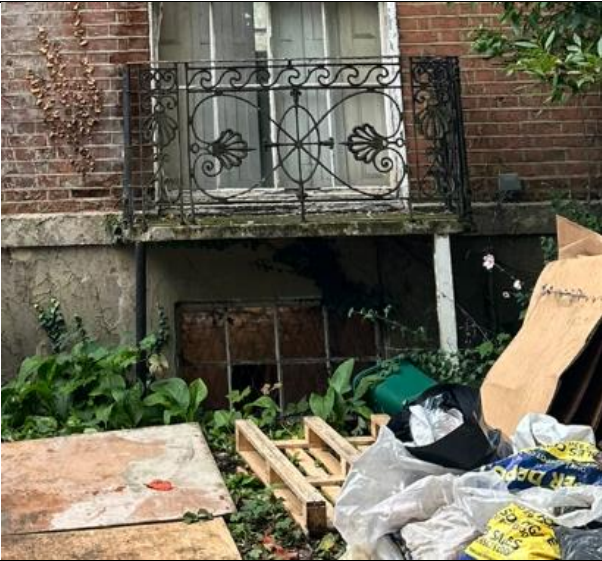
| 1.1 | <p>View of the front balcony.</p> <p>The balcony would have been originally cantilevered from the front façade.</p> <p>Metal and timber posts have been added for additional support.</p> <p>The front corner of the balcony has spalled, assumedly from rot and expansion of the baluster.</p> | |

The front balcony, originally cantilevered, is currently supported on steel and timber props, the external edges having degraded and spalled away. The full balcony section should be repaired and a more sympathetic support system considered for the stone balcony, replacing the props.

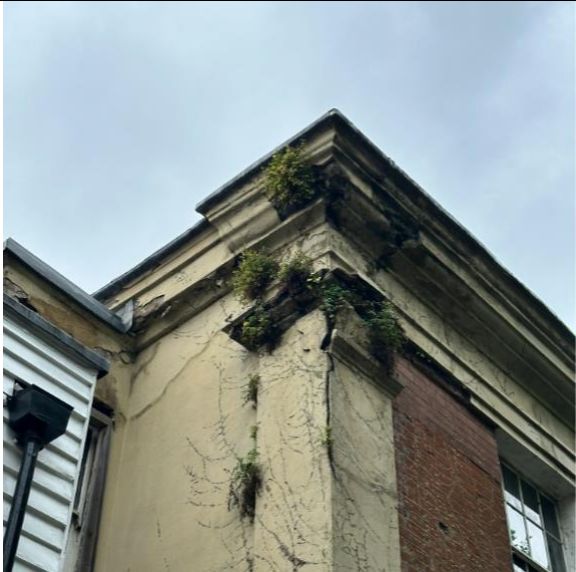
| 1.2 | <p>View to the front corner anthemion and corbelled ridgeline.</p> <p>The anthemion is extensively damaged by vegetation with elements failed and missing and others about to fail.</p> | |

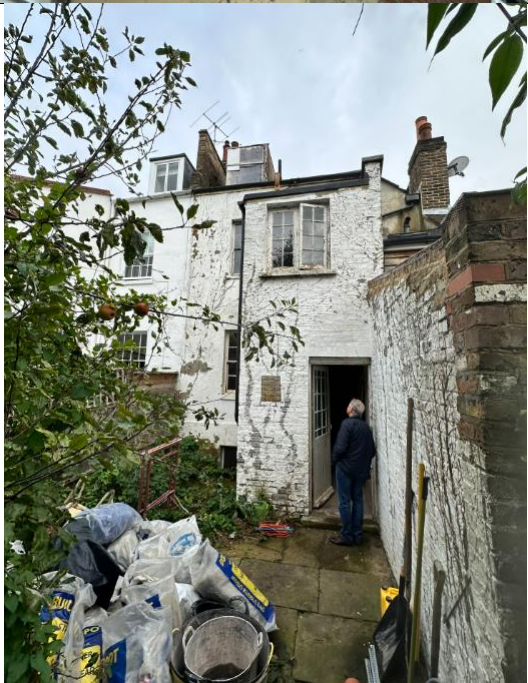
| 2.0 | <p>View of the rear façade.</p> <p>Vegetation has been recently removed.</p> <p>Top floor window is missing and covered with polythene.</p> <p>Adjacent wall to neighbour is finished with exposed expamet edging.</p> | |

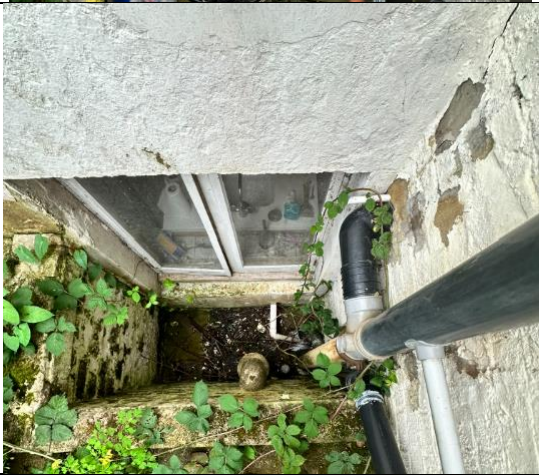
| 2.1 | <p>View in to rear lightwell.</p> <p>Lightwell is fill of leaf litter.</p> <p>Crack to adjacent closet wing.</p> | |

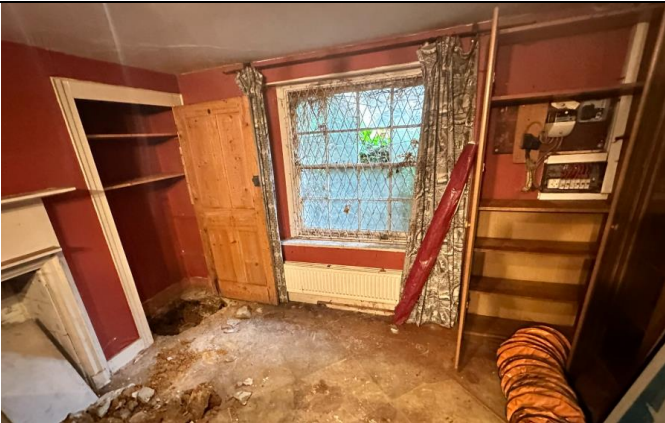
| 3.0 | <p>Lower ground – View to front room.</p> <p>Concrete floors, assumedly a replacement of the original.</p> | |

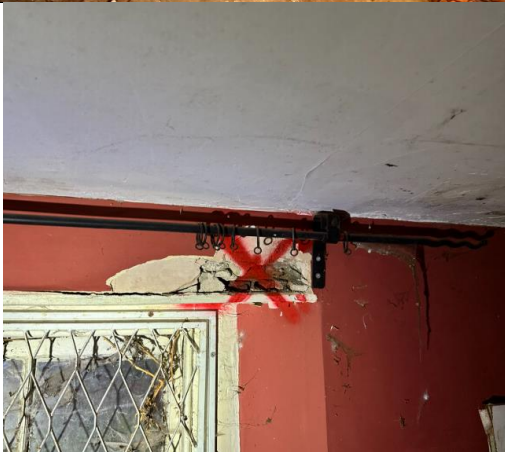
| 3.0.1 | <p>Lower ground – View to front room lintel.</p> <p>Lintel has been investigated and marked as rotten for repair.</p> <p>(18.12.24 visit)</p> | |

The removal of timber lintels that have already failed due to rot, or that will. Their replacement will likely be with modern prestressed concrete lintels to keep materials inert and to fit to the existing brick coursing.

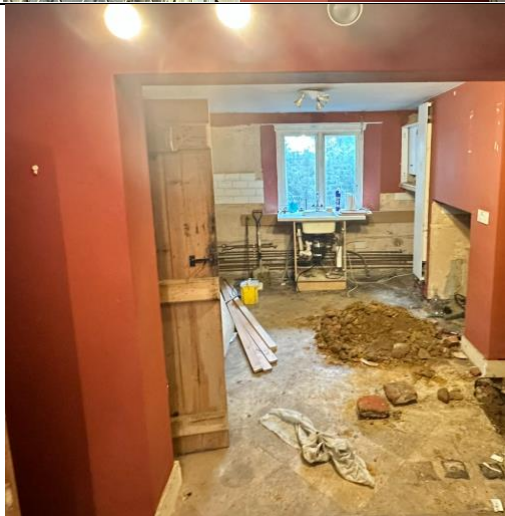
| 3.1 | <p>Lower ground – View to rear room.</p> <p>Concrete floors, assumedly a replacement of the original.</p> | |

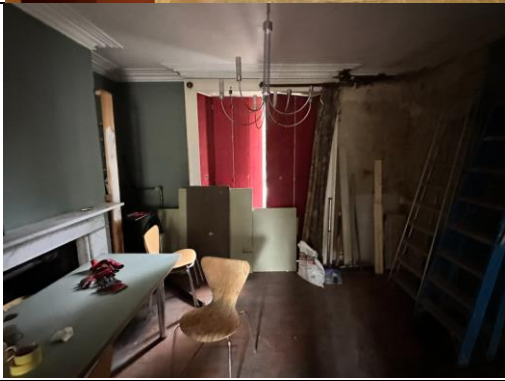
| 4.0 | <p>Ground floor – view to front room.</p> <p>Front façade at high level adjacent to window shows signs of water ingress and deterioration.</p> | |

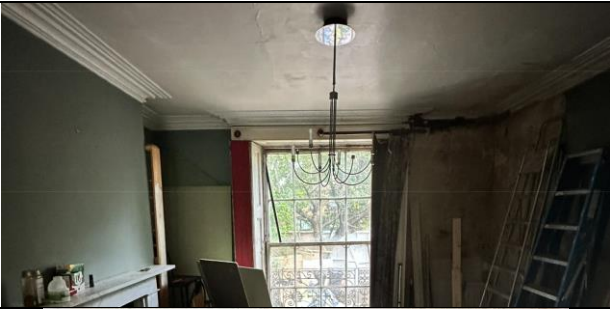
| 4.1 | <p>Ground floor – view to front room. (shutters open).</p> <p>Front façade at high level adjacent to window shows signs of water ingress and deterioration.</p> | |

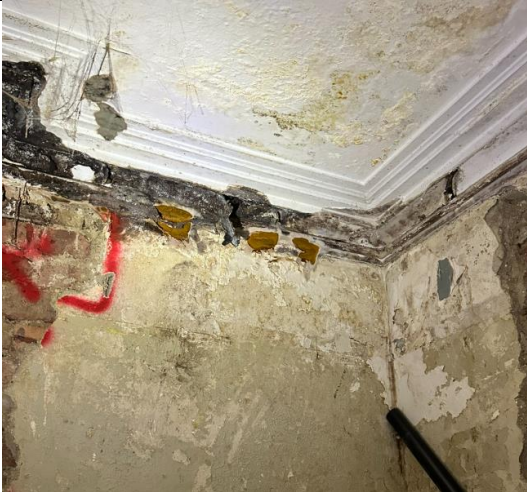
| 4.1.1 | <p>Ground floor – view to front room corner of investigation and live rot with adjacent lintel marked for removal.</p> <p>(18.12.24 visit)</p> | |

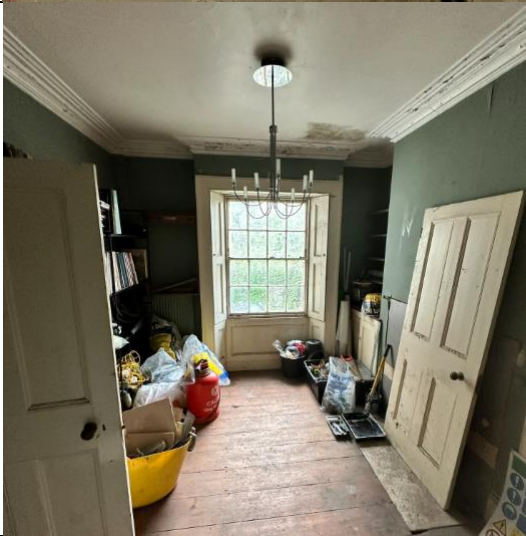
| 4.2 | <p>Ground floor – view to rear room.</p> <p>Ceiling shows signs of water ingress and deterioration from above.</p> | |

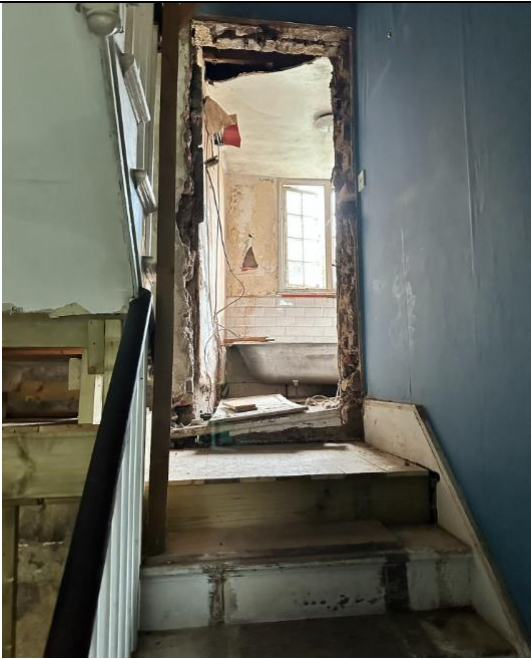
| 4.3 | <p>View from hall to stairs.</p> <p>The stairs have been temporarily repaired and propped to allow access to the 1st floor.</p> | |

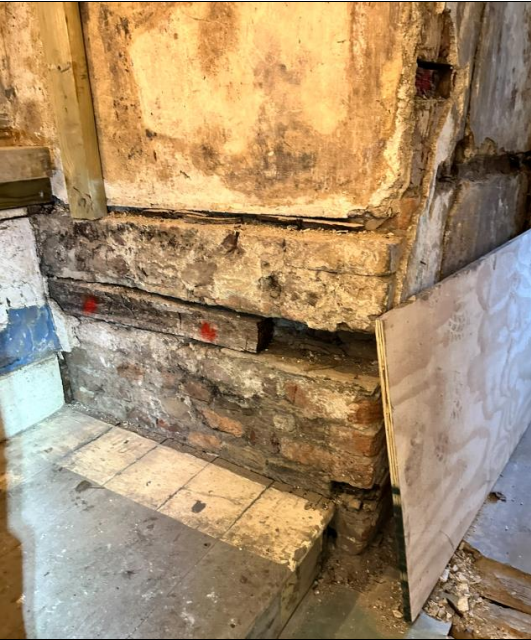
| 4.3.1 | <p>View in ground hall to rear.</p> <p>Timber baton within internal wall marked as investigated and rotten.</p> <p>(18.12.24 visit)</p> | |

Embedded and rotten timber elements in the walls should be removed in sections and replaced with brick masonry wherever possible, in mortar to match the surrounding masonry.

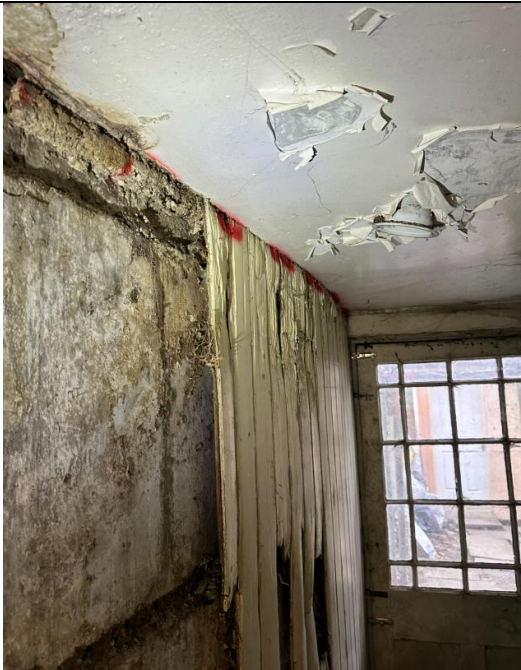
| <div>4.3.2</div> | <div>View in ground hall to rear door.</div> <div>Notable rot and investigation to wall, wall plate to be removed.</div> <div>(18.12.24 visit)</div> | |

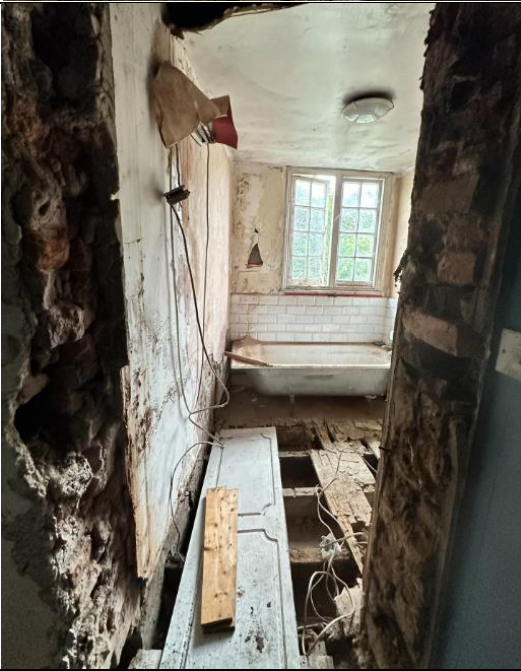
| <div>5.0</div> | <div>Rear closet wing.</div> <div>Room is inaccessible due to extensive rot to floor.</div> <div>Door frame and door has failed, exposing masonry behind architrave.</div> <div>Bonding of masonry appears to be inadequate.</div> | |

It has been noted that certain walls, especially those around the rear closet wing require additional tying, possibly with the use of helical reinforcement or concrete elbows.

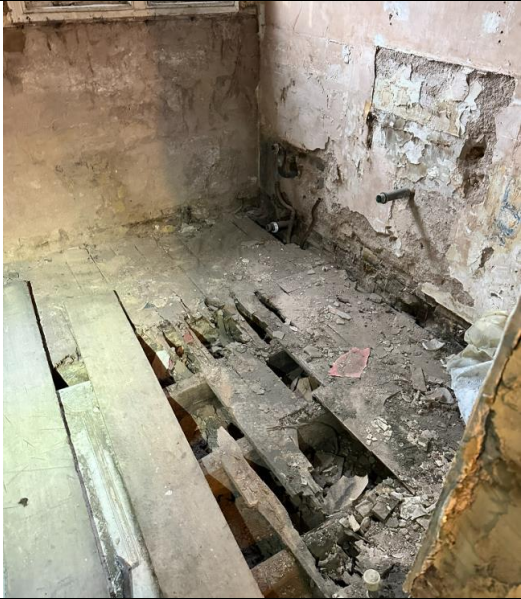
| <div>5.0.1</div> | <div>Rear closet wing.</div> <div>Room cleared and fully rotten.</div> <div>(18.12.24 visit)</div> | |

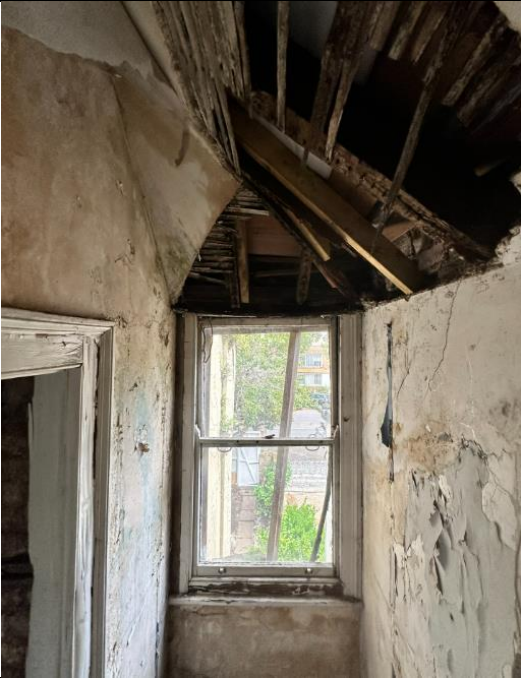
| <div>5.1</div> | <div>1<sup>st</sup> Hall – view to front.</div> <div>All walls show signs of deterioration and water ingress.</div> <div>Ceiling above has failed.</div> <div>Ceiling / roof joists show signs of extensive rot as well as previous repairs.</div> <div>Front window lintel is failed (rotten) and propped.</div> | |

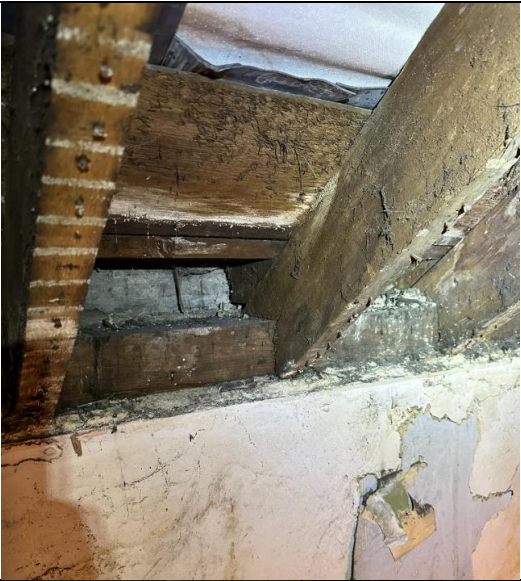
| 5.1.1 | <p>1<sup>st</sup> Hall.</p> <p>Detail of gutter support and water staining</p> <p>(18.12.24 visit)</p> | |

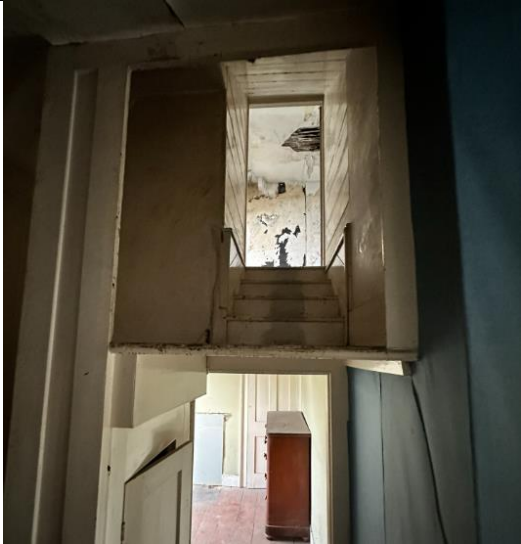
| 5.2 | <p>1<sup>st</sup> hall – view to 2<sup>nd</sup> and rear room.</p> <p>Novel and restricted stair access to 2<sup>nd</sup>.</p> | |

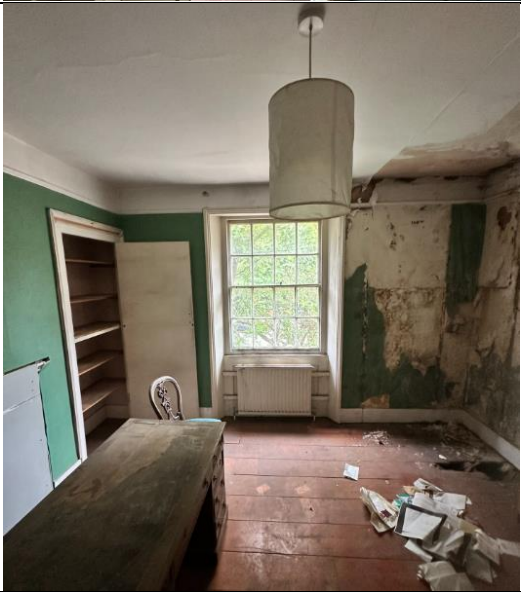
| 5.3 | <p>1<sup>st</sup> floor front room, view to front.</p> <p>Extensive rot and deterioration to front wall, hall wall and floor.</p> <p>Floor boards have locally failed.</p> | |

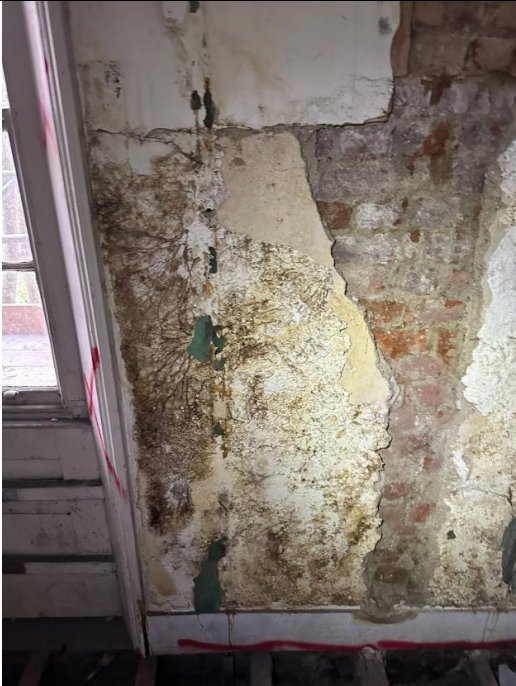
| 5.3.1 | <p>1st floor front room, view to front.</p> <p>View of rot within wall</p> <p>(18.12.24 visit)</p> | | |

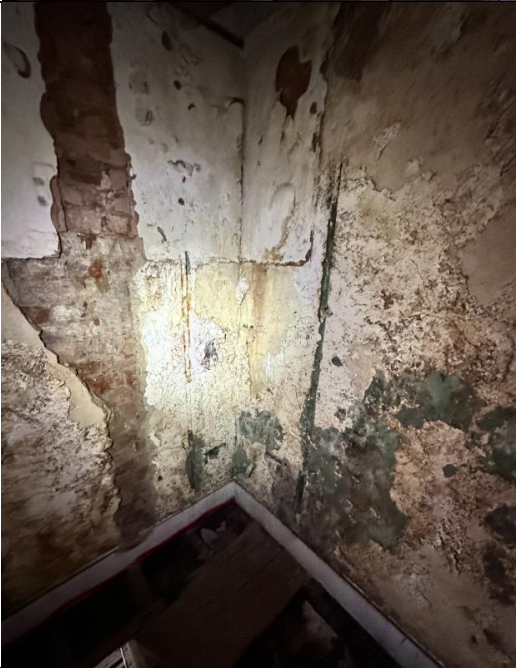
| | <p>1st floor front room, view to front corner with internal wall.</p> <p>View of rot within wall</p> <p>(18.12.24 visit)</p> | | |

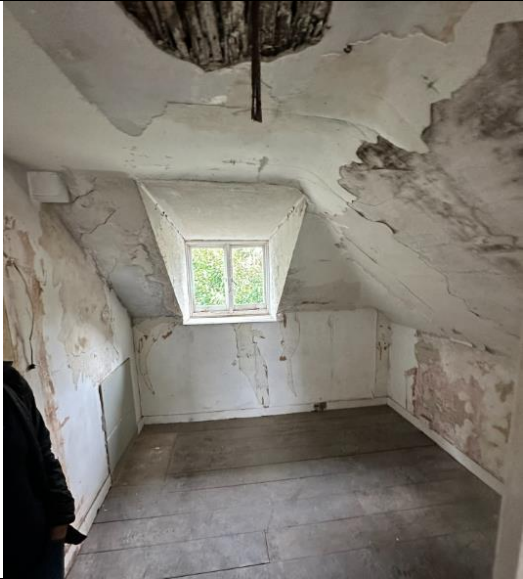
| 6.0 | <p>2<sup>nd</sup> floor loft room – view to front.</p> <p>Signs of extensive damp and water ingress all round as well as failure of roof above.</p> | | |

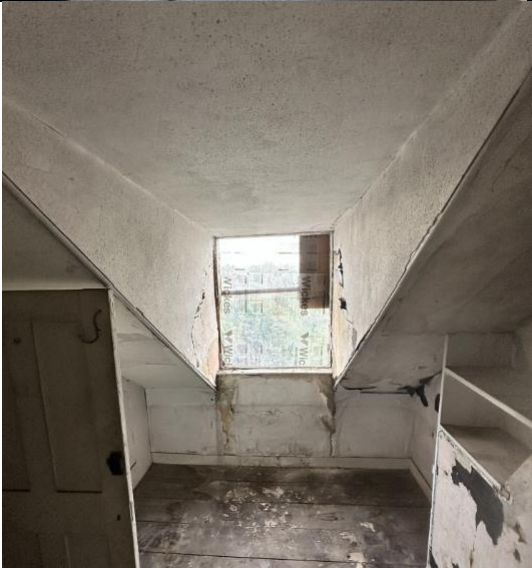
| 6.1 | <p>2<sup>nd</sup> floor loft room – view to rear.</p> <p>Signs of extensive damp and water ingress all round.</p> | | |

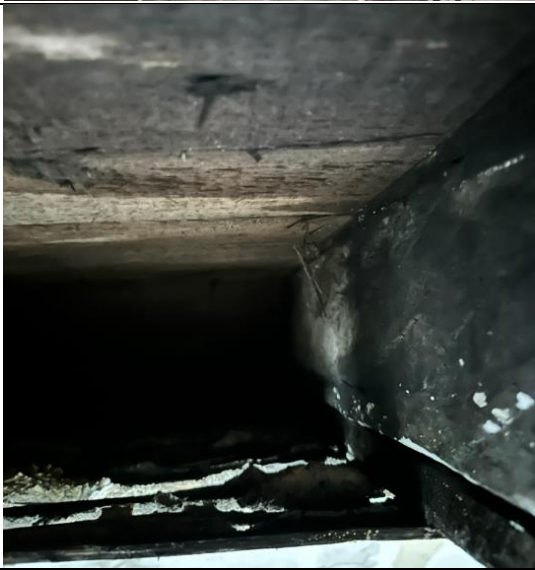
| 6.2 | <p>View in to loft roof.</p> <p>Visible active rot present.</p> | | |

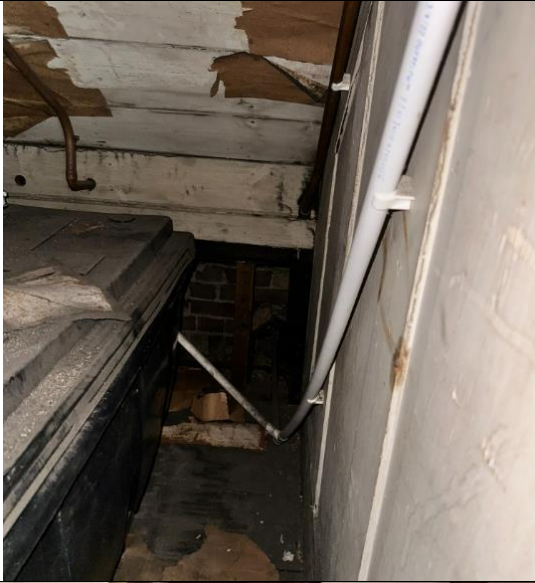
| 6.3 | <p>View into eaves water tank.</p> <p>Some indication of water ingress in area.</p> | |

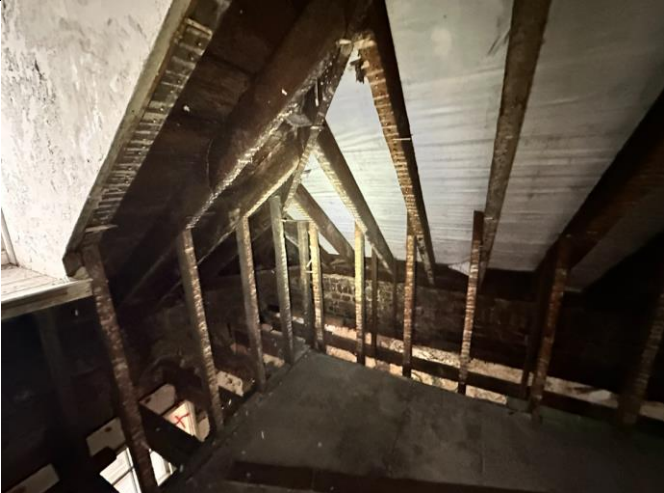
| 6.3.1 | <p>View to front corner, finishes stripped.</p> <p>Visible water ingress through roof.</p> <p>(18.12.24 visit)</p> | |

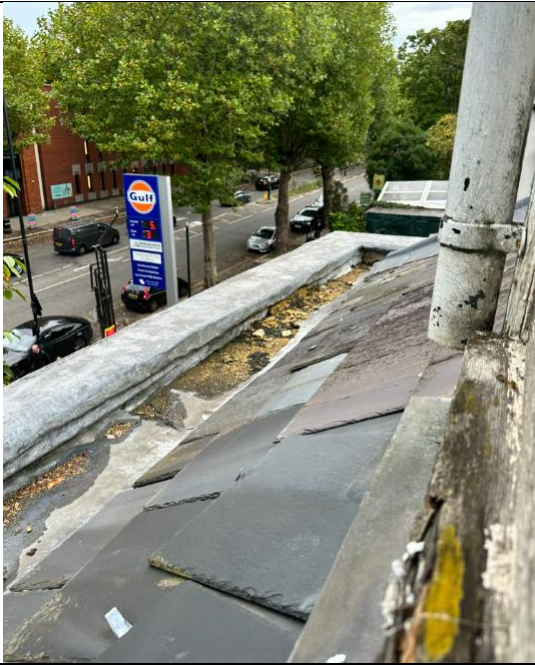
| 6.4 | <p>View from front window to front gutter.</p> <p>Rot to window frame. Slates slipped / missing. Wide gutter fairly full of leaf litter.</p> | |

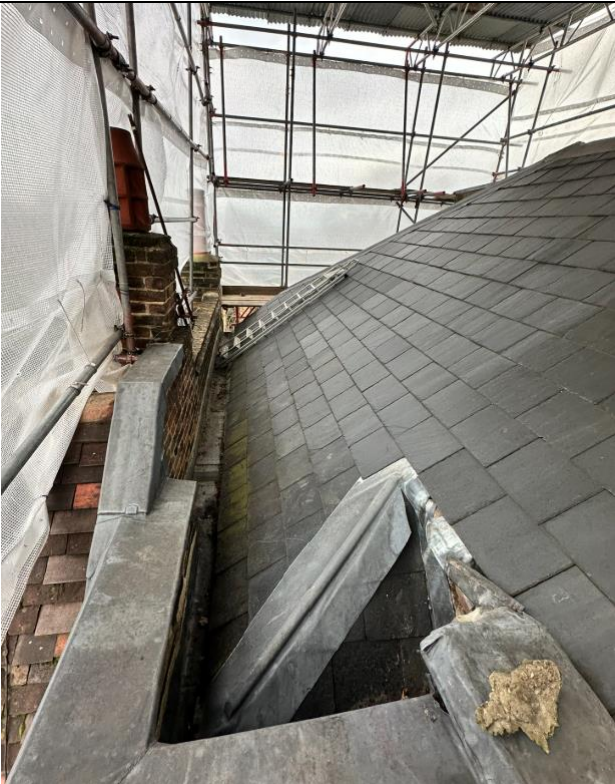
6.4.1

View to side gutter.  
Green staining to slates visible  
(18.12.24 visit)

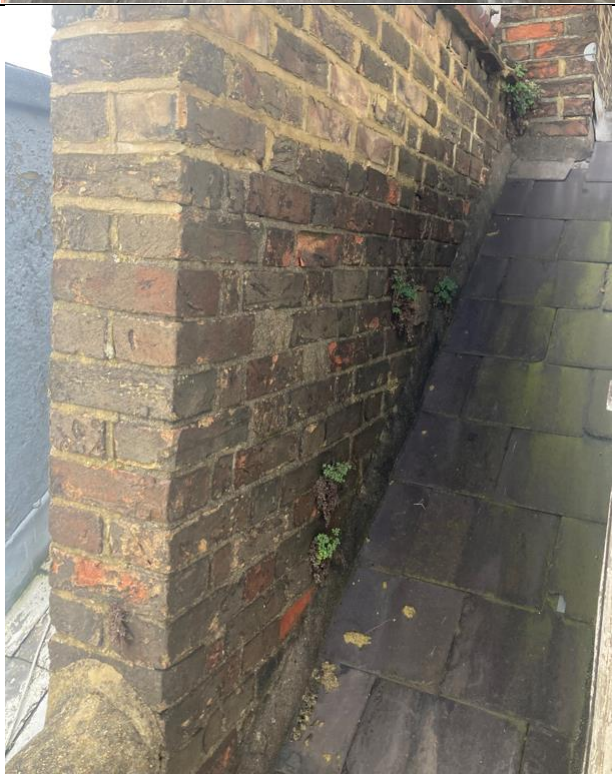
6.4.2

View to Party Wall and interface of  
tiles to masonry.  
Staining to masonry evident.  
(18.12.24 visit)

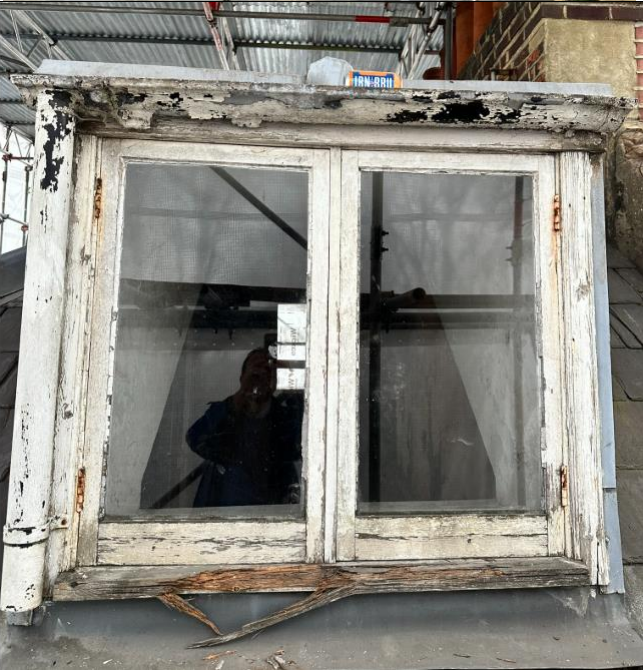
6.4.4

View to front dormer.  
Extensive rot to frame.

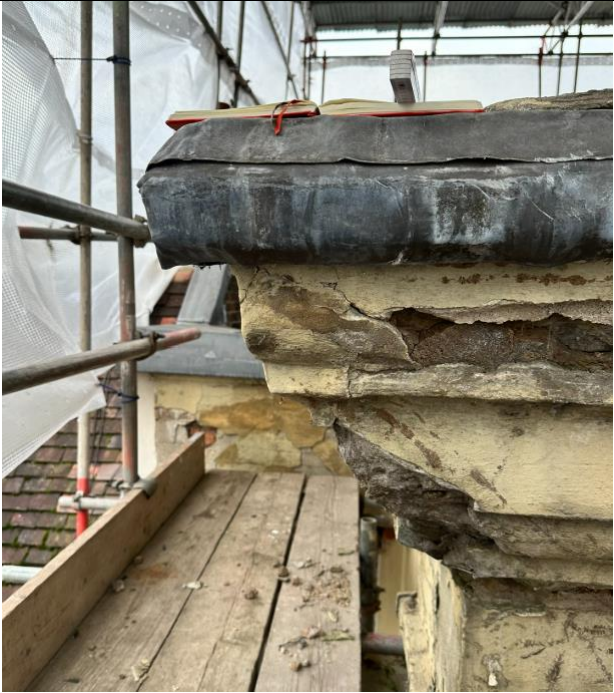
| 6.4.5 | <p>View of front cornice.</p> <p>Extensive damage and spalling from vegetation.</p> <p>(18.12.24 visit)</p> | |

## 5-External local rebuilding of the corner pilaster and cornice.

The external façade will require partial rebuilding where the masonry and render has failed and deteriorated to the point that rendering along is not adequate.

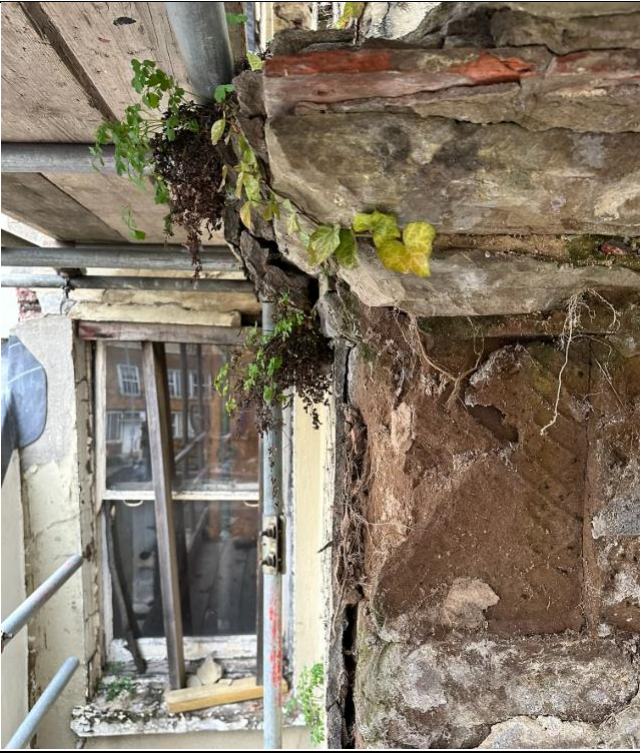
| 6.4.6 | <p>View of front anthemion &amp; pilaster. Lower section.</p> <p>Extensive damage and spalling from vegetation.</p> <p>Propped lintel to rear.</p> <p>(18.12.24 visit)</p> | |

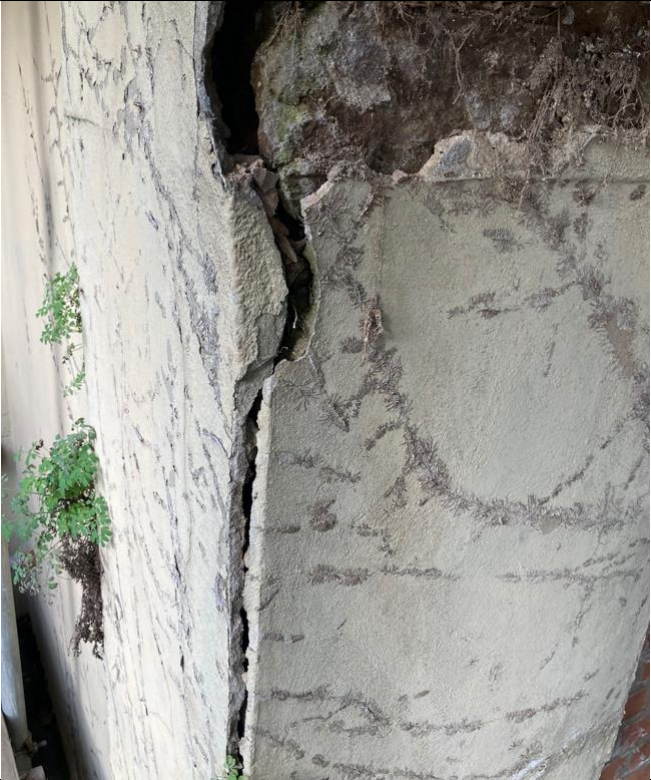
| 6.4.7 | <p>View of front pilaster. Lower section.</p> <p>Extensive damage and spalling from vegetation.</p> <p>(18.12.24 visit)</p> | |

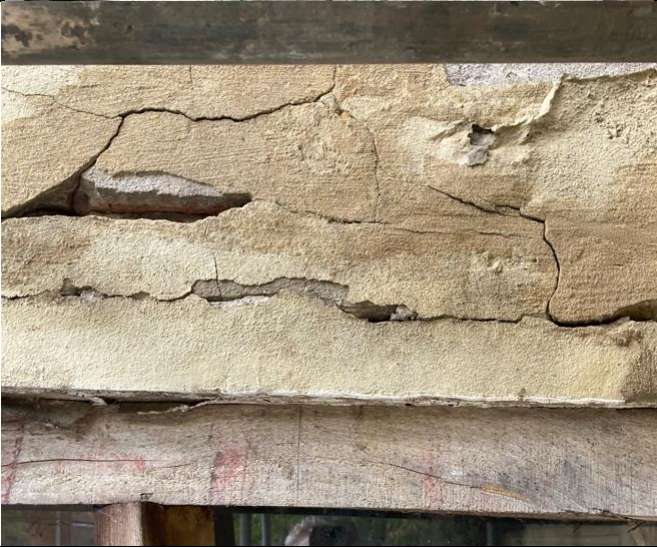
| 6.4.8 | <p>Detail of propped lintel to front.</p> <p>Extensive movement and damage noted.</p> <p>(18.12.24 visit)</p> | |

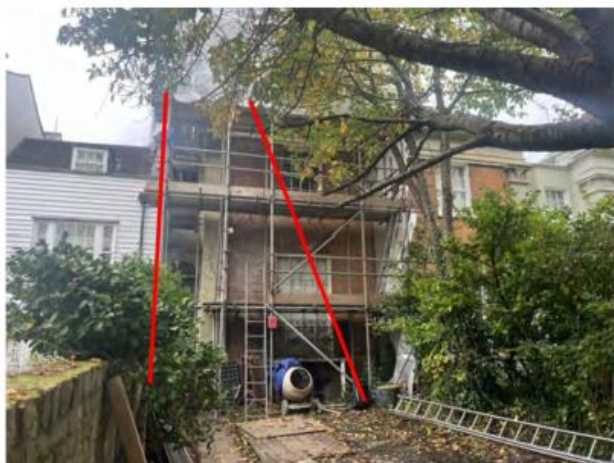
Fig 1:

East elevation; showing a general view to the principal front façade. Note general spread or dry rot 'zone' identified as a cone emanating from roof level and widening substantially down towards ground level

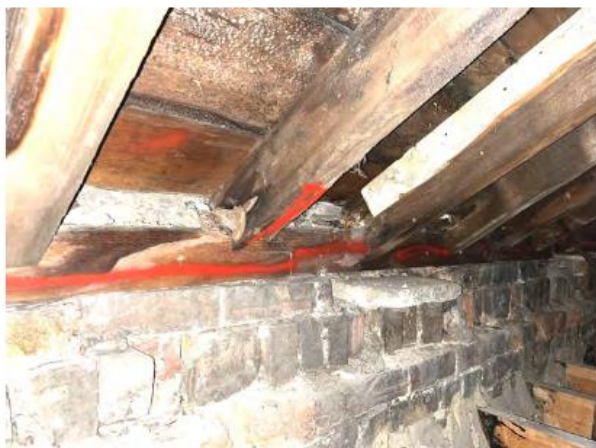
Fig 3:

Roof structures, east pitch; showing structural decay to the rafter plate for almost its entire length at ~4m as well as 1 no. common rafter for ~250mm to its bearing end. All structurally decayed items identified on-site via water soluble red spray paint

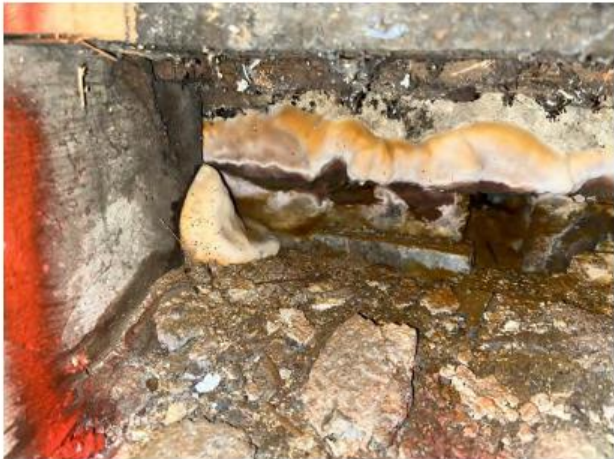
Fig 35:  
Ground floor, east room; showing further evidence for active dry rot fungus to embedded east perimeter floor joists

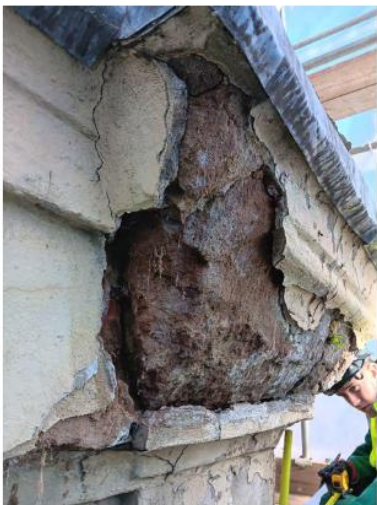
Fig 7:  
Front (east) elevation, showing modern Portland cement re-surfacing of original 'Roman cement' render feature

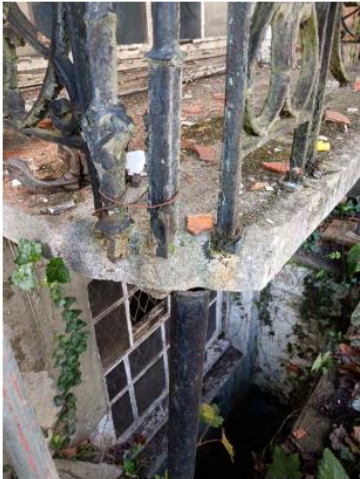
Fig 24:  
Front (east) elevation, showing detail of balcony stone damage at corroded railing feet

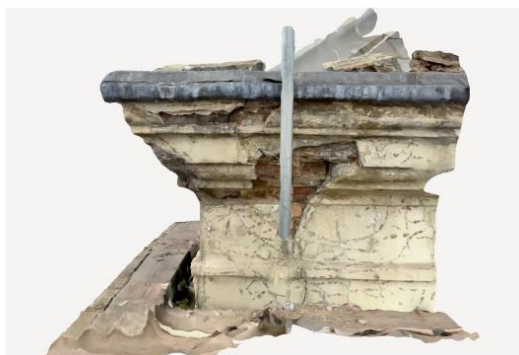
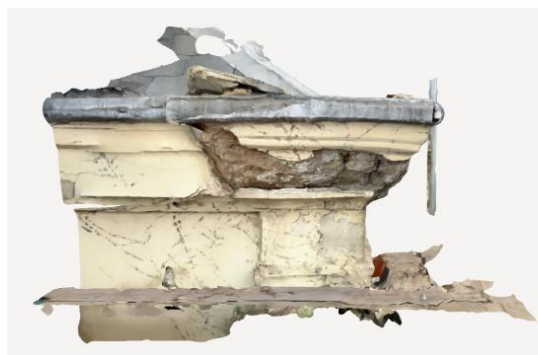
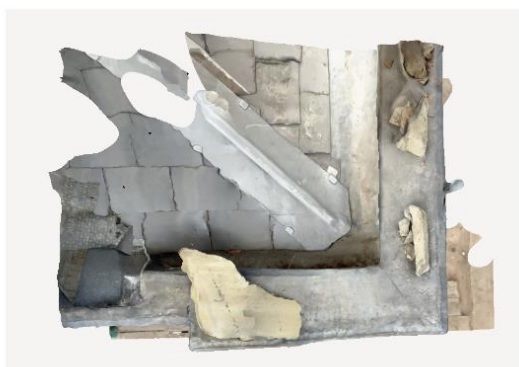
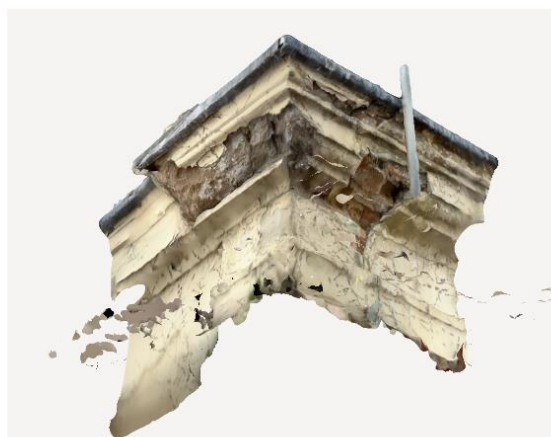
Below are excerpts of a 3D scan of the corner showing the corner failure.

For this element, an expert in masonry restoration may be considered to rebuild in as close as is practically possible to the original intent.
