## LEVEL 2 HISTORIC BUILDING RECORD FOR 37 NORTH ROAD, HORNSEY

JOB NO. 162-58

DOUGLAS PASKIN, PKS ARCHITECTS

18 DECEMBER 2024

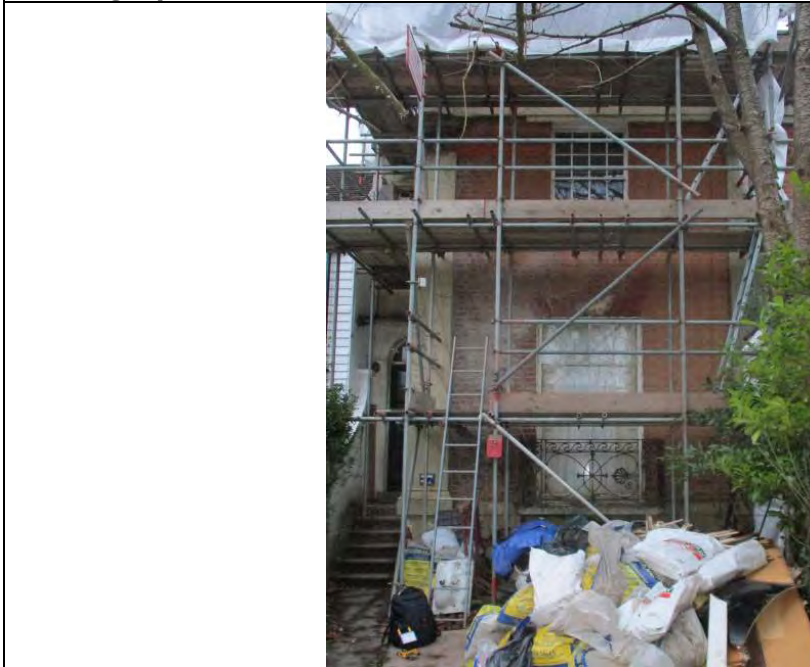
Front (east) elevation.

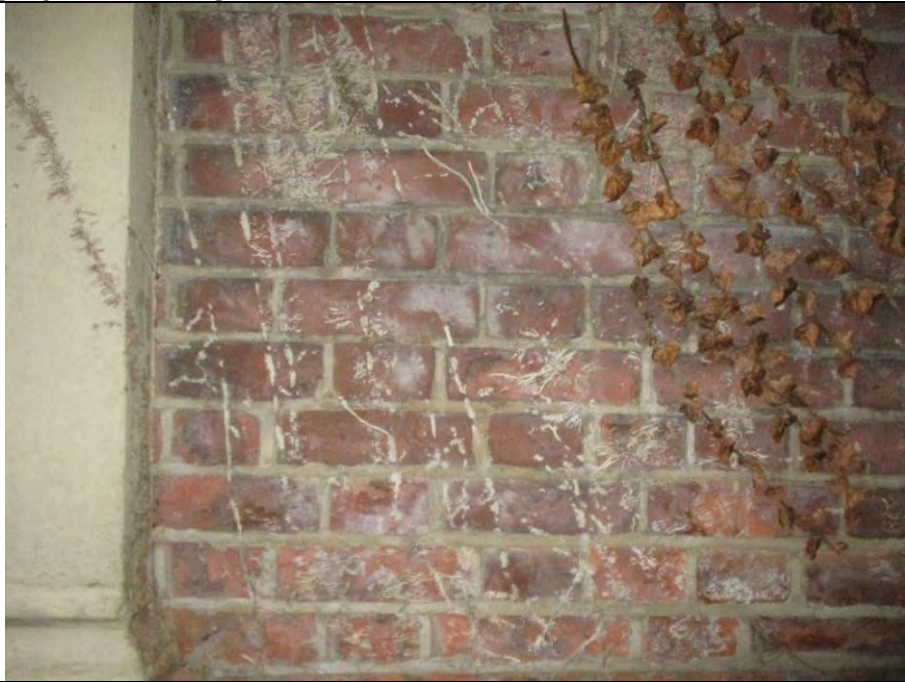
Front elevation, showing red brick laid to a bastardized Flemish bond with later cement repointing.

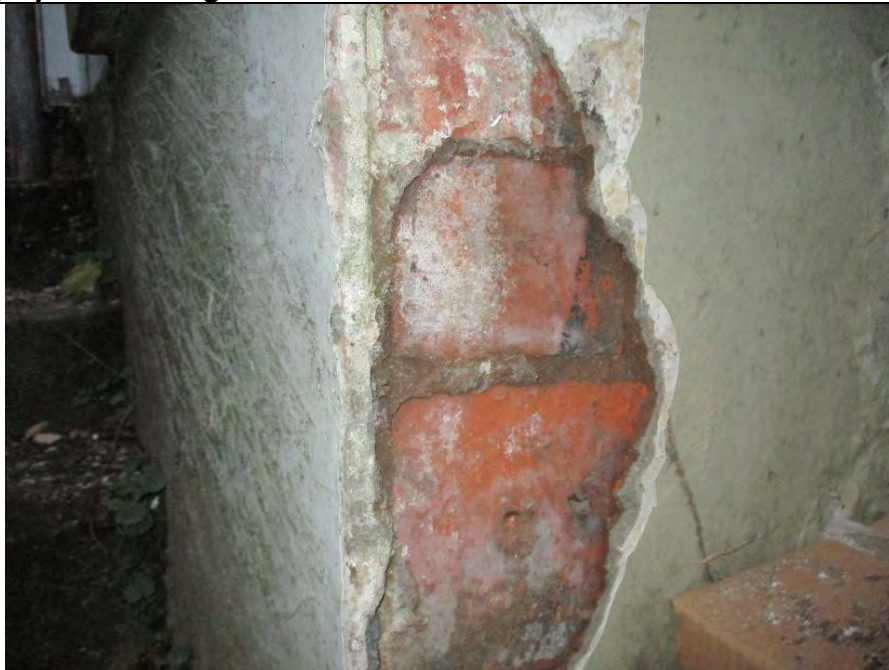
Front elevation, showing damage to render which forms the pilaster detail that has been applied over brickwork. Pilaster render is formed of a cement-based render.

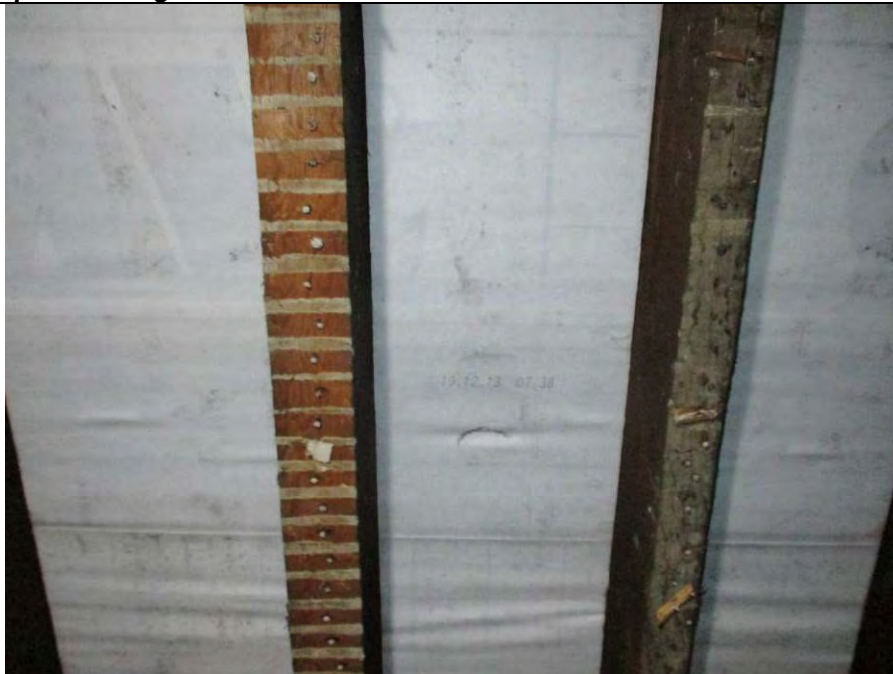
Room S1, showing the underside of south roof slope (east end) where rafters are overlaid by an assume breather membrane with production date stamp 19/12/13.

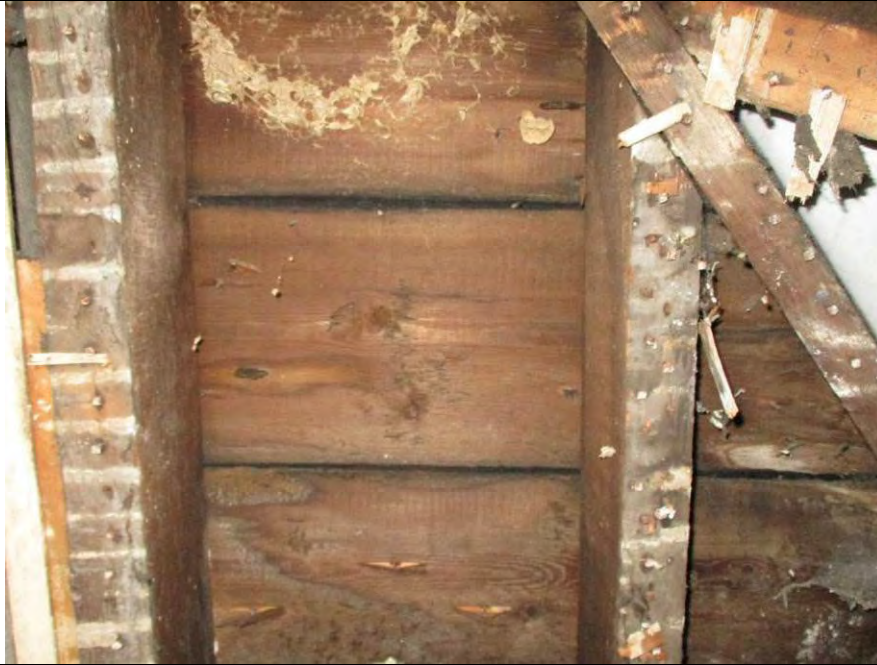
Room S1, showing the underside of the west roof slope with rafters are overlaid by sarking boards which are overlaid by roofing felt.

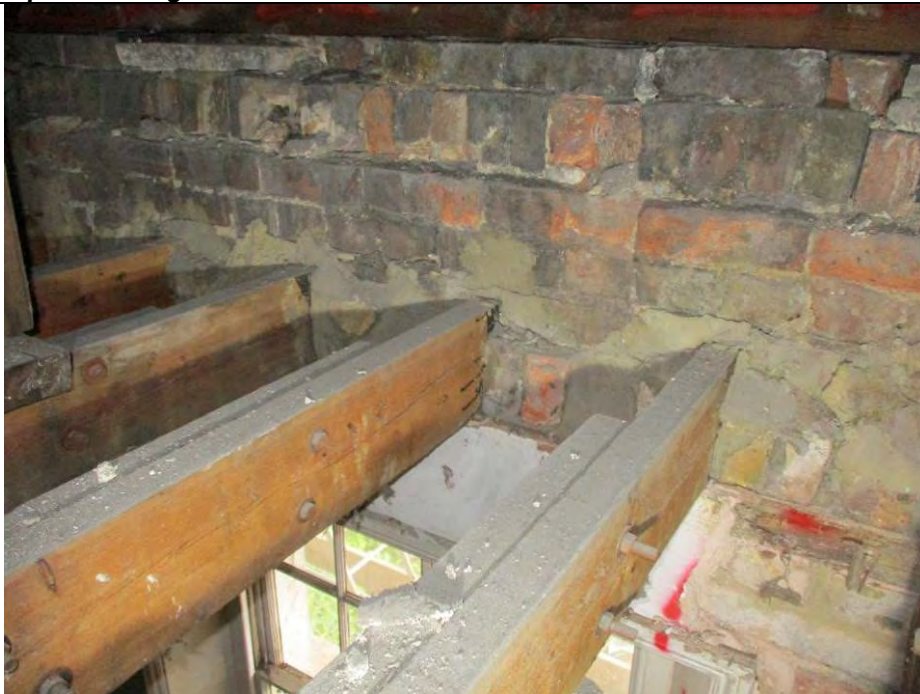
Room S1, showing evidence of previous structural repairs along the east wall. Partnering timbers with bituminous painted ends set in cement mortars are present along east masonry.

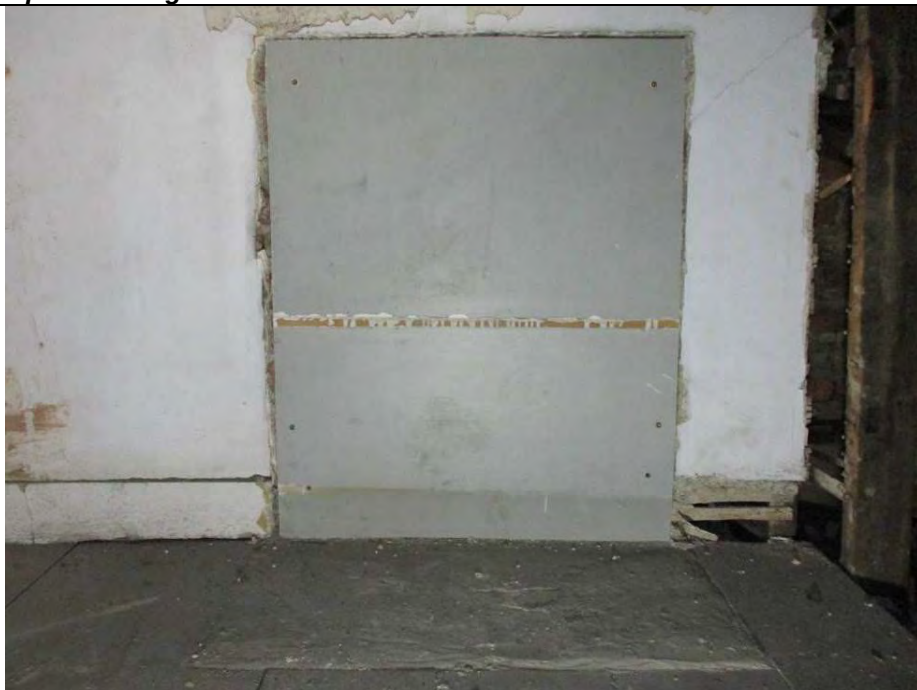
Room S1, showing the position of former fireplace within north party wall. The fireplace (surround and grate) has previously been removed although the hearth remains within the floor.

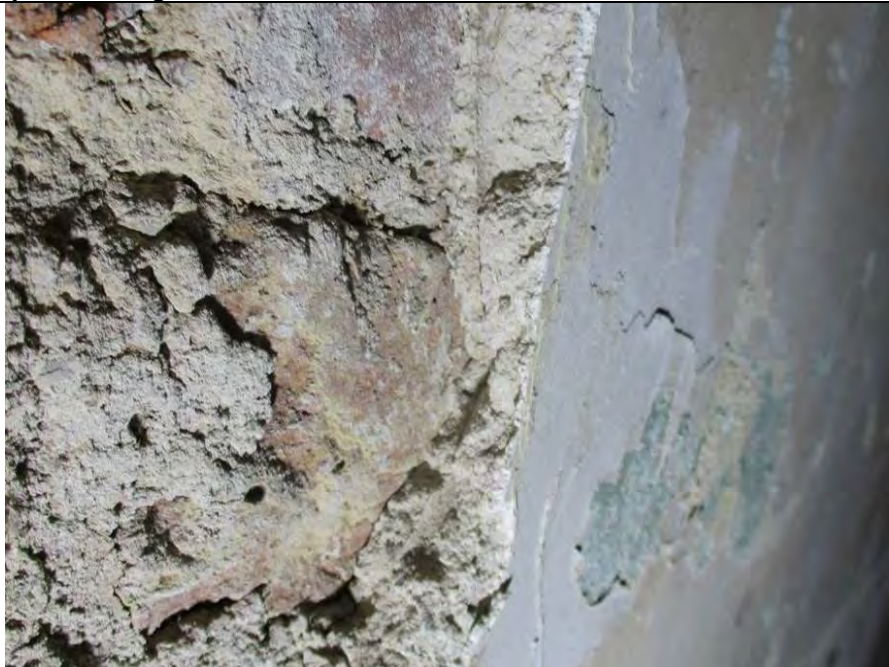
Room F1, showing the south wall which comprises of a plaster finish onto brickwork. The plaster finish comprises of a two-coat plaster - scratch coat and finish coat.

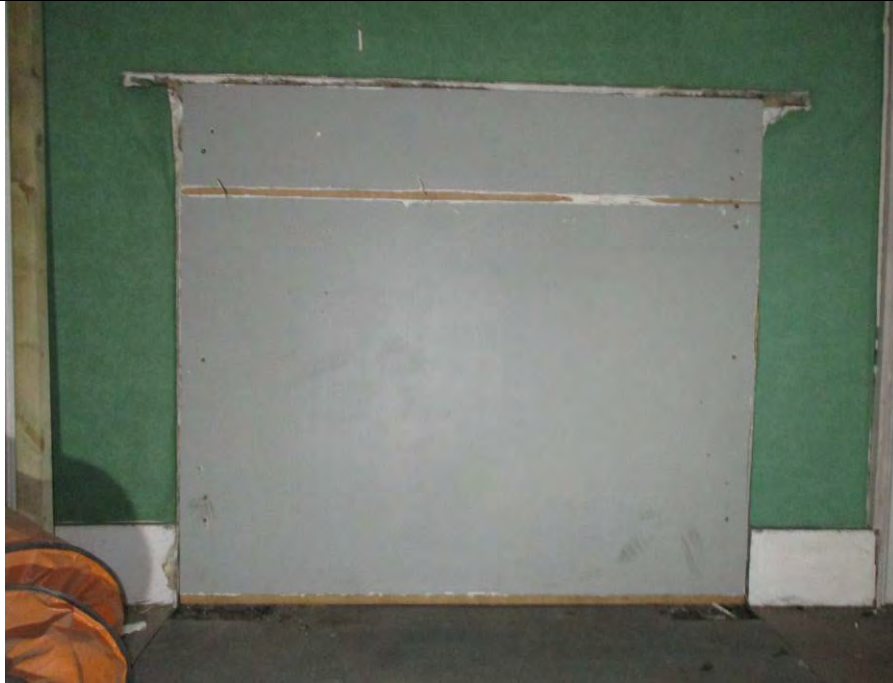
Room F2, showing location of former fireplace.

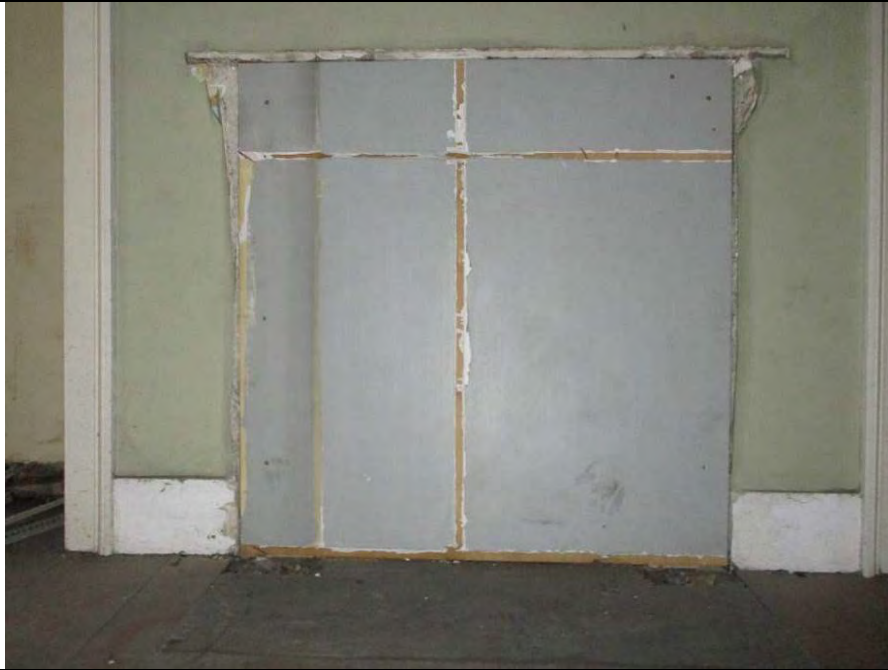
Room F3, showing location of former fireplace.

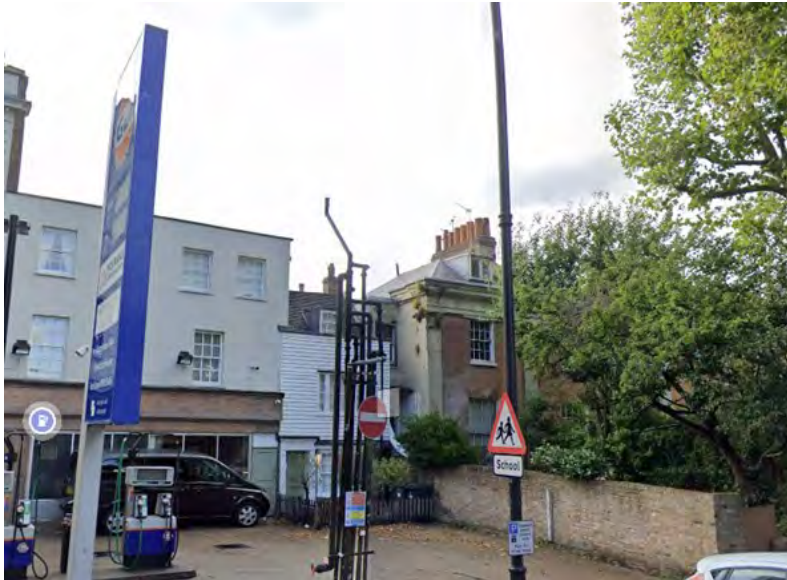
**Fig 1:**

**2024:** Google street view image., showing 37 North Road. The south frontage and south side of the building showing significant damp staining, presence of vegetation (indicative of dampness) and damage. The trees have been removed from the boundary so the building is more visible.

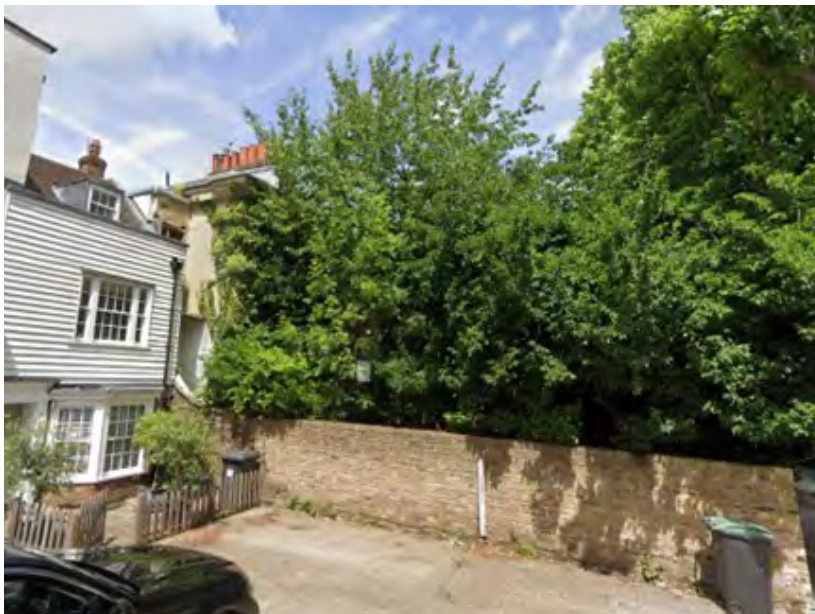
**Fig 2:**

**2022:** Google street view image., showing 37 North Road. The south frontage and south side of the building are concealed by vegetation with evidence of damage remaining to landing window and surrounding masonry as well as ivy growth on the façade.

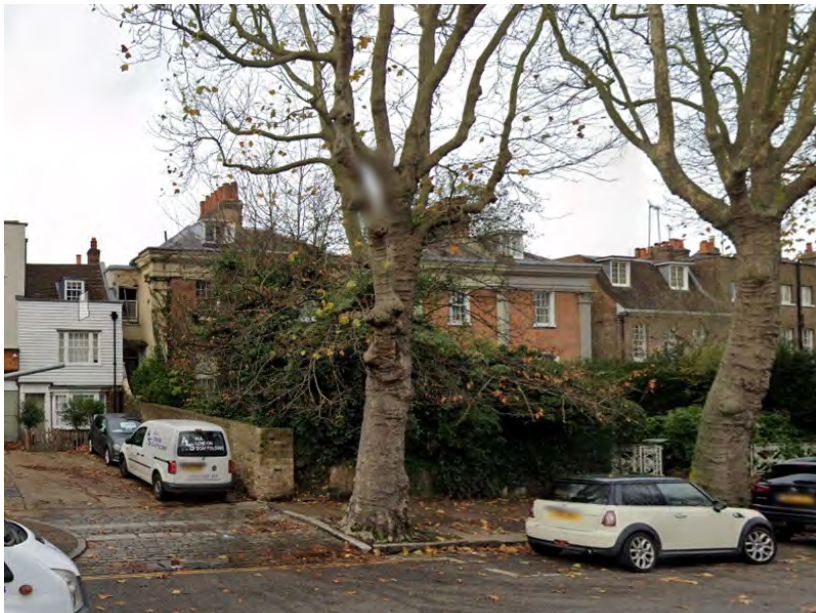
**Fig 3:**

**2020:** Google street view image., showing 37 North Road. The south frontage and south side of the building show deteriorating in condition with the landing window propped and damp staining across the façade.

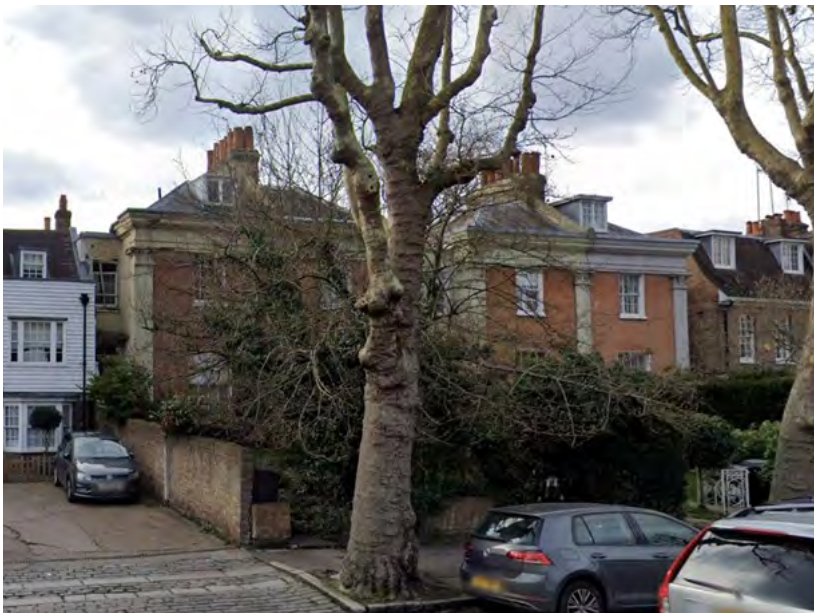
**Fig 4:**

**2018:** Google street view image., showing 37 North Road. The south frontage and south side of the building show deteriorating in condition with the landing window propped and damp staining across the façade.

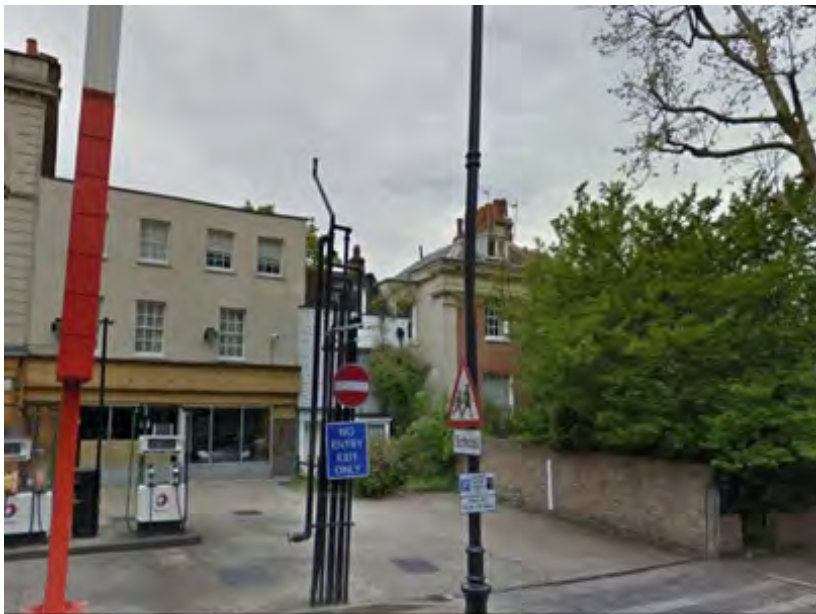
**Fig 6:**

**2012:** Google street view image., showing 37 North Road. The south frontage and south side of the building appear to be in reasonable condition although some damp staining is evident to the parapet in this image.

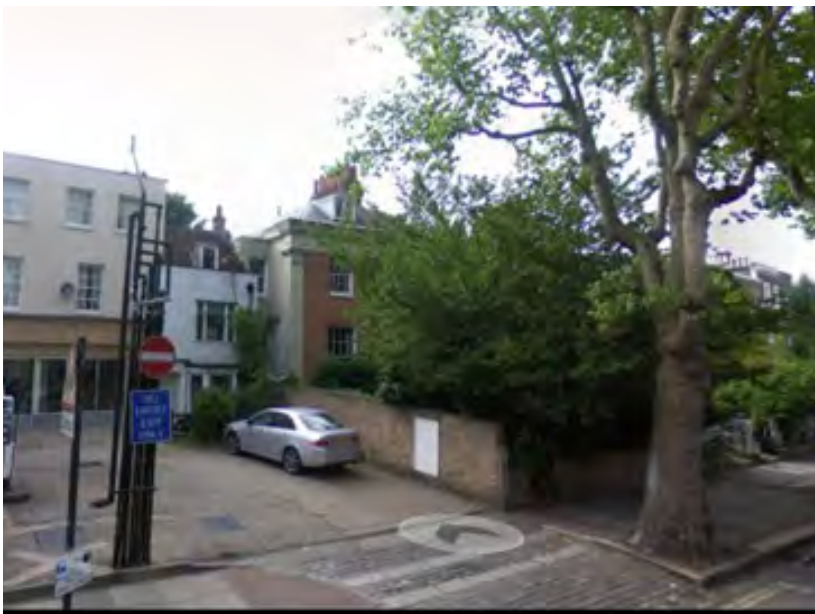
**Fig 8:**

**2008:** Google street view image., showing 37 North Road. The south frontage and south side of the building appear to be in reasonable condition in this image.
