METHOD STATEMENT  
FOR  
REMEDIAL STRUCTURAL WORKS  
DUE TO DRY ROT

37 NORTH ROAD,  
LONDON  
N6 4BE

17<sup>th</sup> February 2025

PROPOSED MEASURES TO  
ERADICATE DRY ROT IN THE  
PROPERTY

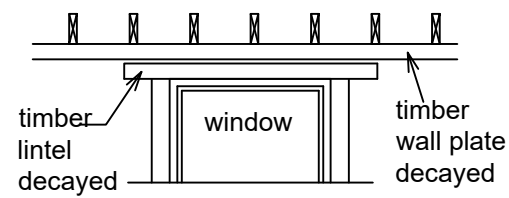
## LOWER GROUND PLAN

landing joists  
decayed joists to be  
replaced to match existing  
and supported on joists  
hangers with ends  
wrapped in dpm

Existing floor joists to be supported in joist hangers

2no. new  
100x140mm  
deep precast  
lintels

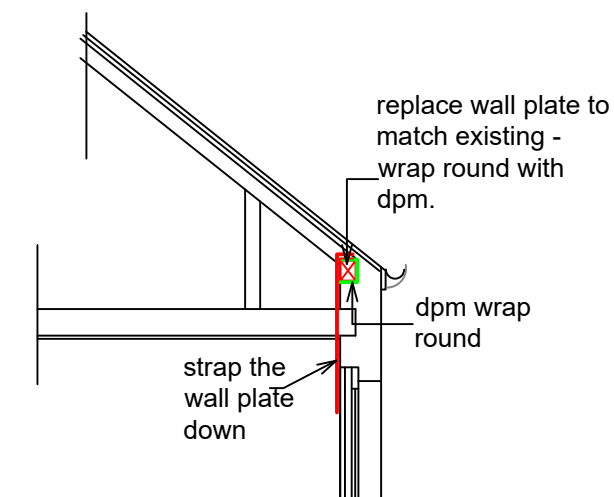
SECTION E - E  
PROPOSED

Some of the wall plates under floor joists and under the roof rafters have deteriorated due to dry rot. Only one area of the building to be worked on at any one time.

- a) Temporary support all the joists where the wall plate has deteriorated.
- b) Carefully remove the wall plate without disturbing the surrounding brickwork, one course of brickwork may have to be removed to insert the new wall plate.
- c) Make good the brick course where the new wall plate will be positioned.
- d) Insert the wall plate with DPM wrapped on the three sides touching the brickwork.
- e) Rebuild the brickwork on top of wall plate and rebuild any loose brickwork in the area.
- f) Provide mild steel galvanised straps tying the wall plates to the brick wall below (Section E-E).

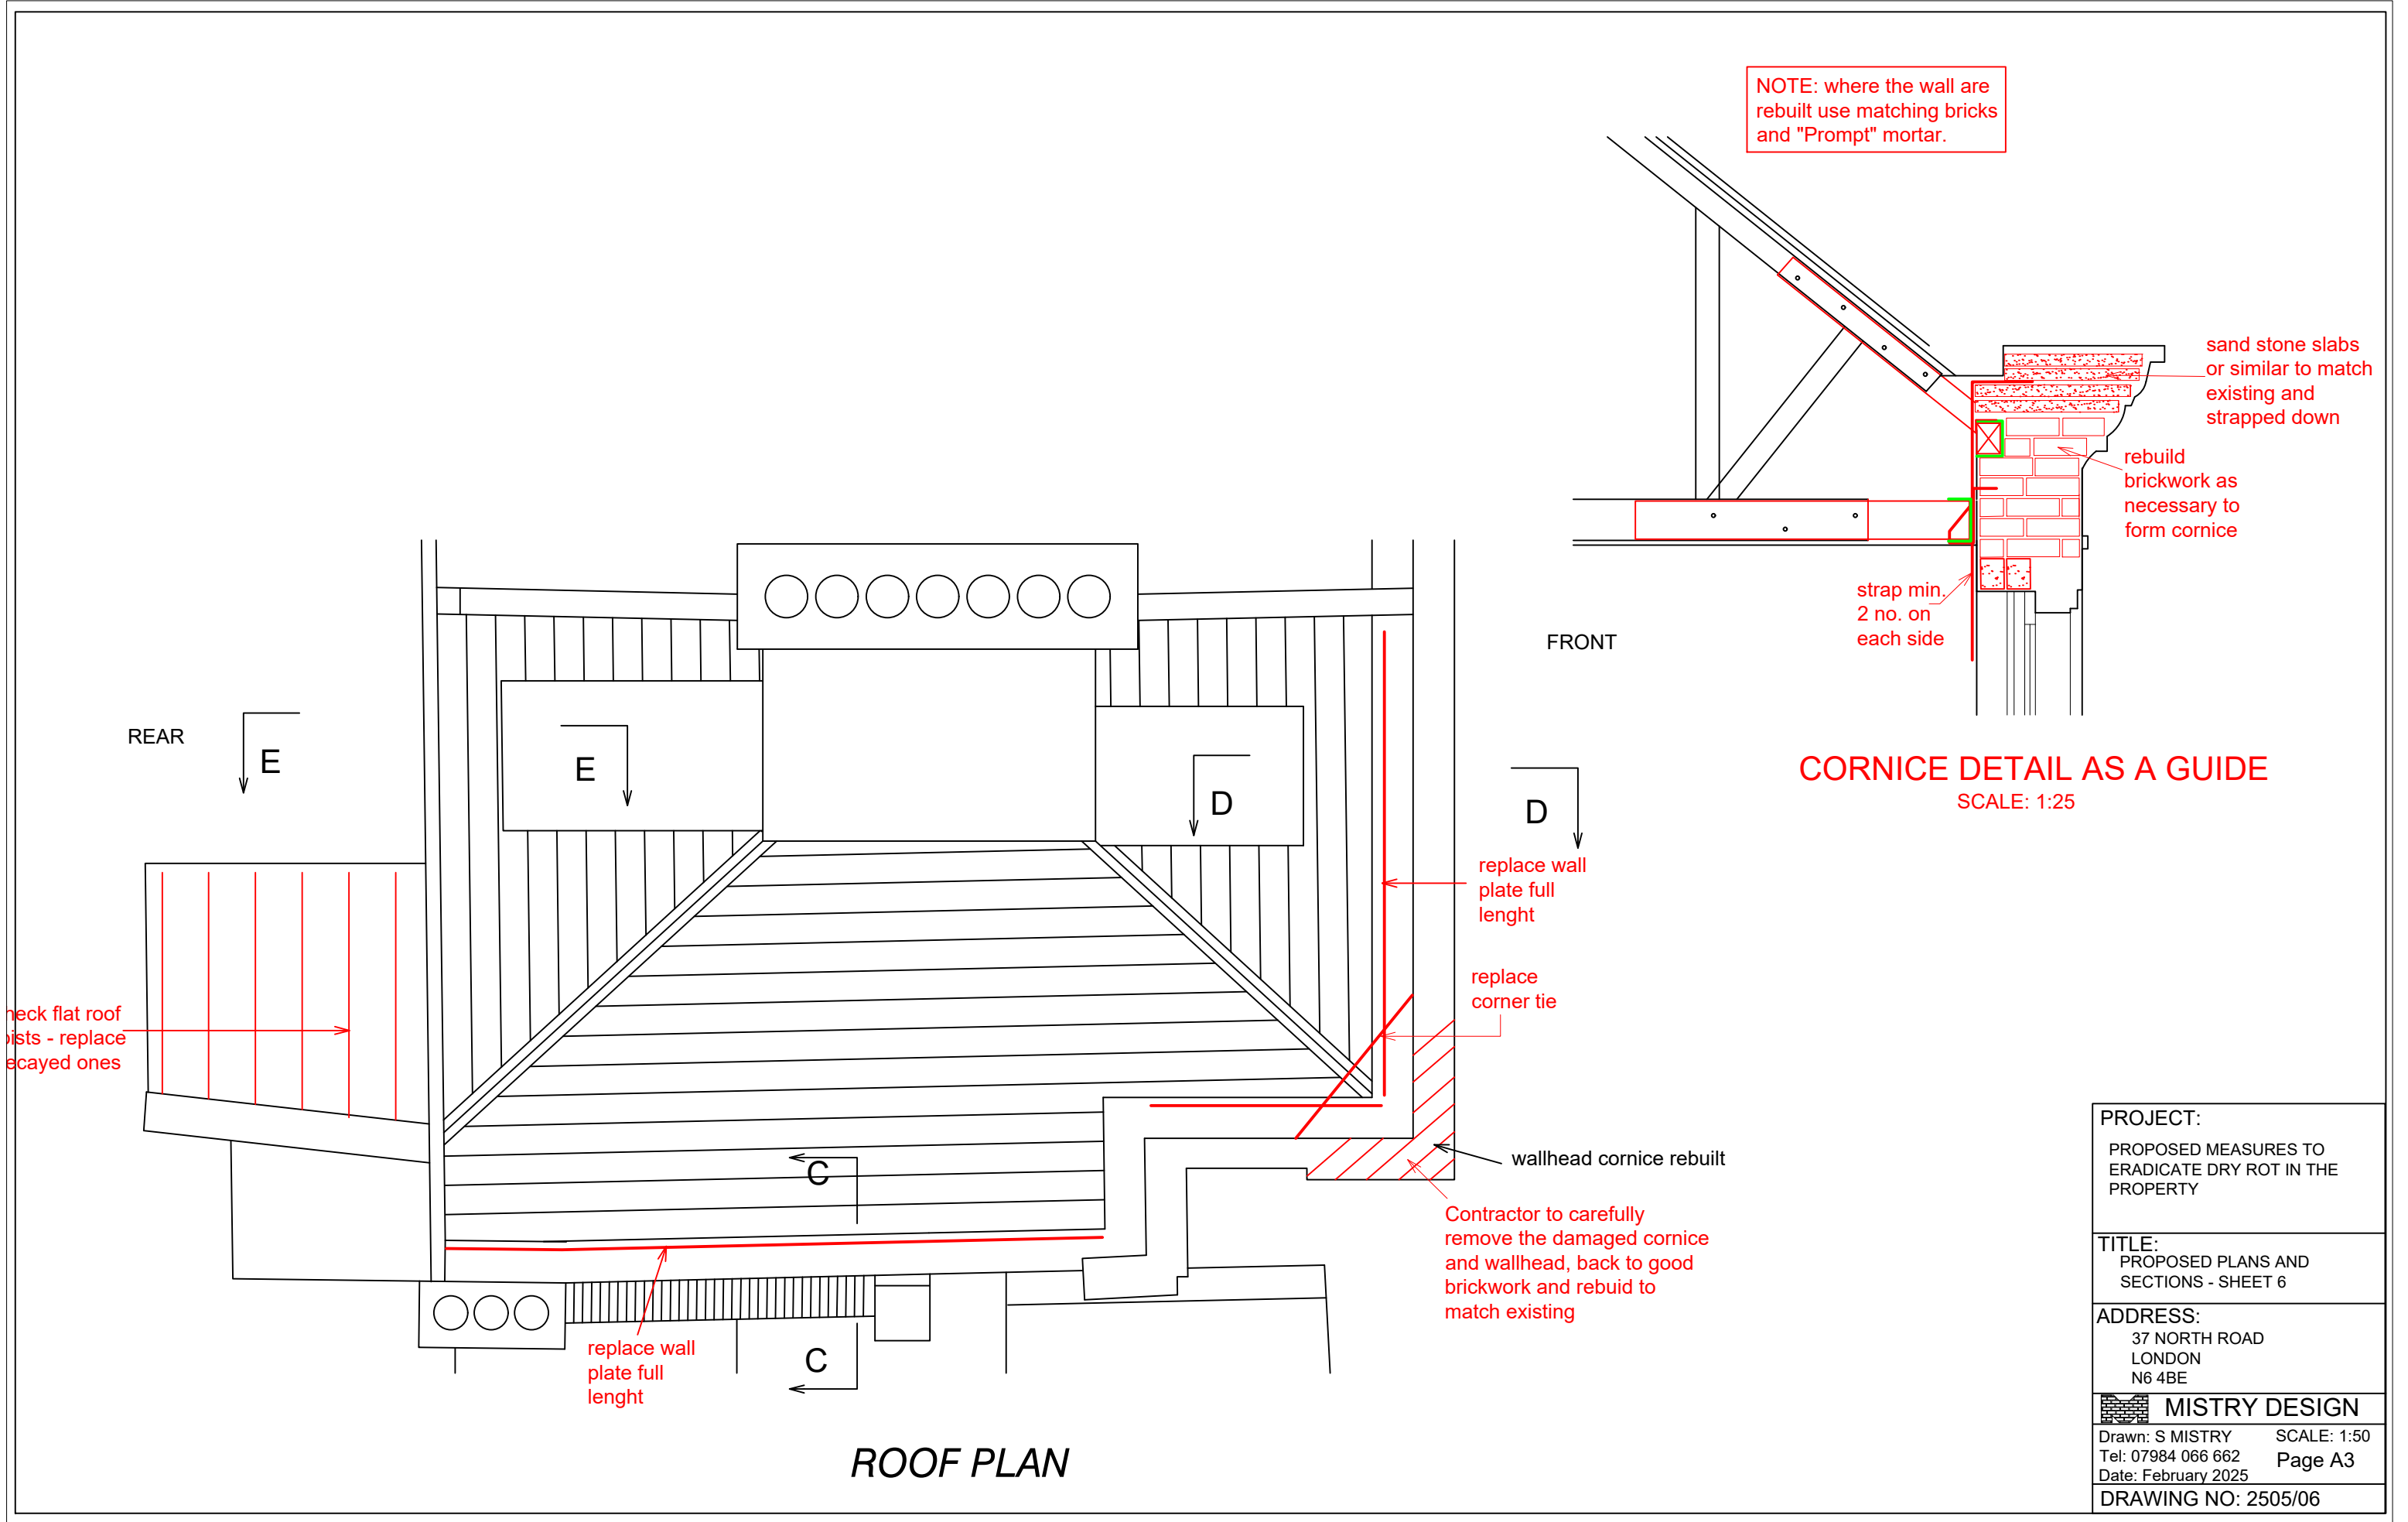
ROOF PLAN

The property at 37 North Road, London has suffered from Dry rot which has spread from the brickwork to most timbers attached to the walls, such as lintels, wall plates, floor and ceiling joist and skirtings. The infection has spread throughout the floors and has also reached the Basement. In the front façade a part of the front wall head, including the decorative render cornice has disintegrated.

- a) Dismantle the sandstone cornice carefully, one slab at a time, and noting how the cornice was built.
- b) Remove the slabs and any loose brickwork below.
- c) Rebuild the brickwork as before and rebuild the cornice corbelling using sandstone slabs or similar.
- d) Strap the cornice down using mild steel galvanised straps, min. 1 m down and screwed to good brickwork below.
- e) Finish the cornice detail to match existing cornice.

sand stone slabs or similar to match existing and strapped down

rebuild brickwork as necessary to form cornice

strap min. 2 no. on each side

replace wall plate full length

replace corner tie

wallhead cornice rebuilt

Contractor to carefully remove the damaged cornice and wallhead, back to good brickwork and rebuild to match existing

check flat roof gists - replace decayed ones
