Gas Membrane Installation  
Validation Report  
Alcema  
Alexandra Park School  
Bidwells Gardens  
London  
N11 2AZ

## Appendix 1 – Site Survey Sheets

| <b>Building Reference/Unit No:</b> | New Sixth Form Block | |
| <b>Area Inspected:</b> | Infill Installation - See Marked Up Plan | |

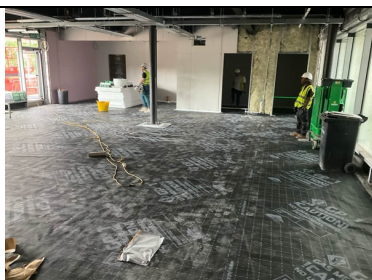
General overview of the infill installation using Juta GP1 Gas Barrier.

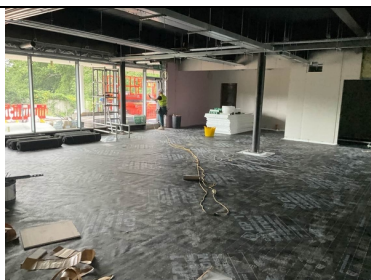
Overview of the infill installation.

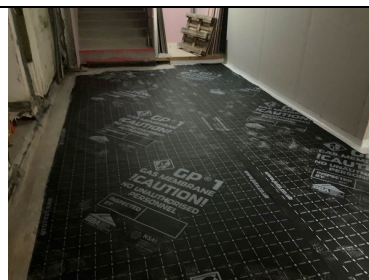
Overview of the infill installation to core area.

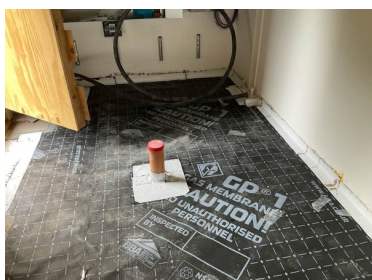
Overview of the infill installation to electrical room.

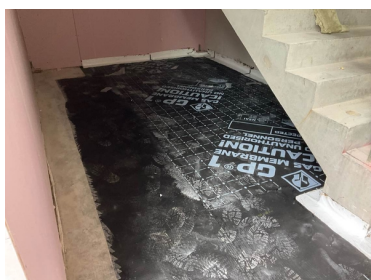
Overview of the infill installation to stair core area.

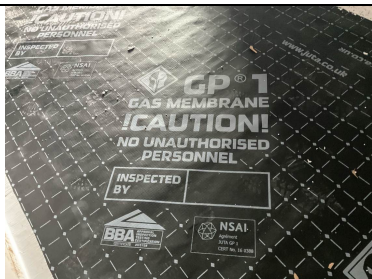
Evidence of Juta GP1 Gas Barrier installed on the project.

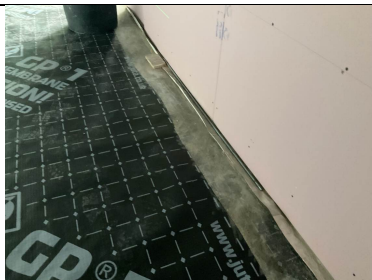
Overview of the infill gas barrier

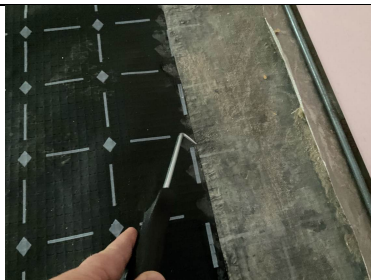
Probe testing to hand welded lap

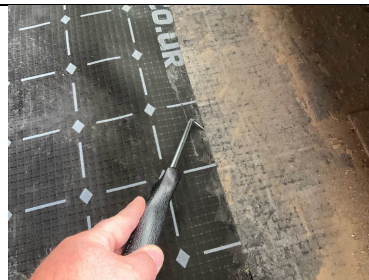
Probe testing to hand welded laps along perimeter edge.

hand welded to the existing  
perimeter installation barrier.

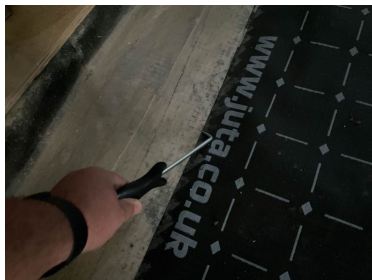
Probe testing to hand welded laps  
along perimeter edge.

joints along existing perimeter  
edge membrane.

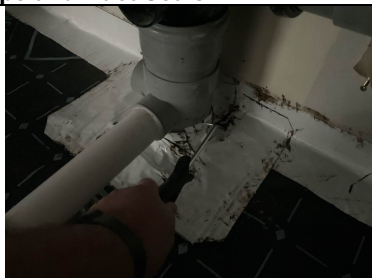
Probe testing to pipe penetration  
details.

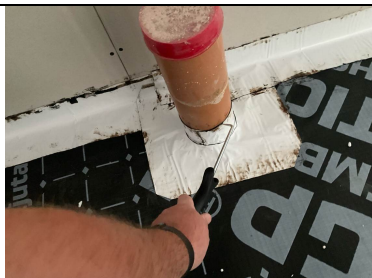
Probe testing to pipe penetration  
details.

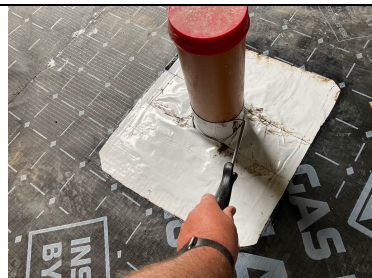
Probe testing to pipe penetrations.

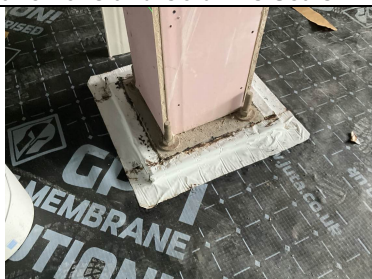
Steel stanchion detailed using Juta  
GPSAM.

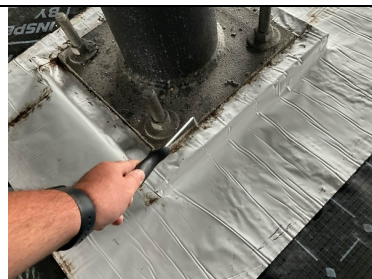
Probe testing to steel stanchion  
details.

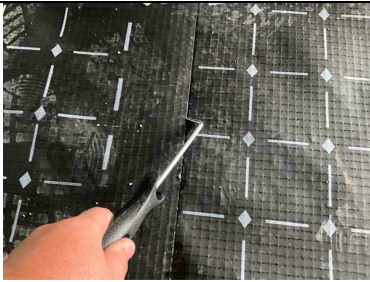
Probe testing along hand welded membrane lap joints.

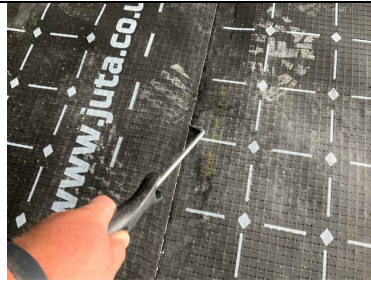
Probe testing along hand welded membrane lap joints.

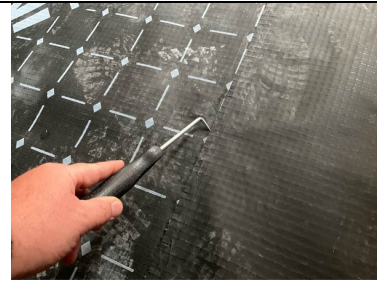
Probe testing to hand welded lap joints.

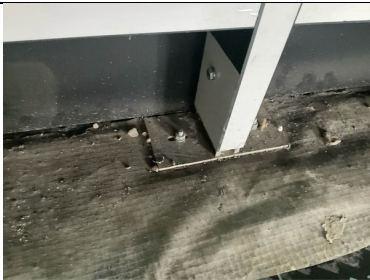
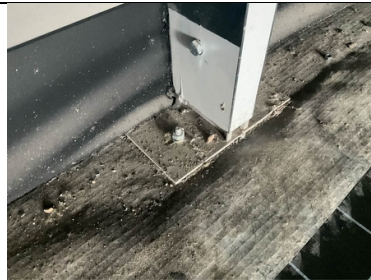
MEC are unable to check the gasket detail to the curtain wall steel bolts.

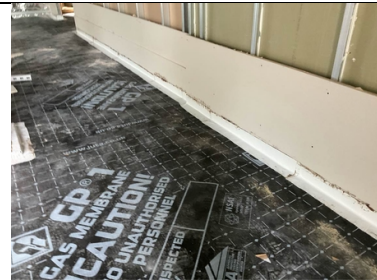
Overview of the retrofit termination detailing to internal wall partition walls using Juta GPSAM.

| | membrane, this includes but is not limited to pipes/ducts, stanchions, wind posts, braces, field seams, masonry abutments, tanking, door thresholds and the like |
|---|---|
| <p>MEC advises that the installers and/or the site contractor checks with the designer that the installation method and retrofit termination detailing to the internal plaster boarded partition walls is acceptable. Once approved, written confirmation should be supplied to MEC to include in the report.</p> <p>MEC are unable to check the gasket detail to the steels along the curtain wall that have been bolted through the gas barrier. MEC advises that site and/or the installers take photographic evidence of this detail.</p> <p>Site does not have specific gas barrier detail drawings., therefore our inspection relates to general workmanship only in line with manufacturers installation recommendations</p> <p>MEC were unable to gather photographic evidence of the materials packaging used (Juta GPSAM) during today's inspection.</p> | N/A |

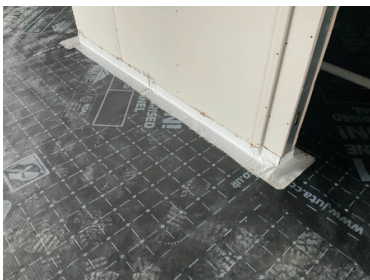
Overview of the retrofit termination detailing to internal wall partition walls.

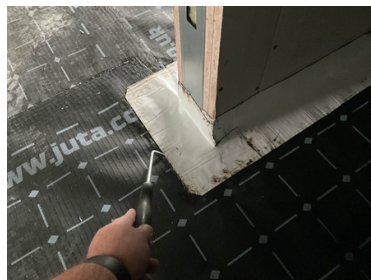
Probe testing along retrofit termination detailing to internal wall partition walls.

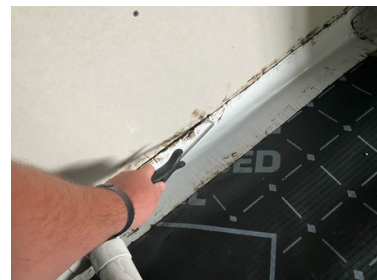
Probe testing to retrofit termination detailing along internal wall partition walls.

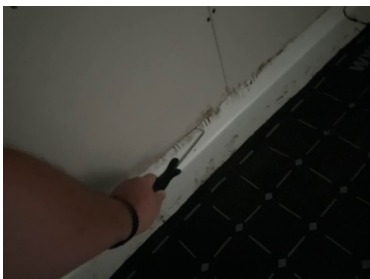
Probe testing to retrofit termination detailing along internal wall partition walls.

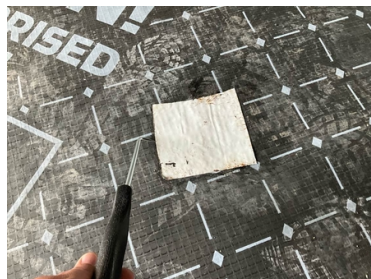
Probe testing to installers own CQA patch repair using Juta GPSAM.

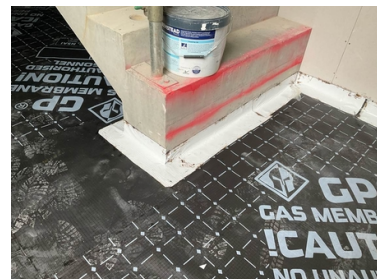
Retrofit termination detailing to stair core base using Juta GPSAM.

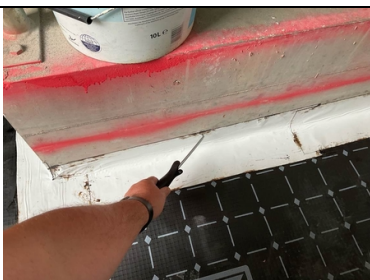
Probe testing along retrofit  
termination detailing to stair core  
base.
