Heritage statement & DAS  
Land to west of 2 King's road,  
London N17 8NP

Reclaimed Brick and proposed lime mortar

## Reclaimed bricks for rebuilding front wall: Enclosure strategy

**Condition 3(b)** Repair works to front existing wall:  
Retain Front External Envelope

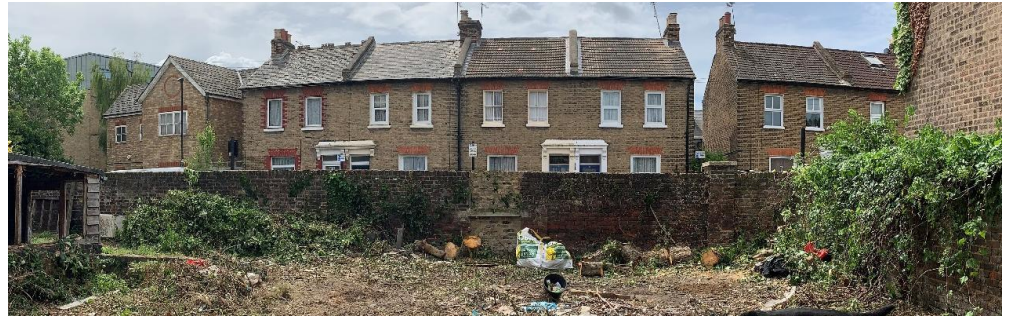
Existing front garden patch wall

The whole wall has many damaged facing brickwork and deteriorated to such an extent that water could penetrate behind this section of brick and had forced it to bulge. The repair front garden wall brickwork will match the existing adjacent and be tuck pointed.

Following cleaning of the facade including piers and caps, an inspection will be carried out to determine the extent of brick and stone repair and pointing required. Prior to cleaning, loosely adhered deposits and growths to be removed using suitable corrosion resistant brushes with copper bristles, and scrapers/ spatulas that do not abrade or gouge the surface.

Brick repairs Minor areas of defective brick are to be cut back on individual bricks and repaired with lime mortar colored to match existing brick. Cement mortar to headers above ground floor window (far right image) is to be carefully removed for inspection, it may be necessary to cut out and replace individual red facing bricks to match existing bedded in lime mortar. Pointing - defective or missing mortar to be raked out and re-pointed in lime mortar to match existing.

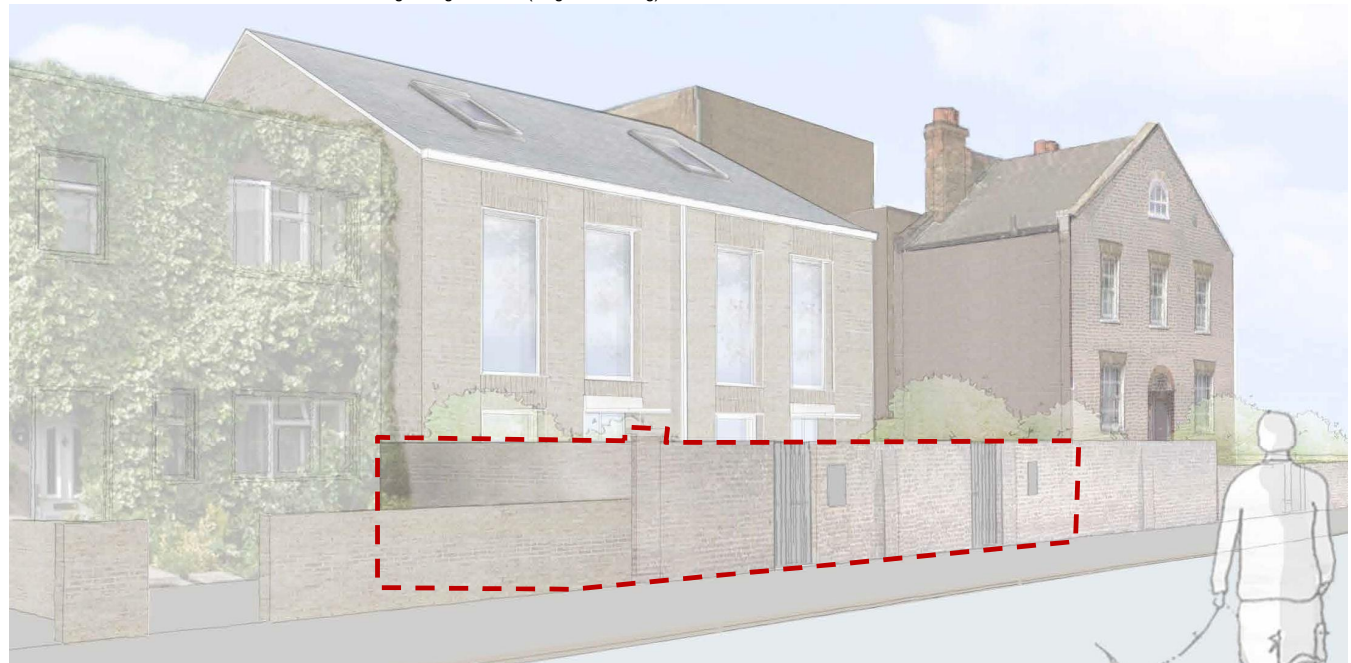
Existing front garden wall (King's road facing)

The previous condition of the wall is in a poor condition and the mortar are cracking and falling away. Works of rebuilding with proper foundation is required. The mix of lime mortar for bricks is also selected in the traditional London mix to match the existing, Parts of the mortar is cover in dirt and patches of repairing mortar over time. Thus, the Heritage lime mortar color is the closest matching mix to the previous existing brick mortar.

In making the openings for the gates the deflected weak wall collapsed and the contractor has bought it to the ground as it was a hazard to the passer-by. There is also discovery these wall were build without foundations.

Works to rebuild wall and allow for new lime mortar repair as specified in methodology in heritage statement and the latest structural statement.

The design due to collapsed wall is to rebuilt the frontage wall including the curved front of the proposed houses. For mitigation, they will be rebuilt with the reclaimed bricks on-site. The frontage wall are to be carried out in accordance with the SE 01/09/2022 report and the conservation Method Statements. The brickwork that was damage unsympathetically will be rebuilt to better respect the details and weathering of the rest of the wall, reusing the bricks from the West Wall and Front wall.

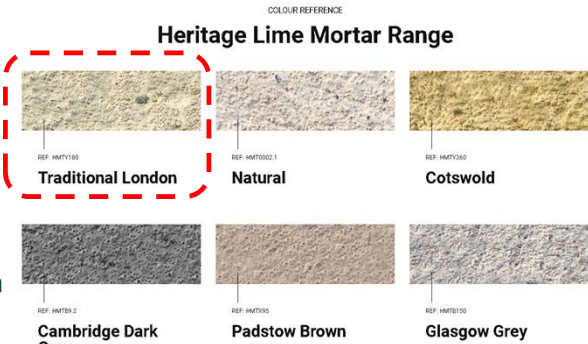
**Proposed of rebuilt reclaimed brick work currently on-site mock-up with traditional London lime mortar**

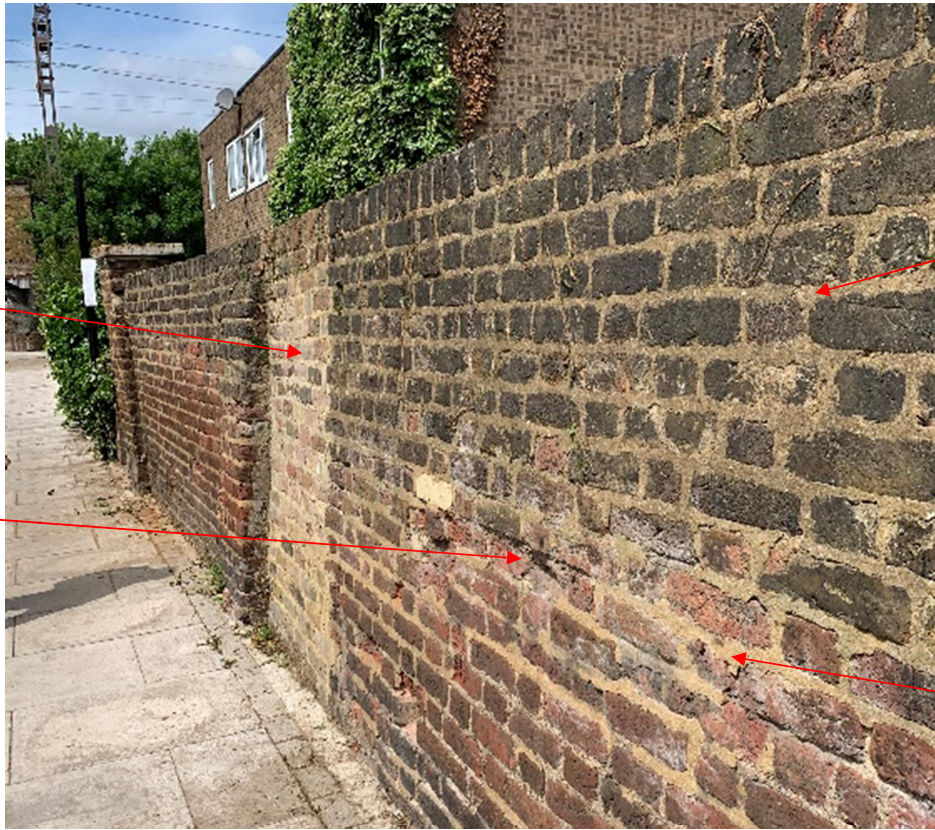
Previous gateway created by previous owners

This shows damage to soft brickwork by the use of cement mortar.

This shows sound lime mortar below a shallow layer of cement repointing mortar which is cracking and falling away.

This shows the joints which are friable and deeply eroded. Wind-driven rain can make its way into the core of the wall through open joints

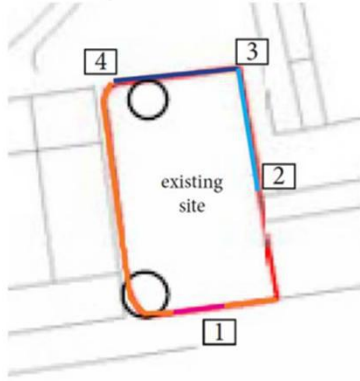
- 2.4 The Mid C19 roadside and west boundary wall (1) has Medium historic interest. Its interest derives from being contemporary with the service wing, showing the historic enclosure of properties, and it has a distinctive layout. Loss of interest derives from its alterations, which include that it is repointed with C20 cement pointing and the top is rebuilt. It has Medium architectural and artistic interest as it is a good example of C19 enclosure and is built in flemish bond like the main house. It is of **Medium value** overall and not of sufficient quality for listing in its own right. For the purposes of this assessment the former unauthorised opening is not taken into account. This is marked pink in Figure 12 and visible as a blocked opening in poor quality brickwork.

Figure 13. C19 roadside boundary wall (1). The blocked opening is towards the left.

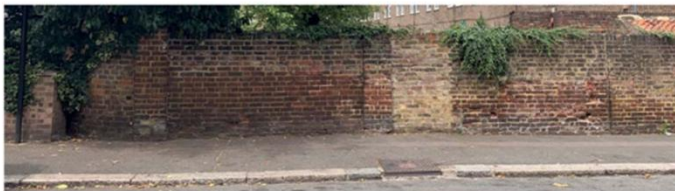
Figure 14. Western end of C19 roadside boundary wall (1) showing the curved corner.
