**Northern Terrace Phase 1**  
**810-812 High Road, Change of use and rear extension**

**Job No. 15208**

**Structural Strategy Statement, Stage 2**

**Dec. 2015 / Aug. 2016**

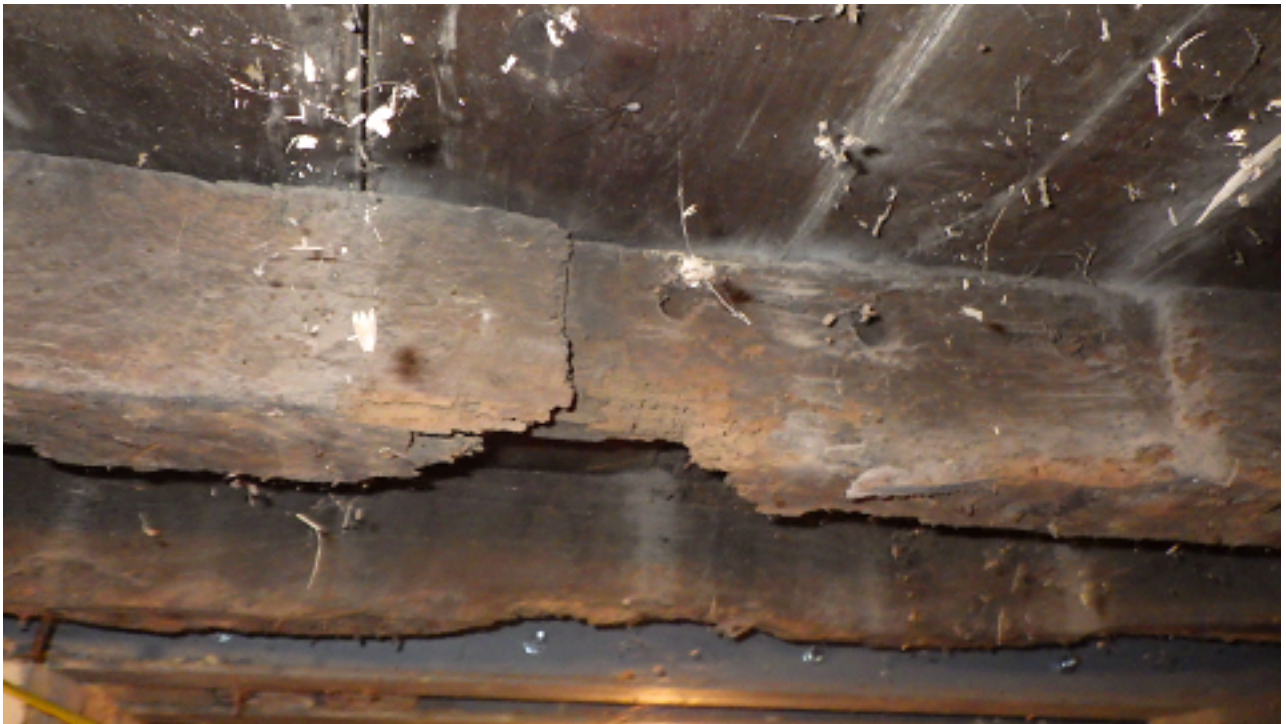
Image 4/SK101

In some locations there are signs of decayed timber, particularly on the ground floor as can be seen in image 4/SK01 in Appendix A. Some of the timber members are likely to require replacing or splicing to remediate this. Further inspections of all timber are likely to be required by a specialist.

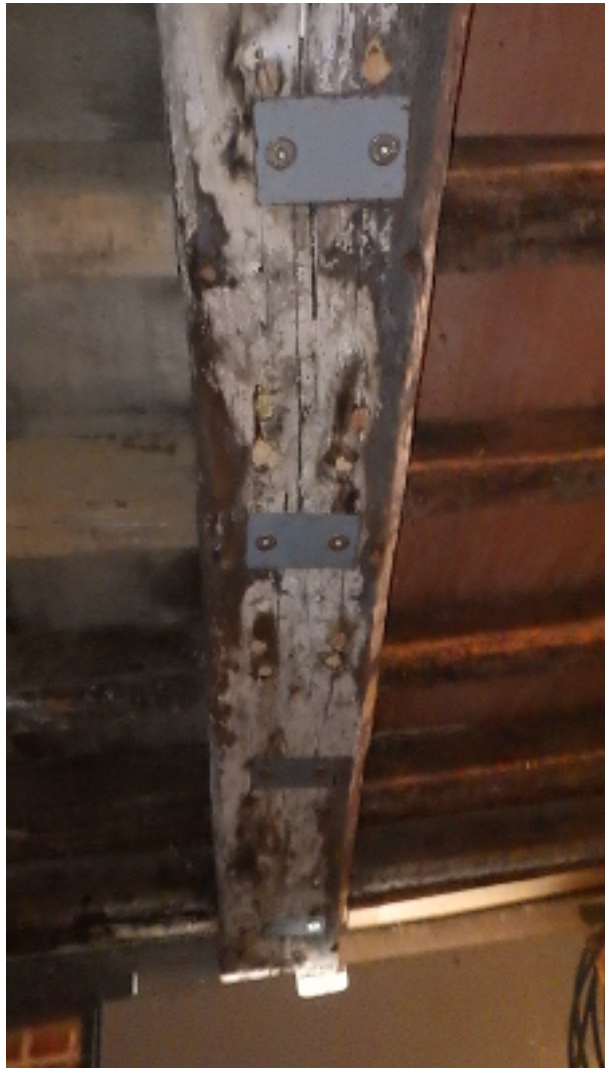
Image 6/SK101

Some of the primary timber members appear to have been strengthened with steel plates. This can be seen in images 6/SK101 in Appendix A. The exact details for this are not known as the joists could not be viewed from above. Further investigations would be required to determine this.

The members that appear to have been strengthened with steel plates GB1, and TB1 cannot be checked as their make-up is not known. Further investigation is recommended to investigate the strengthening works that have taken place so that these members can be analysed further,

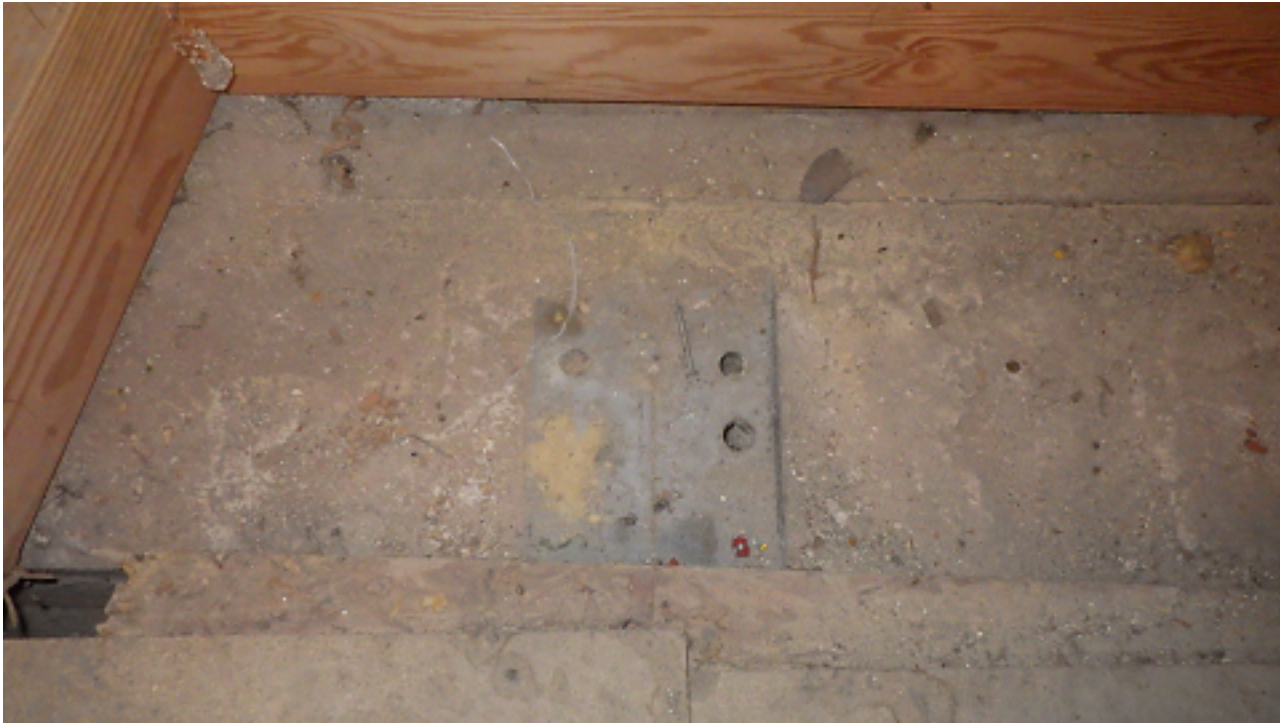
Image 6/SK102

The member GB1 appears to have a new bearing plate as can be seen in image 6/SK102.
