SARABANDE NLHF ROUND II BID

NOS. 808-810/812 HIGH ROAD

| GR01 PROPOSED ROOM ELEVATIONS/DETAILS |

Drawing no  
SBND-1000-ZZ-ZZ-DE-A-22841

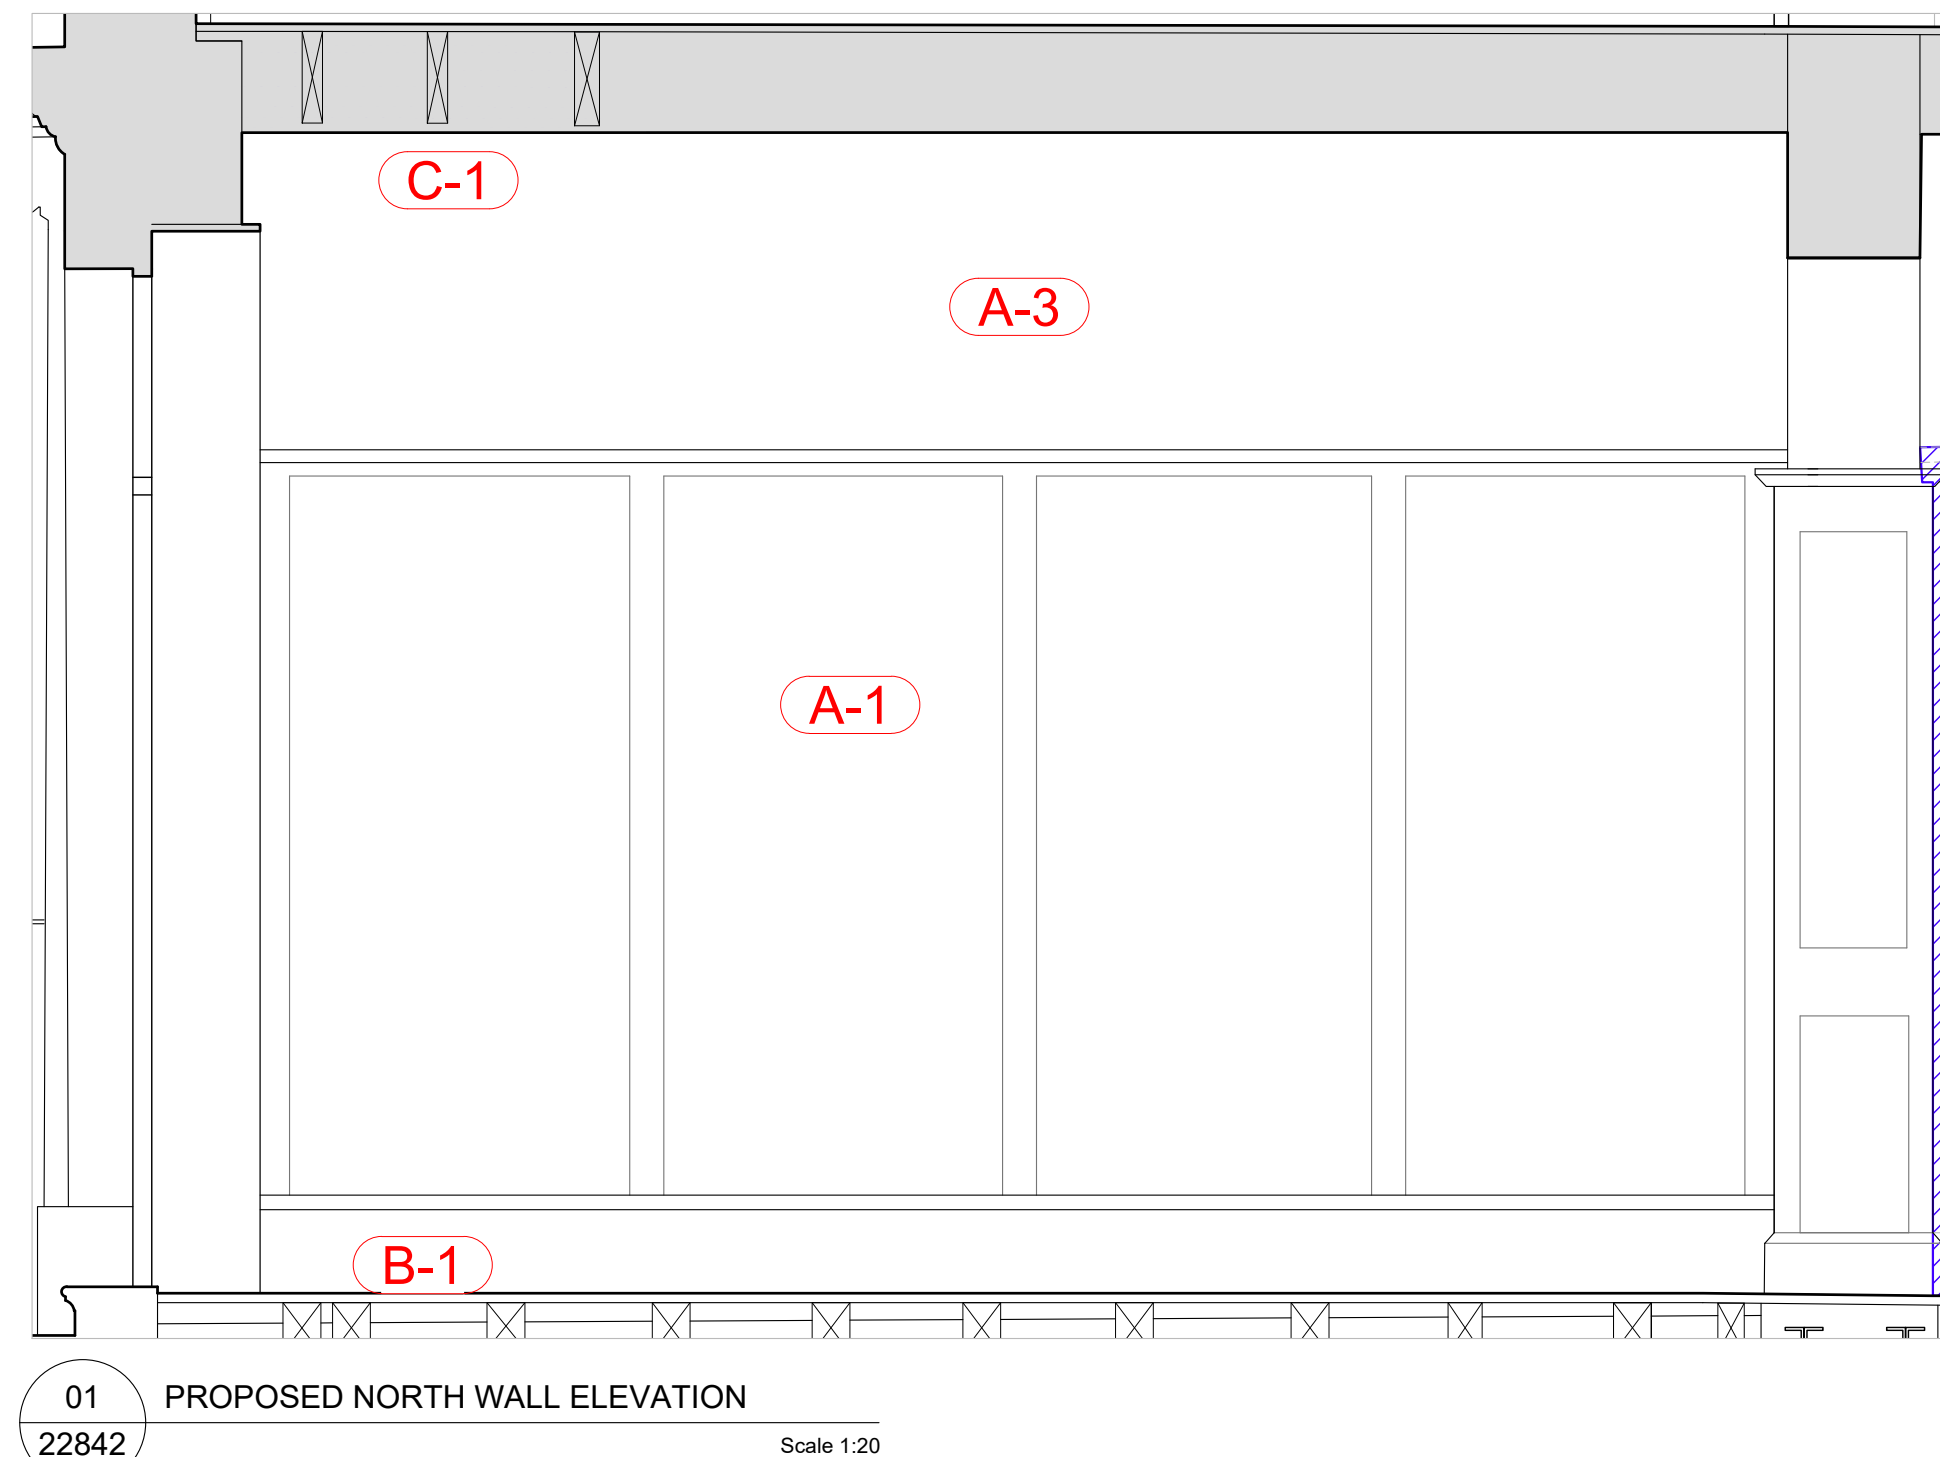
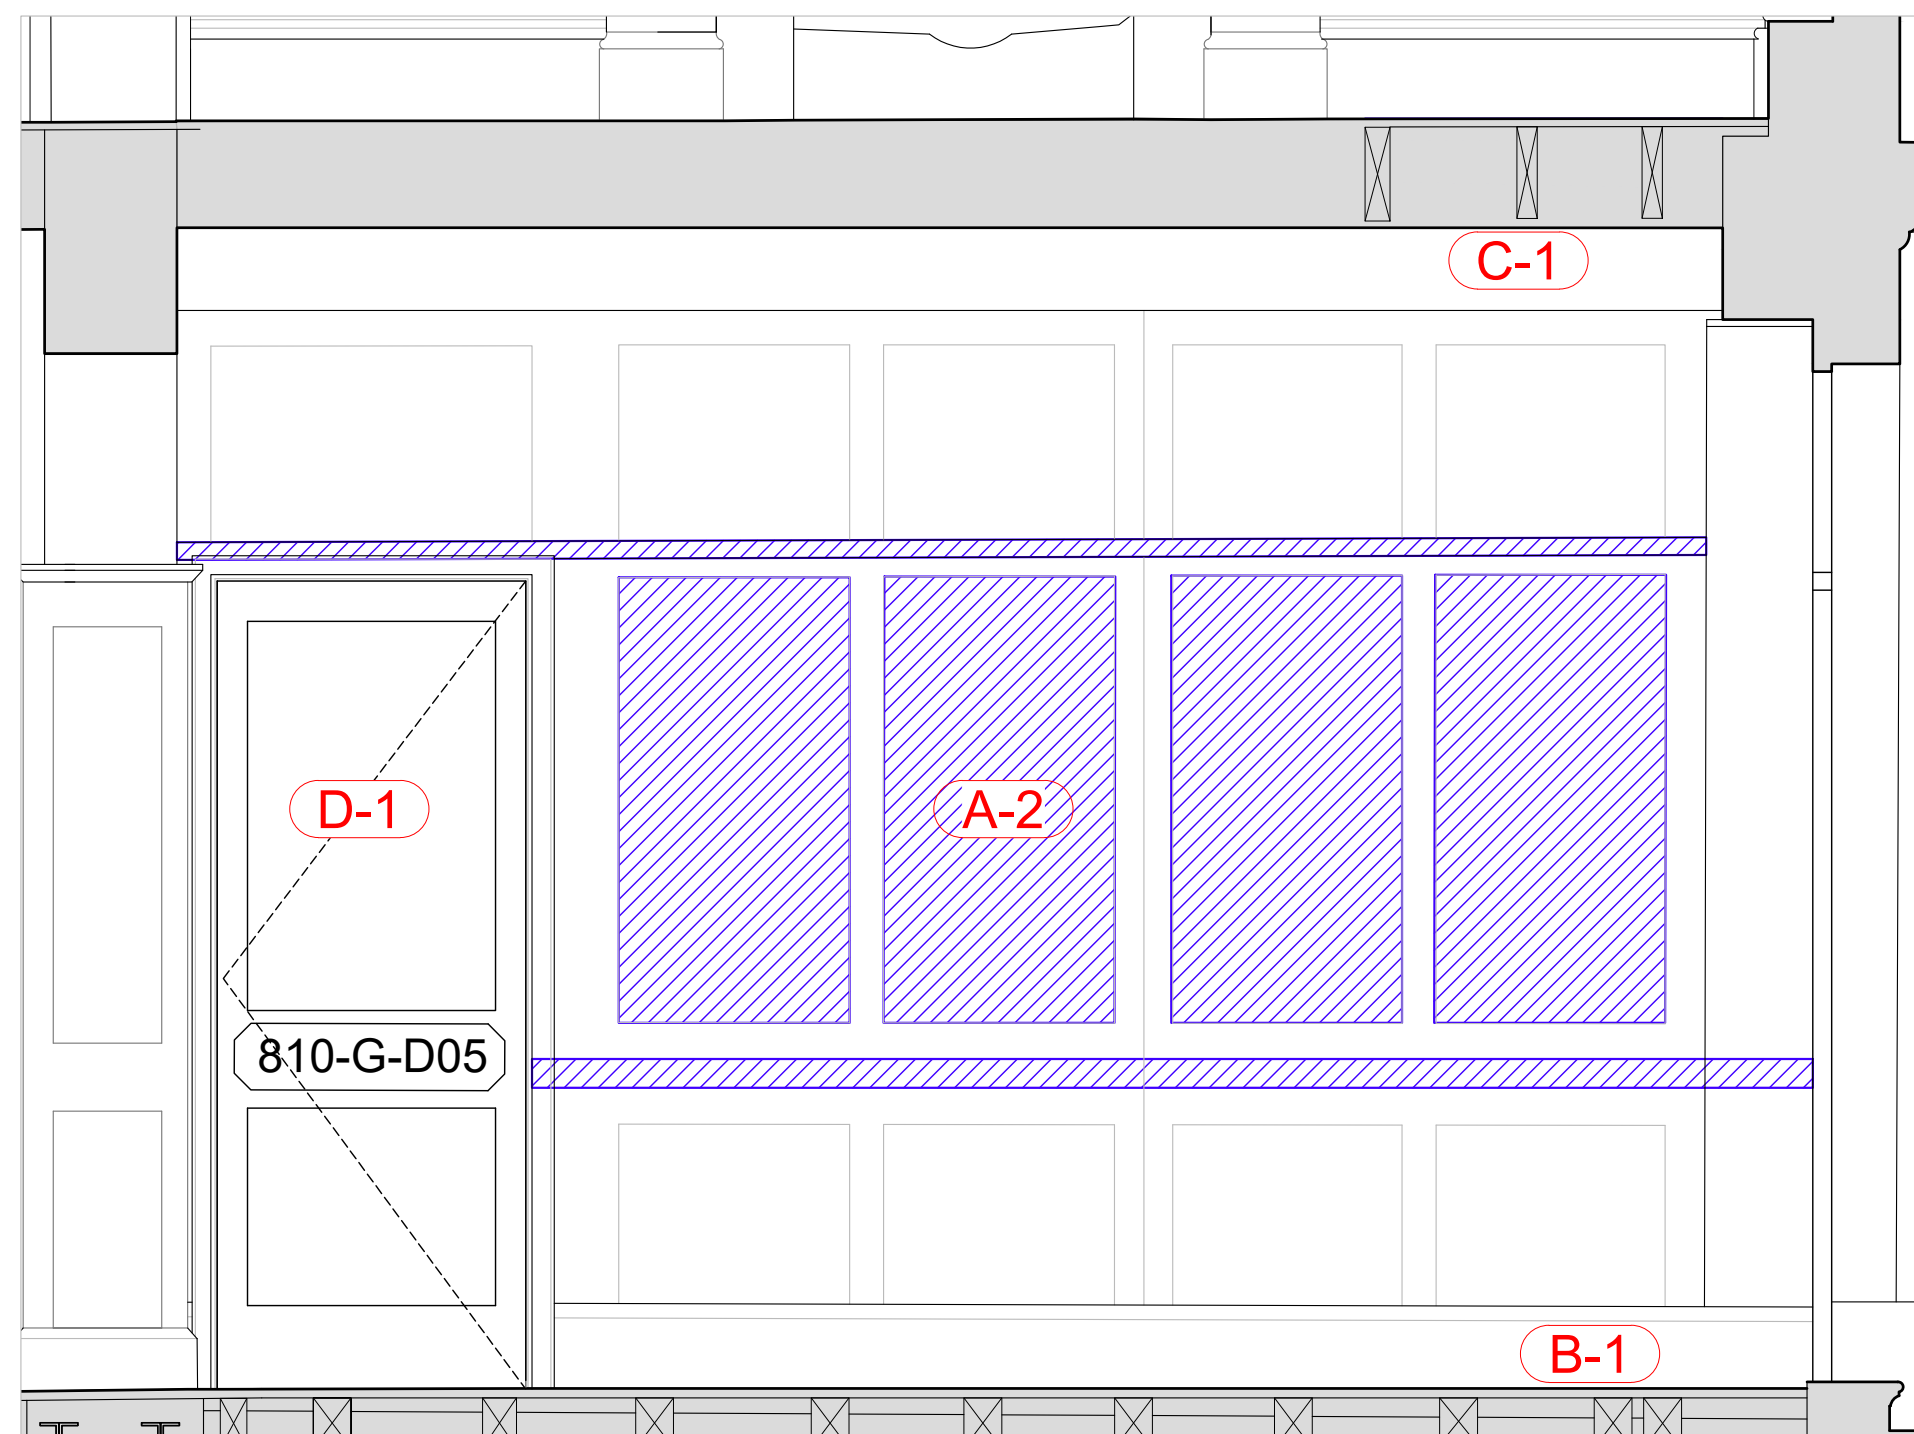
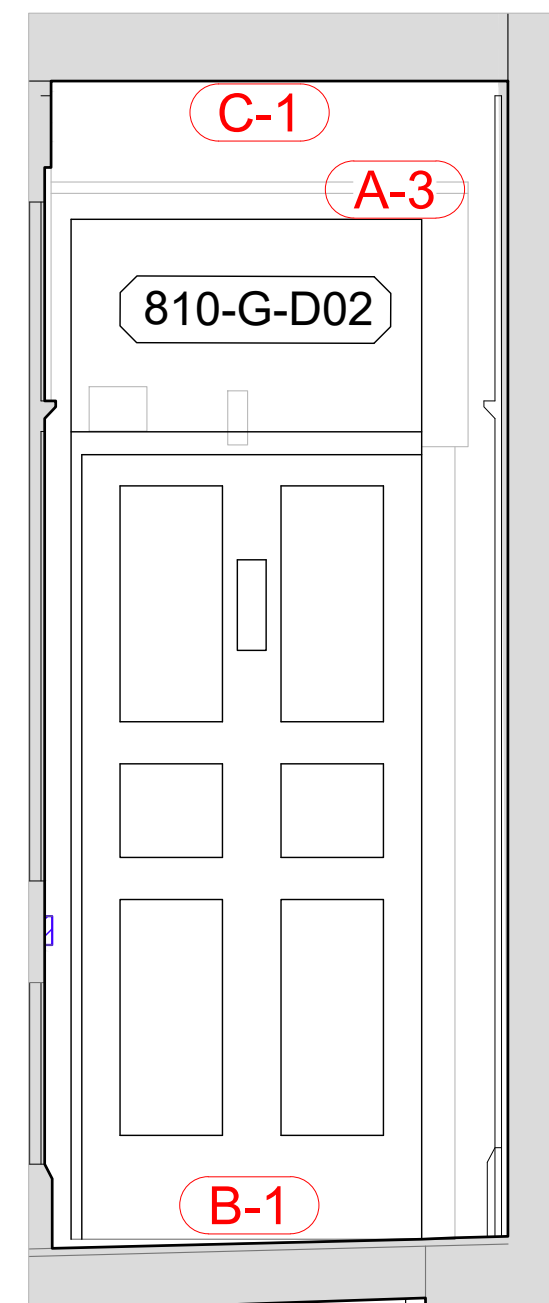
**A-1:** North Wall, east corner has been dislodged. Retain & continue as like for like in-situ joinery repairs to panelling. Once panelling in this corner of entrance hall has been reinstated and panelling realigned, realign door head and panel above and refix using secret nails.

**A-3:** Joinery repairs to panelling (as part of entrance hall repairs) Steam off modern impermeable paint. Infill splits and knothole using timber or reversible wood filler. Some infills in the timber have already been carried out.

**A-4:** Infill hole in flue and panelling above fireplace. Panel is bowed but leave.

**A-6:** Broken & missing softwood half round bead where modern doors have been removed. Infill to match adjacent.

**A-7:** Joint in panelling reveal between jamb & head has opened. Infill in softwood to match.

**A-8:** Broken bead edge to panels scarf in new section softwood. 3 positions to 600mm long.

**A-9:** Split board in panelling. Timber fill or reversible filler by joiner to match.

**B-1:** Floor. All over boarded. No original boards remain. Remove temporary flooring ply & provide new floorboards to match existing in similar status primary room on floor above, laid on Tyvek to prevent dust.

**C-1:** Ceiling lathe & plaster missing or loose. Retain & repair loose with stainless steel, non-ferrous screws and washers and skim lime over holes. Remove modern paint, replace with permeable paint finish.

**C-2:** Cornice rotted on SE end. Allow to reuse section 2m long of existing loose, upper moulding & replace 1.5m long new sections of central & lower moulding.

**C-3:** Loose pieces of timber cornice. remove where loose, clean off glue and debris, refix as a joinery repair.

**D-1:** C18 doorway, door is missing, and lining is dislodged & damaged. Install new two-panel door like for like, with C18 style ironmongery.

**D-2:** C19 archway doors have missing upper panels and ironmongery. Retain & repair like-for-like.

**F-1:** Glazed cupboard to left of fireplace (C19) Has original shelves etc. Infill floor with floorboards. 5 broken panels to RH door. Replace to match 3mm handblown glass. Renew in C19 style, broken/rusted lock to upper doors. Ease lower lock & provide key where missing. Provide timber door stop for lower doors at meeting stile (missing). Construct false backing/access panel to cover proposed service riser.

**F-2:** C19 cupboard to RH of fireplace. Very deformed & door does not open properly. Replace with matching glazed C19 cupboard. Construct false backing/access panel to cover proposed service riser.

**W-1:** West Wall. Windows, panelling & shutters have already been renewed/repaired. Reused 2 shutters, 3 reveal panels & 2 head panels to window openings. Rebuilt reveals have insufficient space for plaster so leave unplastered. Fix new shutter bars & knobs where missing.

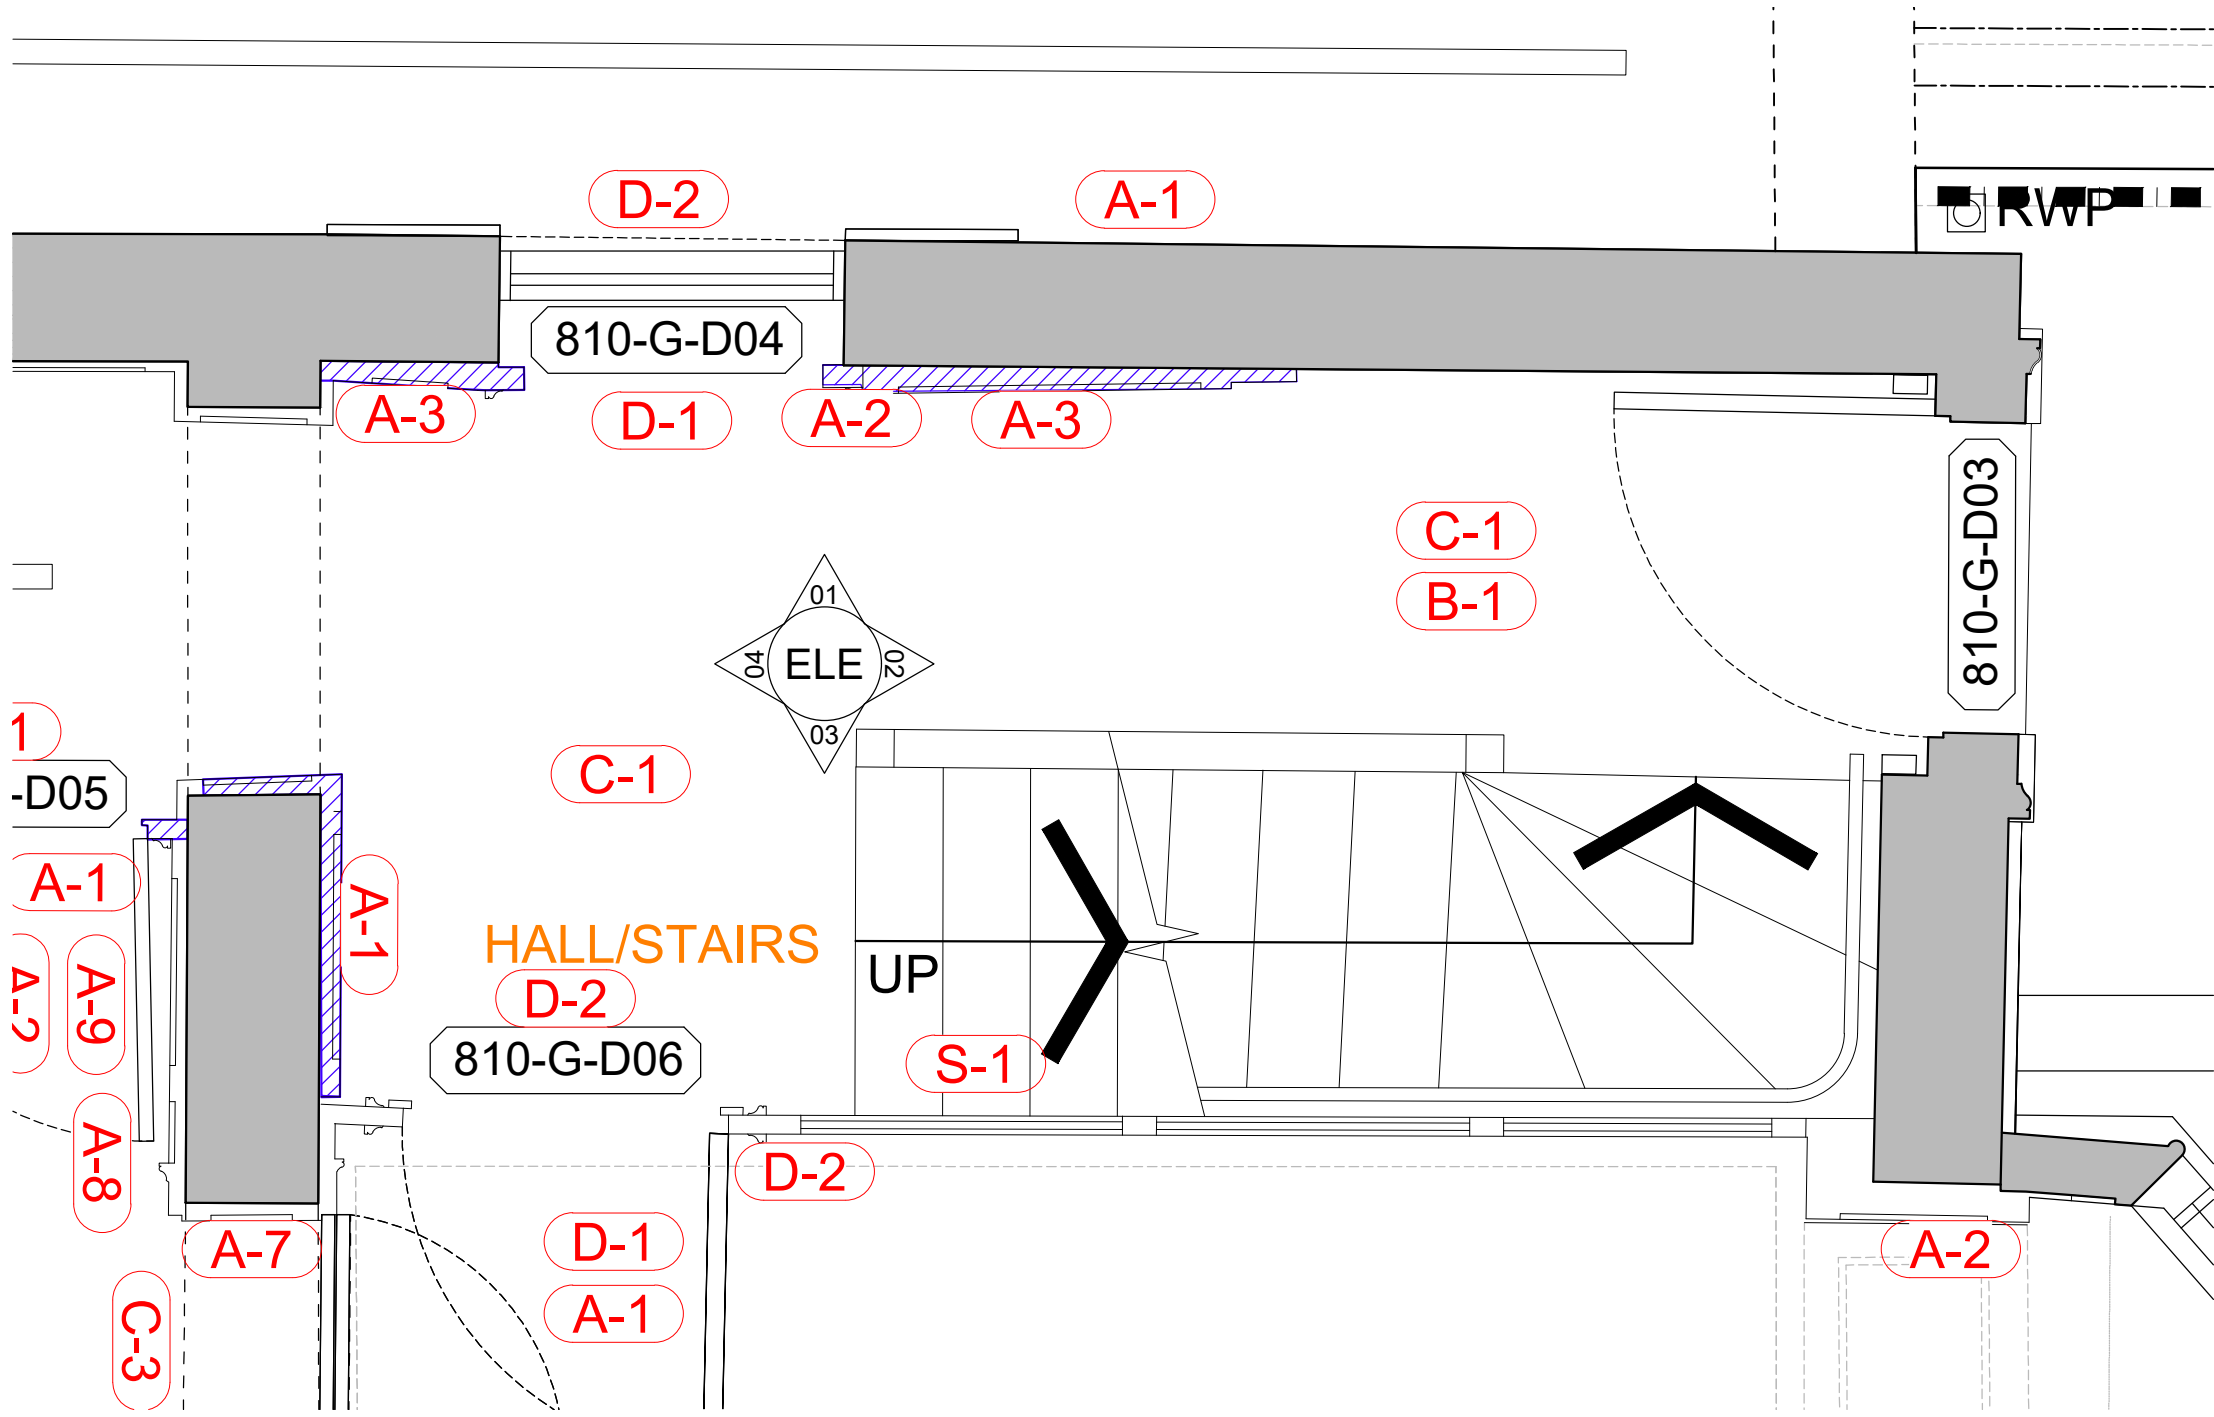
PLN  
22846  
PROPOSED GR06 GA PLAN  
Scale 1:20

- A-1:** Deformed panelling that is loose and away from wall behind- take down loose section for investigation of the structure. Carry out like-for-like conservation repair as required and reinstate panel. Reinstall moulding.

- A-2:** Paint decorations & wallpaper above panelling from C18-C20. Record & conserve the decorative schemes to retain. Board over with protective layer of plasterboard on battens. Take care not to fix through heritage papers.

- A-3:** Remove C19 over boarding and linen remnants to expose C18 panels. Scarf in missing and damaged panelling.
- A-4:** Allow for panelling upgrade/build out to GR03 side, to be agreed with Building Control.

- A-5:** New C18 style partition. To be coated with Envirograf finish to provide 60min fire rating.
- B-1:** Timber floorboards. Uneven. Rotted ends of boards adjacent to external doors to be scarfed in using existing loose boards so not to be noticeable in these most sensitive floor areas.

- C-1:** Lathes & plaster missing or loose. Retain and repair, fixing back loose areas with non-ferrous screws and washers & lime skim over.
- D-1:** Door is badly damaged & loose. Panelling is complete. Retain & Repair C18 doorway like-for-like and replace door with 2-panelled double door. Adapt opening for disabled access.

- D-2:** Door is jammed and over boarded on one side. Only original hinges. Remove fireboard, ease to open and repair like-for-like. Replace modern ironmongery with C18 design.

- S-1:** Severe water damage but lower flights have been repaired. Complete timber repairs like-for-like. Carry out temporary propping as necessary, repair & re-support failed timber bearings on upper flights in accordance with conservation Structural Engineer's advice.
