## HERITAGE STATEMENT FOR

808-812 HIGH ROAD,  
TOTTENHAM

Corrie Newell BA Arch Hons RIBA ARB IHBC

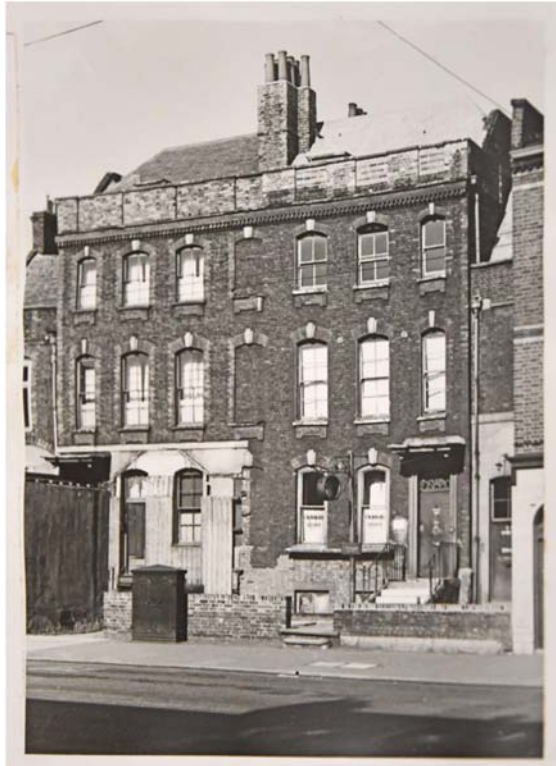
*(Left) Figure 11. Undated photograph c1950, showing extensive damage and poorly matched brick repairs on the front elevation, likely to be the result of the WW2 bombing. The Confectioner's shop has been demolished, but the poorly matched brickwork and projecting bay at ground level of 808 has not yet been rendered.*

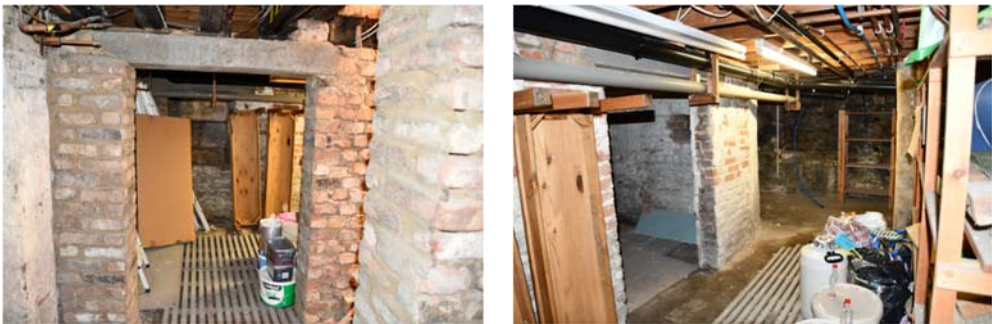
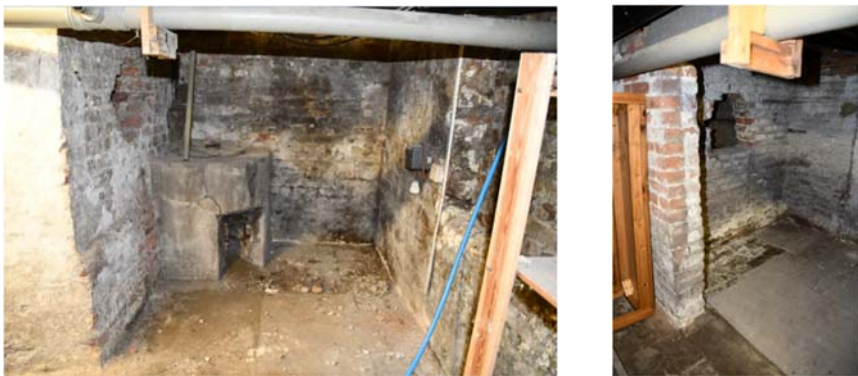
| ELEMENT | HERITAGE SIGNIFICANCE | EXISTING CONDITION | EFFECT/ IMPACT |
|---|---|---|---|
| <p><i>(left) Room BR04 viewed from stair lobby.</i><br/> <i>(right) central space with service enclosures to left and alcove below former bay window beyond.</i></p> <p><i>(left) Alcove with copper and (right) infilled opening. (right) typical service enclosure.</i></p> | | | |
| <b>Walls</b> | <p><b>Medium</b> – C18 outer walls</p> <p><b>Low</b> – C18 Enclosures with reconstructed openings</p> <p><b>Neutral</b> (circa 2000 restructure)</p> | <p>Poor condition with incomplete service enclosures.</p> <p>Exposed brick with occasional friable / missing bricks and small patches of plaster.</p> <p>Openings have been reconstructed with concrete lintels and RSJs.</p> | <p><b>Potential enhancement</b> - Investigate options to re-support the rebuilt section of ground floor and the bearings of the historic bridging beams.</p> <p><b>Repair.</b> Retain C18 brickwork and infill missing bricks with new handmade red bricks to match and stop in holes in lime mortar joints to match. Carry out lime plaster repairs to consolidate existing patches of plaster. Leave exposed as honest repair.</p> |

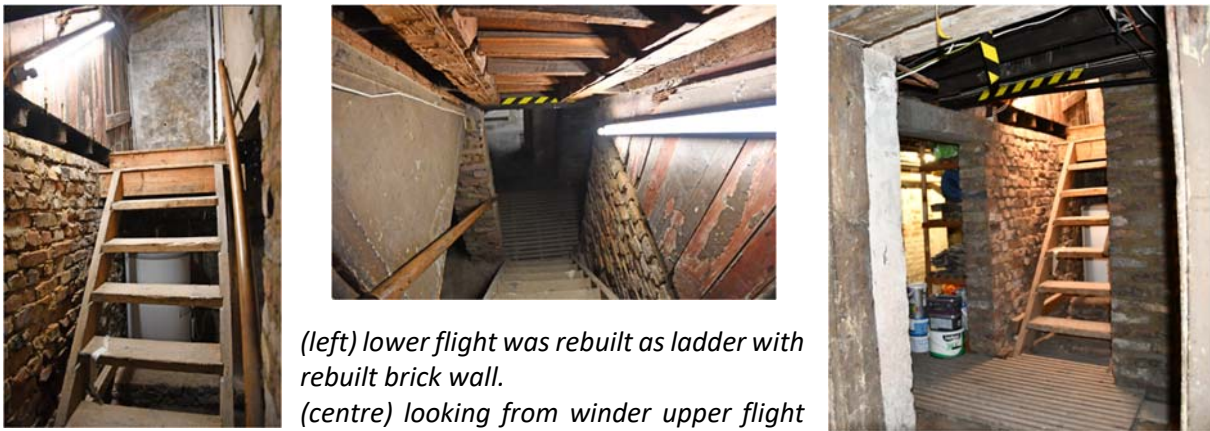
| ELEMENT | HERITAGE SIGNIFICANCE | EXISTING CONDITION | EFFECT/ IMPACT |
|---|---|---|---|
| <p>(left) lower flight was rebuilt as ladder with rebuilt brick wall.<br/> (centre) looking from winder upper flight to C21 ladder, pier and rebuilt wall.<br/> (right) looking from BR04 door opening towards rebuilt wall.</p> | | | |
| <b>Walls</b> | <b>Medium</b> – C18 at upper winder level<br><br><b>Neutral / Negative</b> – C21 in basement space | Reasonable condition for functional storage/service space. | <b>Potential enhancement</b> - Investigate options to re-support the structure without C21 brick pier. Investigate options for staircase to reinstate historic layout and proportions of space, stair and doorway.<br><b>Enhance</b> – Allow to prop as necessary and reconstruct C21 lower wall to match C18 upper timber boarded partition with doorway reduced to domestic proportions with surround and door to match template C18 boarded doors at No. 810. Allow to incorporate FR lining not visible from stair side. |

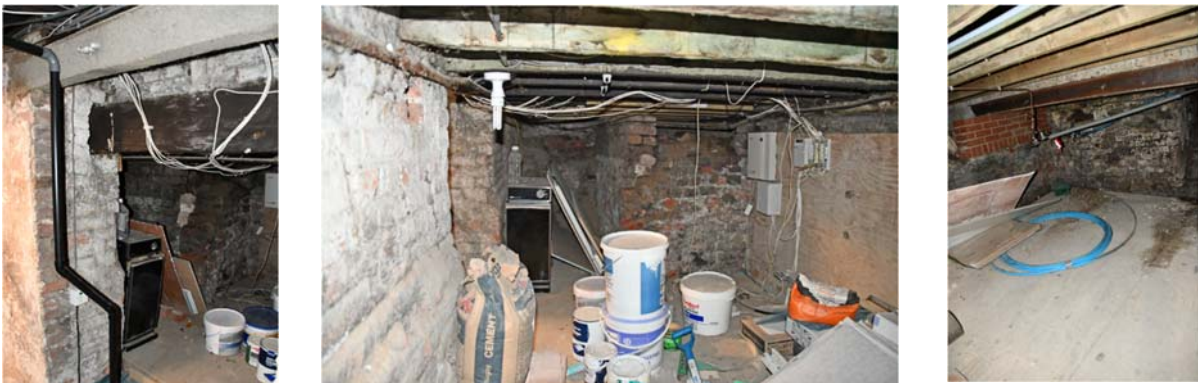
| ELEMENT | HERITAGE SIGNIFICANCE | EXISTING CONDITION | EFFECT/ IMPACT |
|---|---|---|---|
| <p>(Left) Existing viewed through opening from Stair. (Centre) towards rear of BR09) showing remains of partitions. (Right) front bay showing c.2000 stabilisation including replacement GF joists, RSJ and brick support.</p> | | | |
| <b>Walls</b> | <p><b>Medium</b> – C18 outer walls with C18/C19 enclosures (subject to access)</p> <p><b>Neutral / Negative</b> – C21 alterations and piers.</p> | <p>Reasonable condition for functional storage/service space.</p> <p>Evidence of friable bricks and poor quality cement based repairs and changes.</p> | <p><b>Potential enhancement</b> - Investigate options to increase headroom, re-support the structure without RSJs, carry out more sympathetic repairs and tidy services as part of a scheme to improve use of the basement.</p> <p><b>Enhance</b> – repair unsympathetic alterations and damage to openings and reveals (see typical photo below).</p> |

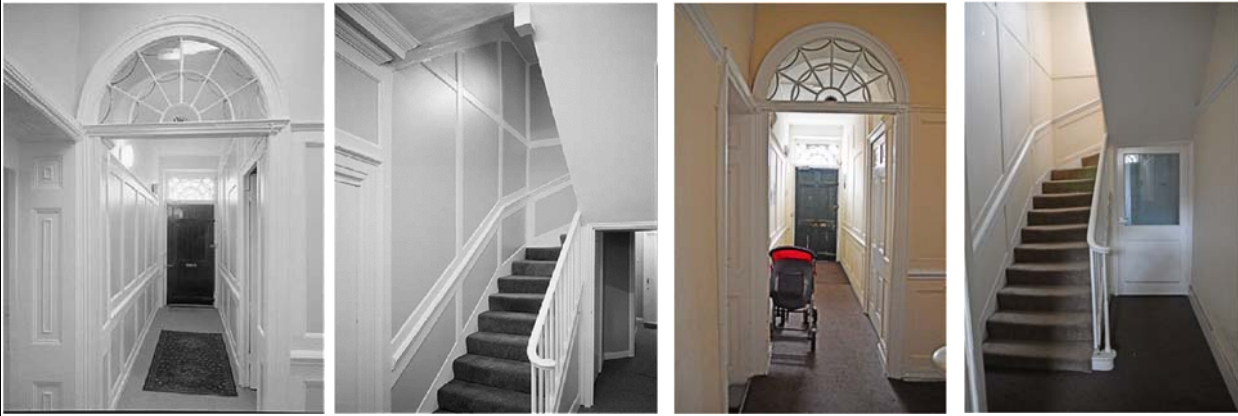
| ELEMENT | HERITAGE SIGNIFICANCE | EXISTING CONDITION | EFFECT/ IMPACT |
|---|---|---|---|
| <p><i>(Left and left centre) 1991 RCHM record photographs of entranceway and stairs.</i><br/> <i>(Right and right centre) Existing entranceway and stairs.</i></p> | | | |
| <b>Staircase</b> | <b>High</b> - C18<br><b>Medium</b> – Early C19 GF flight.<br><b>Low</b> – Basement access and C21 door | <b>Good.</b> | <b>Enhance</b> – Allow to carefully remove C21 doors and frame. Reinstall C21 stair door to Basement in single panel to match adjoining stair boarding. Remove FR door and allow to decorate staircase in Envirograf finish to provide 60 min FR. |

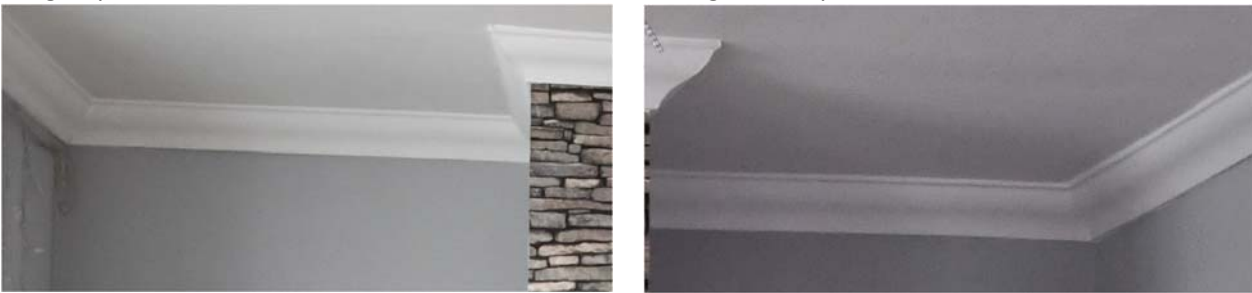
| ELEMENT | HERITAGE SIGNIFICANCE | EXISTING CONDITION | EFFECT/ IMPACT |
|---|---|---|---|
| <b>Room FR08 (808 Front Room)</b><br>Single space with C20 internal details. Firesurround missing and fireplace blocked. <div> </div> <i>Typical C20 finishes.</i> | | | |
| <b>Walls</b> | <b>High</b> -C18 likely. | <b>Good</b> | <b>Enhance</b> - Allow to reinstate painted timber skirtings to match C18 profile in No. 810. |

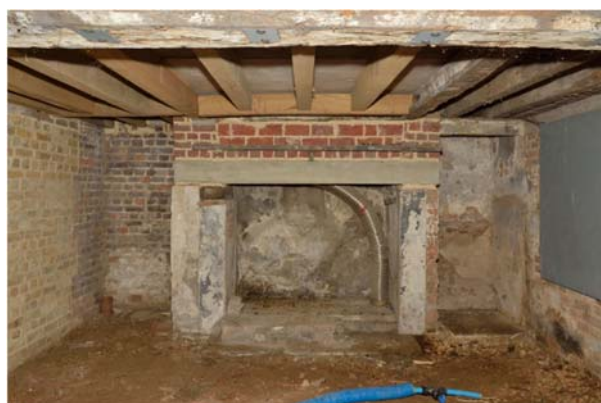
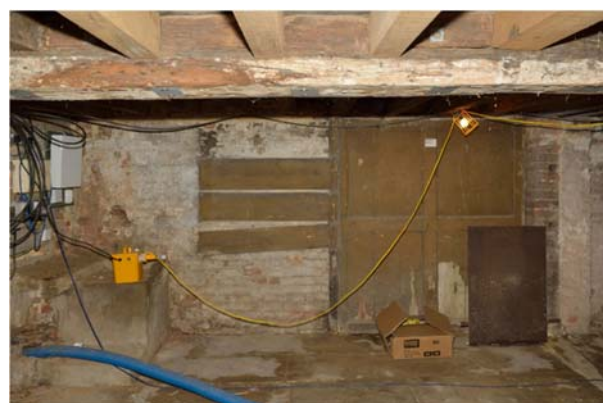
*Current photographs after stabilisation works. (Left) fireplace and blocked opening. (Right) structural repairs, open doorway, floor, boarding and electrical board.*

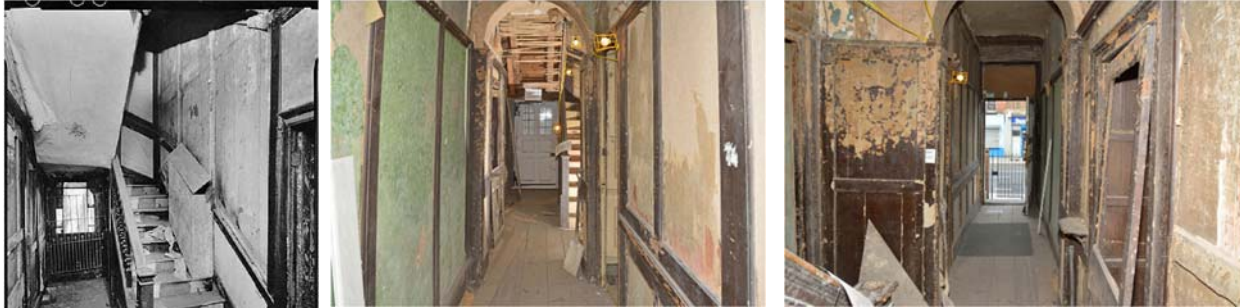
| ELEMENT | HERITAGE SIGNIFICANCE | EXISTING CONDITION | EFFECT/ IMPACT |
|---|---|---|---|
| <p>(Left-right) 1991 RCHM photograph<br/>Existing From Entrance Hall to Stairs From stairs to Entrance Hall</p> | | | |
| Staircase | High (C18) | Severe water damage but lower flights have been partly repaired. Worn treads to lower flights. Temporary boarding where the landing floorboards are missing. | Complete timber repairs like-for-like. Carry out temporary propping as necessary and repair and re-support failed timber bearings on upper flights in accordance with Conservation Structural Engineer's advice. |

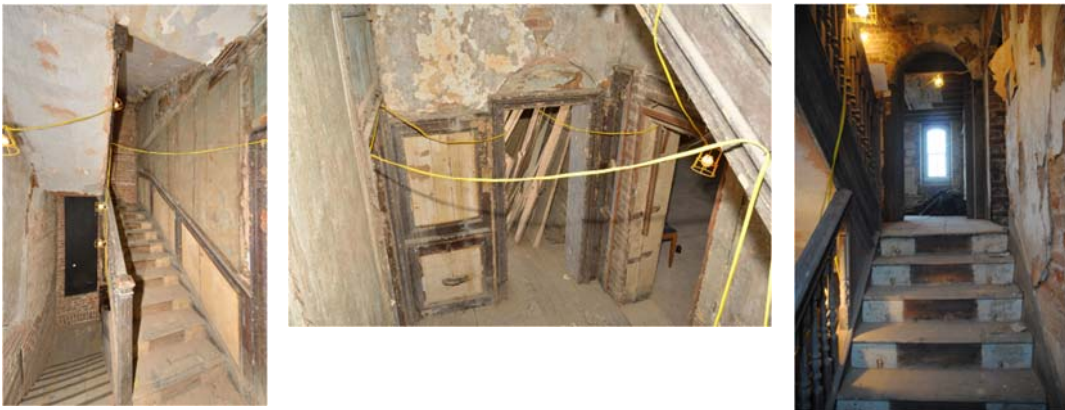
| ELEMENT | HERITAGE SIGNIFICANCE | EXISTING CONDITION | EFFECT/ IMPACT |
|---|---|---|---|
| Staircase | High (C18) | Severe water damage to stair and stair partition. Stair & partition have dropped. One baluster missing. Boarding to landing rotted, one tread previously replaced in chipboard, nosings are worn. Panelling & dado are fragmentary. | Retain - complete timber repairs like-for-like. Carry out temporary propping as necessary and repair and re-support failed timber bearings on upper flights in accordance with Conservation Structural Engineer's advice. Scarf in 4 nosings and replace missing baluster like-for-like. Replace timber boards to landing and tread like-for-like. Reinstate missing sections of panelling, dado and handrail like-for-like to complete this high significance space. Low impact - Upgrade stair and enclosure to Fire Officer requirements using Envirograf fire resistant finishes. |

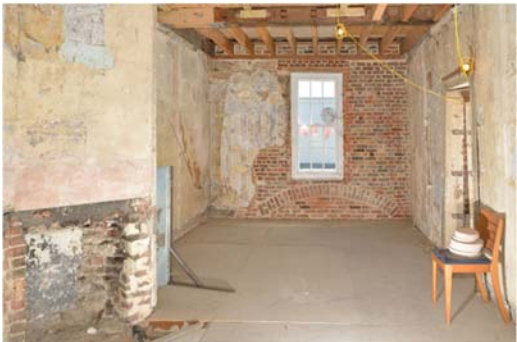
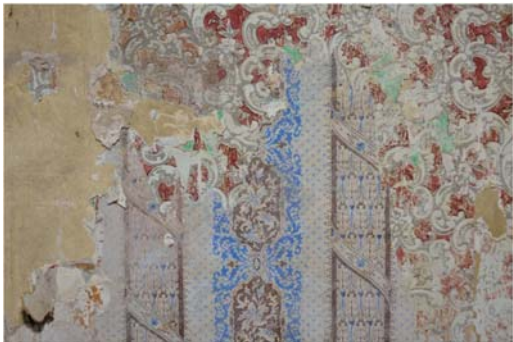
| ELEMENT | HERITAGE SIGNIFICANCE | EXISTING CONDITION | EFFECT/ IMPACT |
|---|---|---|---|
| Room 01-E-02 / FR04 (812 Coach House wing) <div> </div> <div> <i>Looking from front to rear</i> <i>Wallpaper fragments to be analysed and protected</i> </div> | | | |
| Walls | Medium (Altered) | Fragmentary finishes, mainly C19 and exposed C18 brickwork. Missing central partition and skirtings. Exposed structural strapping. Fragments of historic wallpaper. | Retain and repair exposed finishes to show the fabric, textures and evolution of this service area. Carry out conservator repairs to protect historic wallpaper.<br>Enhance – Reinstatement central partition to complete fireplace wall. Reinstatement missing sections of panelling to western end of room like-for-like where previous outline can be seen. Reinstatement skirtings to match.<br>Moderate impact – Install toilet enclosures within original rear room (the most altered room), with fixtures on new partitioning to preserve historic finishes. |

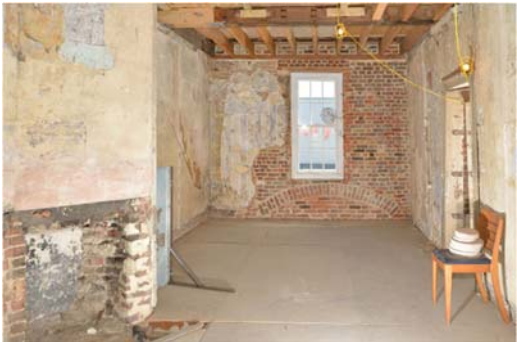
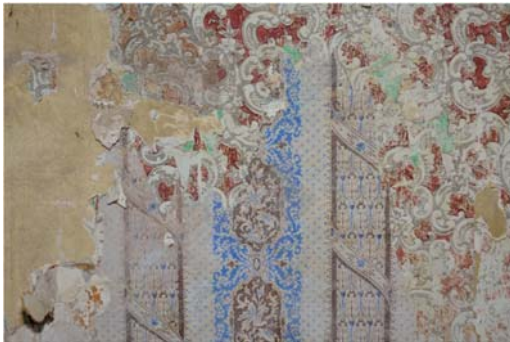
| ELEMENT | HERITAGE SIGNIFICANCE | EXISTING CONDITION | EFFECT/ IMPACT |
|---|---|---|---|
| <div> <div> Room 01-E-02 / FR04 (812 Coach House wing) <p><i>Looking from front to rear</i></p> </div> <div> <p><i>Wallpaper fragments to be analysed and protected</i></p> </div> </div> | | | |
| Walls | Medium (Altered) | Fragmentary finishes, mainly C19 and exposed C18 brickwork. Missing central partition and skirtings. Exposed structural strapping. Fragments of historic wallpaper. | Retain and repair exposed finishes to show the fabric, textures and evolution of this service area. Carry out conservator repairs to protect historic wallpaper.<br>Enhance – Reinstall central partition to complete fireplace wall. Reinstall missing sections of panelling to western end of room like-for-like where previous outline can be seen. Reinstall skirtings to match.<br>Moderate impact – Install toilet enclosures within original rear room (the most altered room), with fixtures on new partitioning to preserve historic finishes. |

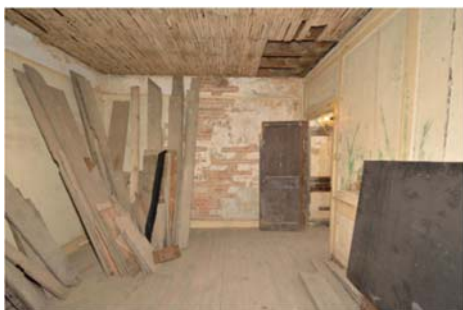
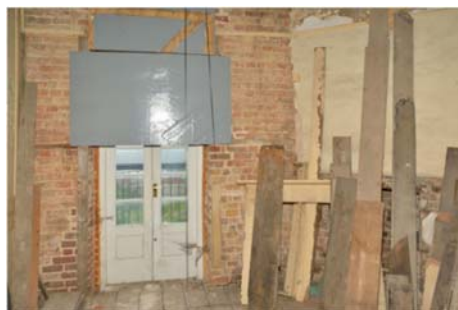
| Walls | High (C18) and Medium (C19 Altered) | Variable condition. Stair partition (as above) cracked. External (East) wall water damaged and missing plaster. Brickwork stitched and partly rebuilt around door opening. | Retain and repair panelling like-for-like. Plaster external wall and make good missing patches of plaster on masonry walls, like-for-like in lime plaster. |

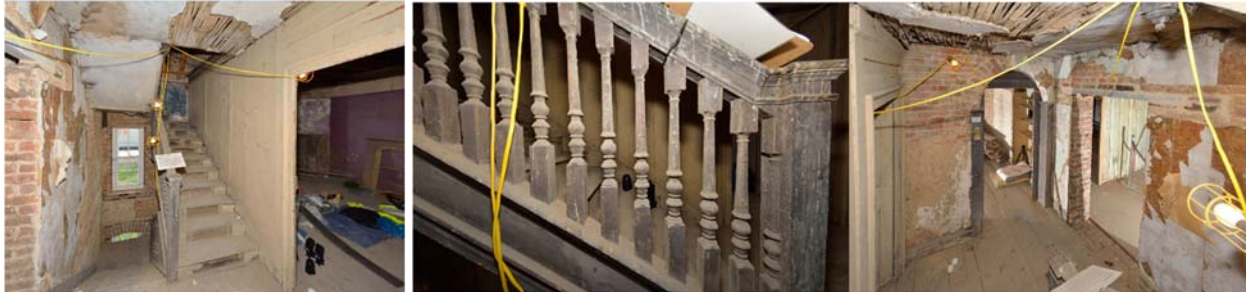
| ELEMENT | HERITAGE SIGNIFICANCE | EXISTING CONDITION | EFFECT/ IMPACT |
|---|---|---|---|
| Staircase | High (C18) | Severe water damage. Staircase and supporting partition have dropped significantly. Stair treads in poor condition at bottom of flight. | Complete timber repairs like-for-like.<br>Carry out temporary propping as necessary and repair and re-support failed timber bearings in accordance with Conservation Structural Engineer's advice.<br>Allow to replace 5 treads and risers like-for-like.<br>Low impact - Upgrade stair and enclosure to Fire Officer requirements using Envirograf fire resistant finishes. |

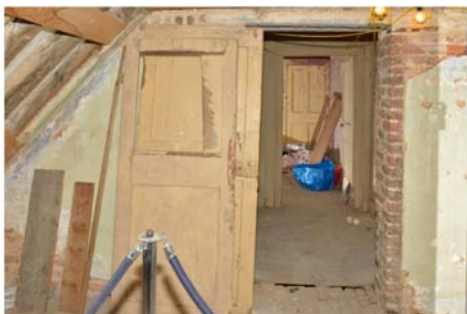
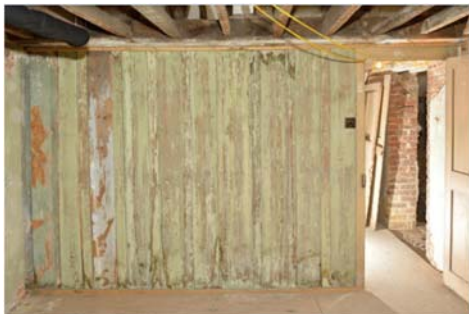
| ELEMENT | HERITAGE SIGNIFICANCE | EXISTING CONDITION | EFFECT/ IMPACT |
|---|---|---|---|
| Room 02-E-02 / SR05 (812 Coach House wing) <div> </div> <p><i>Rear of space looking towards landing    front of space looking towards late C19 central partition</i></p> | | | |
| Walls | Medium (C18 altered) C19 timber board centre partition. | Plaster missing on gable and around doorway. Partition fair. | Retain and repair like-for-like exposed and painted brick finish and boarding.<br><b>Moderate/Low</b> – remove central partition to open up the internal space. |

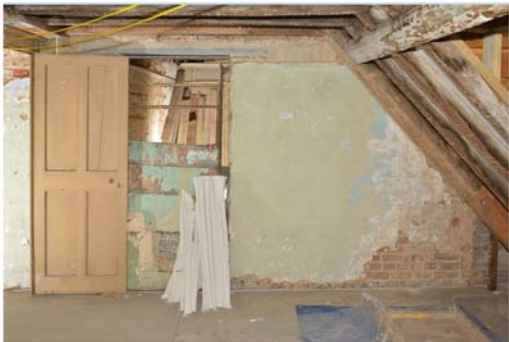
| ELEMENT | HERITAGE SIGNIFICANCE | EXISTING CONDITION | EFFECT/ IMPACT |
|---|---|---|---|
| Room 02-E-03 / SR02 (812 rear room)<br><br>Looking towards infilled opening (C19 wallpaper) | | | |
| Walls | Medium (Altered C18)<br>C19 timber board central partition. | Plaster missing on gable and around doorway. Partition fair. | Retain and repair like-for-like exposed and painted brick finish and boarding. |

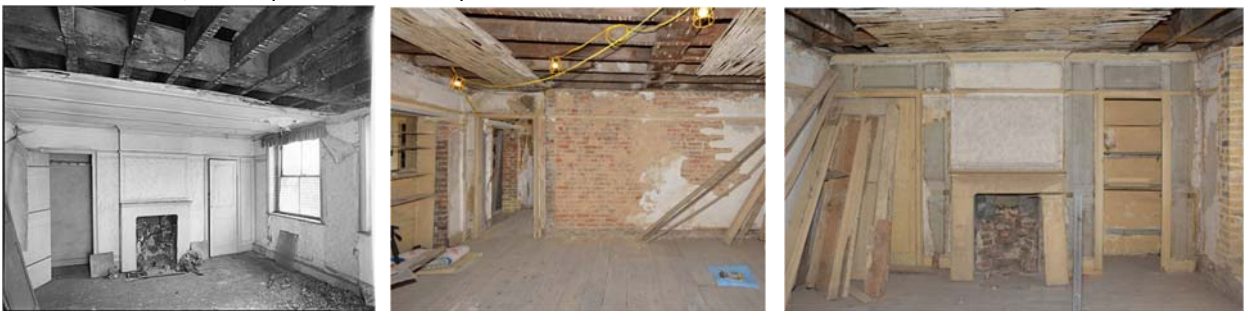
| ELEMENT | HERITAGE SIGNIFICANCE | EXISTING CONDITION | EFFECT/ IMPACT |
|---|---|---|---|
| <p>(Left) 1991 RCHM record photograph showing panelling hidden behind former C19 decorative scheme (centre &amp; right) Existing after previous structural works completed. Graffiti on the panelling.</p> | | | |
| Walls | Medium (Altered C18 and C21)<br>High/Medium (C19 pencil graffiti previously behind hessian) | Plaster missing on most walls. Recent structural stitching on East & West walls. Partial water damaged panelling and cupboards on fireplace wall. | Retain and repair like-for-like exposed and painted brick finish and boarding. Provide like-for-like skirting board to the three walls where missing.<br>(Cupboards see below)<br>Retain and protect graffiti so it remains visible. Scheme to be agreed subject to specialist advice. |

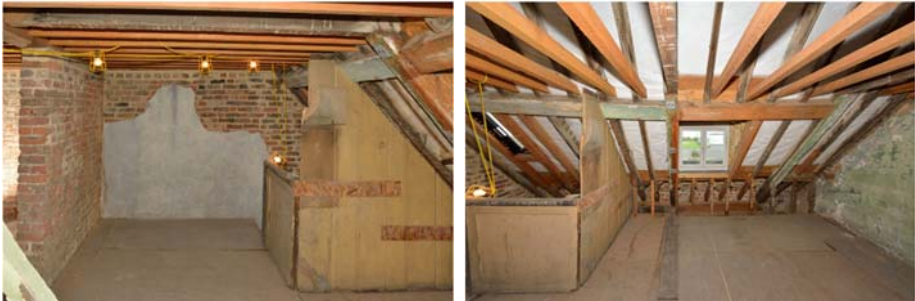
| Third Floor | | | |
|---|---|---|---|
| <p><i>Looking towards stair and fragment of boarded partition.</i><br/> <i>The structural works of c2007-9 including ceiling and dormer are unpainted.</i></p> | | | |
| Staircase and balustrade | Medium (C18 partial) | Missing handrail and dado. | Retain - complete timber repairs including reinstatement of handrail and dado like-for-like. Upgrade stair and enclosure to Fire Officer requirements using Envirograf fire resistant finishes. |
