**ARBORICULTURAL IMPACT ASSESSMENT REPORT FOR:**

44 & 46 Hampstead Lane  
London  
N6 4LL

**Ref:** HVL/44HSL/AIA/01c

**Date:** 29<sup>th</sup> July 2022

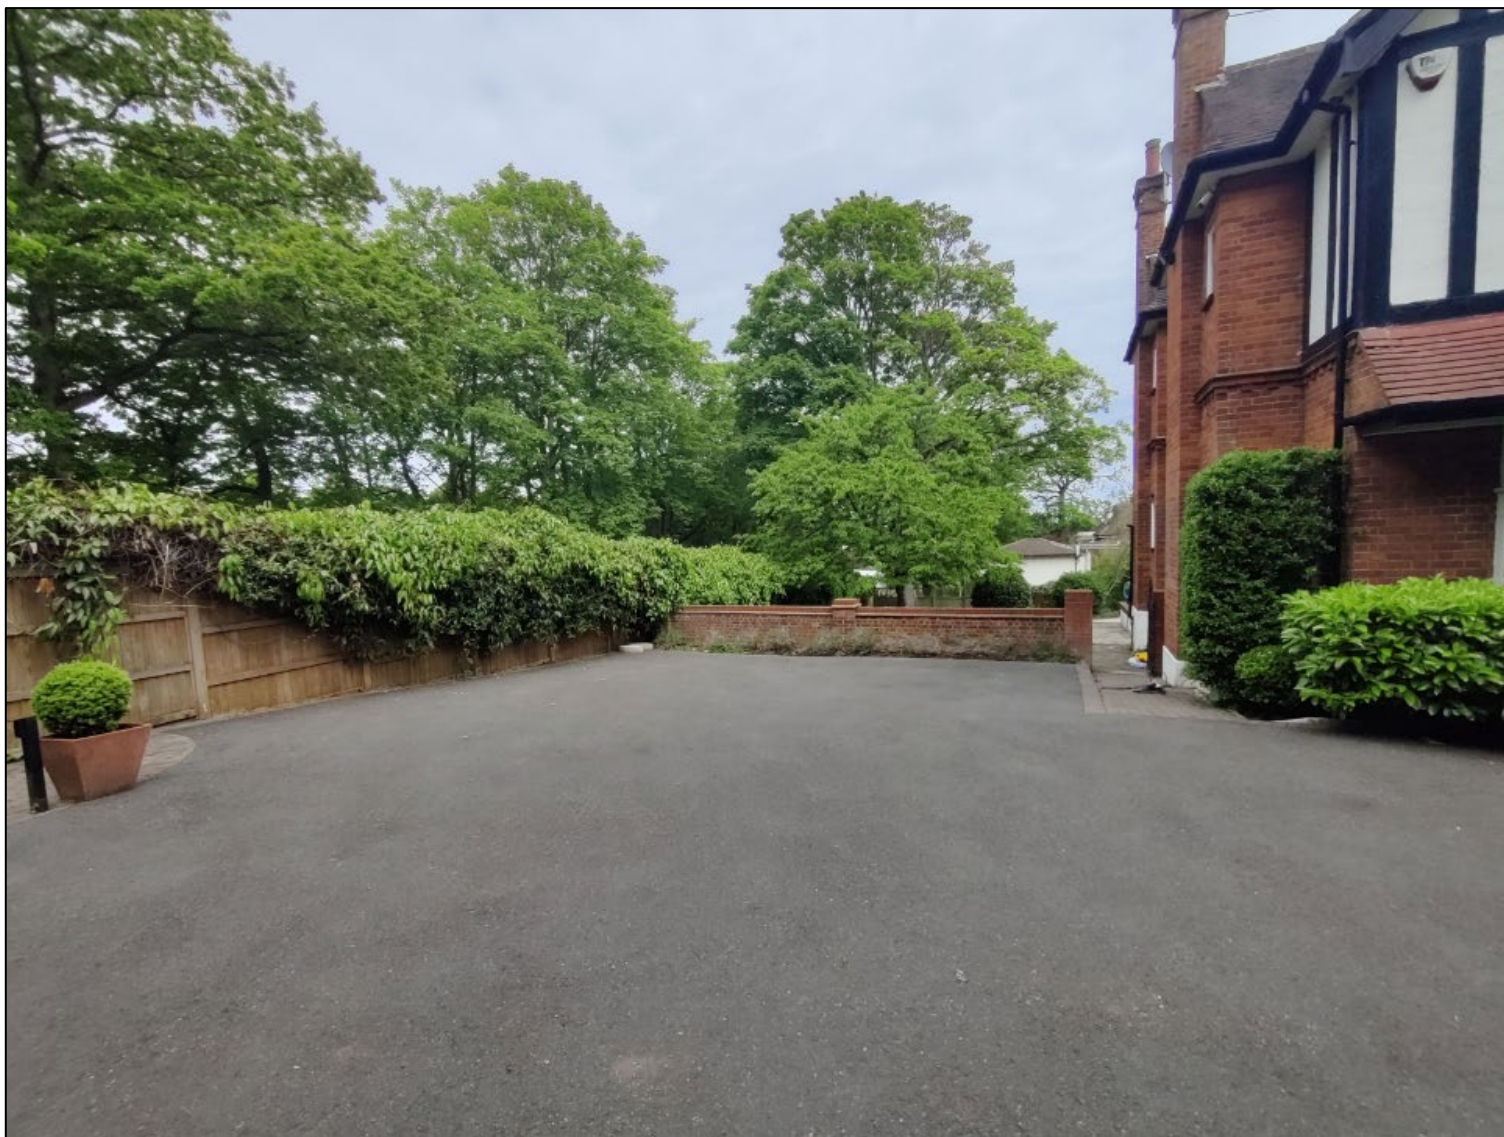
Photograph 2: Existing hard standing within site

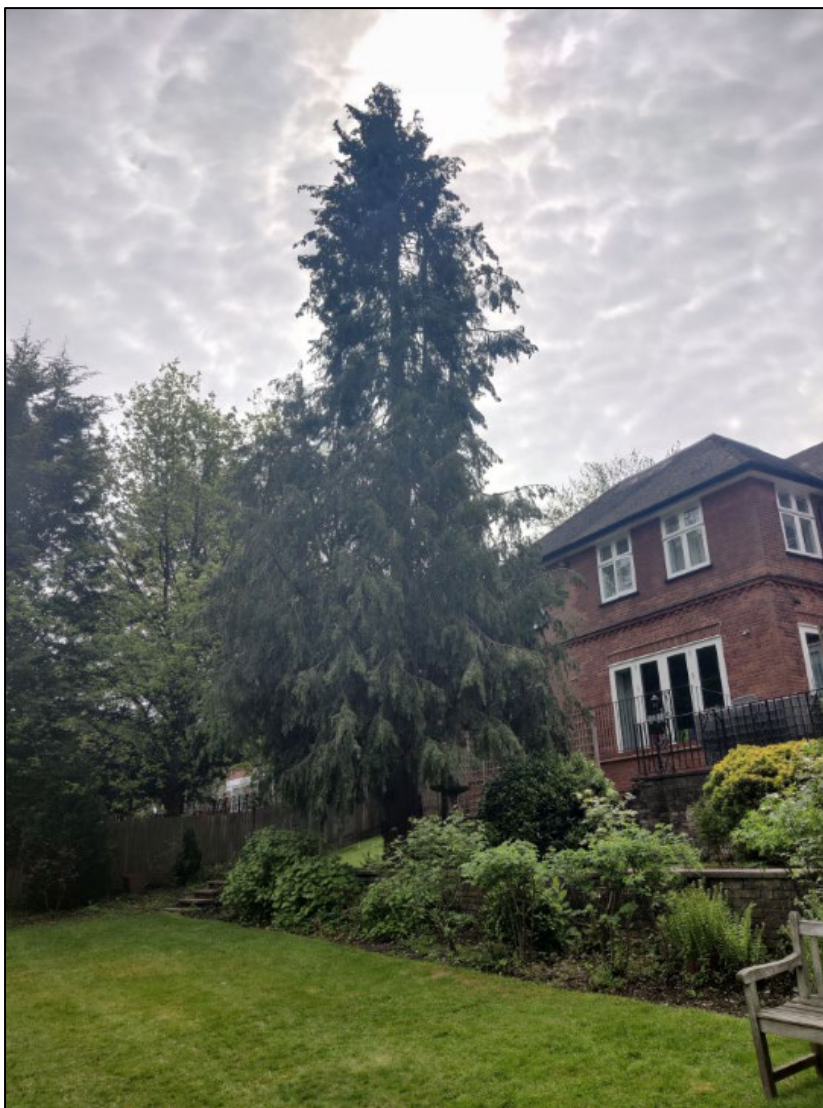
Photograph 3: Cypress T33

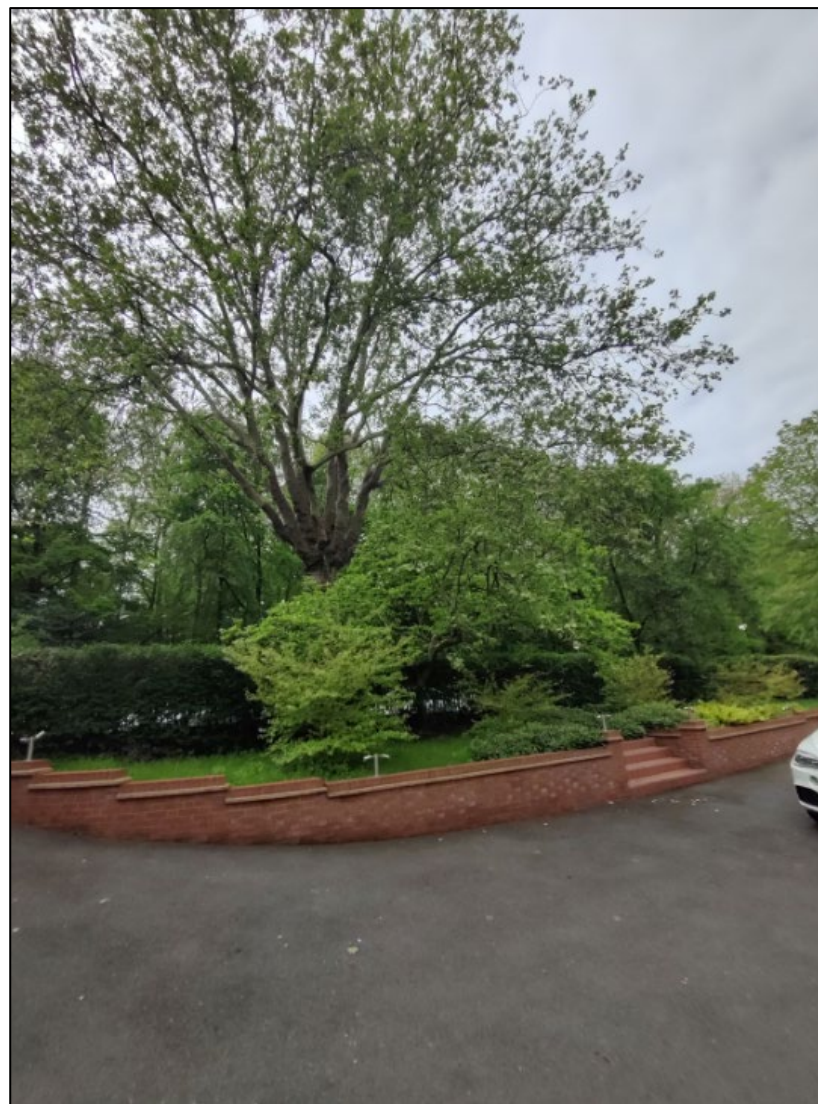
Photograph 4: Magnolia T28 with London plane T27 to rear, note level change from street
