2.0 | The Site

2.4 | Dyne House Site Photographs

2.0 | The Site  
2.6 | Dyne House Building Exterior

### 2.7 | Dyne House Building Interior

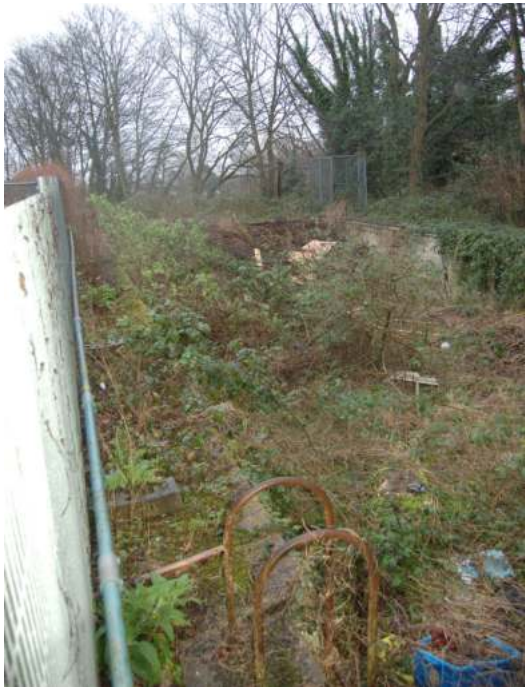
2. The redundant open air swimming pool

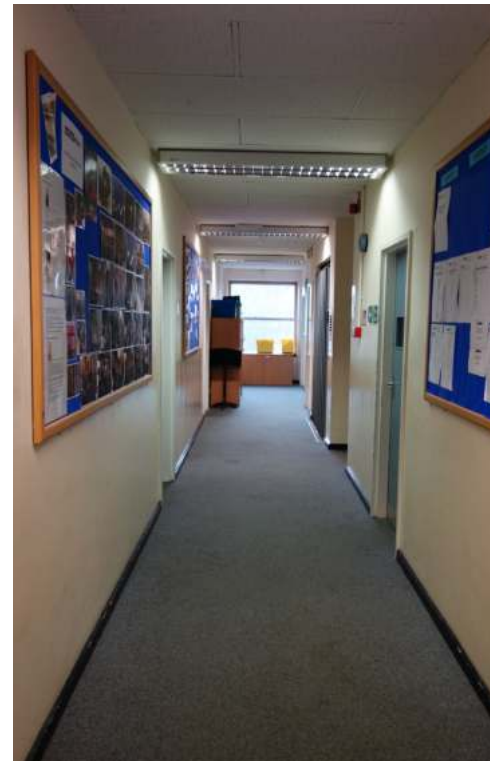
- The Auditorium at the rear of Dyne House is in good condition. Access to it is, however, poor and requires improvement within the new scheme.
- The corridors on each floor are relatively long, are uninviting and daylight only comes from a window at one end.

Narrow, long corridors

Most of the above problems can be resolved by a major refurbishment and remodelling of the building and radical changes to the circulation.

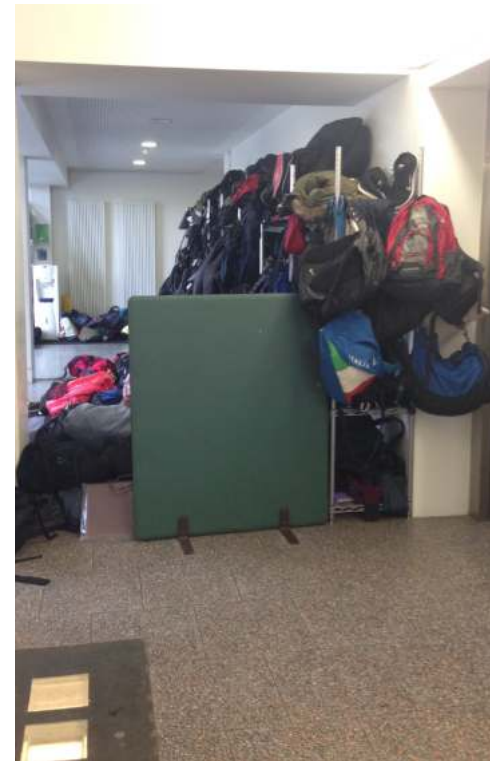
Lack of general storage

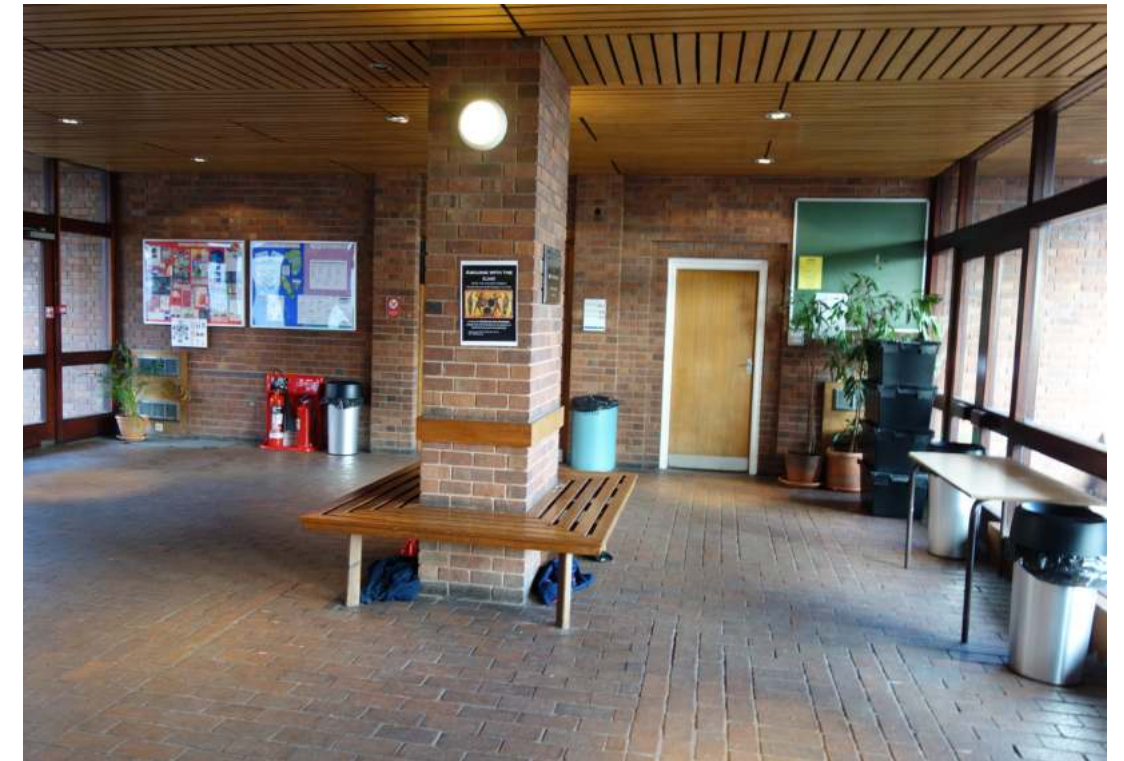
- The tunnel, under Southwood Lane deals unsatisfactorily with the changes of levels.
- The ground floor was designed for use as a large entry area/ reception to the building. Security requirements and changes in educational use have resulted in this having become a large indoor pupil amenity space/horizontal circulation area. The space is too small for the former and too wide for the latter giving a totally unsatisfactory dual use.

Uninviting dual use entrance foyer

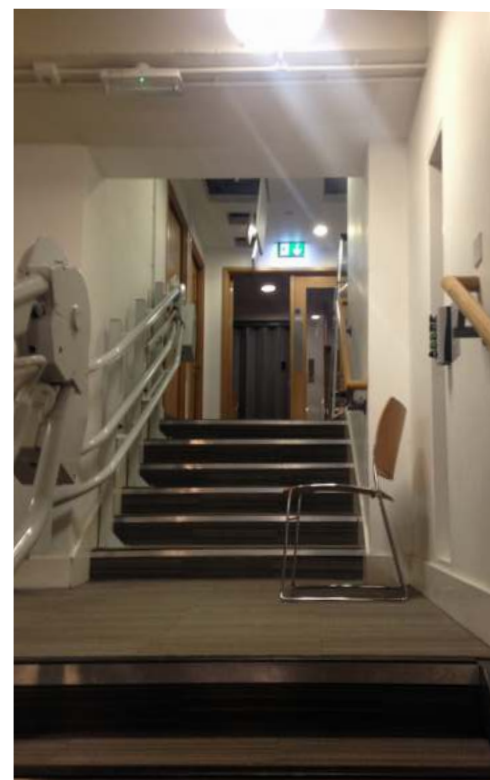
Restricted access to the Auditorium

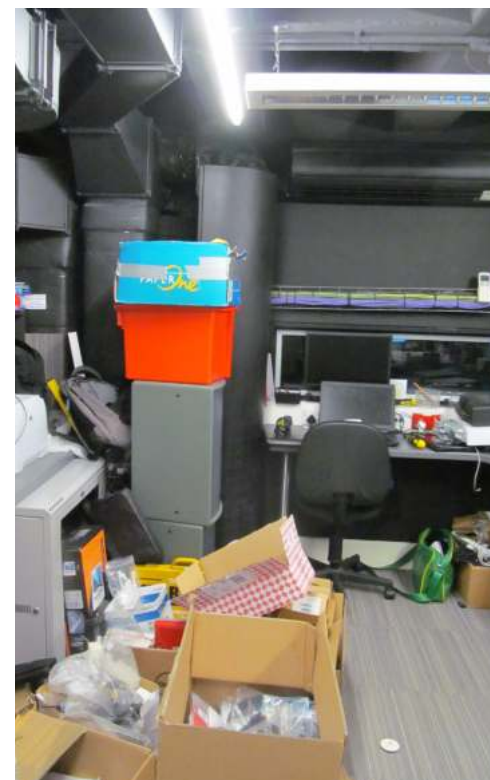
Inappropriate support facilities

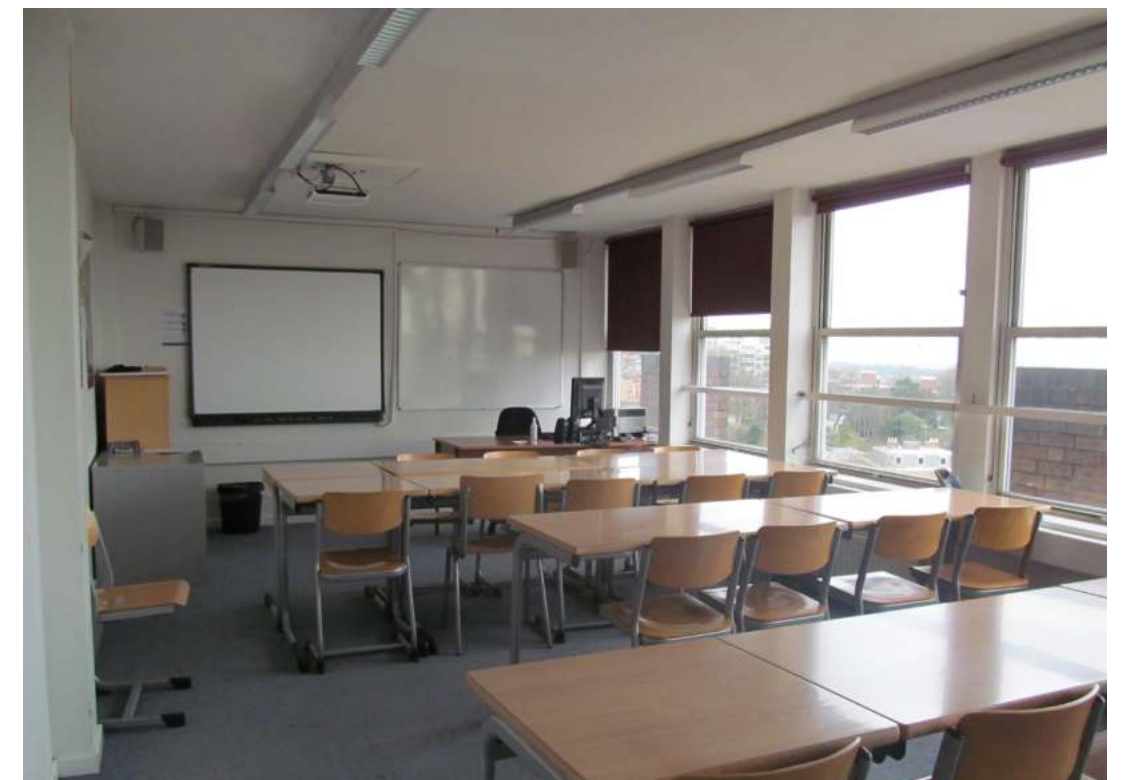
- The large proportions of the rooms and high ceilings are not conducive to modern educational requirements.
- The building gives the character, both internally and externally, of a dated 1960's building and does not provide the inviting, stimulating and uplifting educational experience that is required by the School.

Cluttered classrooms that are out of date with current educational requirements.
