## Omega Works A FRA and SUDS Strategy

Issue P02

| Report Number: | OMA-EOC-RP-001 |

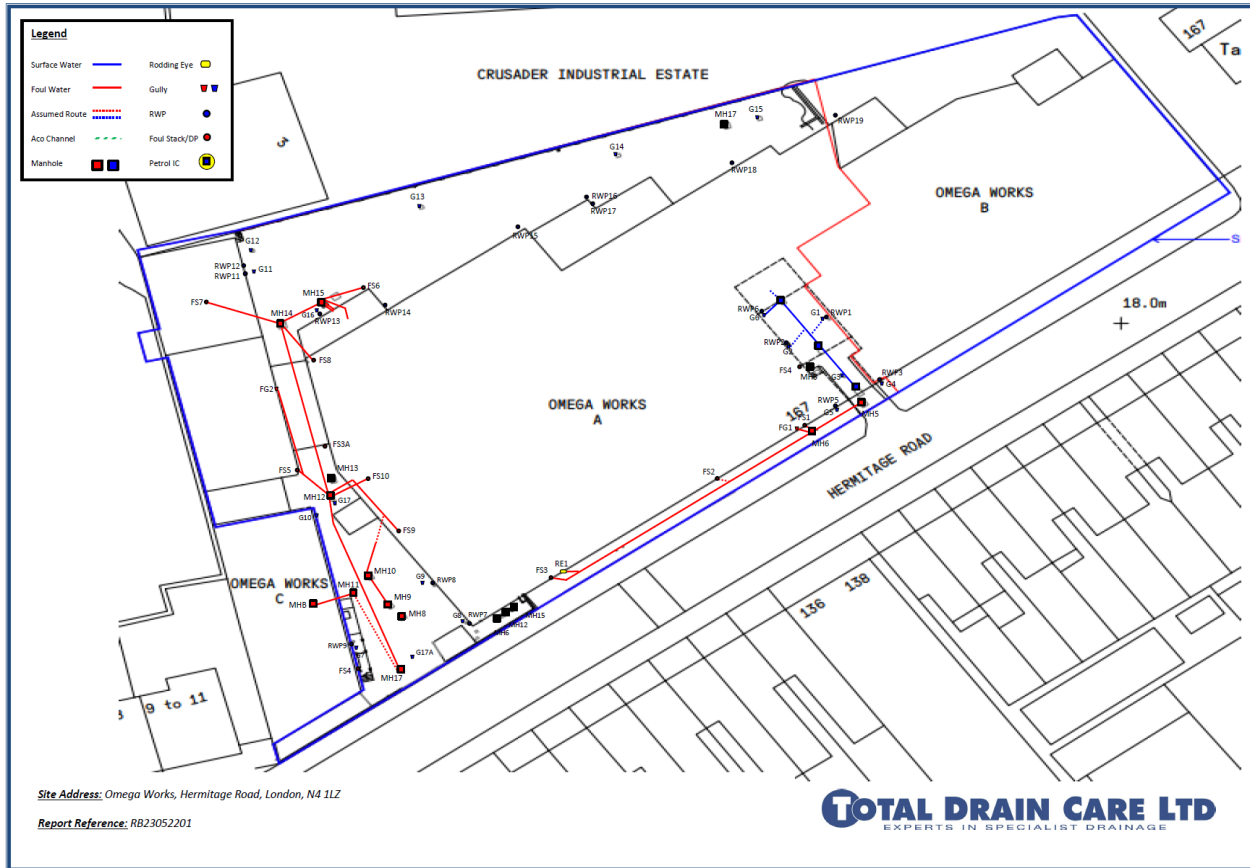
Figure 3 Below Ground Drainage Survey

A CCTV survey has been completed and indicates that the current drainage system is a gravity fed combined system, connecting into the sewer on Hermitage Road between Omega Works A and Omega Works B sites and a connection at the southwest of the site. There appears to be no connection from the site to the surface water sewer at the north of the site.

EOC have consulted Thames Water regarding the existing surface water sewer running across the site and their preference is to divert the sewer around the proposed building, rather than retaining it and applying for a build-over agreement. Due to the location of the existing manholes, a build-over agreement will be required for one building and the sewer will be diverted around another. Refer to Appendix 1 for the proposed surface water strategy layout drawing, indicating the proposed diversion.
