**Client:** A2 Site Investigation  
**Project:** Harringay Warehouse District, London  
**Date:** 14/10/2022

## Appendix D: Site Walkover Records

# A-squared Studio Site Walkover Record Sheet

**Site Name:** Harringey Warehouse District  
**Project number:** 24822  
**Date:** 18/10/2022  
**Surveyor (name):** Katy Gant

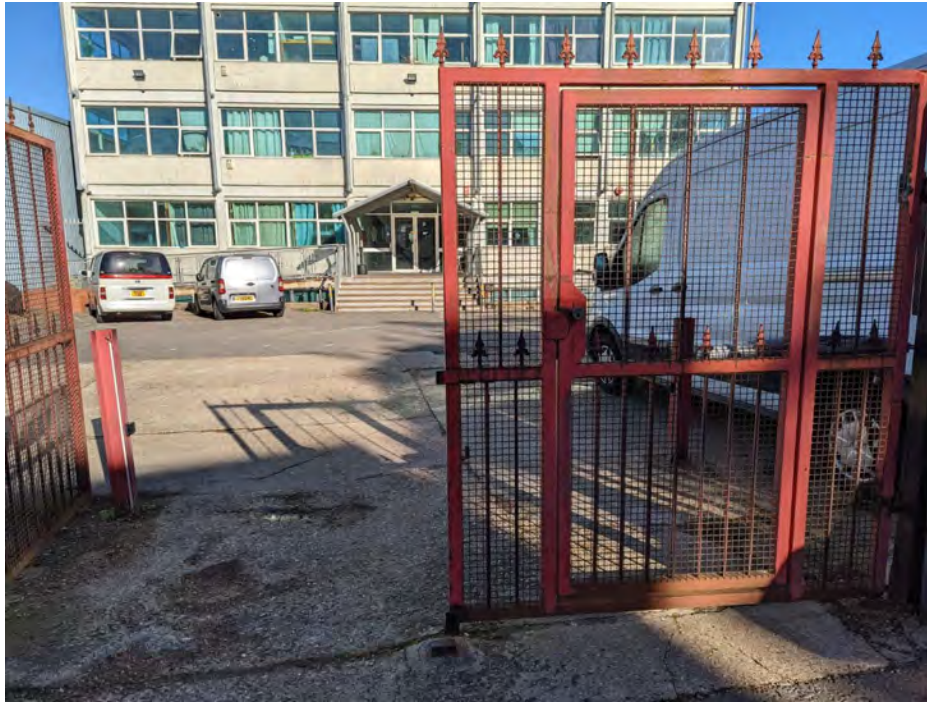
**Image 1:** Main site entrance to the south of the site. Opposite Cara House.

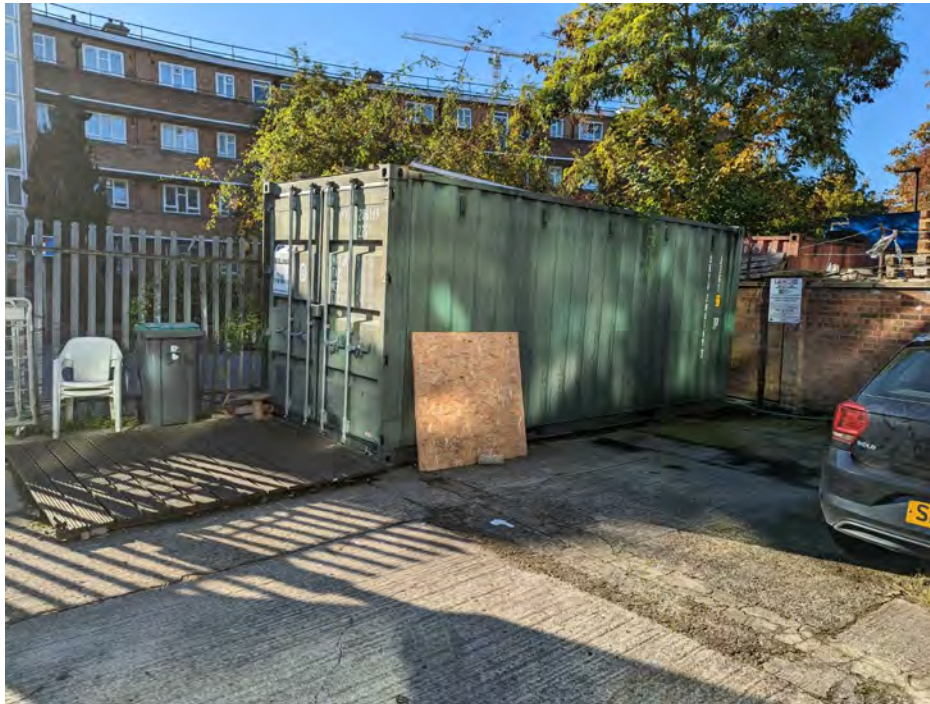
**Image 2:** Carparking area with a lockable storage container in the southern portion of the site.

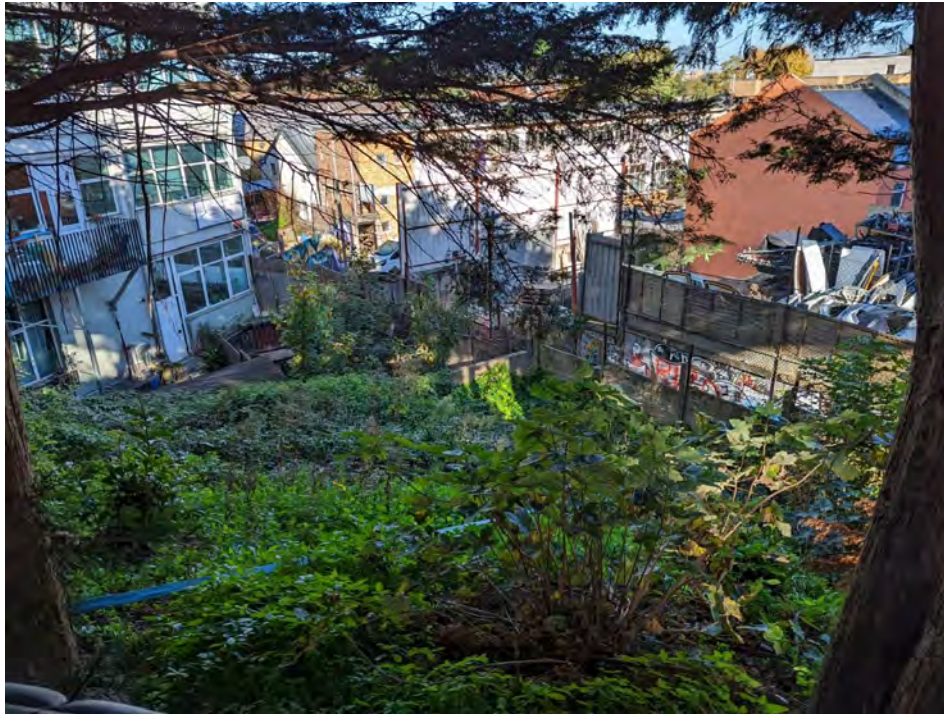
**Image 3:** Steep sloped vegetated area in the eastern portion of the site. Passage way between Tewksbury Road and Seven Sisters Road and part of the Breakers Yard visible to the right.

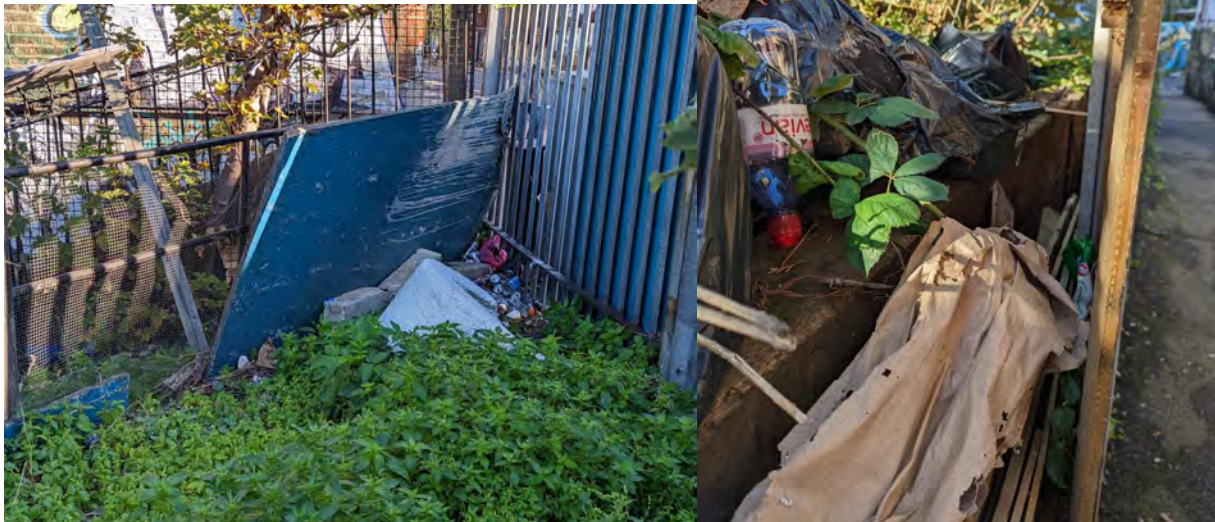
**Image 4:** Example of stockpiled materials and waste/litter scattered around the site.

| <b>Current Site Features</b><br><i>(or evidence of similar historical features)</i> | <b>Walkover Comments and Photograph References</b> |
|---|---|
| Stockpiled materials | Small stockpile of concrete cores behind bike store in NE corner of the carpark. Small stockpile of breeze blocks/ concrete blocks, old table and litter at eastern extent of site. |

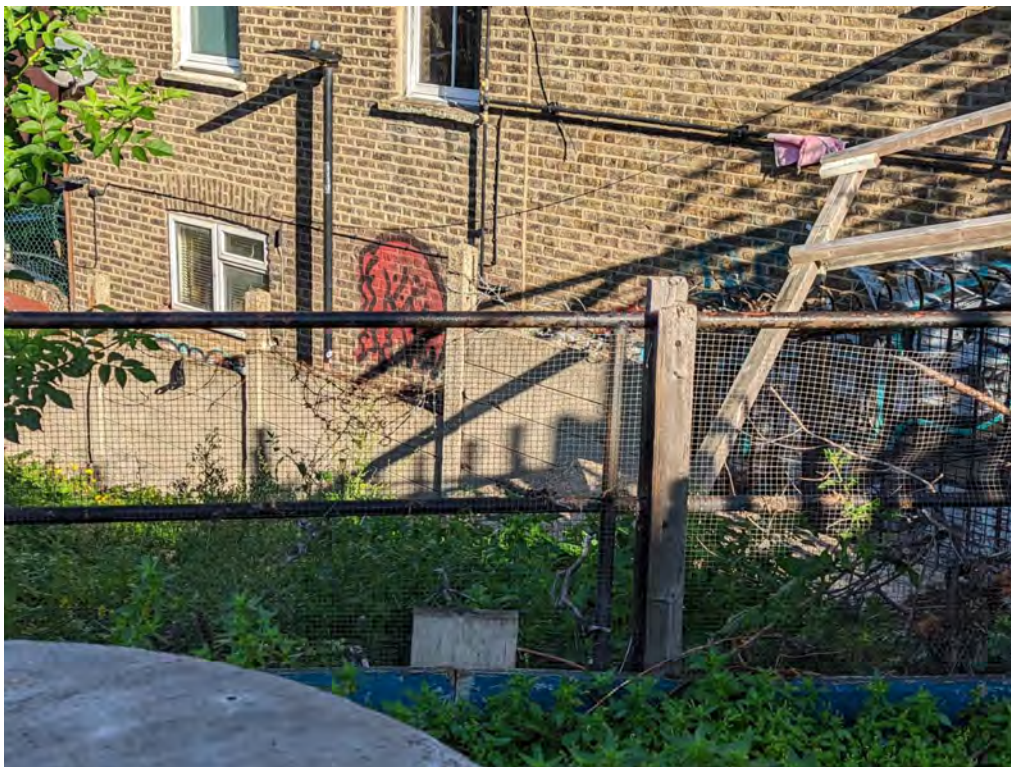
**Image 5:** Area adjacent to the passage way between Tewksbury Road and Seven Sisters Road.

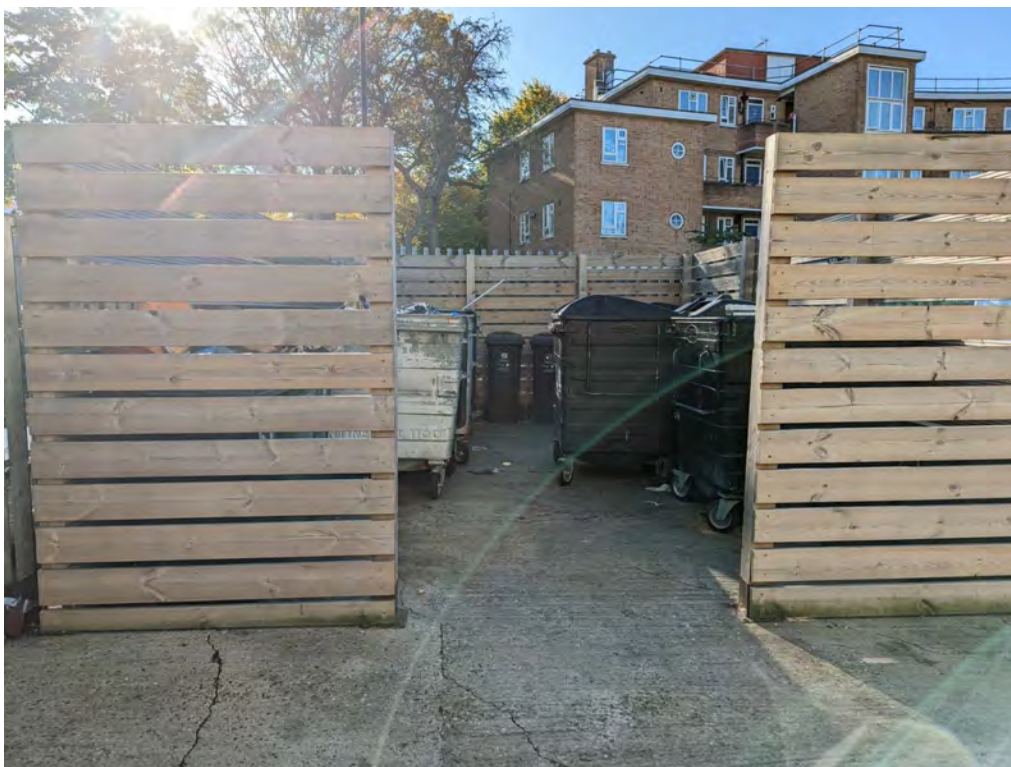
**Image 6:** Bin storage area.

| <b>Current Site Features</b><br><i>(or evidence of similar historical features)</i> | <b>Walkover Comments and Photograph References</b> |
|---|---|
| Evidence of poor housekeeping | Substantial orange staining on concrete under bins in bin store. Two gas cylinders stored upwrite but incorrectly e.g. not secured/caged. Staining on road and visual confirmation from owner/representative of oil (possibly motor) being poured into drain from non-specified motor garage on Tewksbury Rd. Moderate quantities of litter surrounding fish and chips van and seating/standing area. litter extends north into vegetated area. Courtyard area appears generally "cluttered" but nothing of substantial impact to the environment or ground condition. |

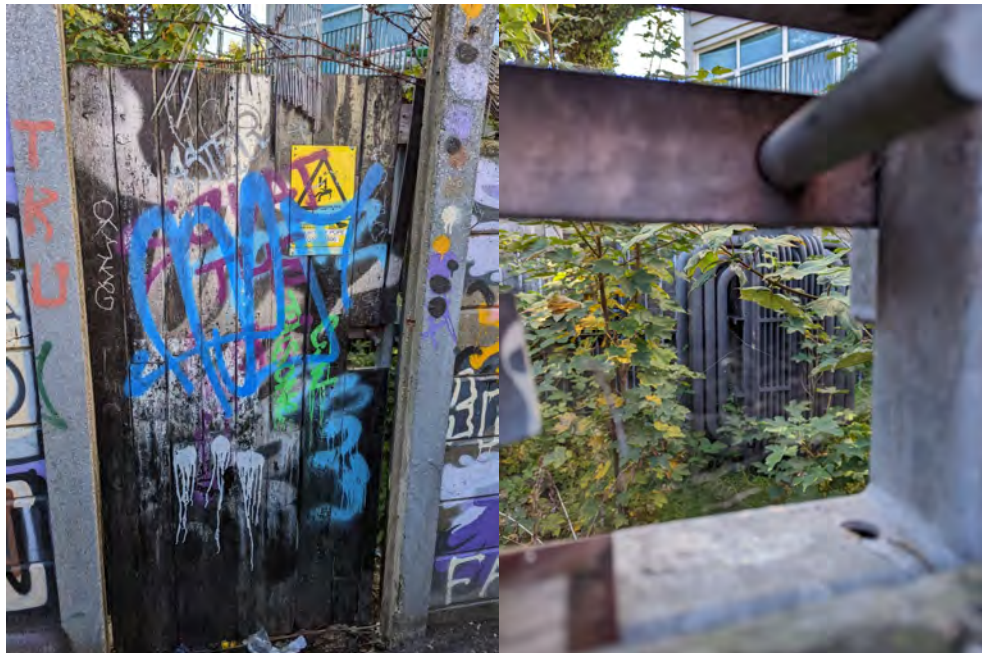
**Image 7:** Electricity Substation entrance with warning sign obscure by graffiti and the view from the back.

| <b>Current Site Features</b><br><i>(or evidence of similar historical features)</i> | <b>Walkover Comments and Photograph References</b> |
|---|---|
| Electrical substations / transformers | 1 no. at base of vegetated verge with central site location. Warning sign is visible on door to substation but partially covered with graffiti. Area is bound by wooden fence and appears overgrown. |

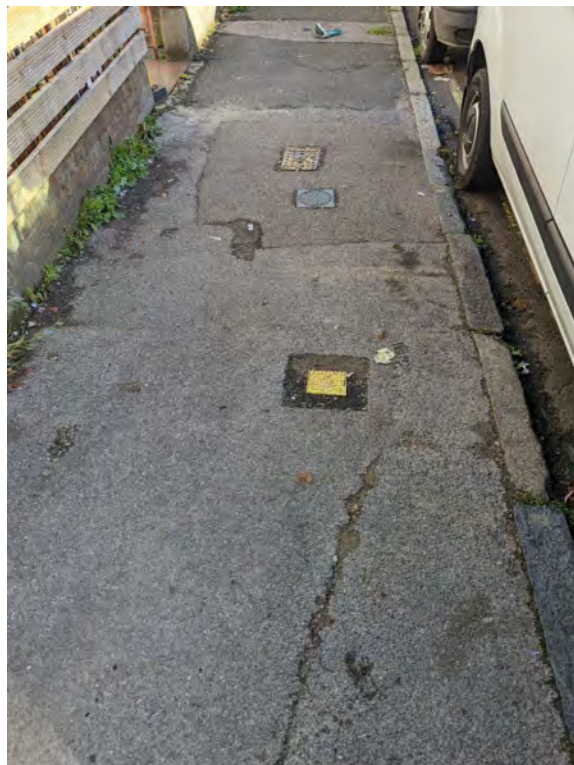
**Image 8:** Thames Water monitoring wells located on site at the end of Tewksbury Road.

| <b>Current Site Features</b><br><i>(or evidence of similar historical features)</i> | <b>Walkover Comments and Photograph References</b> |
|---|---|
| Existing monitoring wells (locations, serviceability, reference IDs) | <p>3 no. Thames water monitoring wells at the end of Tewksbury road.<br/> 2 no. (at least) manholes in NW courtyard.<br/> 1 no. Thames water manhole at entrance to NW courtyard.<br/> 1 no. drain on the side of the road at the end of Tewksbury road.<br/> 1 no. gas monitoring well on the path at the end of Tewksbury road.<br/> 1 no. manhole in centre of Cara House carpark.<br/> 1 no. drain close to NW carpark perimeter wall</p> |

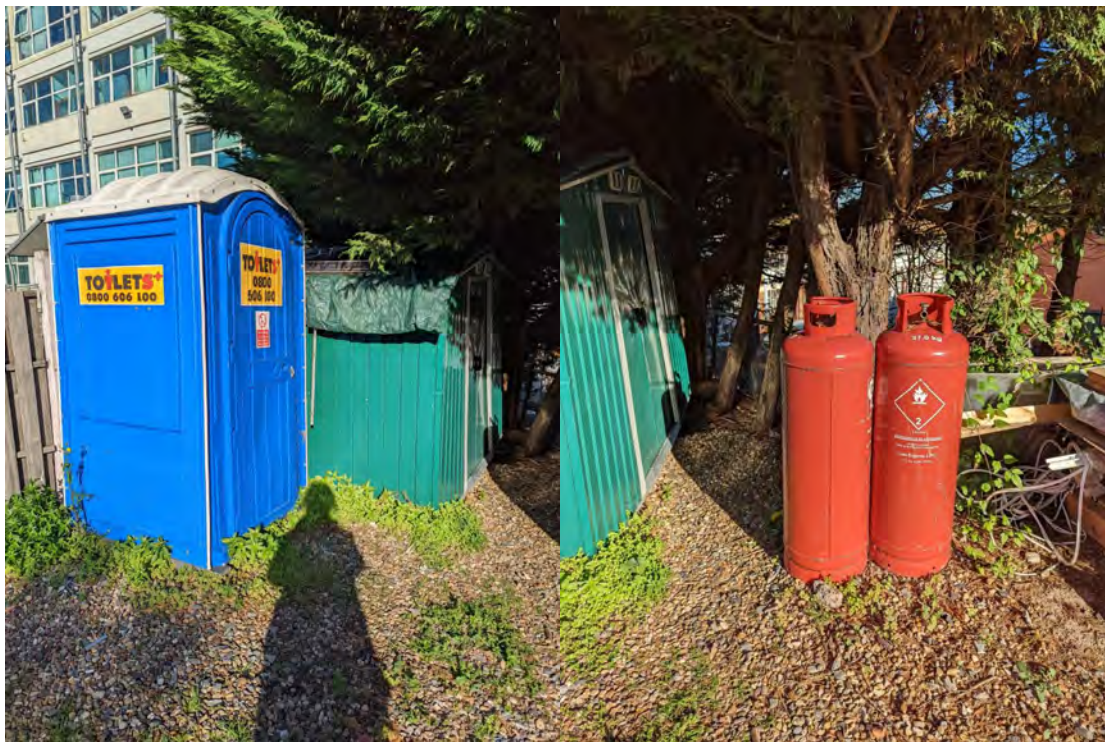
**Image 9:** Porta loo and gas containers next to metal-panel shed in the central portion of the site.

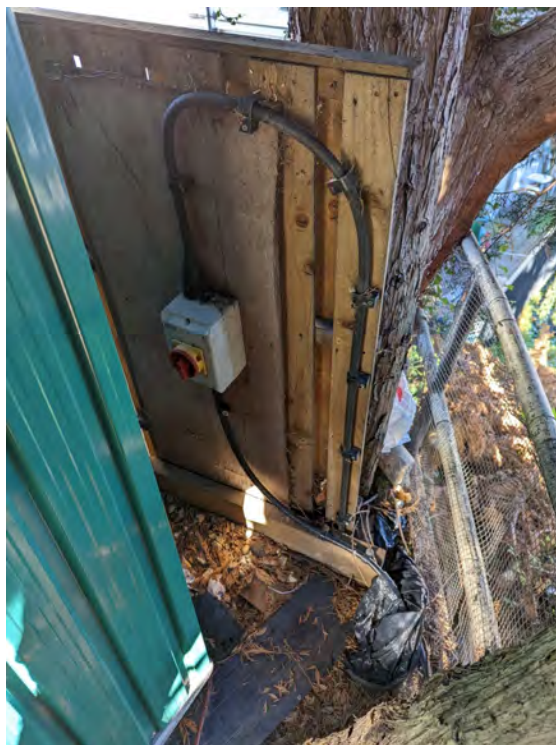
**Image 10:** Metal-panel shed and associated electric cables in the central part of the site.

| <b>Current Site Features</b><br><i>(or evidence of similar historical features)</i> | <b>Walkover Comments and Photograph References</b> |
|---|---|
| Hazardous chemical storage areas | None visible however, a locked container was observed in the southwest corner of the carpark as well as a small locked, metal-panel shed at the centre of the site (at least four cables run under the shed with no visible source). Next to the shed is a single porta loo. Although not observed, potential for hazardous chemical storage in food truck. Two gas cylinders observed on site (not known whether full or not). Likely hazardous chemical storage within scrapyard/motor repair unit. |

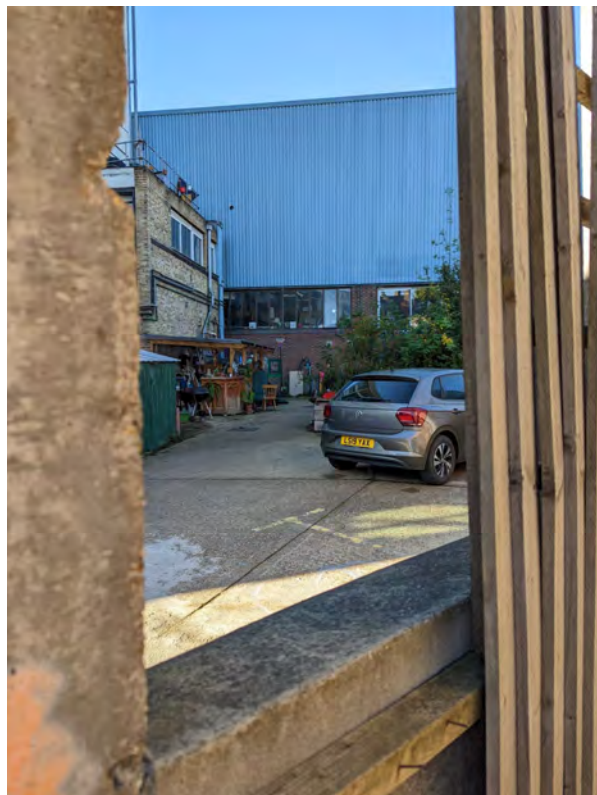
**Image 11:** Courtyard at the back of Cara House- north side of the site.

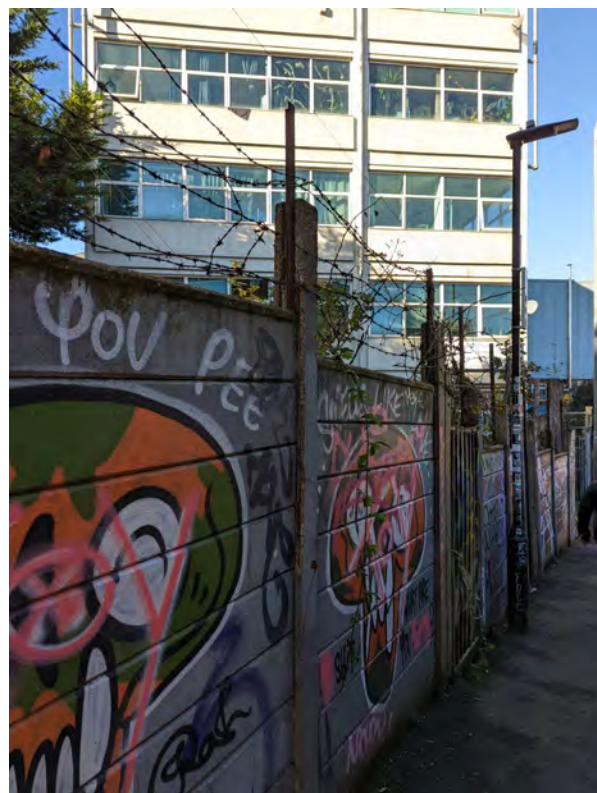
**Image 12:** Passage way – eastern side of the site.
