## Arboricultural Impact Assessment BS5837:2012

108-110 Colney Hatch Lane, Muswell Hill, N10 1EA

Project ref: AEL-18617

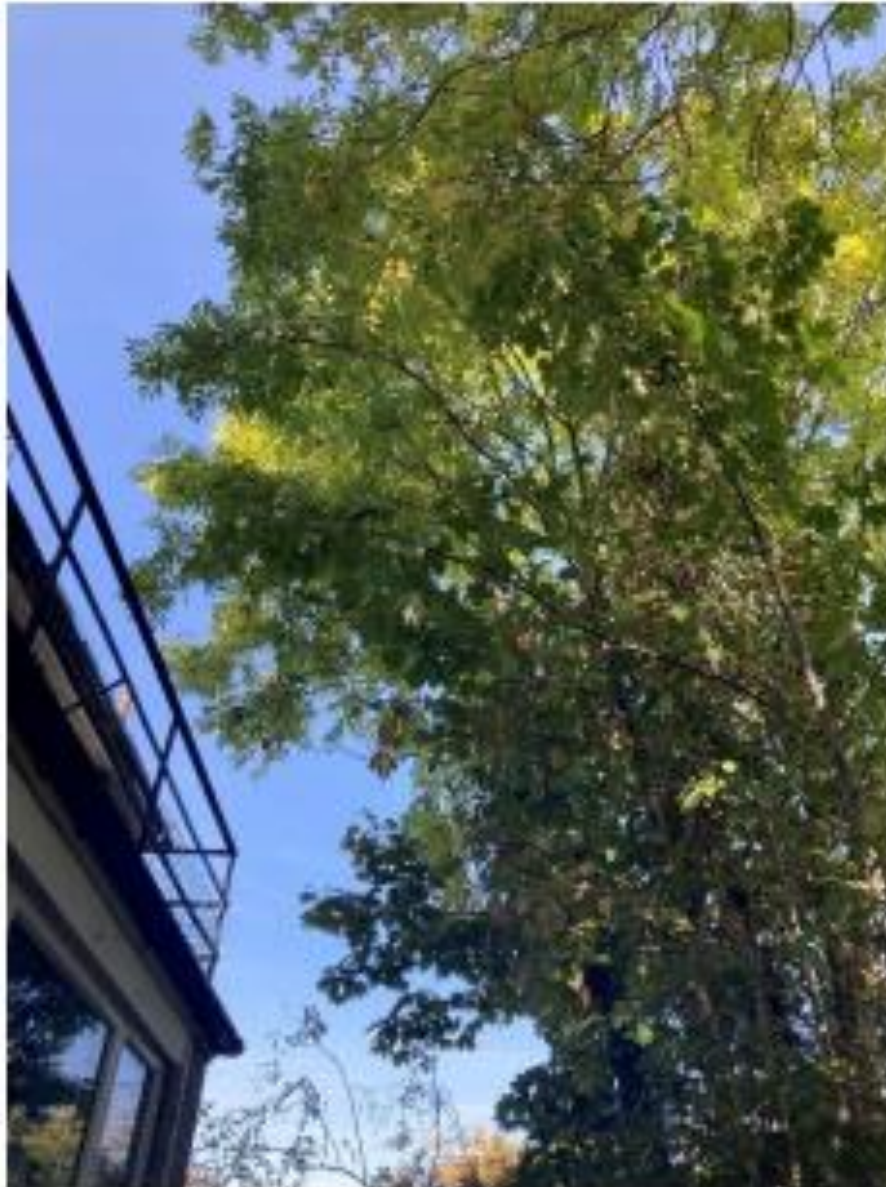
| Ref. | Species | General Observations | Retention Category |
|---|---|---|---|
| T04 | Common Ash<br>( <i>Fraxinus excelsior</i> ) | Dense undergrowth at base preventing fuller inspection - estimated dbh; Multistem - two dominant stems with two smaller / subordinate stems; nest in upper canopy | B1 |

**T4 canopy as viewed from lower  
ground level**

| Tree reference number | Species | Category grading | Works required | For Development | For Arboriculture |
|---|---|---|---|---|---|
| T04 | Common Ash<br>( <i>Fraxinus excelsior</i> ) | B1 | Remove tree | Yes | |
