# St Marks Methodist Church Façade

### 3.7 Facade Repairs - Structural Engineer Report

**St Mark's  
Tottenham High Road  
London**

Prepared by Robert Walton  
Project No 838/01  
Rev Draft for comment  
Date 15 June 2022

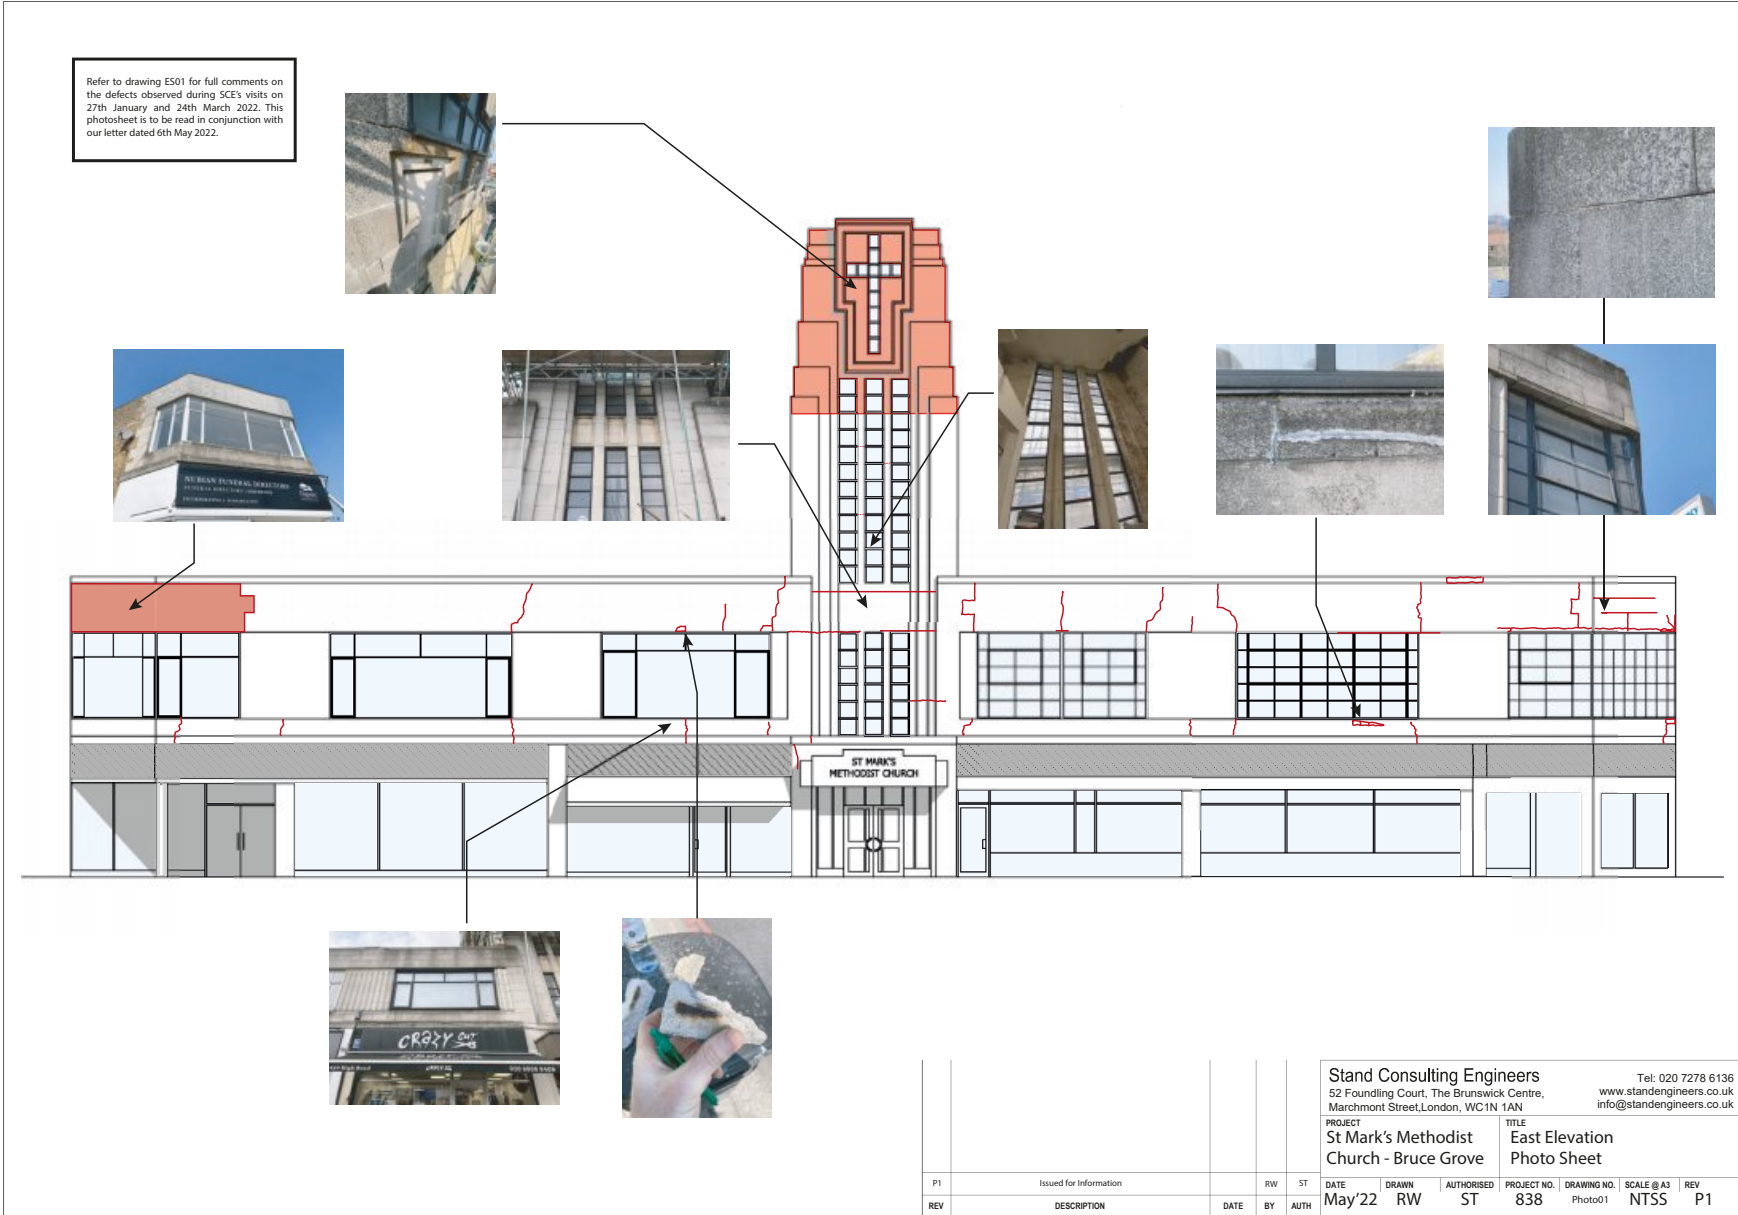
Photographs

At the northern end of the Tottenham High Road elevation, the blockwork above the first-floor window is in a poor condition. A horizontal crack was noted to run through the soffit of blocks directly above the window. In a few locations, sections of the concrete blocks had spalled to expose corroded steel reinforcement, and during our visit in March, we were able to remove sections of loose concrete from the soffit of the blocks. Horizontal 'jacking' cracks were also observed in the bed joints between the courses of blockwork in this area.

Similar defects were noted around the windows along the rest of the elevation, including significant horizontal jacking cracks in the blockwork between the two levels of slender windows to the tower.

At the southern end of the elevation, the panel above the first-floor window has been altered/repared in the past. Instead of concrete blocks, the elevation in this area is rendered, with bed and perp joints inscribed into the render to replicate the original cladding. We suspect that this work was undertaken to address similar defects to those observed at the other end of the elevation.

The pattern of the cracks is likely to be a combination of two main actions; corrosion of the reinforcement within the concrete blocks (leading to expansive forces which have caused the local cracks to form), and corrosion of the internal steel frame, which like the corrosion of the reinforcement creates an expansive force, resulting in the wider spread crack pattern (propagating diagonally from the windows). As the blockwork is unjointed, some of the cracks may also be due to/exacerbated by thermal movements.

The magnitude of the repairs/intervention to the building is dependent on the results of the investigations. Based on our observations to date we expect the majority of repairs to the 1939 building to a mix of areas of low and medium-level of intervention. In each case we suggest trial repairs are carried out on a representative area of damage to review the methodology and the materials and mix-proportions for new areas of concrete.

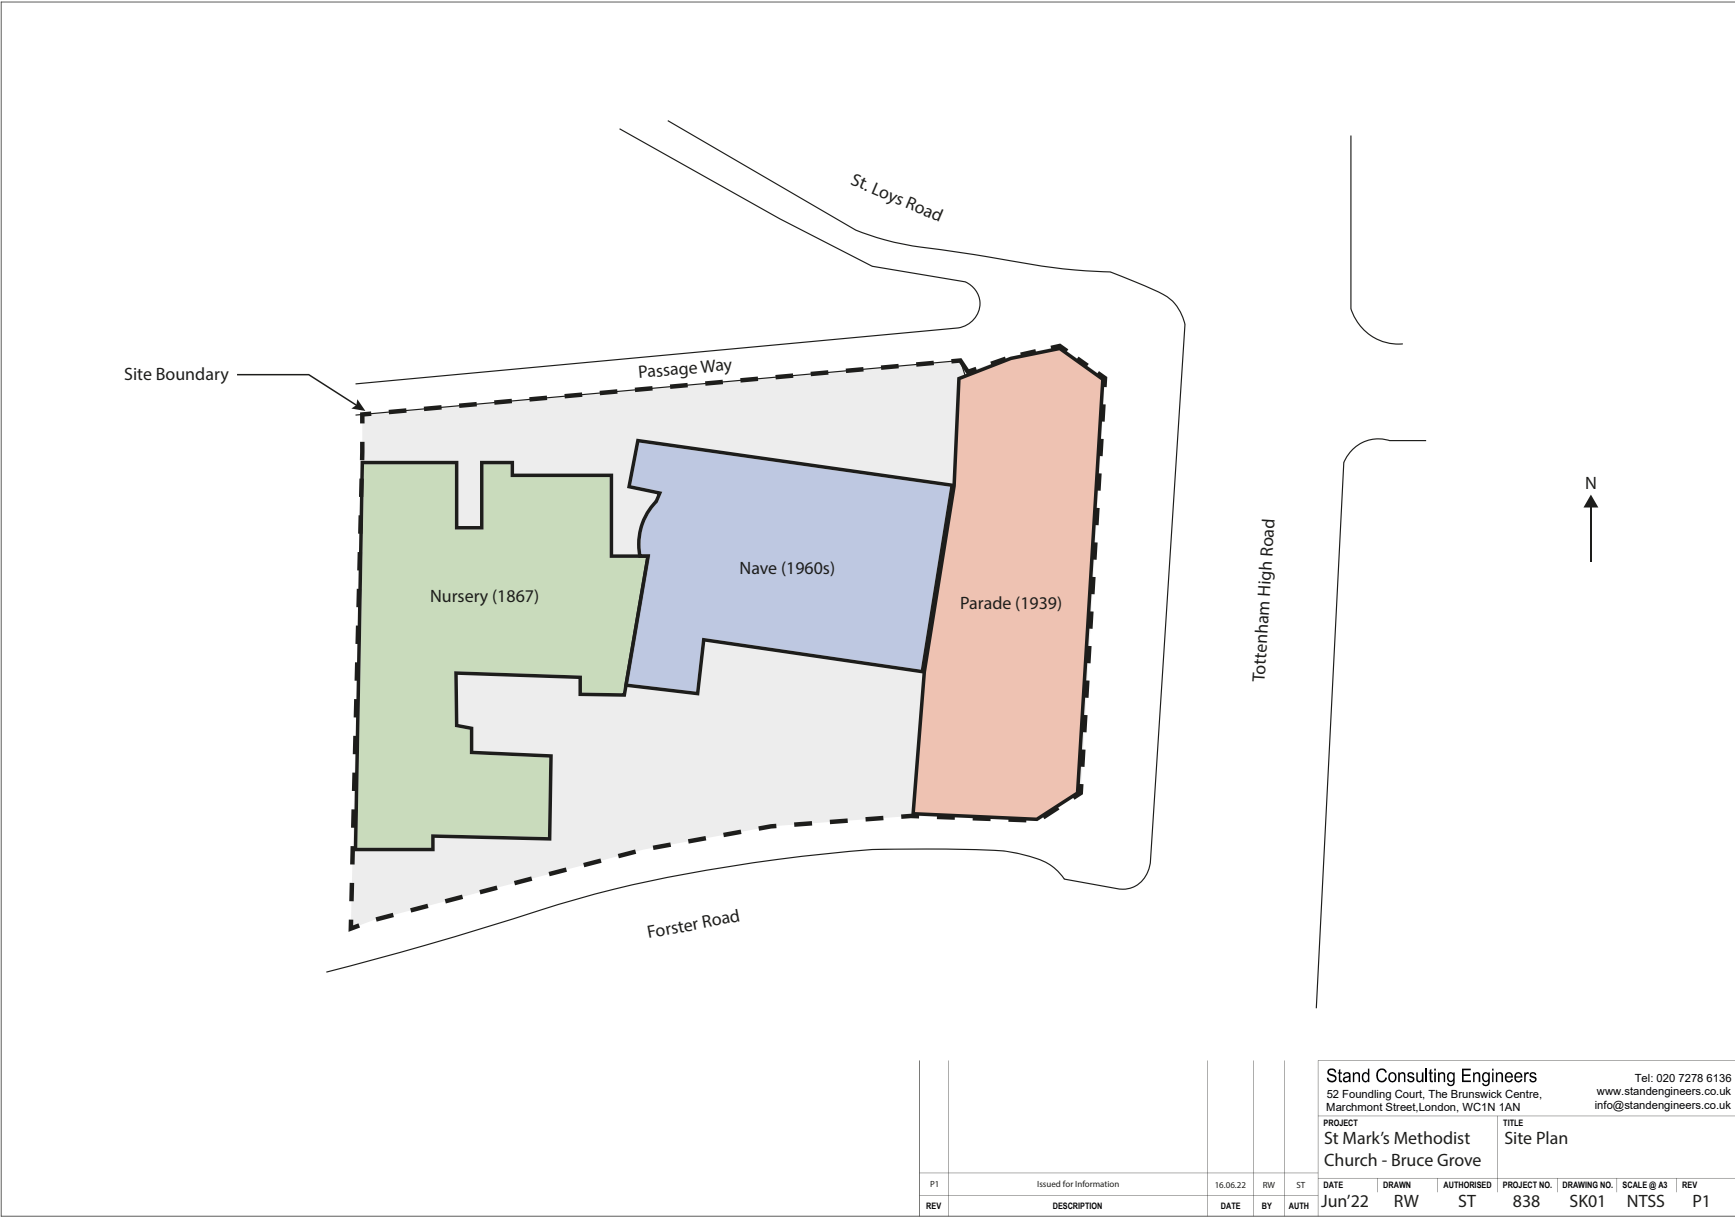
From our observations, both the 1867 and 1960s sections of the building appear to be in a reasonable condition for their respective age and type of construction. The 1939 section of the building was in a poorer condition with a large number of defects noted in the blockwork cladding. The extent of these defects is recorded on drawing ES01 and the attached photo sheet.

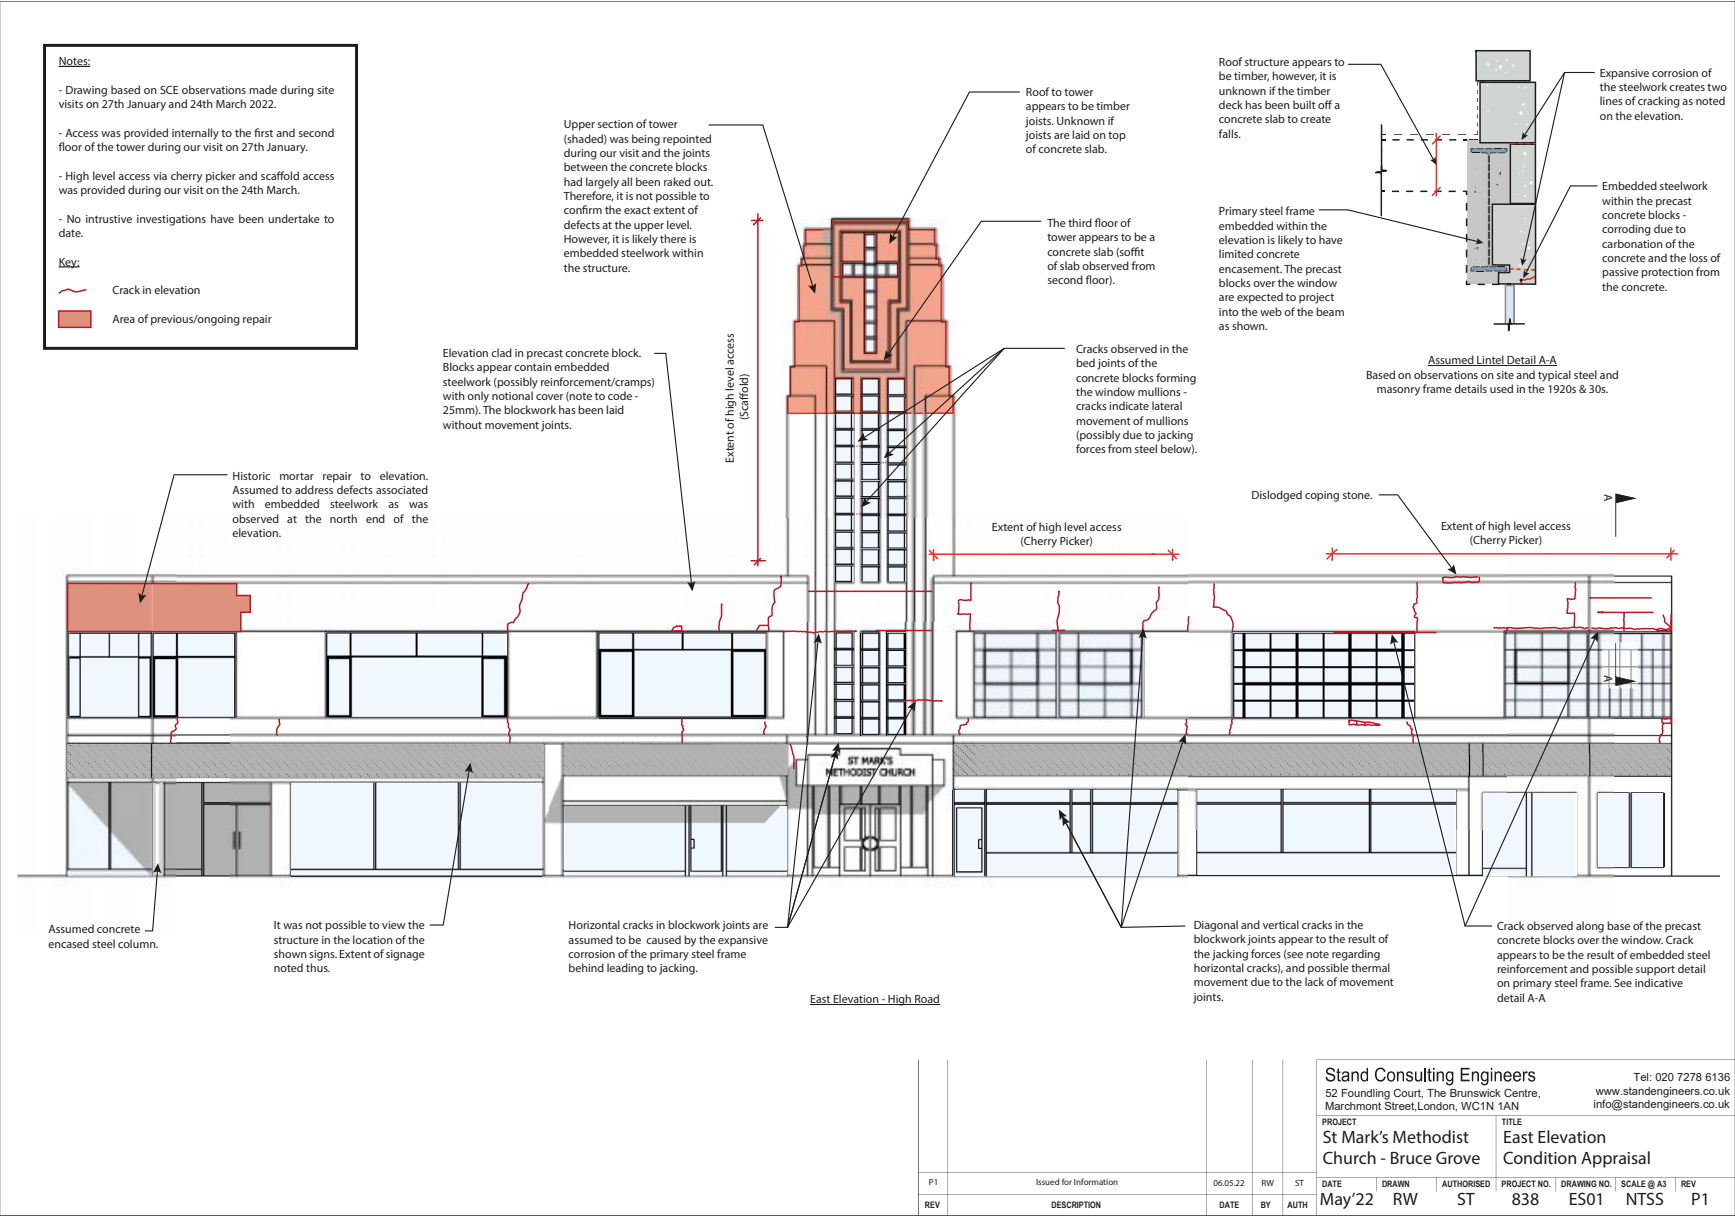
Given the area of the buildings, it is likely that there are further structural defects that have not yet been uncovered, or are in areas of the building yet to be accessed. Areas of structure at higher risk of hidden defects are noted in the commentary below. Structural investigations are proposed at Stage 3 to help determine the extent of these defects. The scope of investigations is shown on drawing S01.

Intrusive structural investigations are required to confirm the arrangement of the existing structure, its condition and the cause and extent of observed defects. The scope of the proposed Stage 3 investigations is shown on drawing No. S01. Whilst the building is not statutory listed, it would seem prudent that the approach to the intrusive investigations is agreed with Haringey's Conservation Officer.

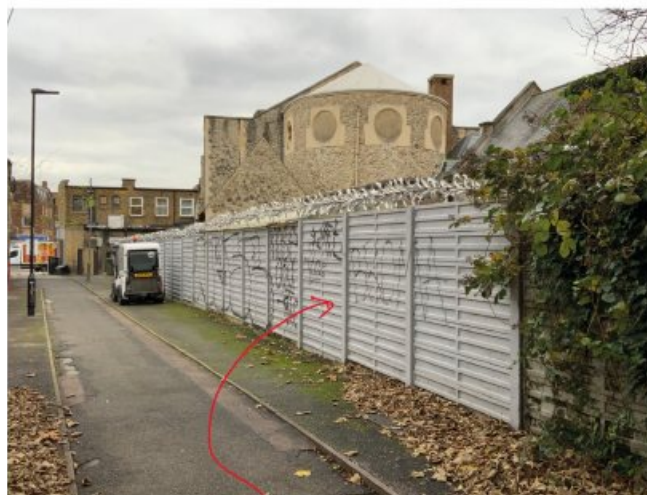
- CONCRETE PANELS WITH ANTI-Climb MEASURES TO TOP
- UNWELCOMING & UTILITARIAN; TOO LOW GENERALLY & EASY TO CLIMB...
- DESIRE TO IMPLEMENT 'GREEN EDGE'
- PANELS IN GOOD CONDITION GENERALLY - CURD?
- BLANK CANVAS FOR GRAFFITI - CANNOT PAINT PLANTS!

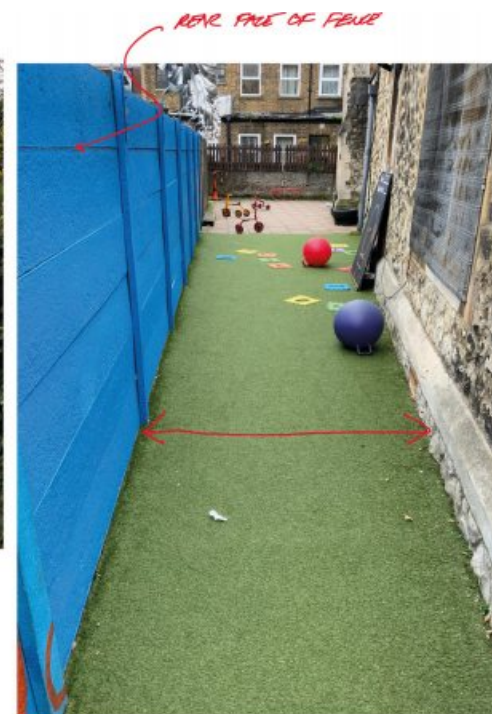
- RESTRICTED WIDTH;
- NO OPPORTUNITY TO INCREASE DEPTH OF FENCE AS AT SOUTH BOUNDARY WITH PLANTING

- ANTI-CLIMB MEASURES BOLTED TO FENCE POSTS
- SHUDD POSSIBLE

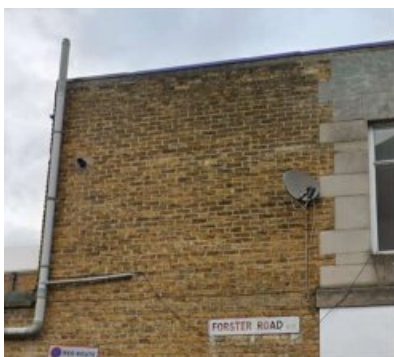
The funeral parlour frontage is mostly clear of services, but to the side there is a satellite dish. The satellite dish will be removed as part of the proposals.

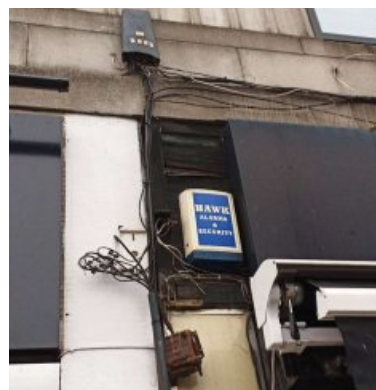
Between the funeral parlour and the hairdressers, there is an unsightly collection of cables, including redundant equipment hanging off the wall. The cables are likely to be telecoms cables – i.e. phone lines serving each of the businesses. Reordering of the cabling would need to be negotiated with the relevant statutory authority but would greatly improve the appearance of the façade, particularly as the cabling also spans the length of the shopfronts above the signage, without fixings at suitable intervals.

The cabling above the pharmacy is also untidy – an electrician should attend to trace and identify the cables, remove redundant cabling where present and install suitable containment and fixings. Periodical inspection of the electrics in each business is recommended.
