Existing Building

Key Internal Spaces - Lobby

External Fabric Condition

Summary of Facade Condition

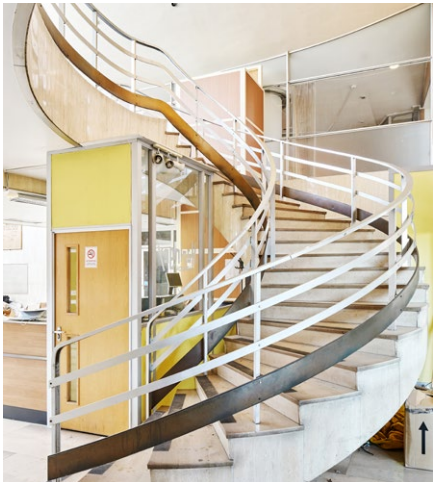
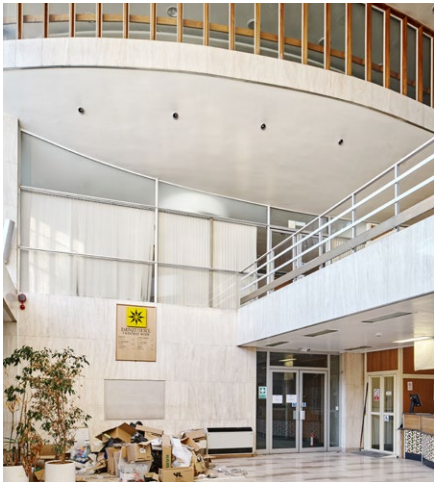
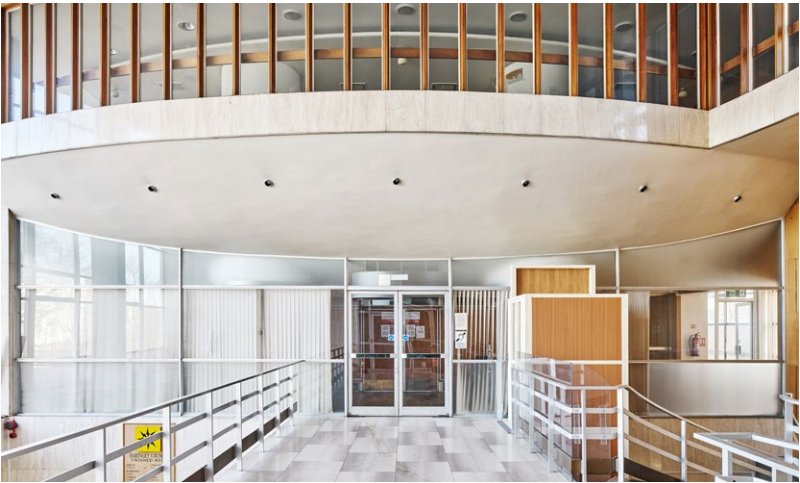
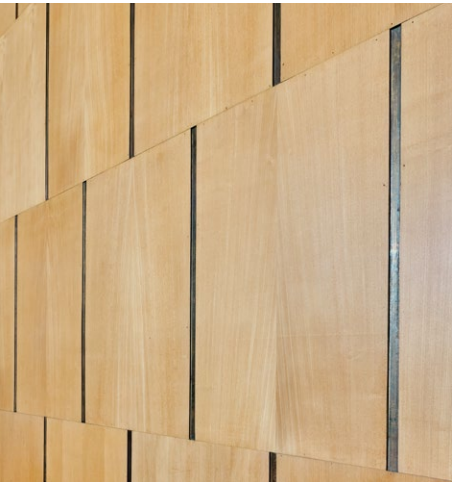
Middle  
Pre-Enabling Works

- Pre-Enabling Works Condition**
- Extensive cracking/chipping in stone tiled flooring
  - Brass inlays tarnished
  - Spotlights and recessed strip-lights in bridge require upgrading

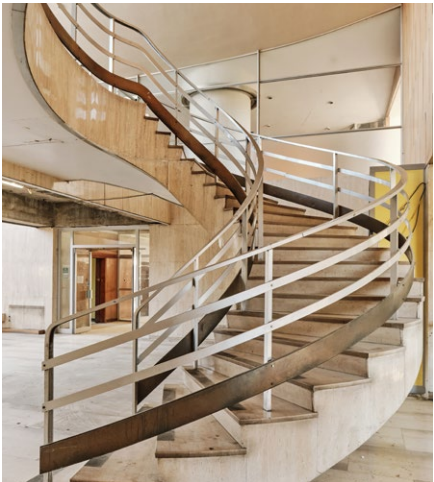
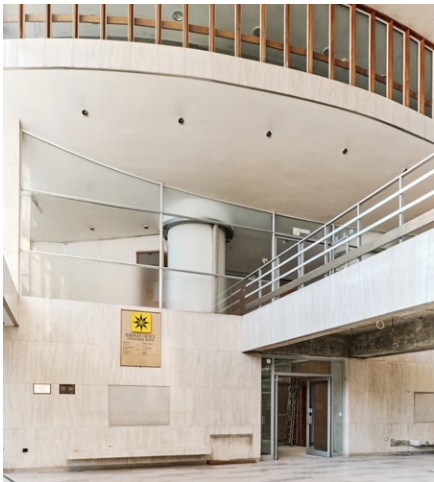
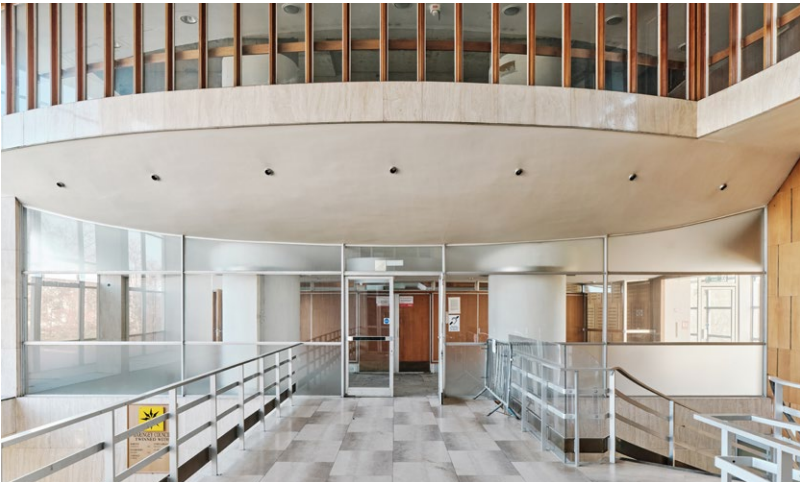
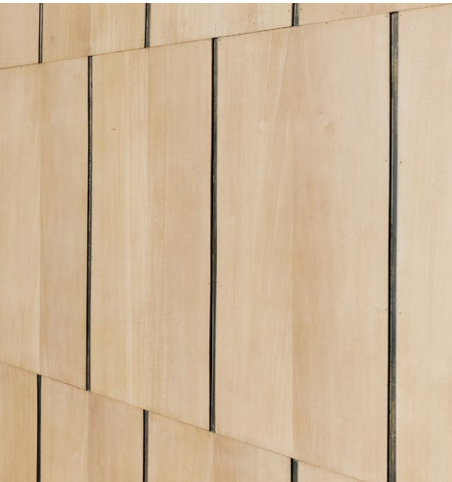
Bottom  
Post-Enabling Works

- Post-Enabling Works Condition**
- Ceiling below bridge removed
  - Carpet Removed & Blinds Removed

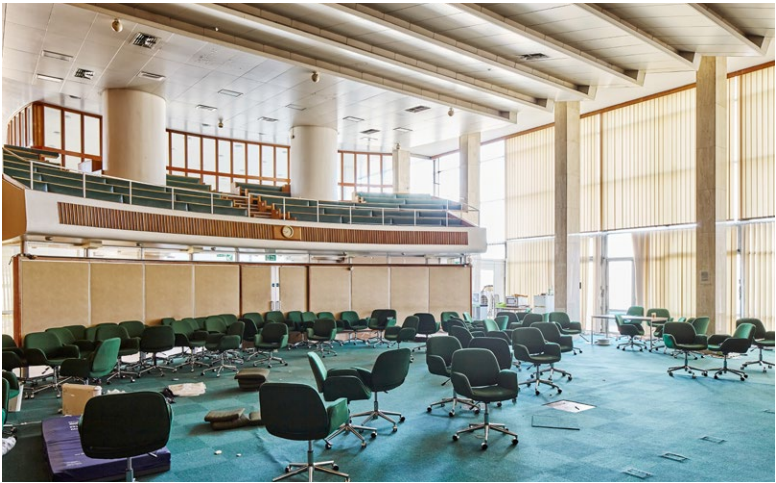
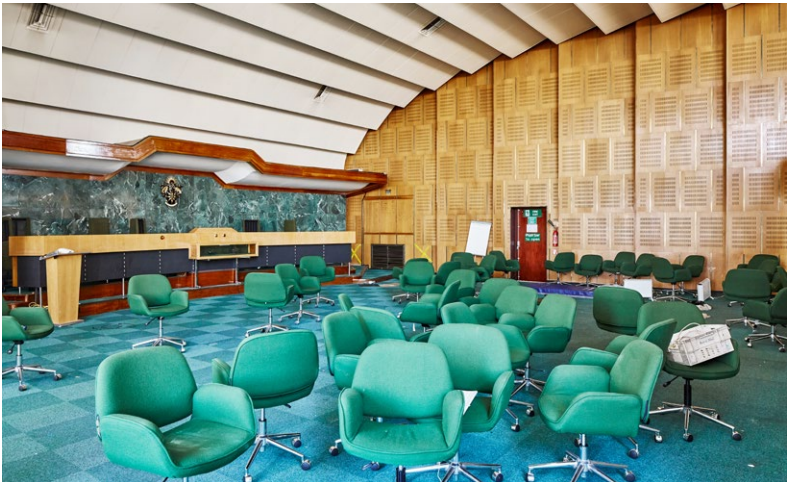
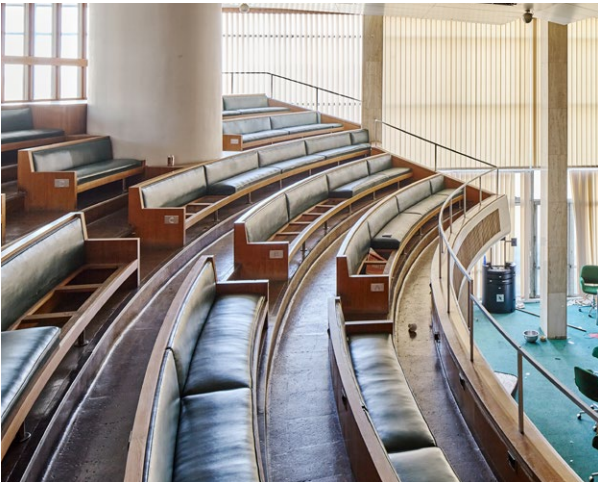
Middle  
Pre-Enabling Works

- Asbestos ceiling
- Timber panelling with brass inlays - brass tarnished
- Non-Original carpet
- Vertical Blinds
- Original brass clock removed

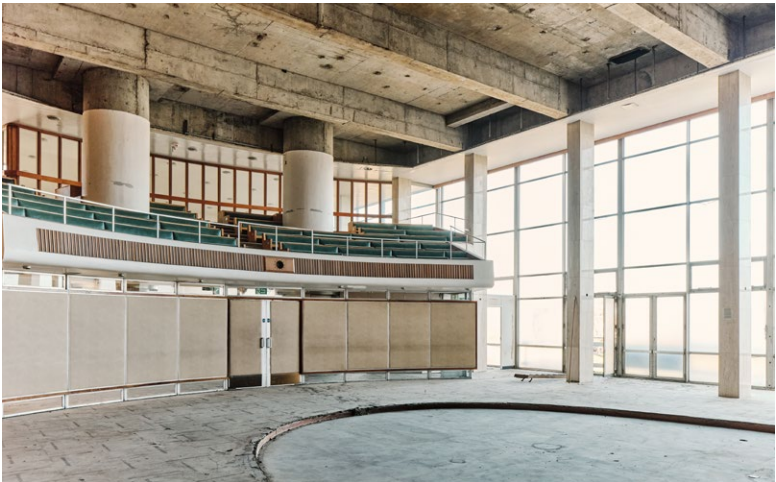
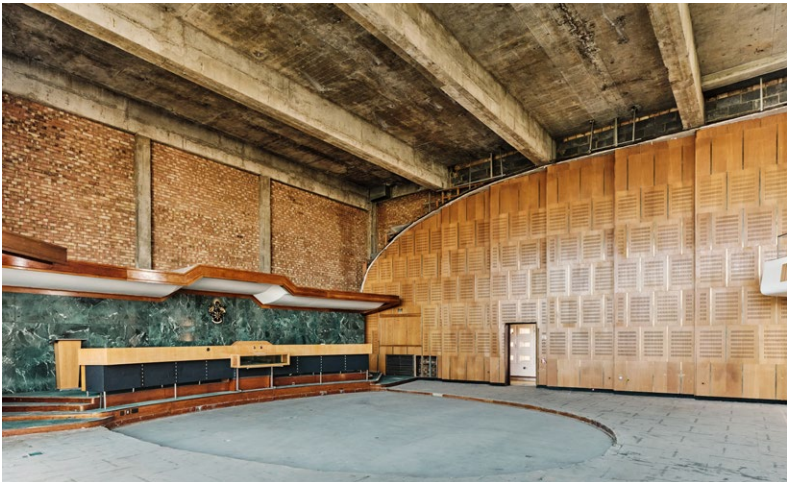
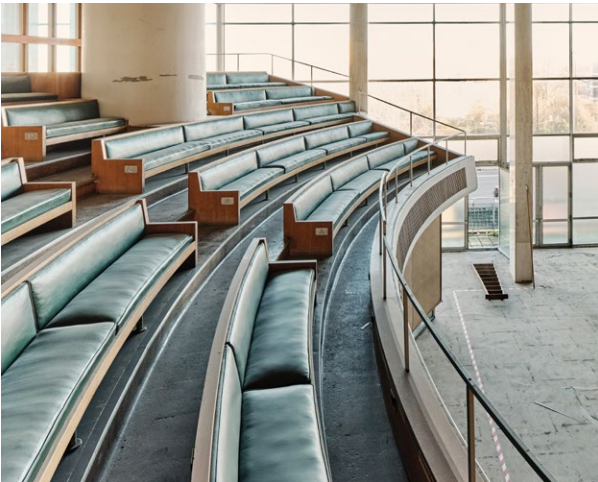
Bottom  
Post-Enabling Works

- Asbestos ceiling removed
- Carpet Removed & Blinds Removed (Curtain track retained)

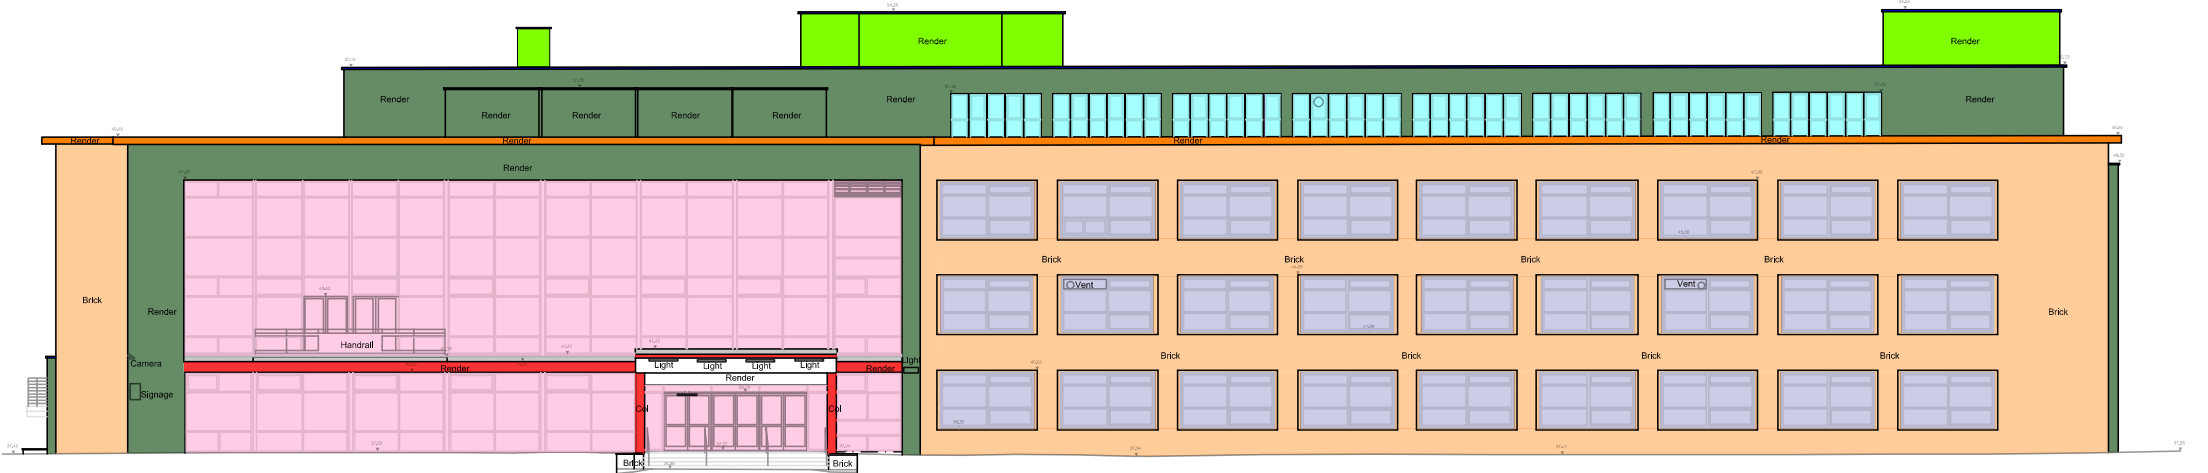
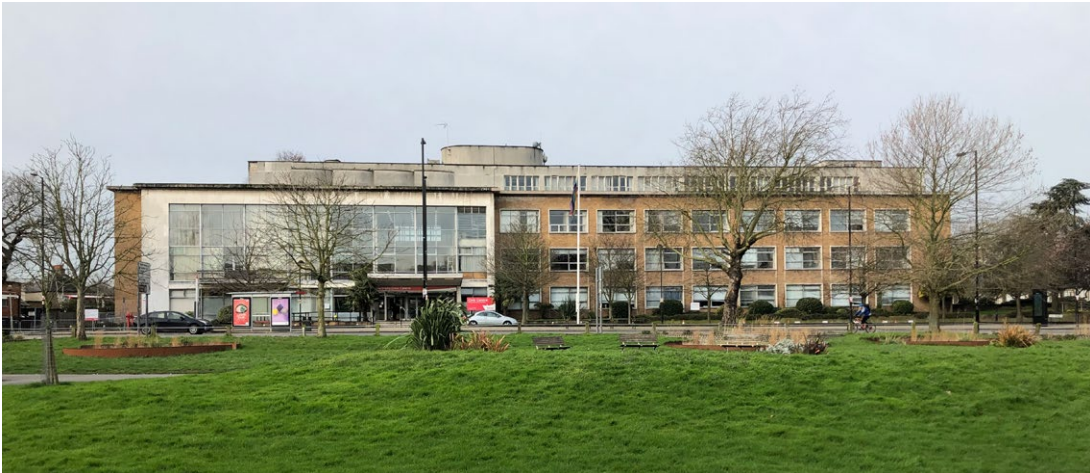
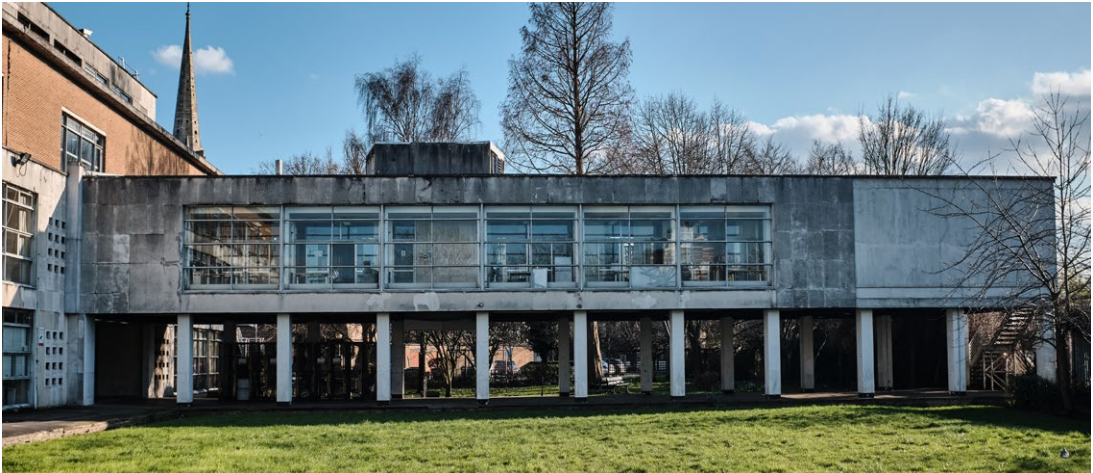
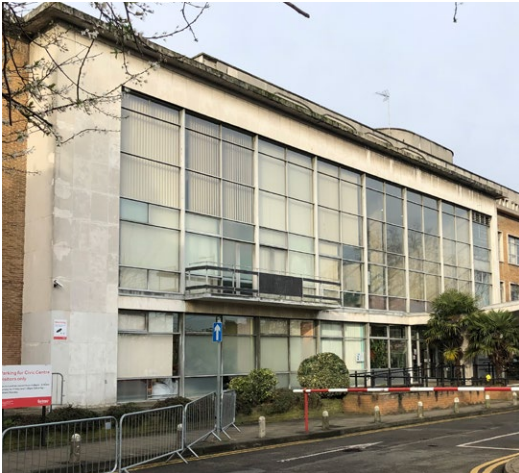
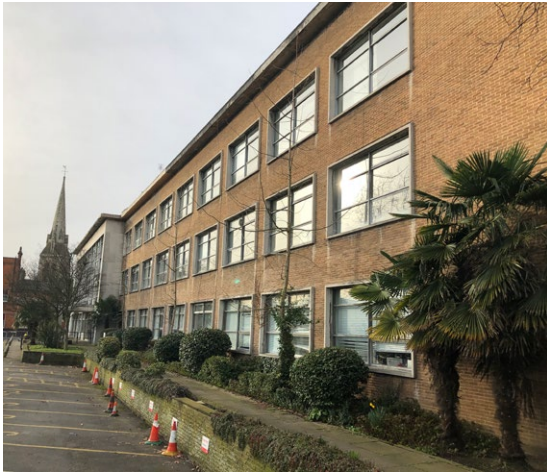
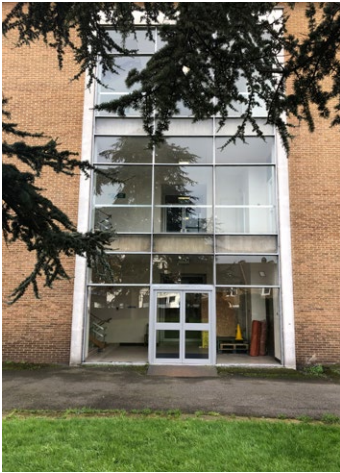
East Facade (Front)

Facing brickwork to all elevations is in fair condition, and cleaning, local re-pointing and minimal crack repairs will be implemented as part of the refurbishment works. Within certain locations there is more extensive visible cracking which will require further structural investigation to assess the cause of movement and propose remedial works.

The pre-cast cladding at levels 0 to 2 are generally in poor condition. The cladding at level 3 is in a more advanced state of disrepair.

A small band of travertine stone cladding to the East elevation fascia and canopy appears in fair condition: some cracked tiles require replacement and a general cleaning is recommended as well as possible re-fixing of the larger cladding stones at the canopy columns which appear dislodged.

All existing glazed areas, both the aluminium curtain walling and steel windows all levels are in poor condition. The glazing is generally single ply: glazed areas account for a large portion of the façade surface and therefore it is expected that the overall thermal performance of the building will be poor unless replaced. In addition to this, there is evidence of previously perceived glare discomfort and heath gain (solar film was applied to the majority of the windows).

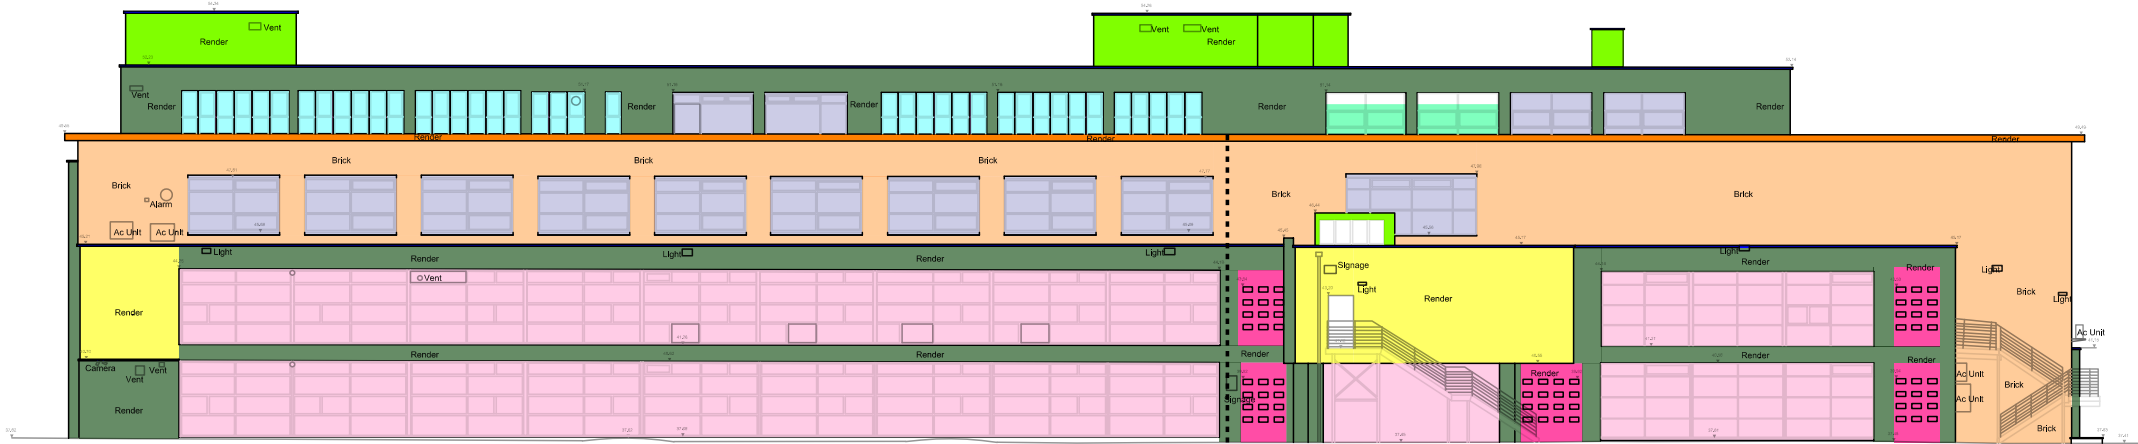
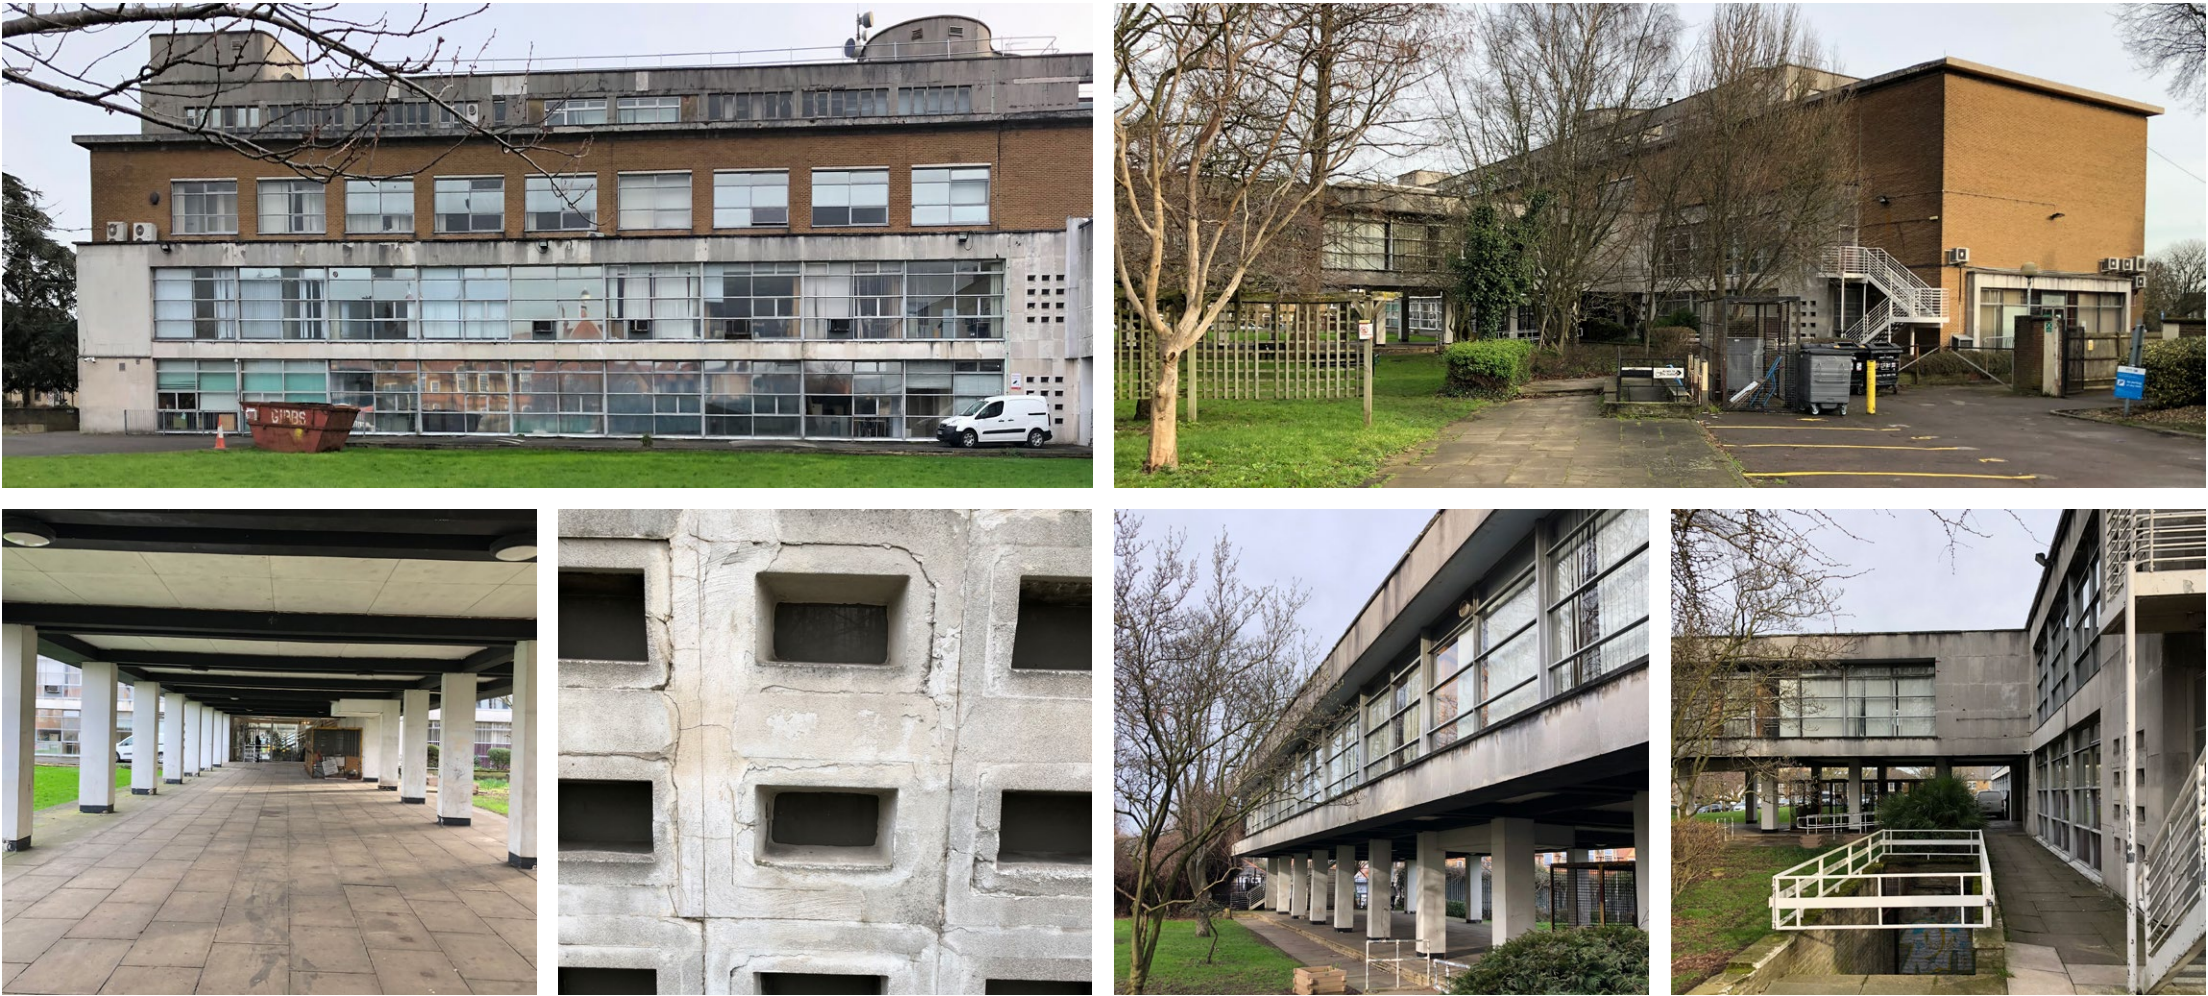
West Facade

The rendered areas of the facade to the West wing are in poor condition with cracking in areas which require further structural investigation. New render should take into account any movement joints required in the façade of the West wing to minimise the risk of future cracking.

The reinforced concrete cornice at level 3 is in need of urgent concrete treatment including removal of stone cladding, removal of detached and loose portions of concrete, making good of the exposed reinforcement with anti corrosion treatment, refacing with thixotropic mortar products.
