## Heritage Statement (Addendum)

42 Southwood Lane, London N6 5EB

### Analysis of Upper Stair

March 2023

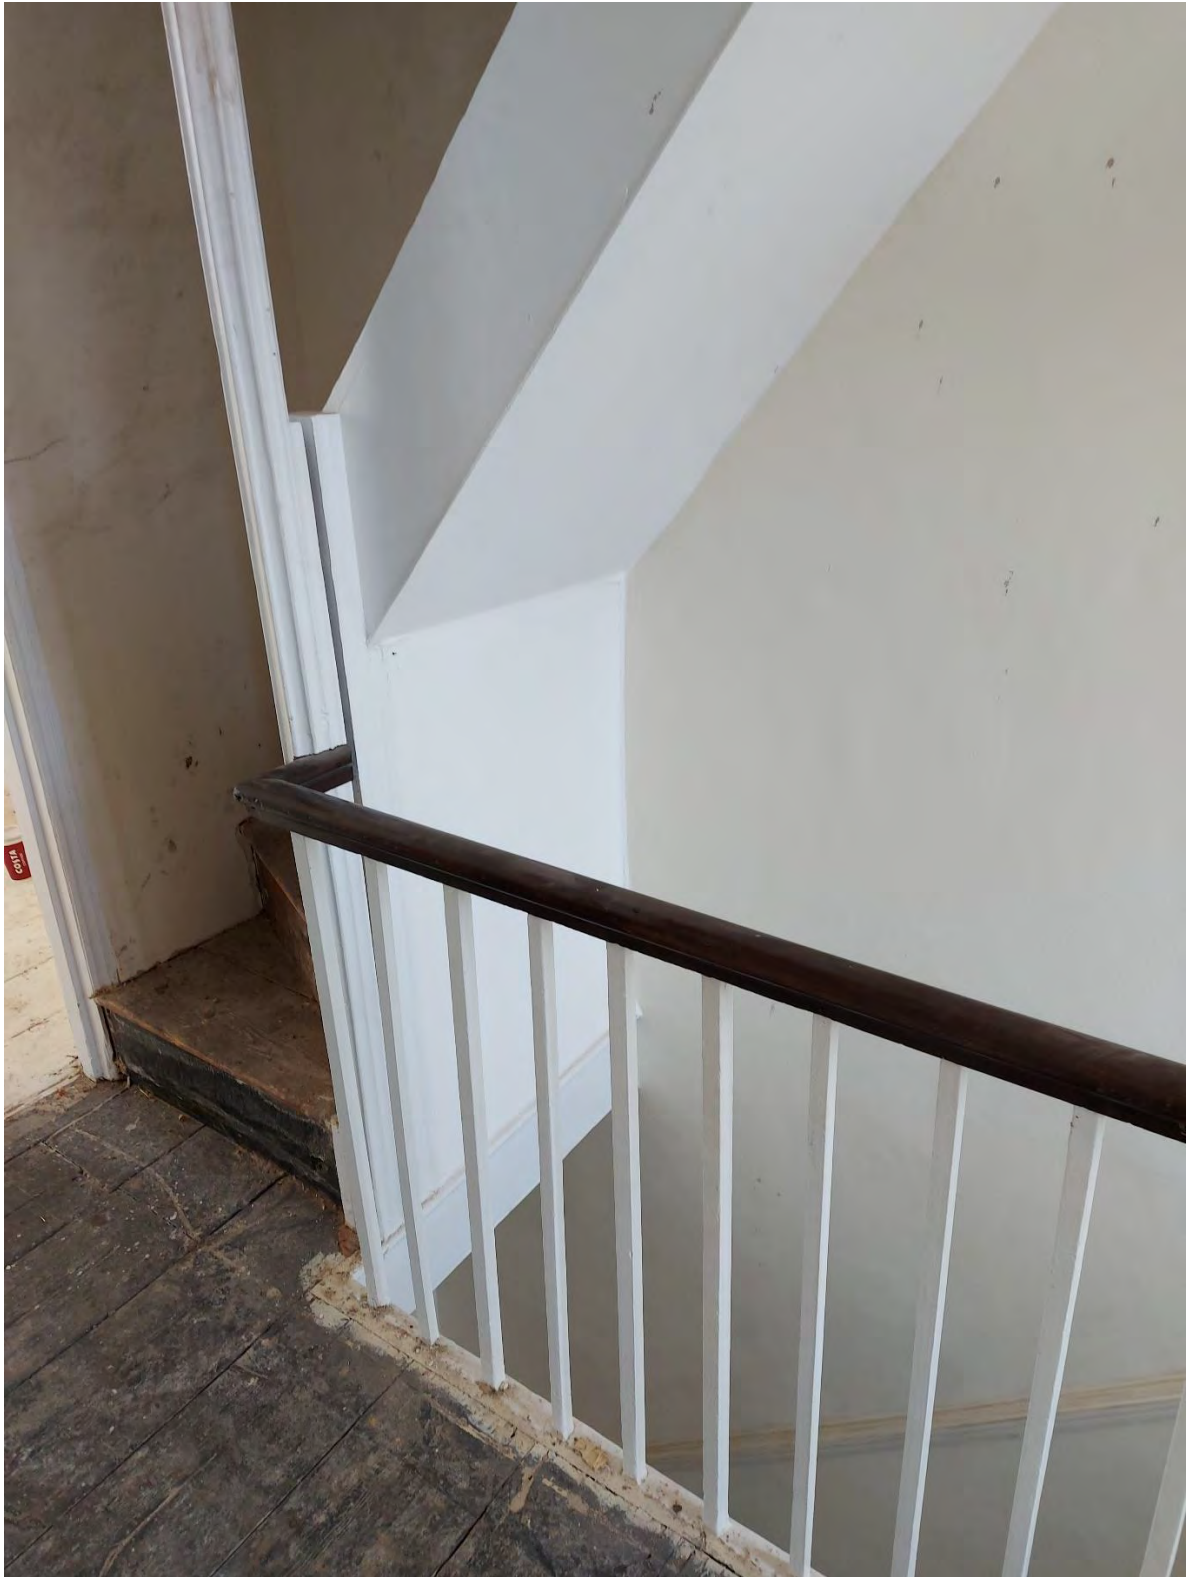
The present stair from first to second floor is oddly narrow (figs. 1 & 2). It is set hard against the party wall with number 40 Southwood Lane and a principal joist against the party wall has been cut short to allow the stair a few inches of greater width (fig.3). On the second floor landing there is a small lobby enclosing the doors to the front and rear rooms. The lobby has a moulded plaster cornice like those in the rooms and is clearly an early feature, possibly original. On the north side of the lobby is a door-opening with a plaster moulded surround on the stair-well side (fig.4). The door is now blocked and reduced in width by the insertion of a modern timber upright, but would once have opened directly onto the open well of the stair. Alongside is a doorway with a modern timber surround which opens onto the landing. Clearly there has been some alteration.

Fig.1: The first floor landing showing the lower part of the upper stair

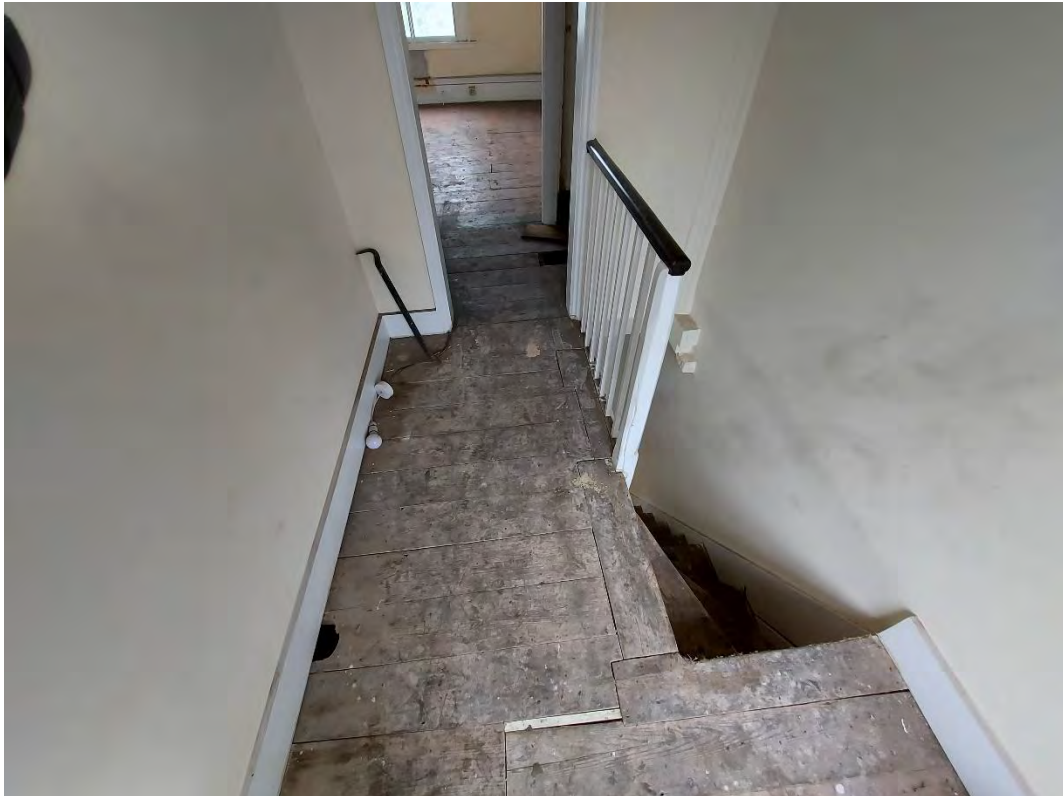
Fig.2: The stair at second floor level

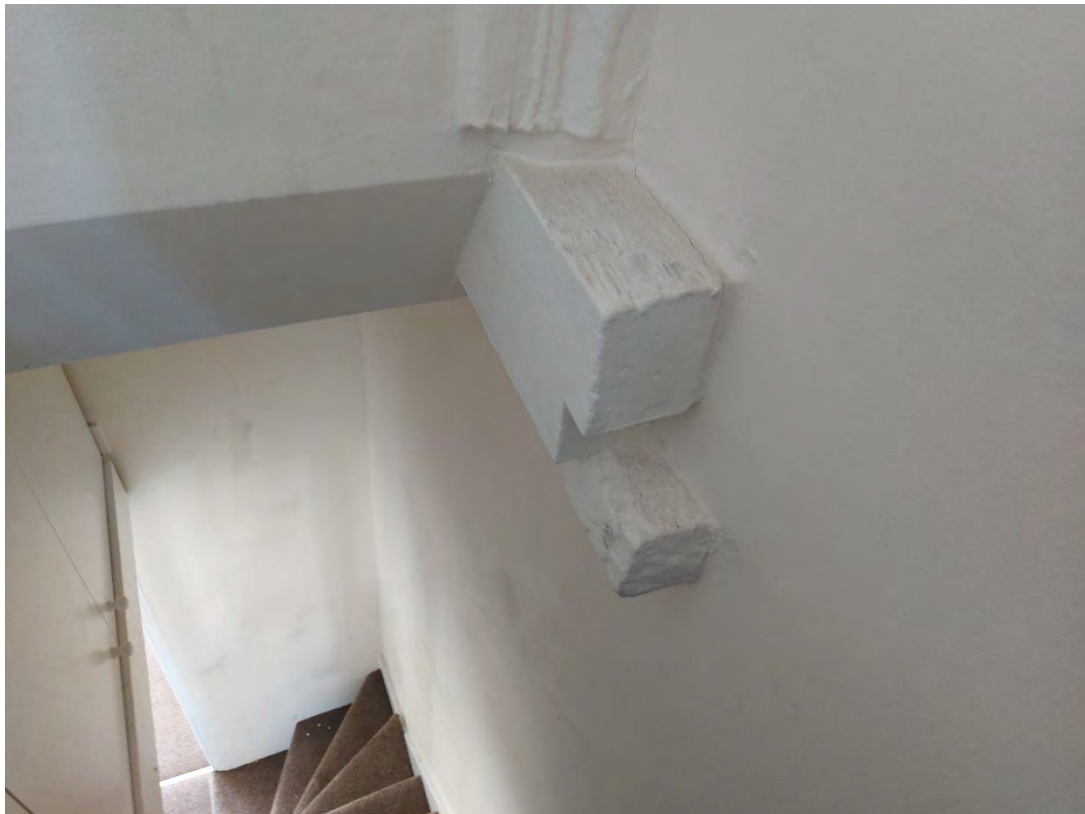
Fig.3: view of the stairwell showing a truncated joist against the party wall resting on a small padstone, and above it the base of the moulded surround to the doorway which now faces onto the stairwell

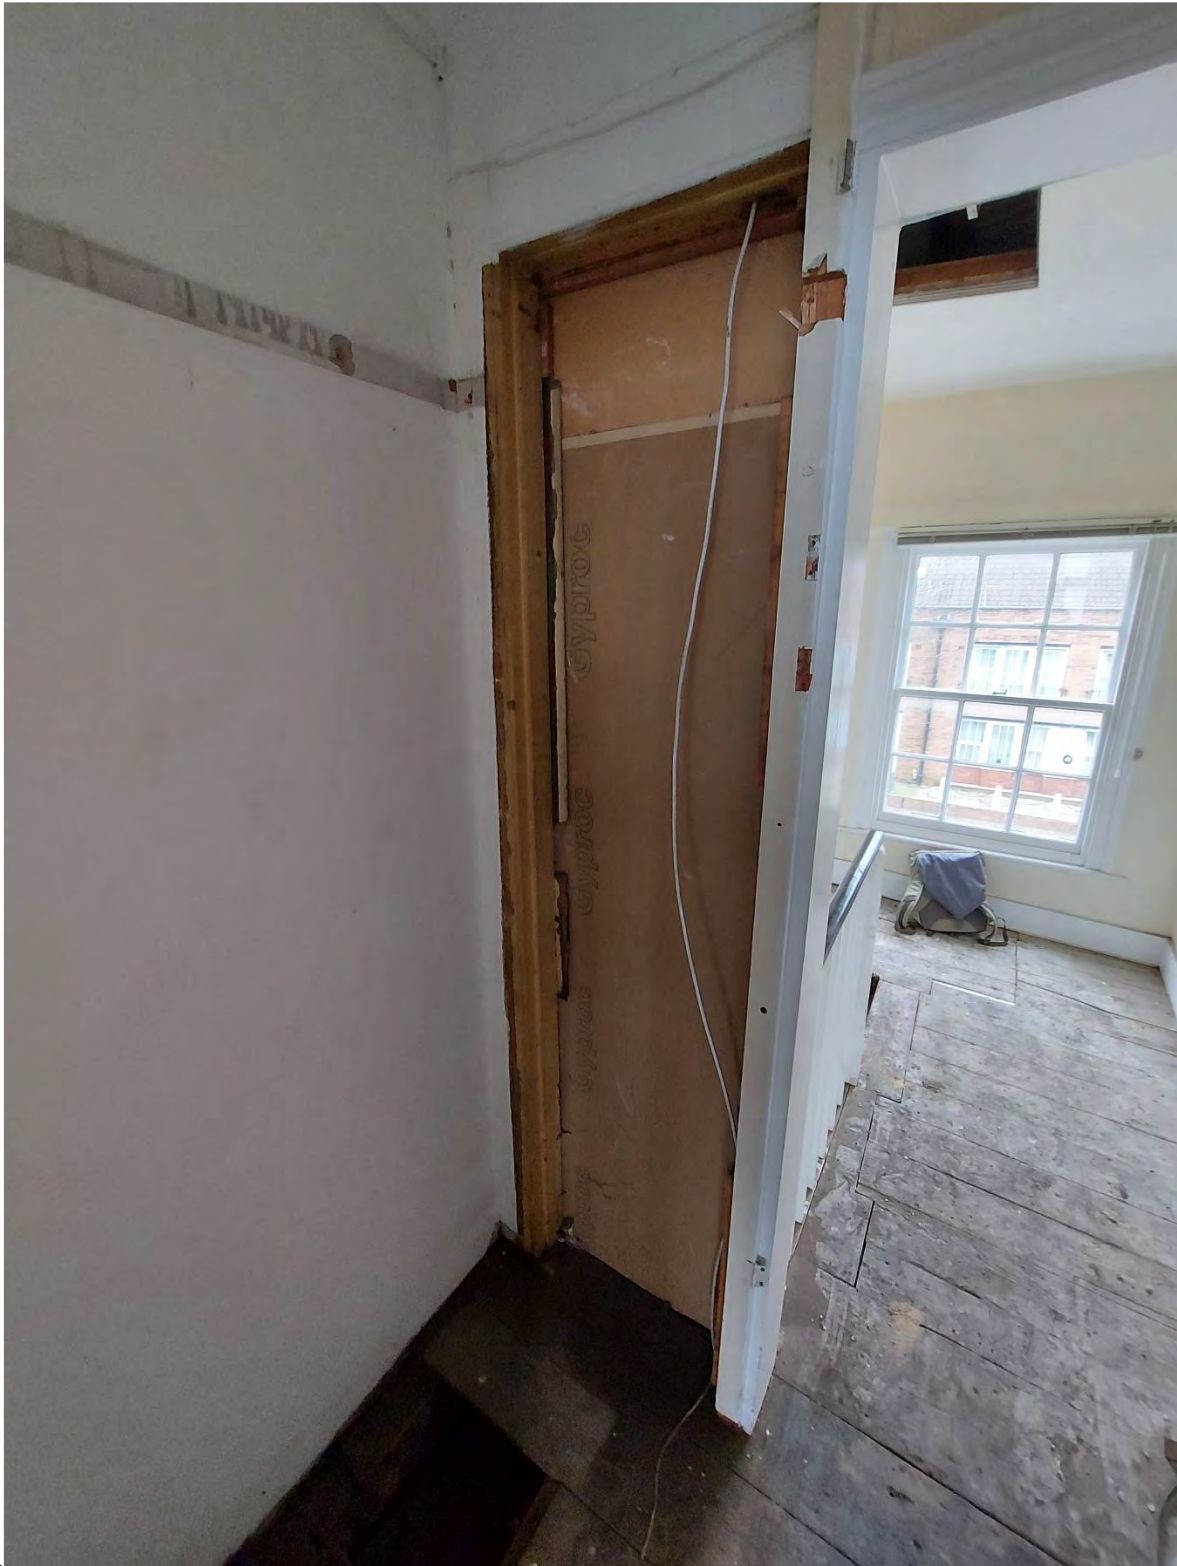
Fig.4: The second floor landing, showing the blocked and truncated former door opening in the lobby to the two main rooms.

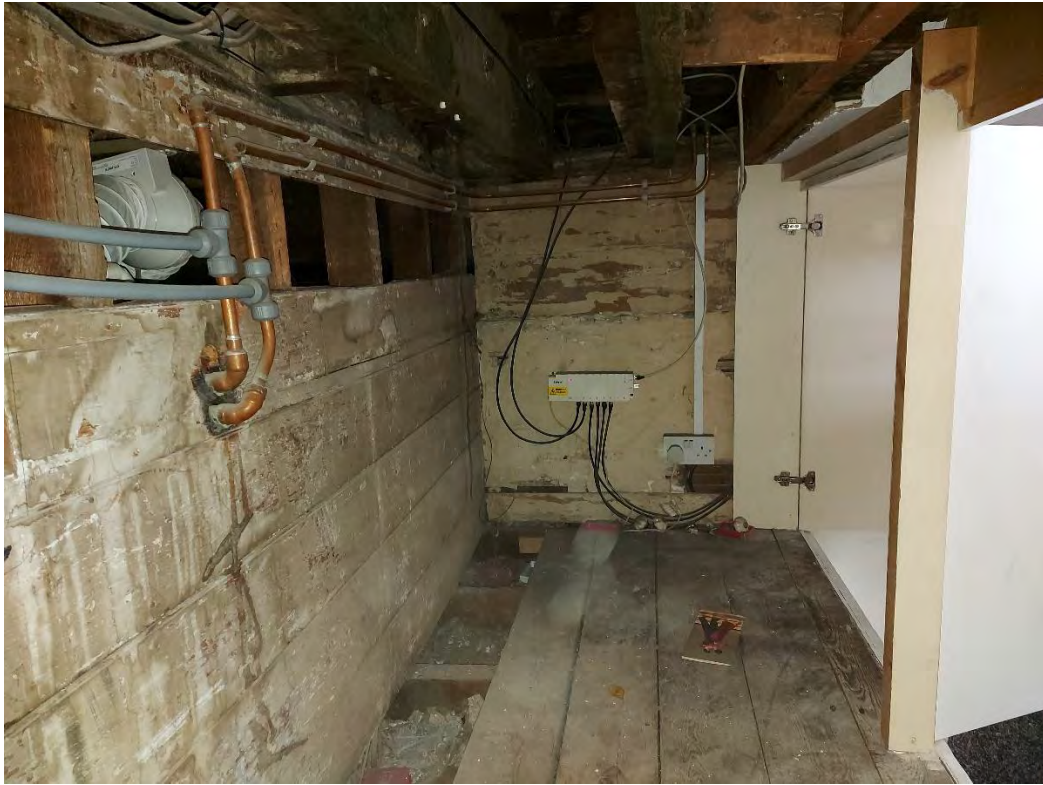
More substantial evidence of alteration can be seen in a cupboard opening off the stair at its mid-point. The ceiling of the cupboard is formed by the boards of the second floor landing, and these are supported on modern joists which have been treated or tanalised – a process only invented in the 1930s (fig.6). The inner or east side of the cupboard is formed by horizontal edge-to-edge boarding which has been painted a cream colour and was once clearly exposed to view (fig.5).

Fig.5: The interior of the cupboard on the stair under what is now the second floor landing, showing the vertical horizontal boarding of what was probably the original stairwell.

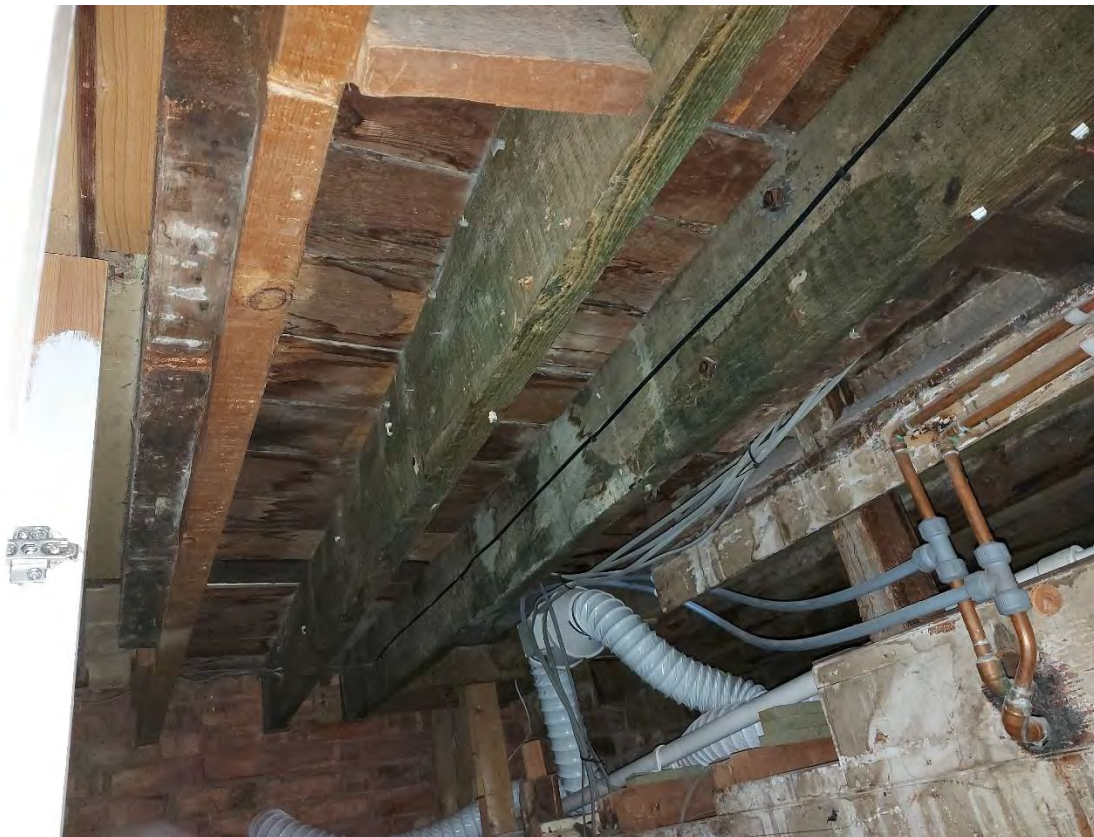
Fig.6: The underside of the second floor landing from the cupboard on the stair, showing the modern joists and also some modern Fletton brickwork in the front wall of the house

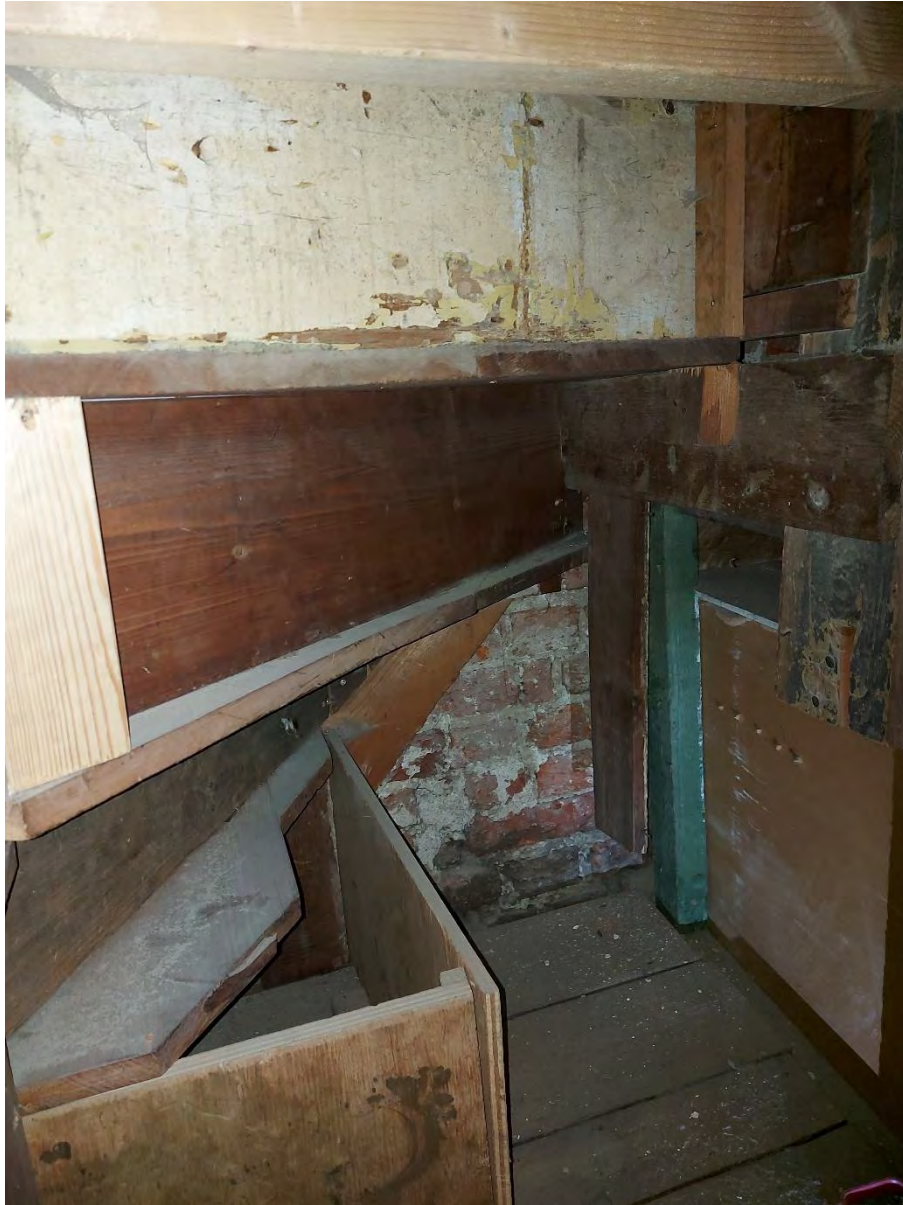
From inside the cupboard it is possible to see the rear of the stair itself, which is at least partly made up with mismatched pieces of modern timber (fig.7). Other treads and risers may have been shortened when the stair was narrowed. The boards of the second floor landing certainly show signs of alteration, with irregular joints and signs of piecing-in.

Fig.7: The upper winders of the upper stair, made of odd pieces of modern timber with some plywood.
