## 6.0 Gazetteer

### 6.1 Exterior

## 6.2 Interior

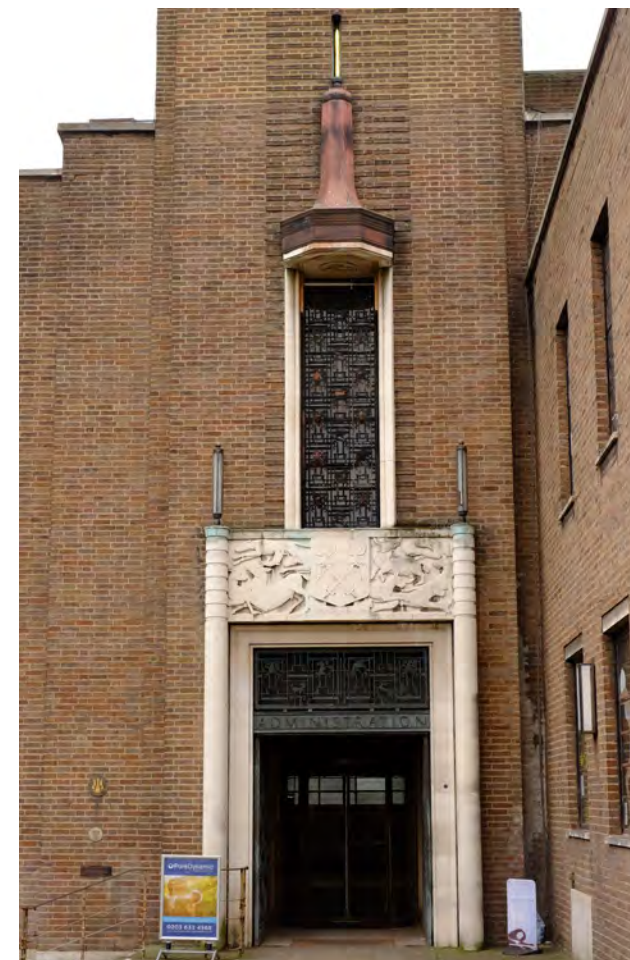
32 Carved stone doorpiece to the Administrative Entrance (2017)

The entrance to the Administration and Civic Block is set within the base of the tower. It is accessed via stone steps and ramps (original with some areas of earlier and more recent alteration). Original steel handrails were not present during the recent site visit. The entrance contains a large door with a Portland stone surround carved with Haringey coat of arms and animals. Above is a copper-grilled window surmounted by a bronze hood [plate 32]. The central bay of the tower features rusticated brickwork. Its upper stage contains four slit windows with stone strips set between. At the very top is a central flagpole, supported by curved brackets.

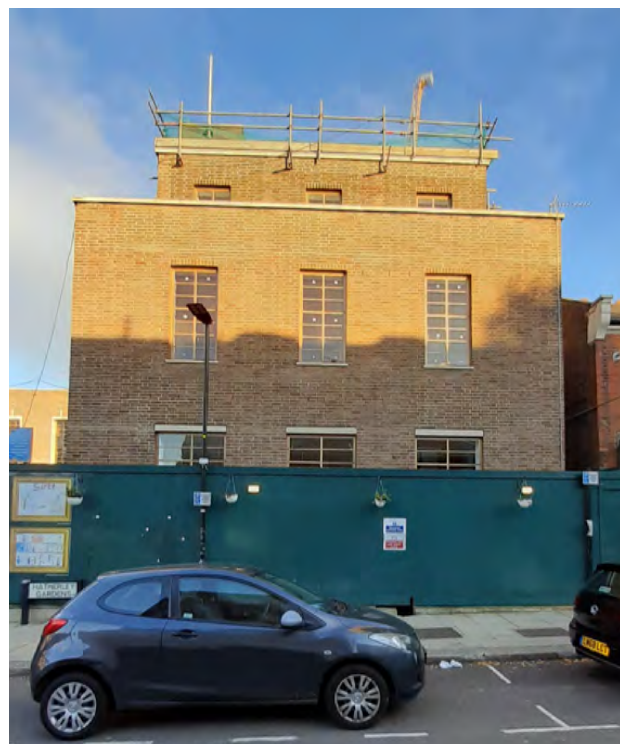
**33** West elevation to southern block

The north elevation of the west office wing is six bays wide. Beneath the first window on the left is the inscribed Portland stone foundation stone. Its ground floor contains squat bronze-framed windows with Portland stone lintels and sills and the first floor contains taller windows with Portland stone sills and brick lintels. There is a set back third floor which is five bays with a three bay return (this contains the former caretaker's flat). There are curved flagpole brackets set between the windows, some are missing / broken and no poles survive. The west elevation of the west office wing is three bays wide and otherwise matches the north elevation, with three further bays to the set back second floor. There is a narrow south elevation to this block, where it abuts No.10 Hatherley Gardens. It contains steel-framed casements and a fire escape stair **[plate 33]**.

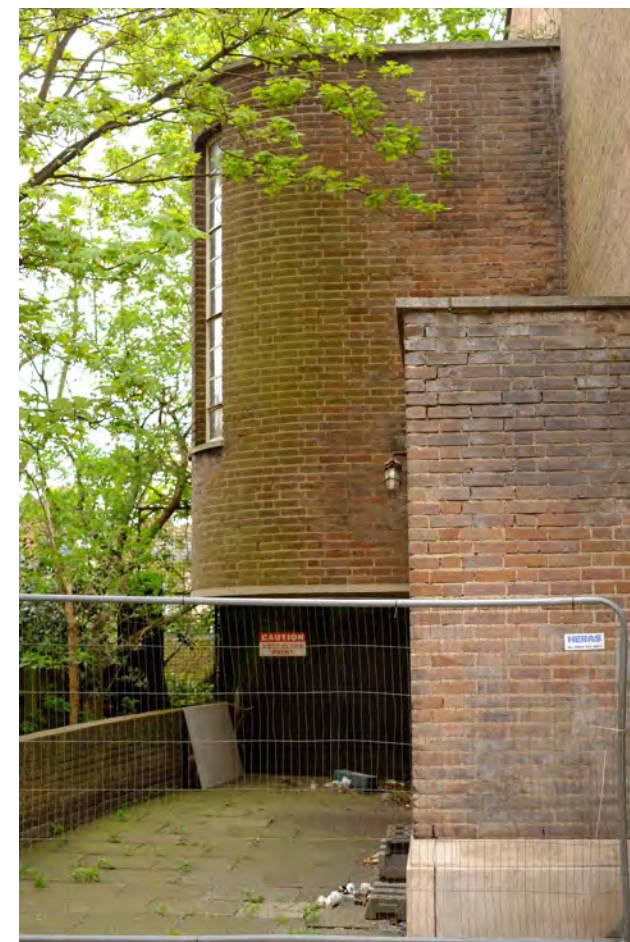
**34** North elevation of the Assembly Hall Block, cantilevered stair (2017)

The north elevation of the Assembly Hall block is largely plain except for the attractive curved cantilevered stair core, which is lit by three tall steel-framed windows **[plate 34]**. The Assembly Hall is lit by five tall narrow steel-framed windows.

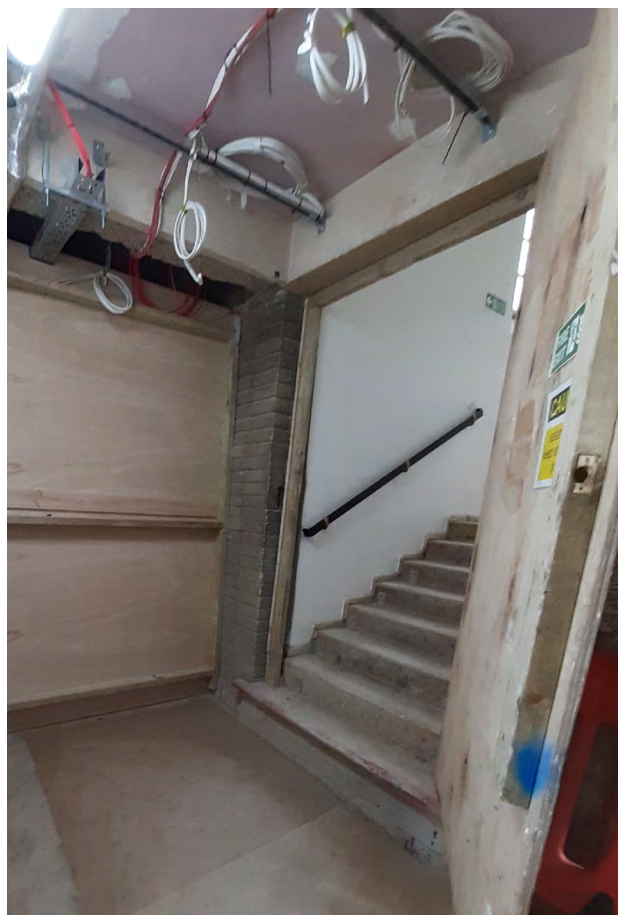
**50A** LG.03 Entrance Hall Basement

**General Description:** Entrance Hall, with access to stair No.6 and lift No.2. Construction works underway.

**Doors:** No timber framed doors or concertina security gate visible (opening boarded during site visit Dec 2022)

**Doors:** (description to lift doors from earlier report as doors not present during site visit) The lift doors were veneered with cross band detail, and framed with yellow terrazzo, with a large concrete lintel over. It has large tripartite timber-framed windows (borrowed lights), which illuminate the rooms beyond (LG.5 and LG.6). Lift doors and tripartite timber framed windows not present during construction works.

**Floor:** Floor covered during construction works.

**Fittings:** Lift call buttons not present during site visit.

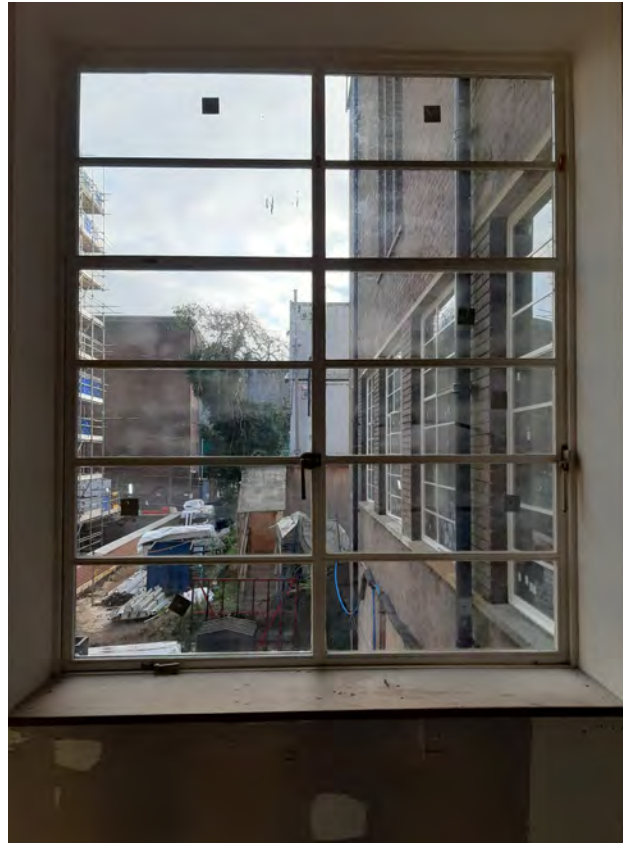
**72A** G.4 Corridor window (original)

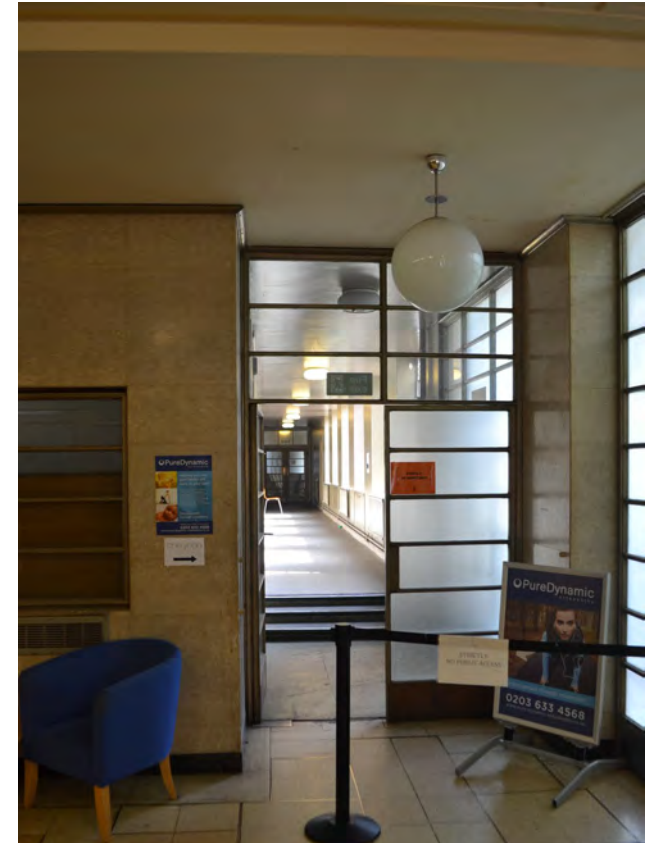
**Floor:** Covered during site visit (2017 inspection noted that this section is carpeted but the cork floor remains beneath [Plate 72B, 2017].

**72B** Ground Floor, G.4 from the Entrance Hall (2017)

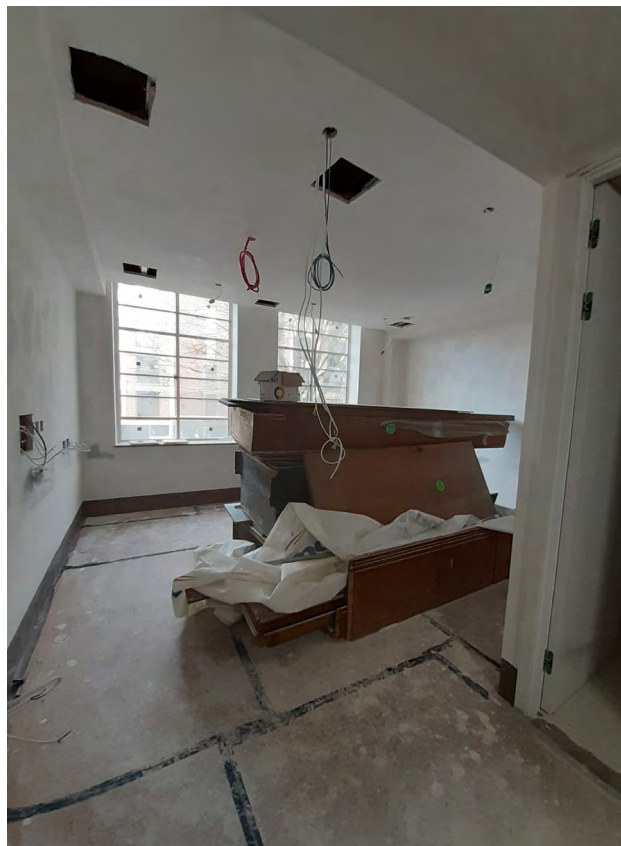
2017 inspection noted that this room (Former Borough Engineer's Office) had full-height panelled walls with Indian silver greywood and teak; set out with cross-banding and glazed and solid panel doors to built-in cupboards. **[Plate 76A]**.

**76** G.15 Hotel Room Former Borough Engineer's Office

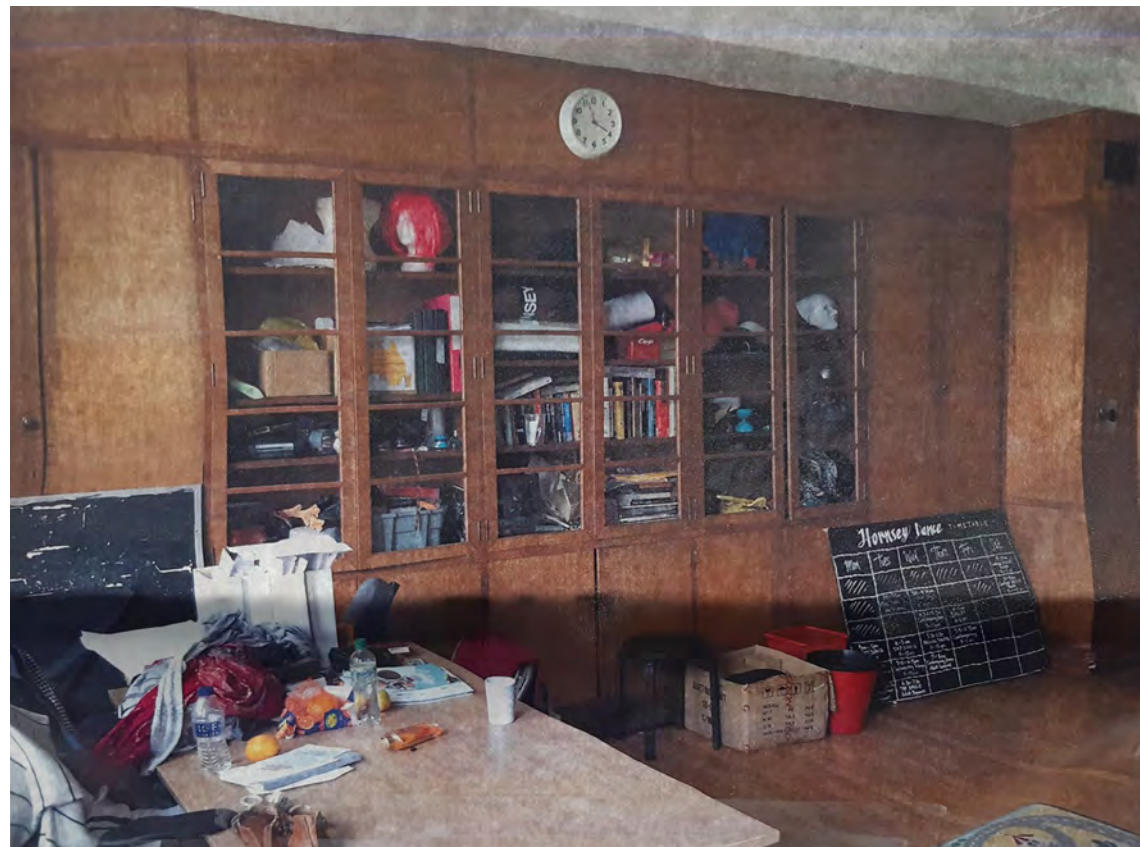
**Significance:** High**Use:** Hotel accommodation.**Ceiling:** Modern plasterboard with services concealed.**Walls:** Painted plaster and modern drylined walls.**Windows:** Two large original steel-framed casements.**Doors:** None during site visit (Dec 2022).**Floor:** Covered during site visit, Narrow timber floorboards.**Fittings:** None during site visit, although original cabinetry to be rebuilt in room **[plate 76B]**.

**76B** G.15 Hotel Room original cabinetry to be rebuilt in room (historic image in room)
