**31 Milton Park, Hornsey, London, N6 5QB**

## **RESPONSE TO COMMENTS RECEIVED FROM HARINGEY BOUROUGH COUNCIL – 07.06.2023**

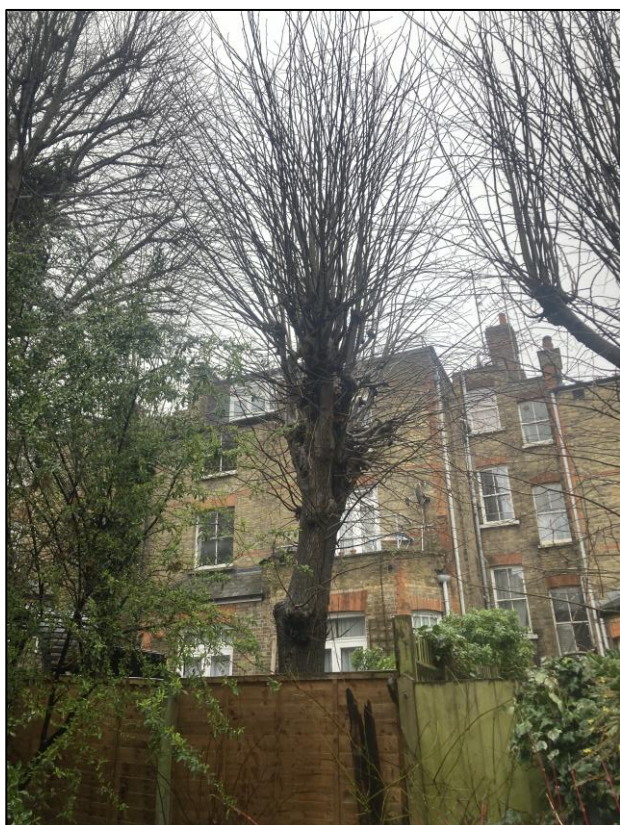
ACD – Trees T4 – T8 do form a linear group, including with additional trees further offsite not picked up in the tree survey to the South, however these x5 specimens in particular have all been historically pollarded far lower than all the neighbouring Lime trees to a height of approximately 5m with crowns of circa. 3m regrowth. Although it is conceded that as a collective group feature these trees could be subjectively categorised as ‘B’, these trees have been surveyed as individuals which are significantly sheltered and not widely visible from the public realm due to their much larger neighbouring trees, and therefore have been categorised as ‘C’.

*Figure 1(left): photo showing tree T8 (which is similar to adjacent trees T4, T5, T6 & T7) and much larger pollarded specimens which can be seen to the Left-hand side of this photo which are over twice as tall and much more significant.*

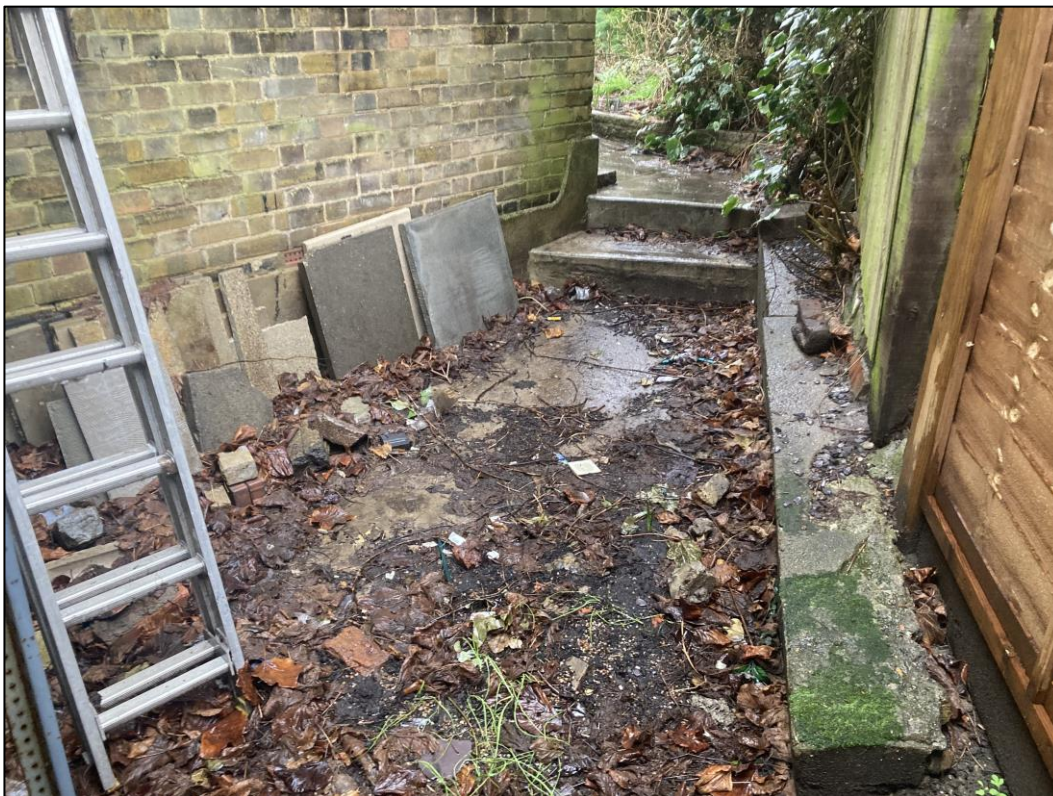
*Figure 2 (left): photo showing existing hardstanding, building and level changes between the offsite tree stems and the proposed area of development which gives rise to unfavourable rooting conditions which will have likely suppressed the development of substantial rooting systems but creates difficulty in amending standard RPAs.*

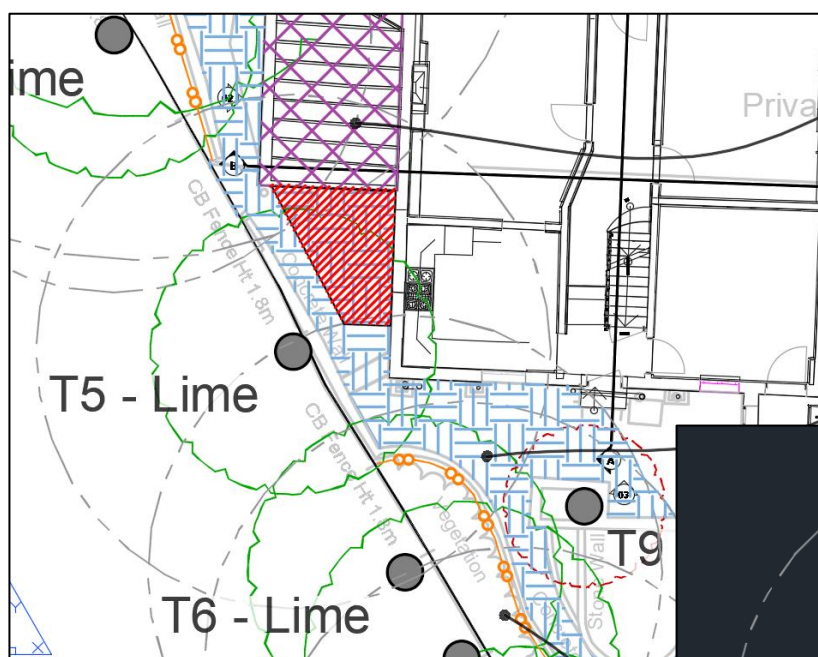
ACD – The area of new construction encroachment into the RPA of T5, which sees the biggest relative incursion into its RPA from the proposals, has been measured in AutoCAD as 5.6% of the overall required RPA area as calculated in line with BS5837:2012 for single stemmed trees ( $\varnothing \times 12$ ) – this area of impact would be further reduced if the RPA were to be offset to favourable rooting medium offsite. It is further considered that the area of proposed incursion is within an existing hard surface of cast concrete, with a noticeable drop in ground levels within the development boundary which will have likely suppressed the establishment of rooting systems in this area. For areas of RPA reaching beyond the shown area of impact, the context of development will not be changing (from building construction/foundation) and therefore no additional impact is considered.

Figure 3 (left): Largest area of proposed relative impact within a standard circular RPA where proposed development sees an increase of intensity and change of context from hard surfacing to building foundation

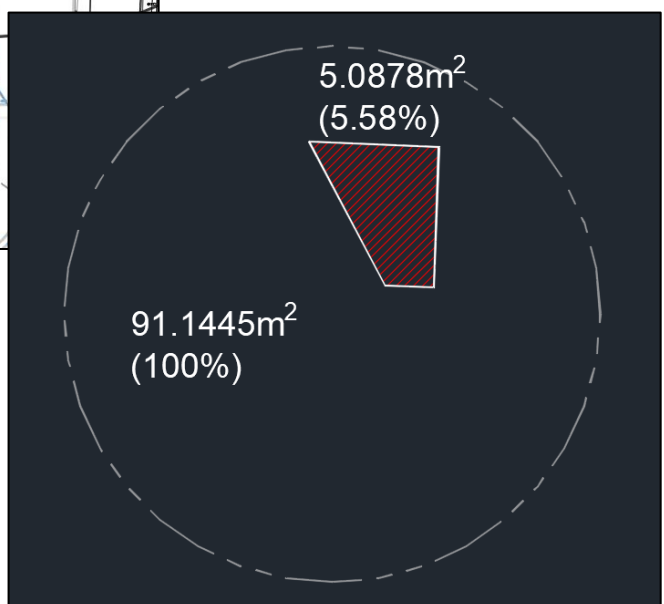
Figure 4 (right): area and relative percentage of the proposed RPA impact .

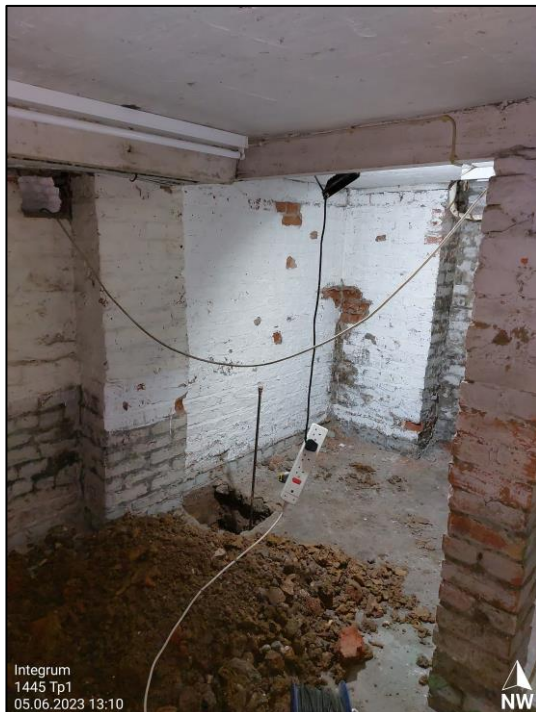
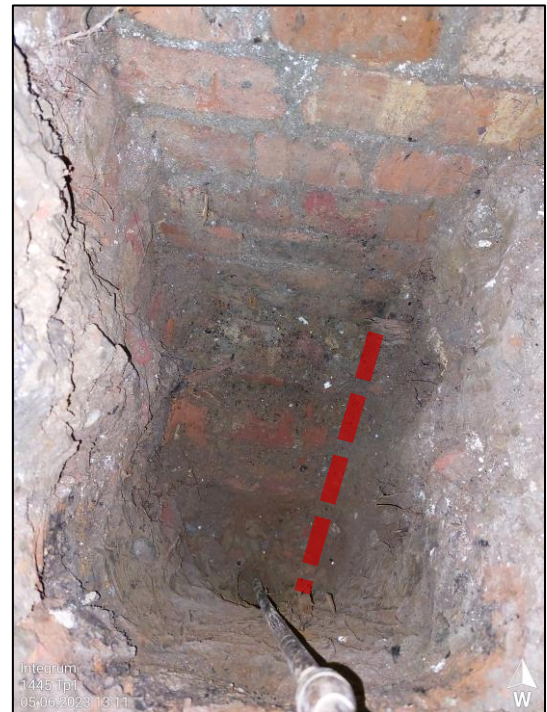
- ACD – Where the proposed development footprint follows the line of the existing brick building foundations, there should be no need to specify bespoke foundation design as there is not likely to be any significant additional impacts to potential rooting systems in these areas. The findings of x2 recently excavated chambers (“TP1” & “TP2”) show that only minimal rooting presence of >10mm<sup>Ø</sup> was found in an area along the proposed area of new foundation line within the RPA of T5 (TP2), and within the existing basement (TP1) where a new staircase is to be installed, a single root of approximately 20mm<sup>Ø</sup> was found – this larger root is on the lower threshold of what would be considered a significant root, however it is far from what would be considered a structural root that has an integral role in relation to the overall stability of a tree.

Figure 5 & 6 (above): TP1 with single root of approx. 19mm – 20mm  $\varnothing$

Even with these findings showing reduced rooting presence, sensitive and supervised methodology is to be used in these areas to ensure that if any large roots are found during further excavations, that appropriate steps which have been agreed and approved by Haringey Borough Council can be followed.

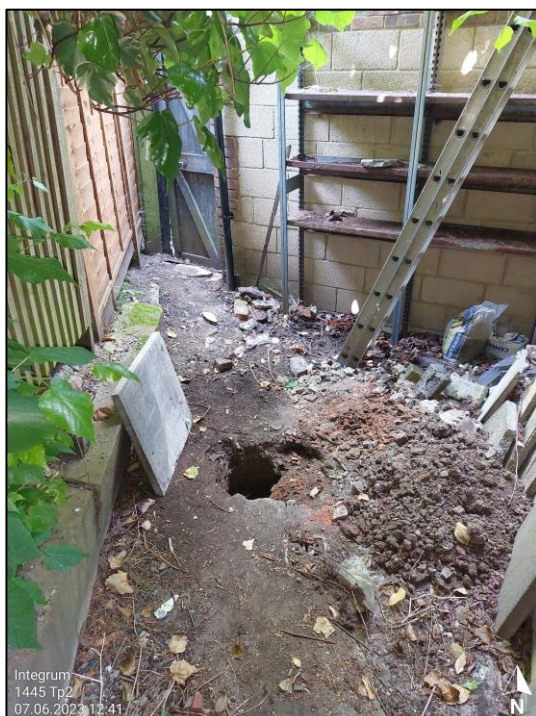
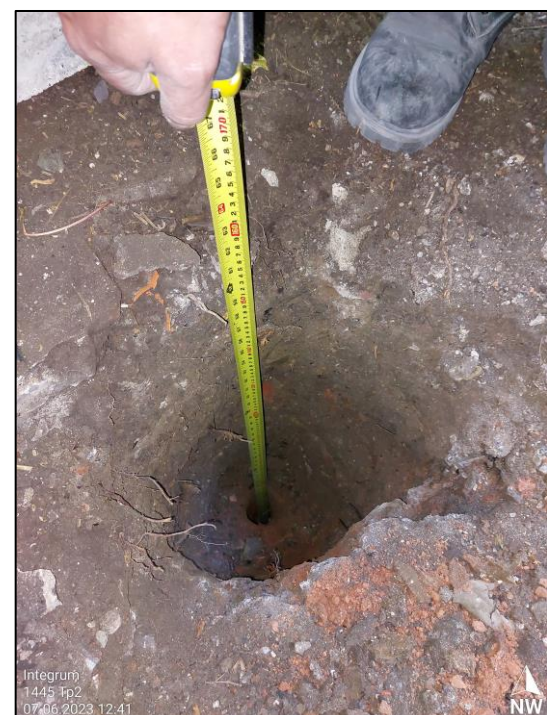
Figure 7 & 8 (below): TP2 with sparse multiple small roots <10mm  $\varnothing$

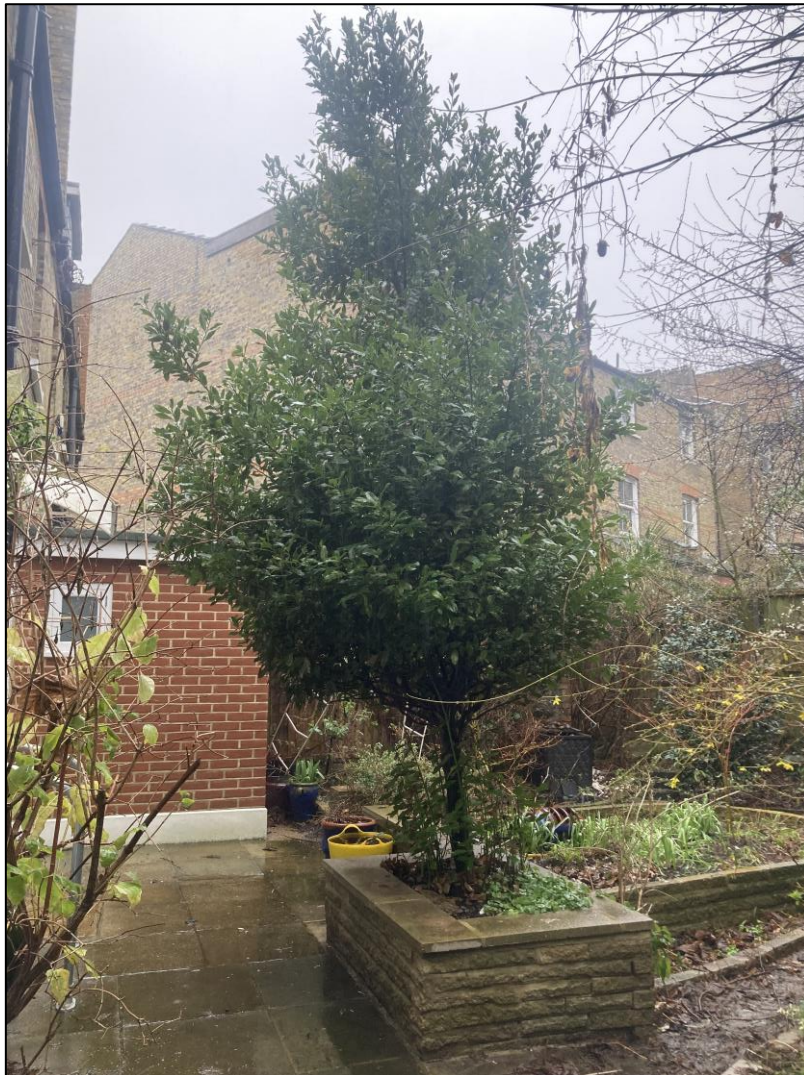
*Figure 9: T9 – Bay tree proposed for removal.*

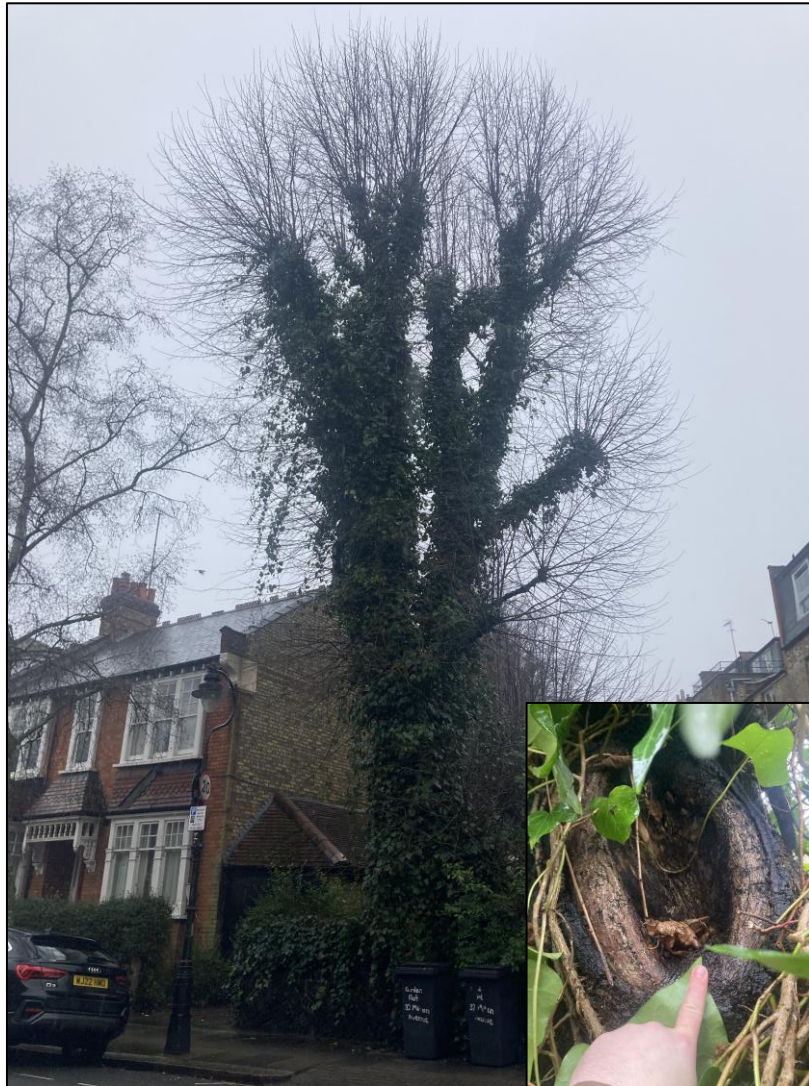
*Figure 10: T3 – Ivy smothered Lime tree at the front of the property with a historic cavity in the stem.*

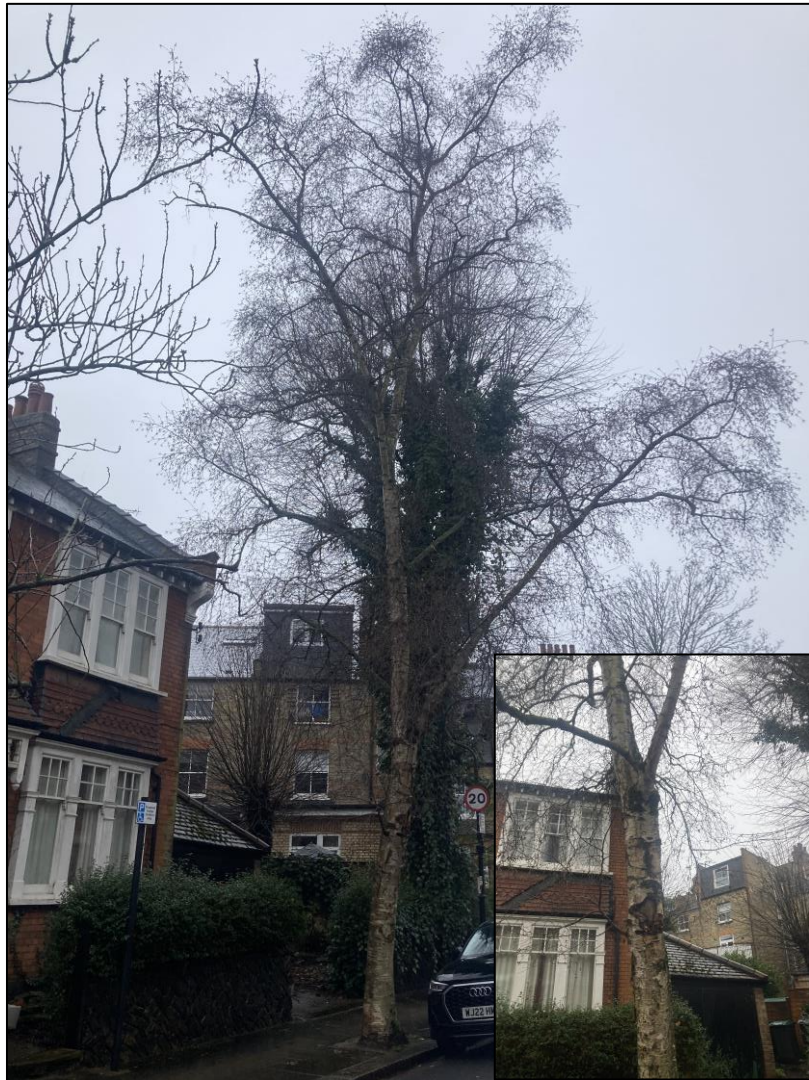
*Figure 11: T2 – Birch tree located at front of property with cambium damage on stem.*

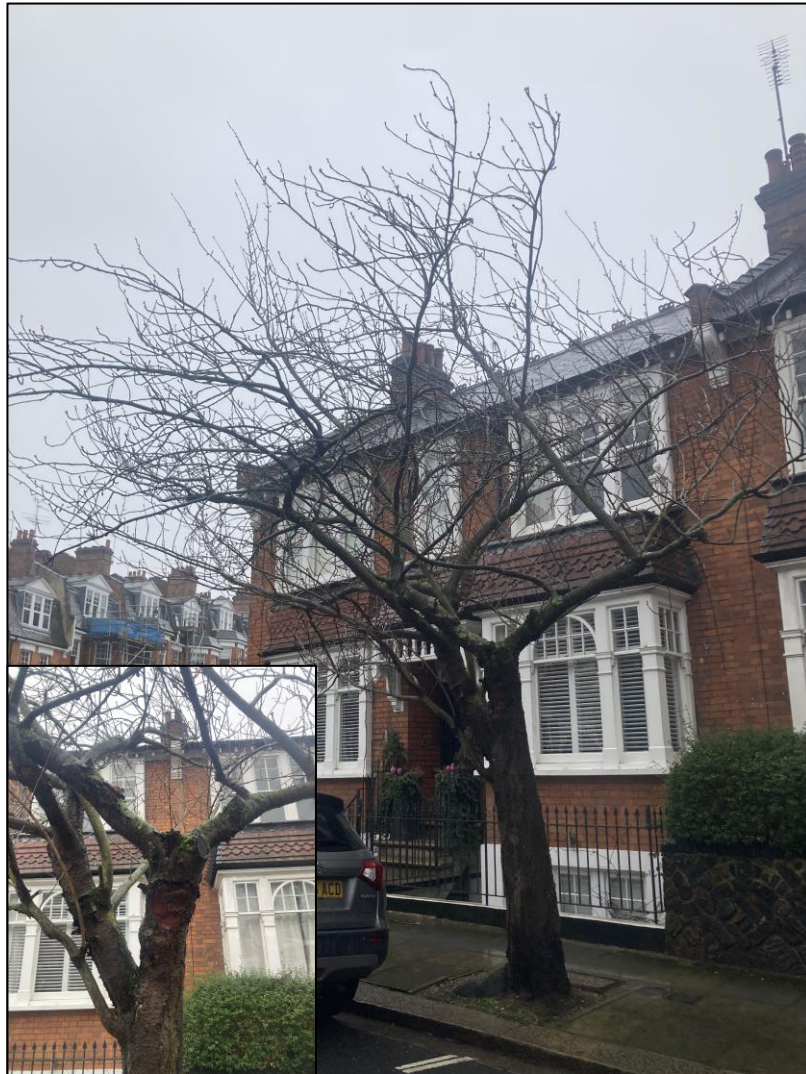
*Figure 12: T1 – Cherry tree located at front property with historical cambium damaged on stem*
