THE  
CHOCOLATE  
FACTORY

## Arboricultural Impact Assessment Report

ARBORICULTURAL IMPACT ASSESSMENT REPORT  
BS 5837:2012 'Trees in relation to design, demolition and construction.  
Recommendations'

5 Clarendon Rd, London N22 6XJ

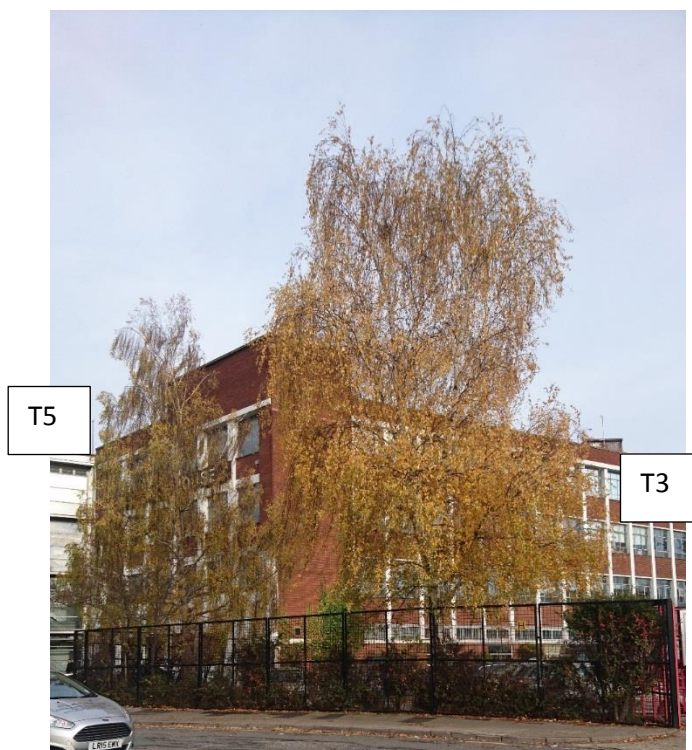
*Photo 1 of T3 and T3 from Clarendon Road*

The two silver birch trees are in a good condition and provide a high level of visual amenity. They are 13m high with a crown spread of approximately 6 – 8m. They are classified as T3 B1 and T5 A1. The root protection area for T3 equates to a circle with a radius of 4.2m and extends within the pavement. T5 has a root protection area of 4.3m which extends into Parma House, under the bike shed.

The silver birch trees' root protection areas extend under the pavement and bike shed. It is proposed that the surface will change, and that the bike stand will be removed.

Therefore, this report includes method statements at appendix 5 to ensure that root integrity and function remain. The proposed change to block paving is an improvement as it will allow gaseous exchange and water infiltration to the roots. The areas to which these method statements apply is shown on the plan *SHA 260 TPP* by blue cross hatching.

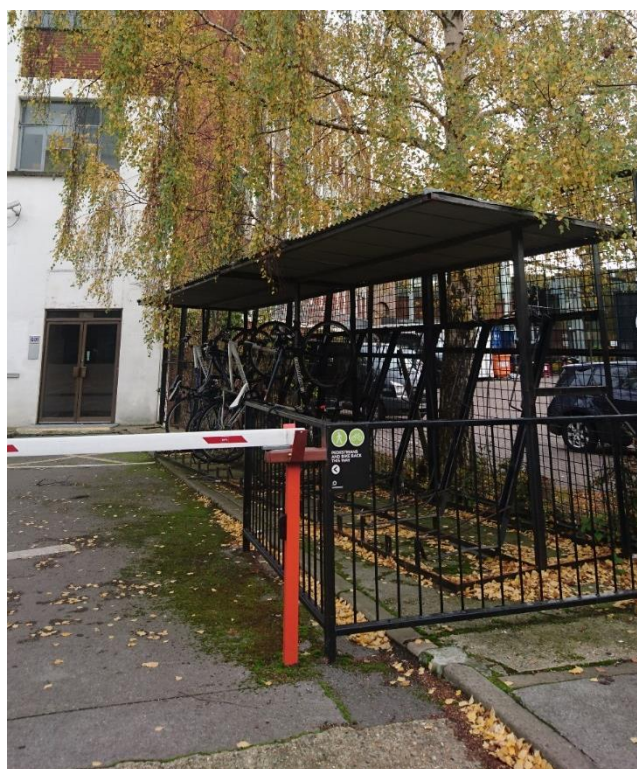
*Photo 2 of T5 looking east along the boundary of Parma House. Note how the crown overhangs the bike shed.*

| Tree ID | No. | Species | Height (m) | No. of stems | STEM DIAMETER (cm) | | | | | CROWN SPREAD (m) | | | | Crown Clearance (m) | Life stage | Condition Notes | Recs | RPA (m <sup>2</sup> ) | RPR (m) | Life expectancy (yrs) | BS Category |
|---|---|---|---|---|---|---|---|---|---|---|---|---|---|---|---|---|---|---|---|---|---|
| Tree T5 | 1 | Betula pendula 'Tristis' (Silver Birch cv.) | 13.0 | 1 | 36 | | | | | 4.0 | 4.0 | 4.0 | 4.0 | 2.0 | Mature | Structural condition - Good. Physiological condition - Good. Deadwood - Minor. Form - Good crown structure. No significant faults observed. Pruning wounds - Historic. This tree is growing in a planting bed between a car park and the site. It is a very good example of the species and provides a high level of visual amenity. The crown overhangs the bike shed on the site. | | 58.6 | 4.3 | 20-40 | A1 |

- Carry out the crown lifting to T5 (4m over the site boundary, as described in the tree surgery schedule)
- Remove the above ground structure in the normal way in accordance with the contractors Risk Assessment and Method Statement
- Remove any deeper posts with care. Any roots found entwined around the post to be pruned cleanly with bypass secateurs and the hole backfilled with good quality top soil.
- The method statement for removal of hard surfacing applies.

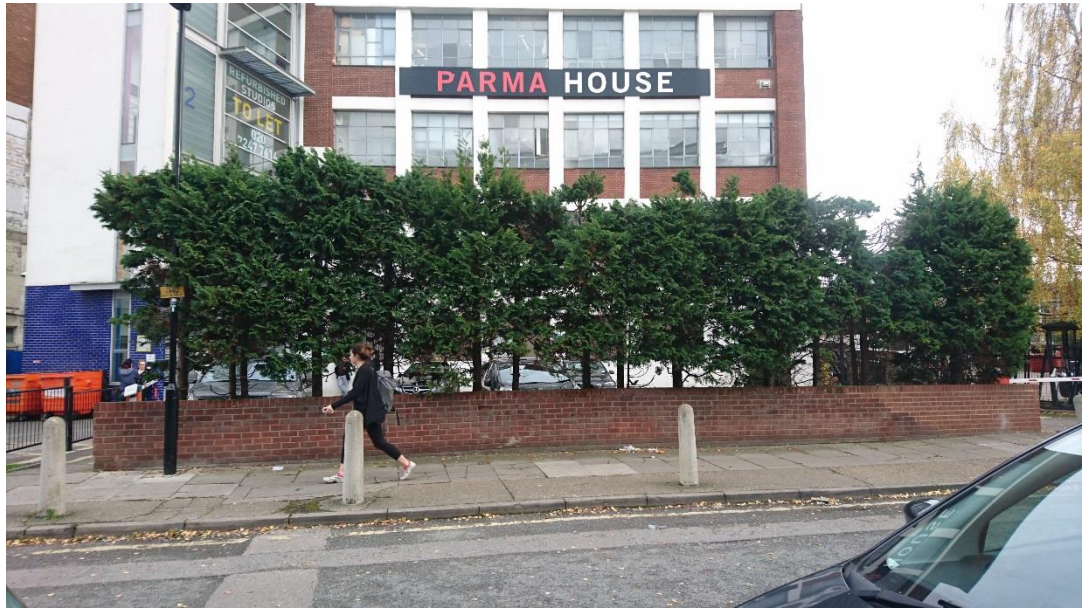
*Photo 3 of G7 looking east from Clarendon Road*

G7 is a group of regularly topped Lawson cypress growing in a strip of land between the car park and the pavement, fronted by a low brick wall. Two of the trees are dead. They are classified as C under the BS (low value). They provide a screen, but are a common and widespread species which provide little benefit to the area. They should not be a constraint on development.

| Tree ID | No. | Species | Height (m) | No. of stems | STEM DIAMETER (cm) | | | | | CROWN SPREAD (m) | | | | Crown Clearance (m) | Life stage | Condition Notes | Recs | RPA (m <sup>2</sup> ) | RPR (m) | Life expectancy (yrs) | BS Category |
|---|---|---|---|---|---|---|---|---|---|---|---|---|---|---|---|---|---|---|---|---|---|
| Group G7 | 13 | Chamaecyparis lawsoniana (Lawson Cypress) | 4.0 | 1 | 20 | | | | | 1.0 | 1.0 | 1.0 | 1.0 | 1.5 | Early Mature | Structural condition - Fair. Physiological condition - Good. Arboricultural work - Historic. Deadwood - Minor. This line of Lawson cypress are growing in a line between a 1m high wall and the car park. The second tree (from the south) is dead and the third in decline. They have all been topped at 4m and maintained to form an approximately flat fronted profile. | | 18.1 | 2.4 | 20-40 | C2 |

*Arboricultural impact assessment: Fell to facilitate construction.*

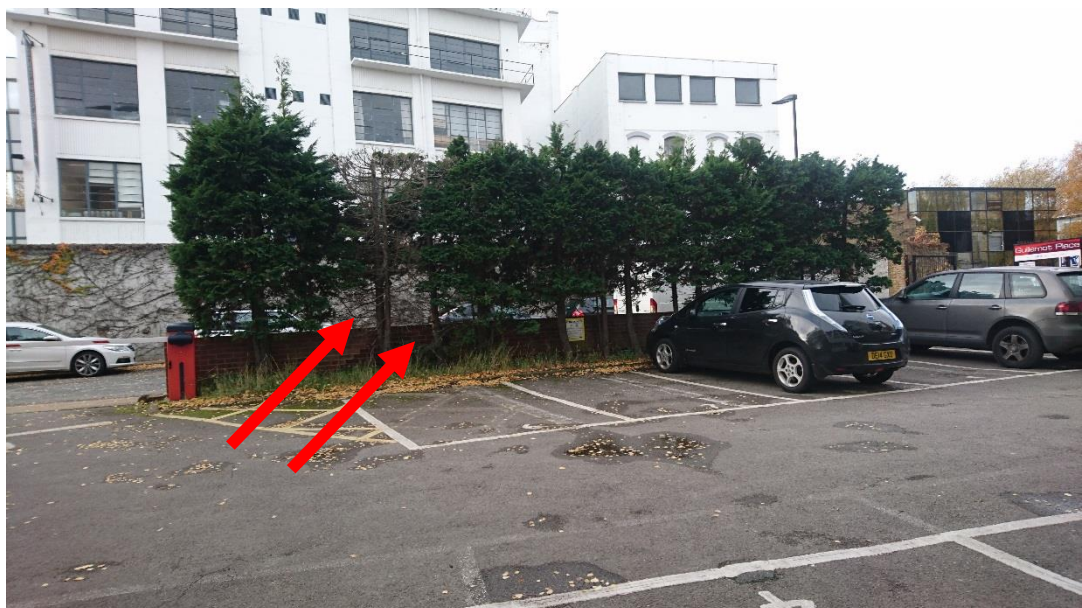
*Photo 4 of G7 looking west from the car park. Two dead trees are shown by the arrows.*

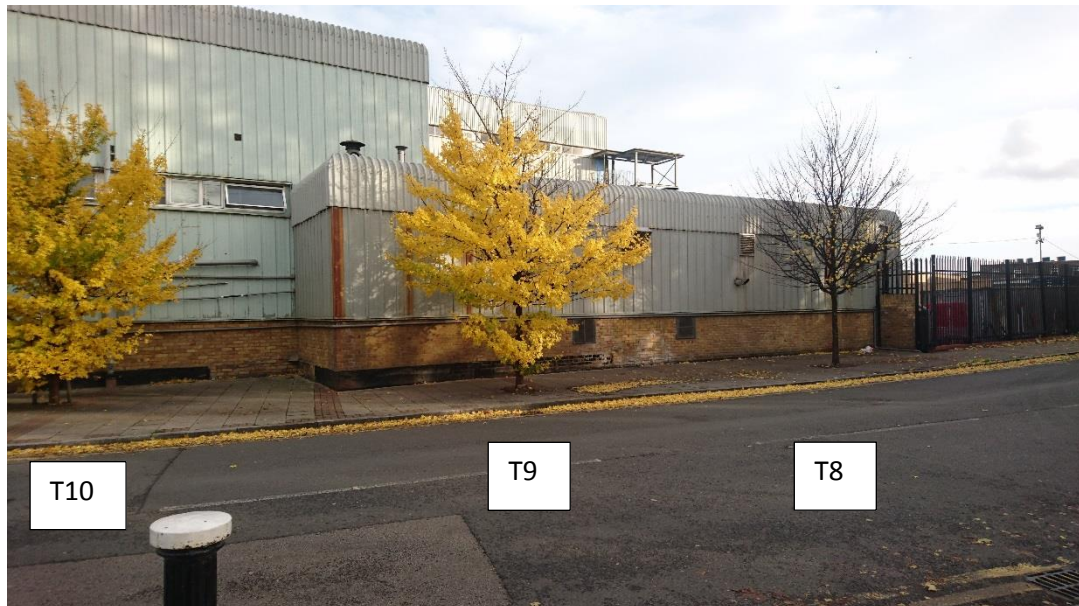
*Photo 5 of T8 – T10*

These four trees are growing in the centre of the pavement fronting Western Road. They are in good health and will provide a high level of visual amenity when they mature. They currently have small root protection areas (averaging 1.6m radius) and crown spreads (averaging 2m radius). A mature field maple will typically have a 4m radius.

*Arboricultural impact assessment:* T10 and T11 will need to be removed to facilitate the new access. As the trees are Haringey Council street trees, consent is required from Haringey Council and they will seek a financial contribution, most likely including CAVAT calculations <https://www.ltoa.org.uk/resources/cavat>. In this case the two trees have a CAVAT valuation of £3,504 each. The financial cost will also include tree removal, officer time and replacement elsewhere. The total cost is therefore likely to be at least £10,000. The CAVAT tables for the two trees are found at appendix one.

T8 and T9 will be retained. Crown lifting is recommended and the trees need to be cut back slightly to enable demolition. The trees are young enough to re-grow and establish a full, balanced crown. The site hoarding will be erected along the boundary for demolition and to protect the footpath. The demolition is outside the root protection area of the trees.

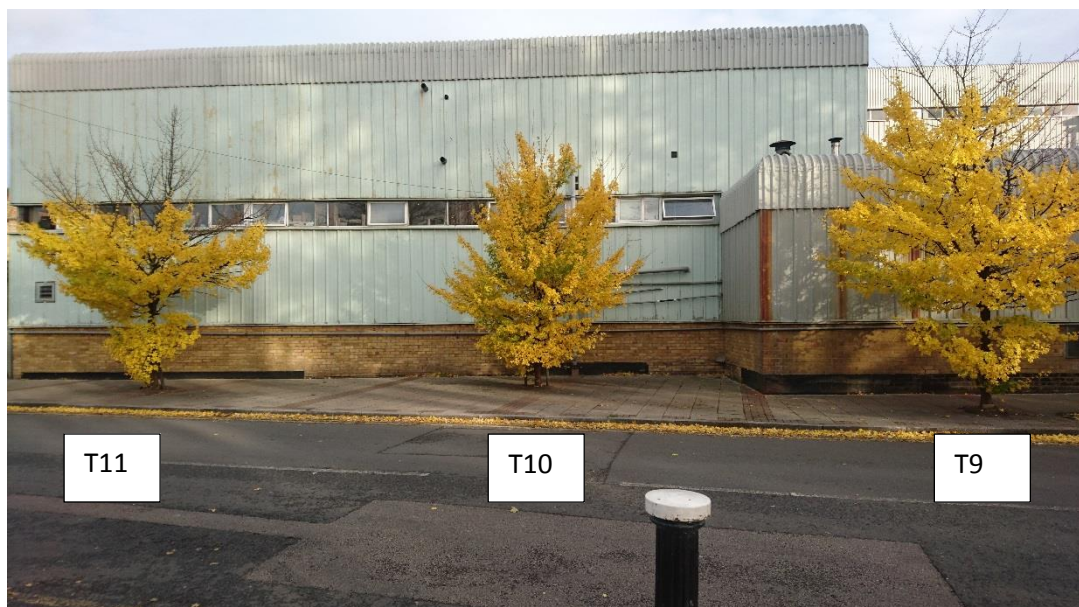
*Photo 6 of T9 – T11*

| Tree ID | No. | Species | Height (m) | No. of stems | STEM DIAMETER (cm) | | | | | CROWN SPREAD (m) | | | | Crown Clearance (m) | Life stage | Condition Notes | Recs | RPA (m <sup>2</sup> ) | RPR (m) | Life expectancy (yrs) | BS Category |
|---|---|---|---|---|---|---|---|---|---|---|---|---|---|---|---|---|---|---|---|---|---|
| Tree T9 | 1 | Acer campestre 'Elsrijk' (Field Maple cv.) | 7.0 | 1 | 13 | | | | | 2.0 | 2.0 | 2.0 | 2.0 | 1.5 | Semi Mature | Structural condition - Good. Physiological condition - Good. Epicormic growth - Bole / principal stems. Form - Good crown structure. No significant faults observed. One of four attractive street trees growing in the pavement. Dense growth of maturing epicormic shoots on the western aspect. Tips of the crown are touching the building. The roots are lifting the resin bonded gravel. | | 7.6 | 1.6 | 20-40 | B1 |

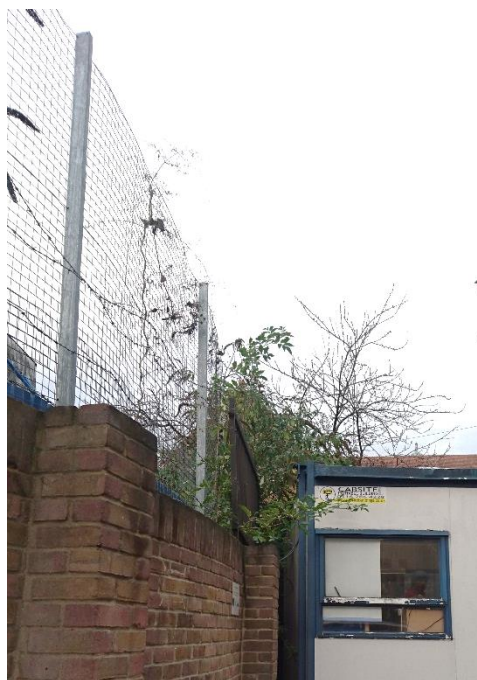
*Photo 7 of the butterfly bush and apple*

There is a small apple and butterfly bush behind the boundary wall on the north-west corner and a fig tree near the mid – east corner. Neither tree constrains development due to their size, and both are low value.
