**The Dominion Centre  
Wood Green  
London  
N22 6DS**

**Specification for structural  
investigations**

| Project No | 860/01 |
| Date | 17 July 2023 |

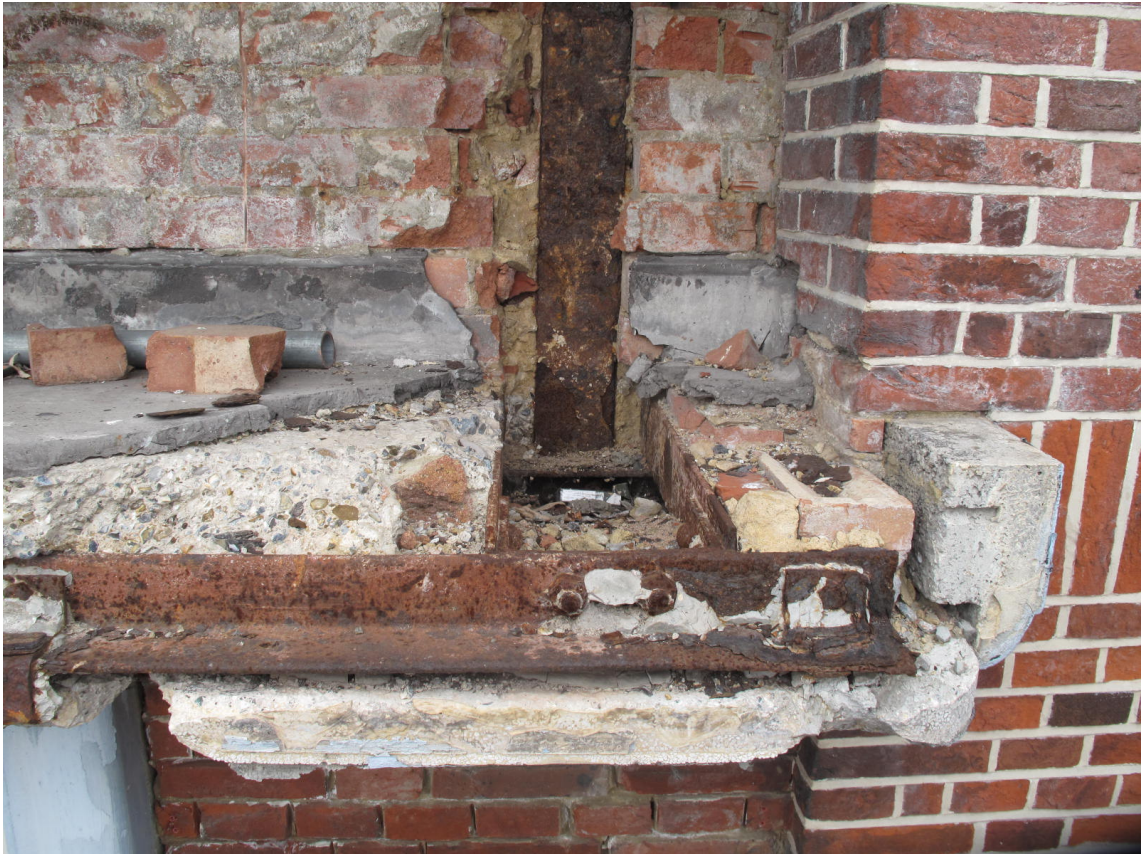
3. Area 2 on drawing SK 2

- 2.1 The existing structure at high level on the main, front elevation is shown on Stand drawing No. SK 1. The investigations are shown on drawing No SK 2 revision P2.
- 2.2 The contractor is to remove brickwork and concrete in the areas shown on drawing No. SK 2 to expose parts of the steel frame.
- 2.3 Provide attendance during the visit of the structural engineer to carry out further opening up where instructed.

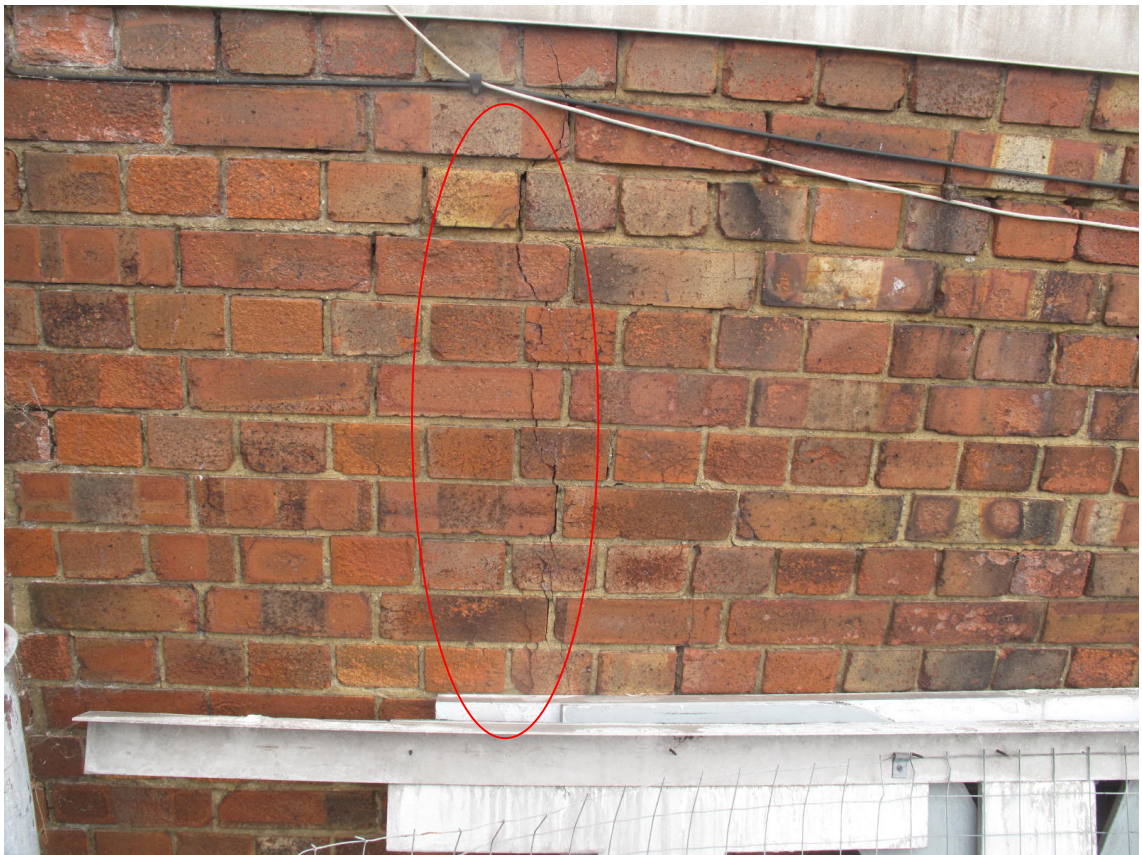
5. Detail of cracked brickwork to rear of front elevation to be investigated

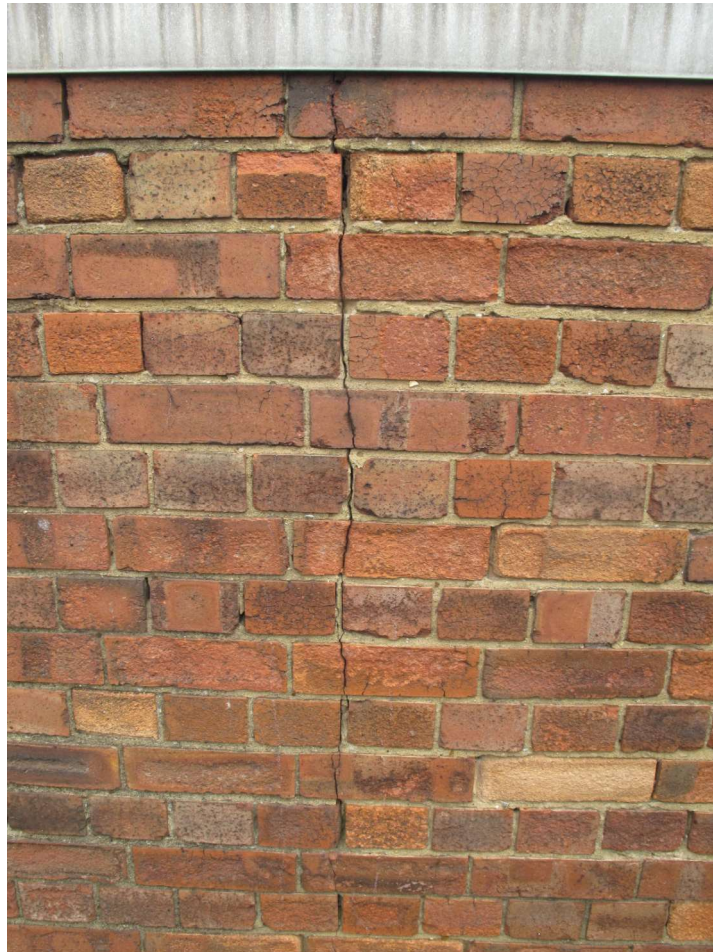
7. Crack in side elevation to be investigated
