D: Foyer (Entrance Hall)

Entrance Hall

Drawing Title  
Joinery  
Barista Room G.40  
Kitchenette and bar

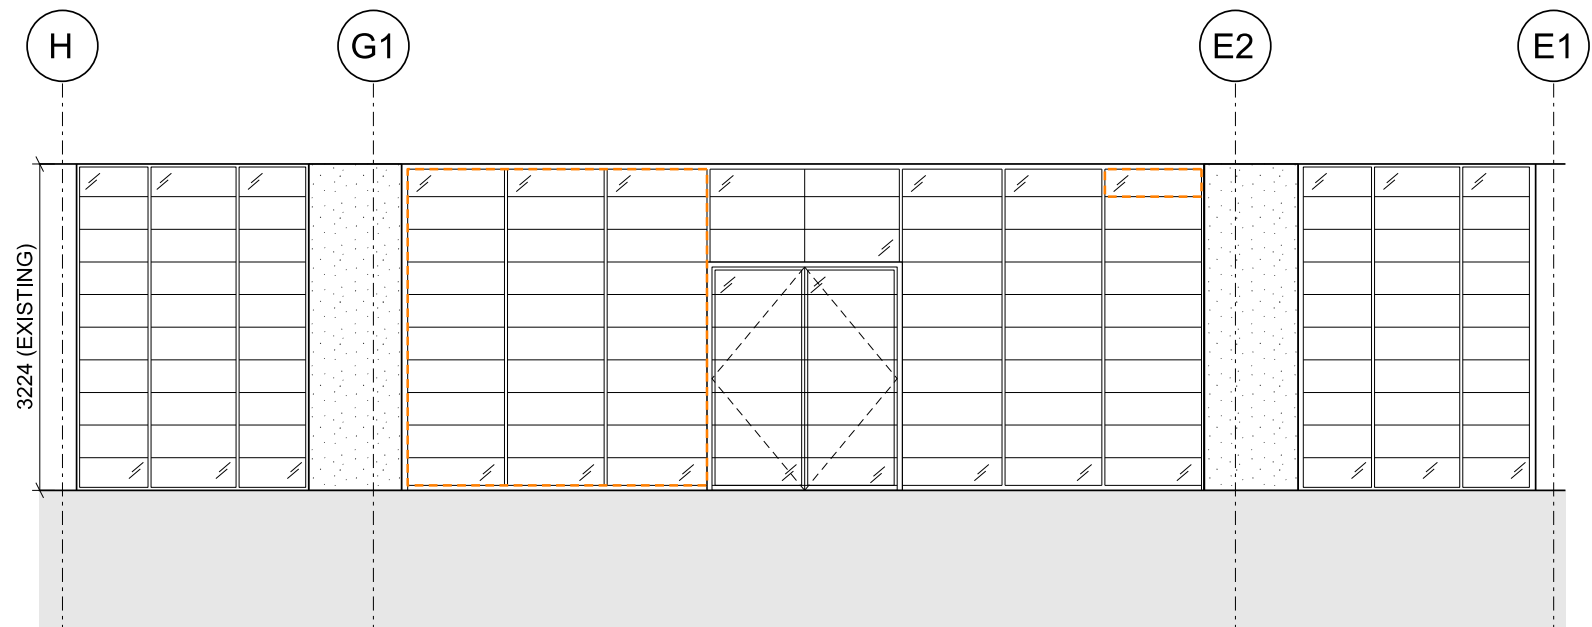
02 Internal Elevation

LATER GLASS REPLACEMENT (PYROSHIELD GEORGIAN WIRED GLAZING) TO BE REMOVED AND NEW GLAZING TO MATCH EXISTING RESTORED. EXISTING FROSTED FILM TO BE REMOVED.

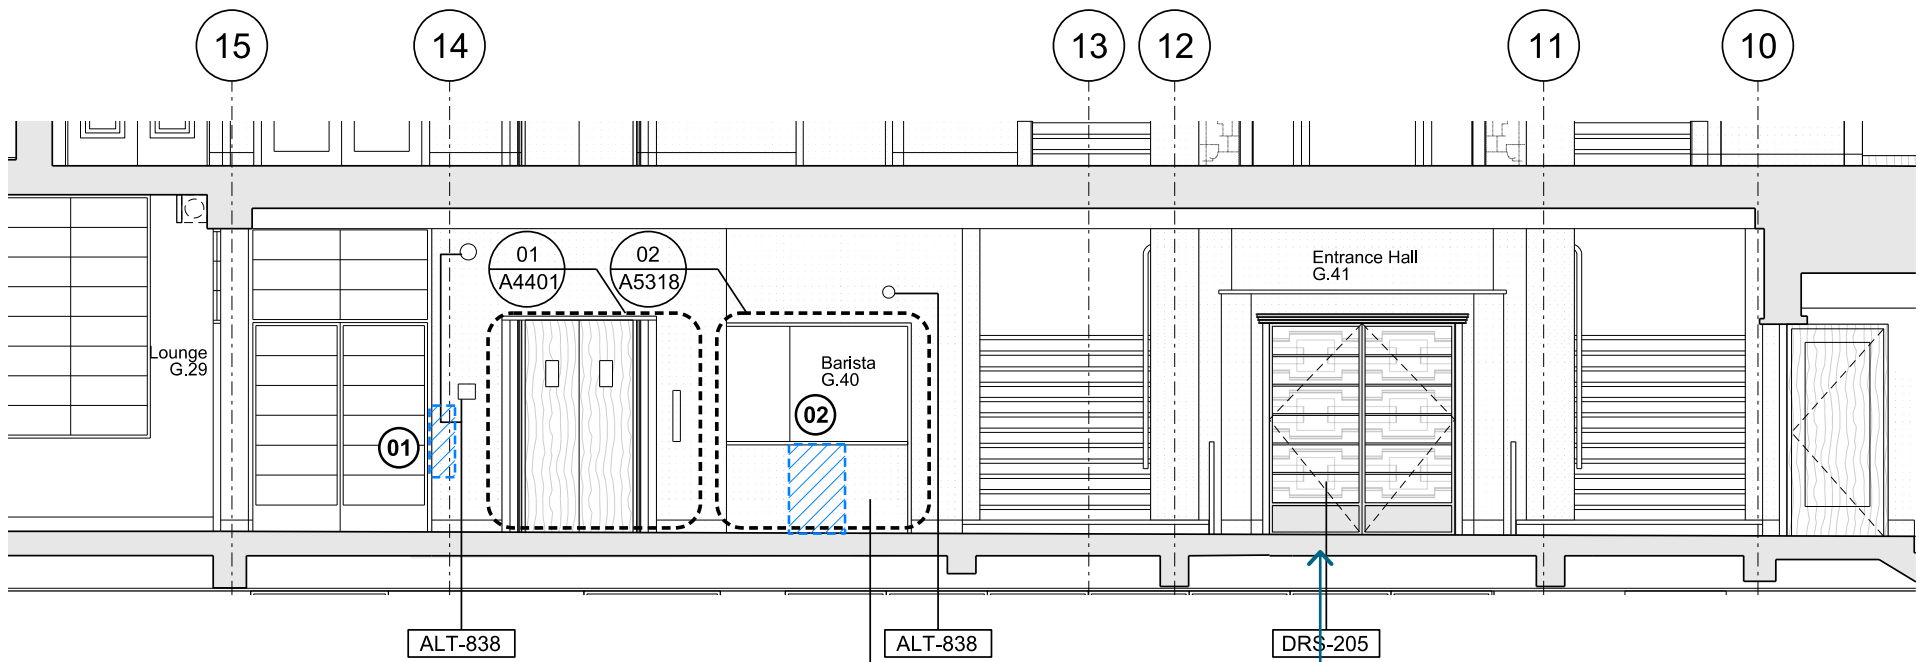
03 Internal Elevation

Original glazing with opaque film to be removed

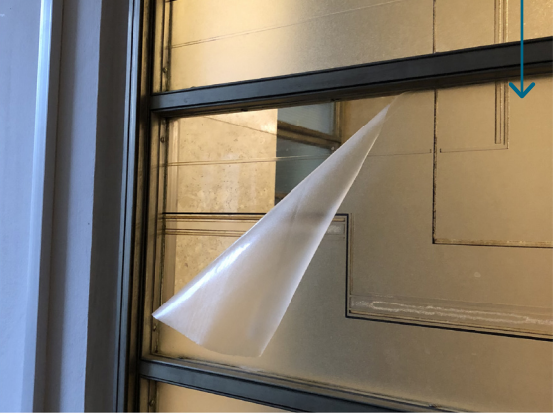
Existing crittall frame unit with doors is to be retained and refurbished. Opaque films as shown above are to be removed. Some glazing has previously been replaced with Georgian wired glass, these are to be replaced with new glazing with matching decorative pattern.

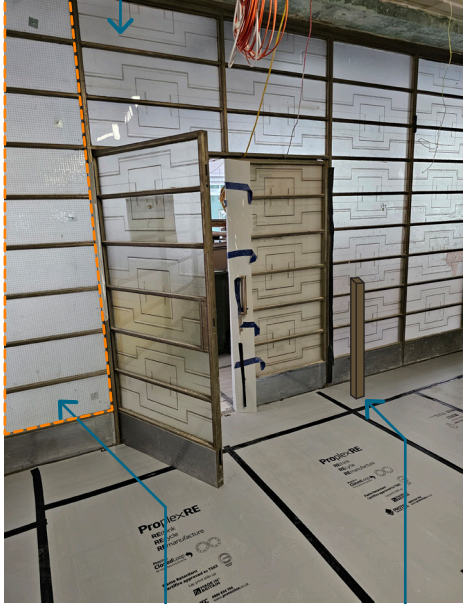
Later replacement Georgian wired glazing to be removed and replaced

New access post to be introduced, finish to match repaired screen. This is to removed the requirement to intrusively drill or attach into the existing screen.

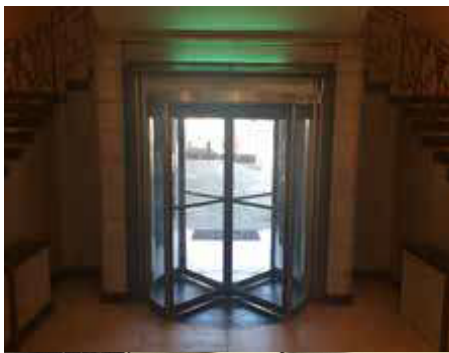
Entrance door to be replaced with replica door to match original that had previously been replaced by a revolving entrance. Door to be supplied by Crittall to closely match existing structure as possible and it to have matching ironmongery, with decorative films to the glazing to repeat the existing pattern.

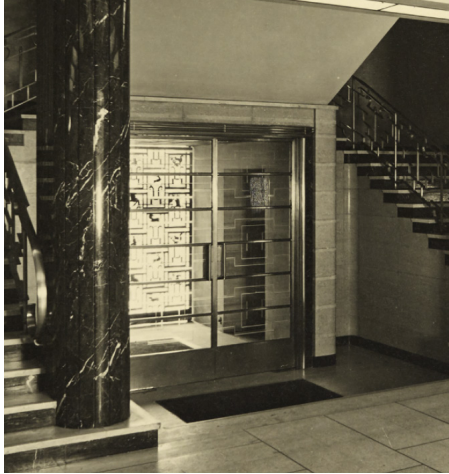
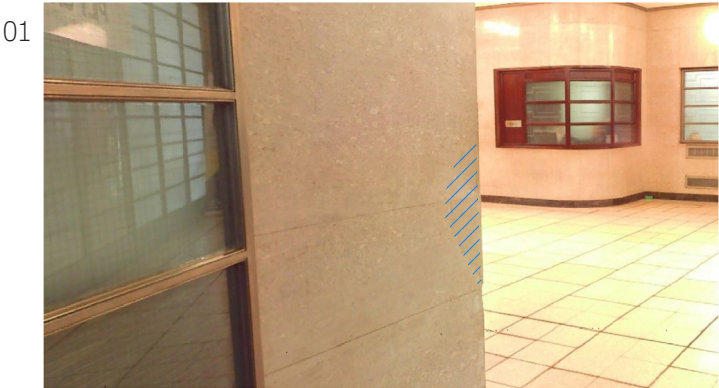
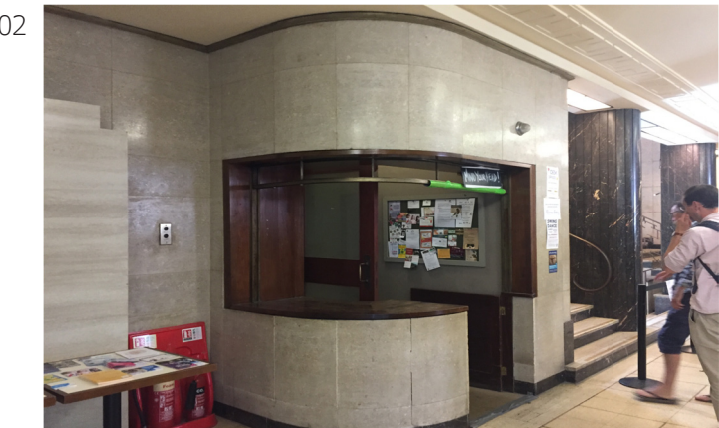
ALT 418 - Refurbishment of existing stone work

Lose panels are to be fixed back in place, 'fake stone' from previous refurbishment is to be replaced, minor cracked stone work to be re-bedded and crack resealed using matching resin, hairline cracks are to be left in situ. All replacement or new stonework is to be from salvaged stonework from foyer as refurbishment strategy.

01 - picture and labelled on elevation shows area were particular stone shown is known to be 'fake stone' from previous repair works.

02 - picture and labelled on elevations shows example of cracked stone that has come lose from its bedding. As noted on the drawings the counter is to be in-filled, this will be using salvaged stone similarly to the wider refurbishment strategy.

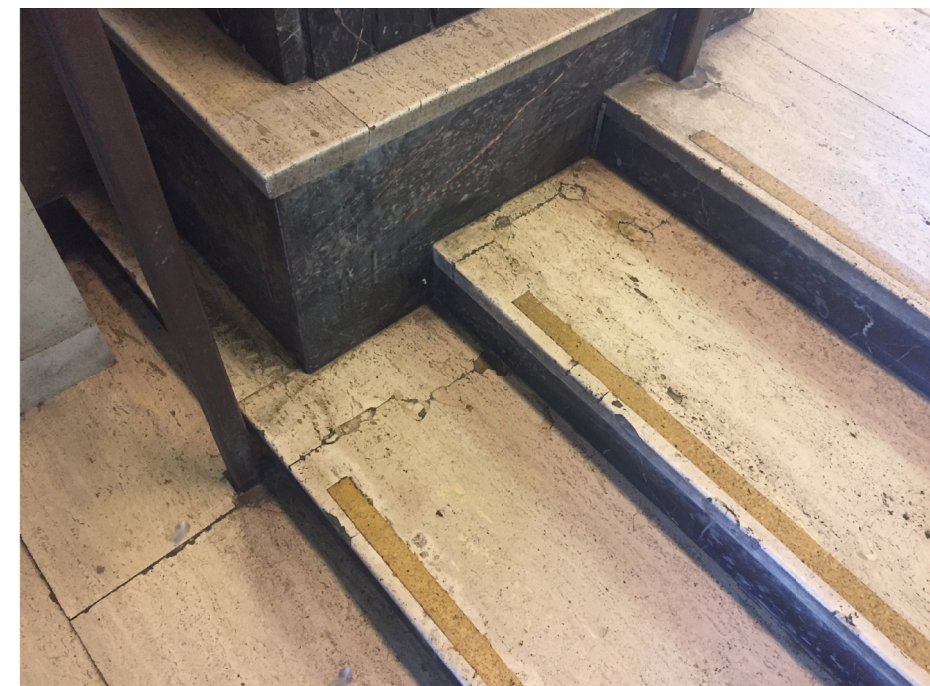
ALT-415 - Stone Floor Repairs  
Travertine stone is used within the entrance and borders the terrazzo across the main entrance area. Floor showing sign of damage. Cracking to be repaired with a matching resin by stone specialist, with hairline cracks and minor wear and tear are to remain in situ. Lose stone to be re-bed.

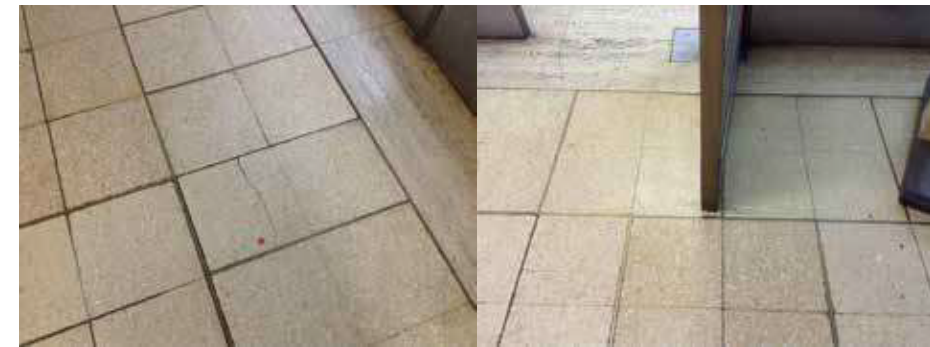
ALT-411/412 - Terrazzo Floor and Skirting Repairs  
Existing terrazzo flooring is made up of cream tiles with brass expansion joints, localised areas contain mostly hairline cracks with some tiles showing larger sections of damage. Larger sections of damage are to be repaired as the proposed method statement with hairline cracks and wear and tear to be left in situ.

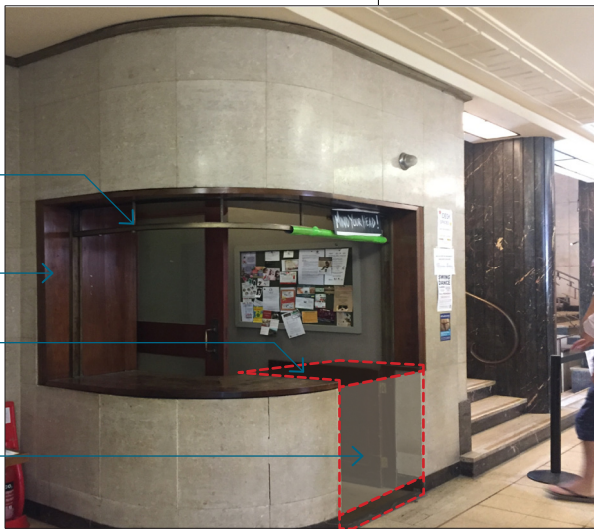
- Metal frame replaced with replica and integrated LED lighting
- Existing joinery refurbished
- New infill to surface - to match existing
- Salvaged stone to be used to infill existing gap

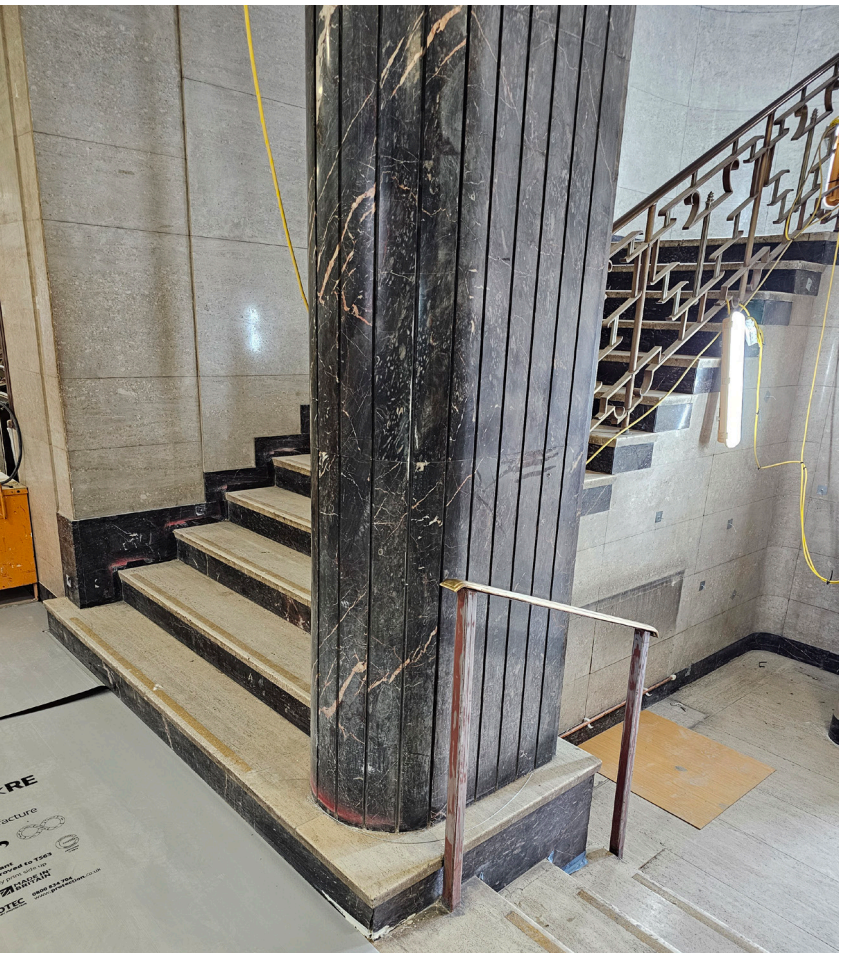
Ashburton Marble is used in feature columns and across the skirting line, it is in good condition, any loose tiles are to be re-bedded, small cracks are to be filled with a matching resin with hairline cracks and general wear maintained.

- Existing bench to be refurbished and reupholstered.

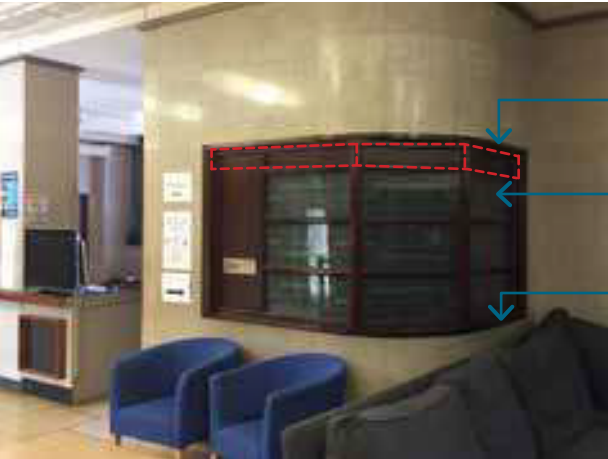
- Replica metal frame matching barrista room
- Un-original glazed screen to be removed back to timber top and bottom
- Joinery surface to be refurbished

ALT-563 - Re-purposing of Existing Joinery  
Existing joinery to be refurbished and re-purposed as a barrista room. The existing metal frame is to be replicated with new LED trims, with existing timber top refurbished and a refill of the opening with matching stone work. As submitted drawing A5381

ALT-563 - Re-purposing of Existing Joinery  
Existing hardwood top to be refurbished, with metal frame to be replicated with new LED strip lighting as barrista room and non-original screen to be removed. With new joinery fitted below existing top and behind. As submitted drawing A5319

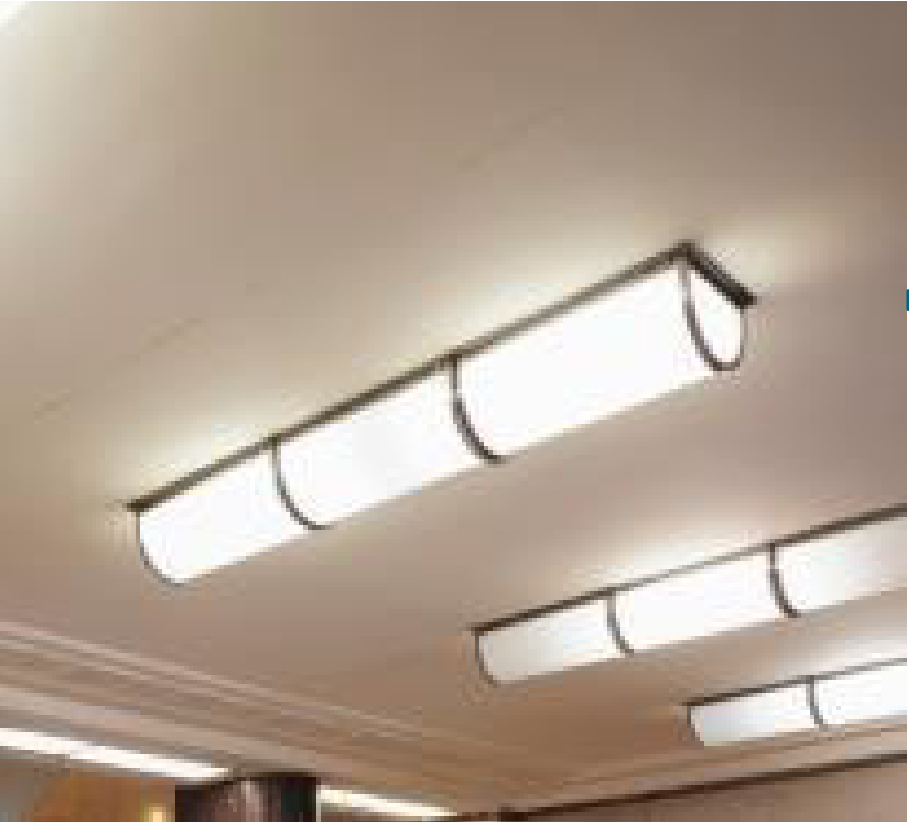
Existing half barrel strip lights X4, 345 radius, 1607 in length are to be relamped and refurbished and restored to original positions.

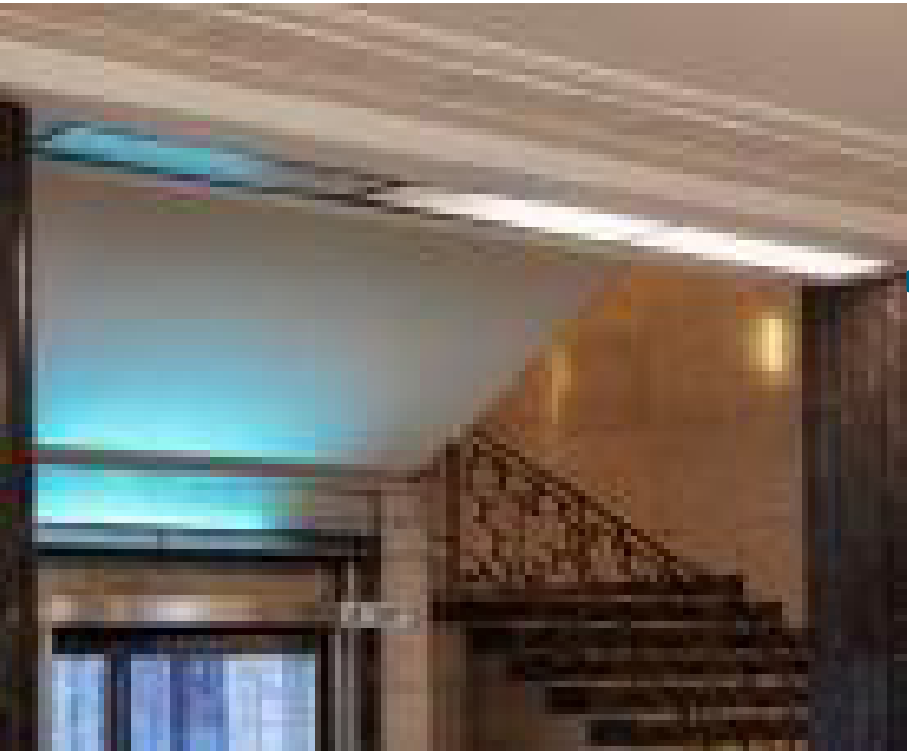
Light panels X9 & X10 between feature columns at entrance are to be relamped, refurbished and restored in original location.

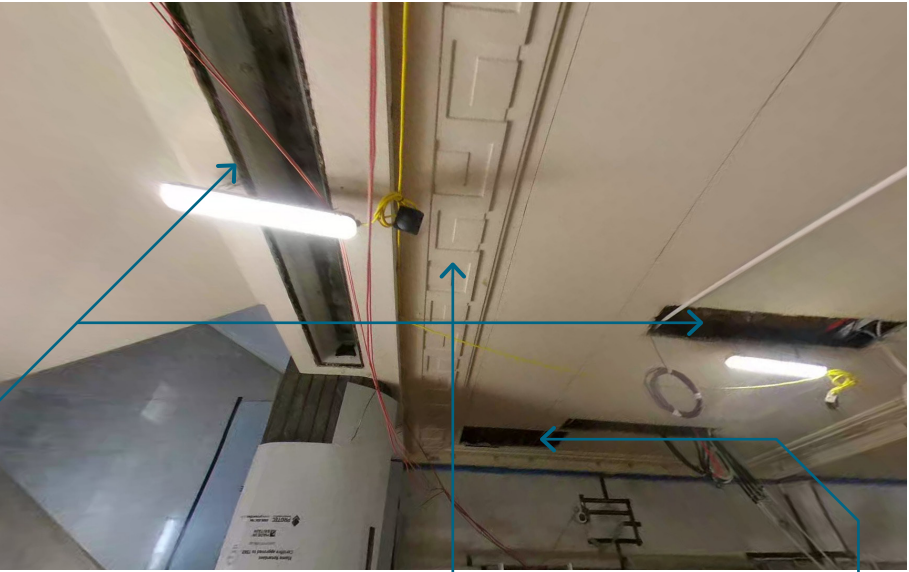
Ceiling lights removed during construction for protection and as part of refurbishment and re-lamping. Existing openings were viable used as access to feed services to reduce number of openings required during construction.

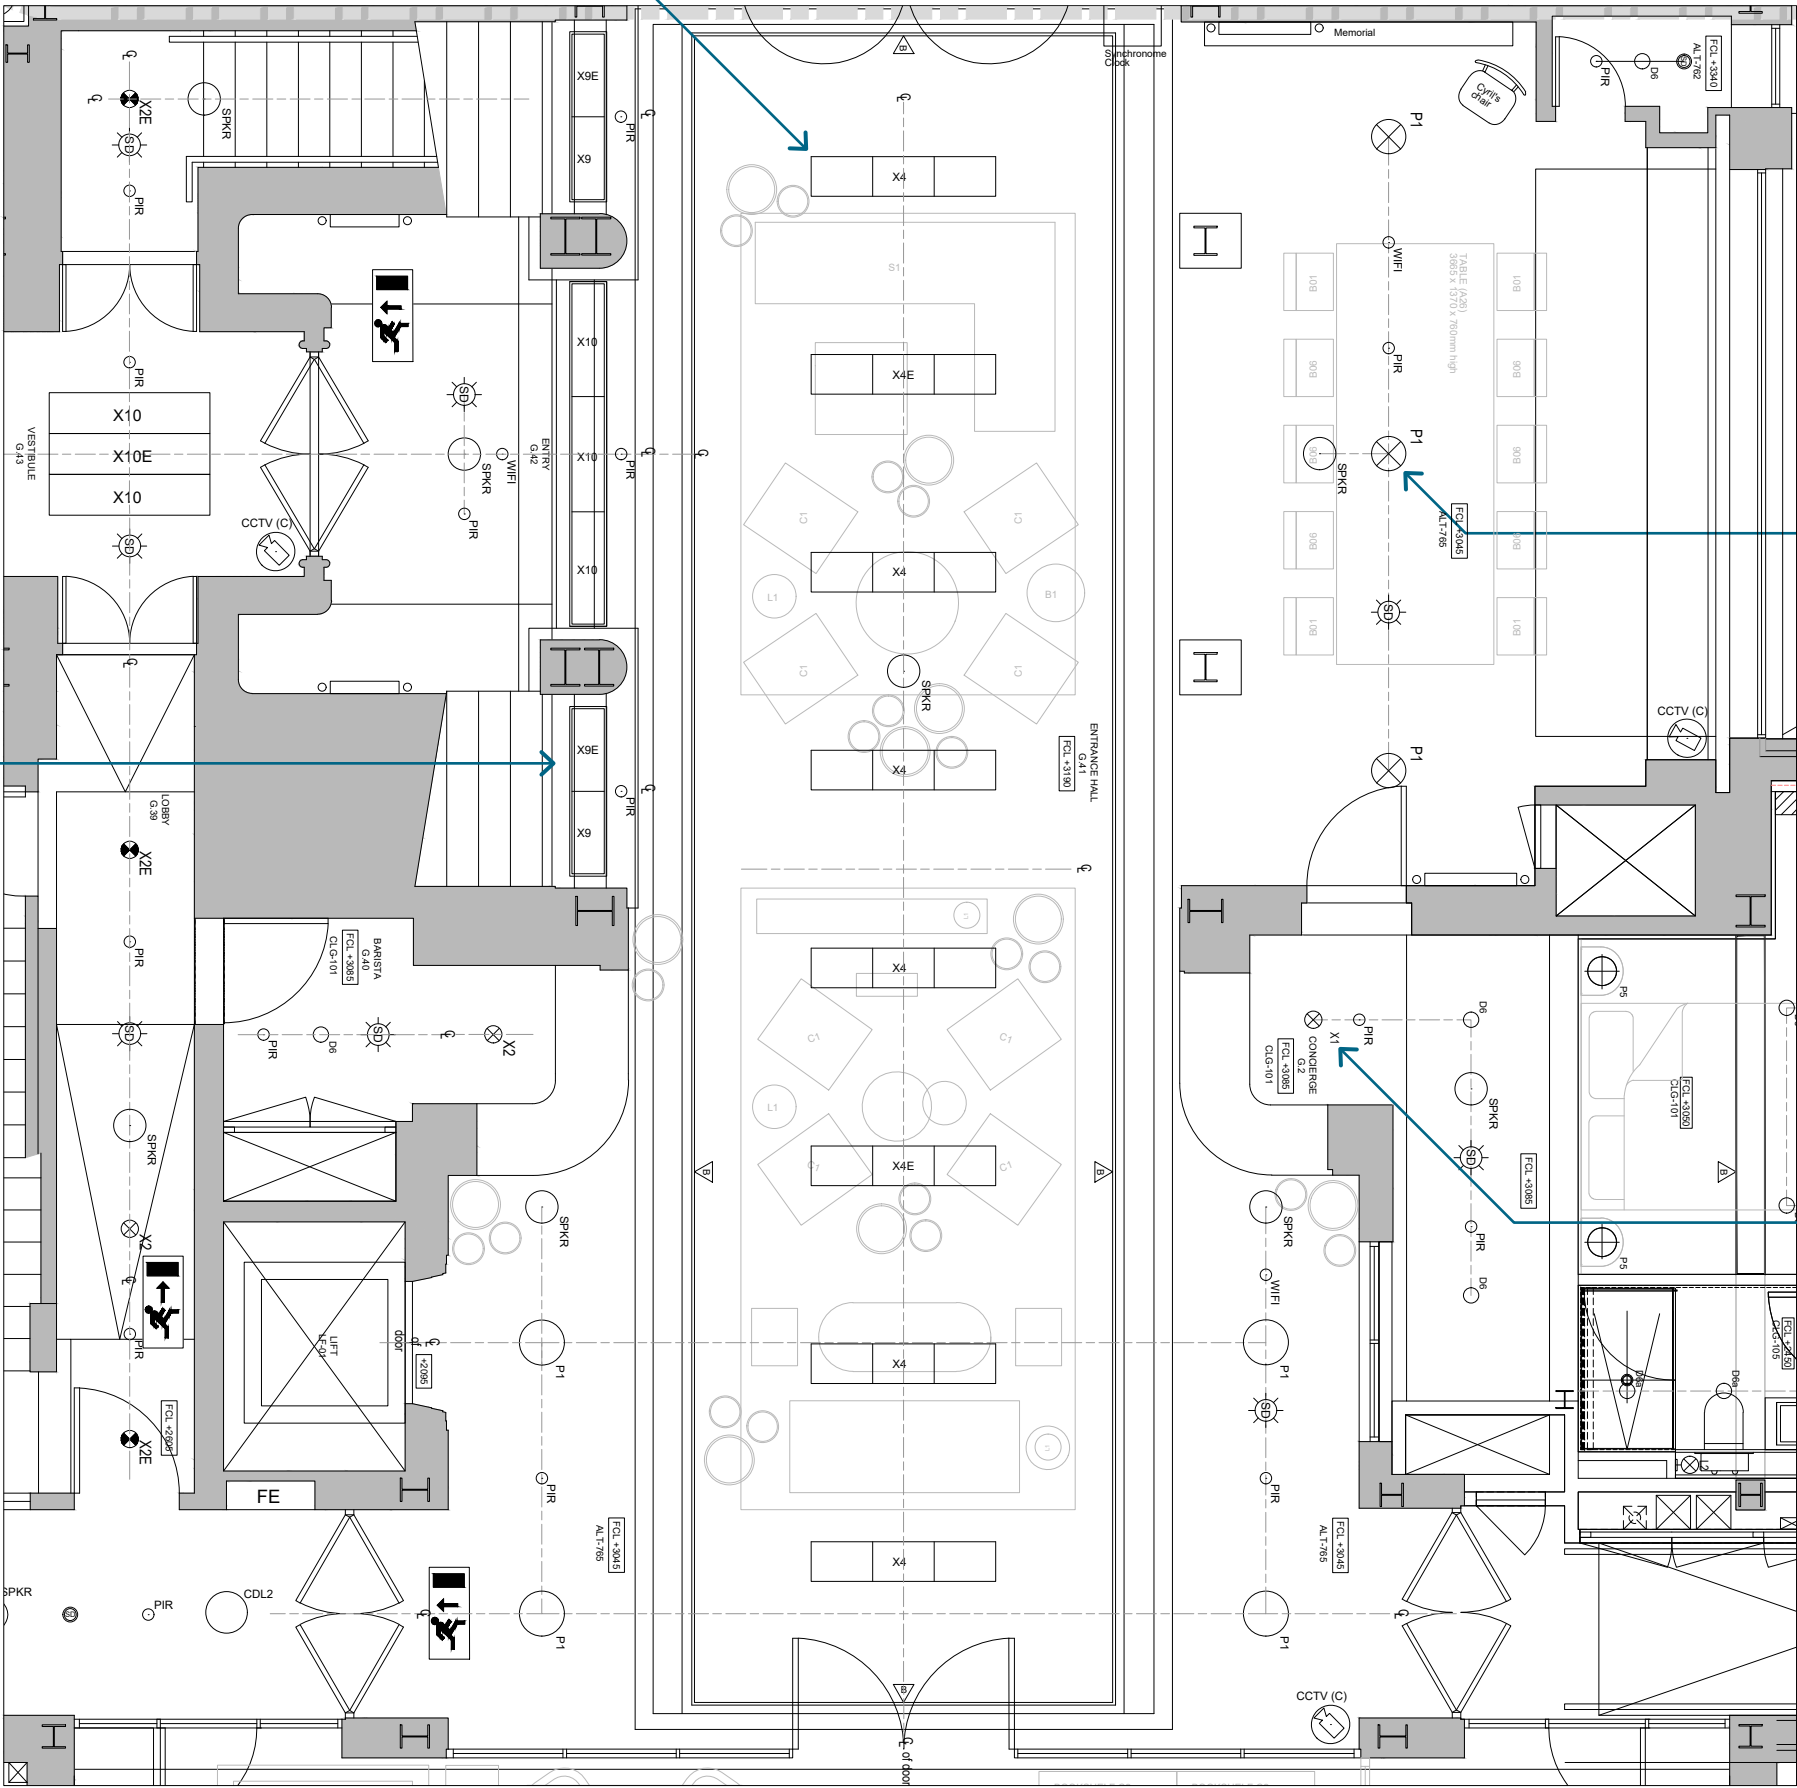
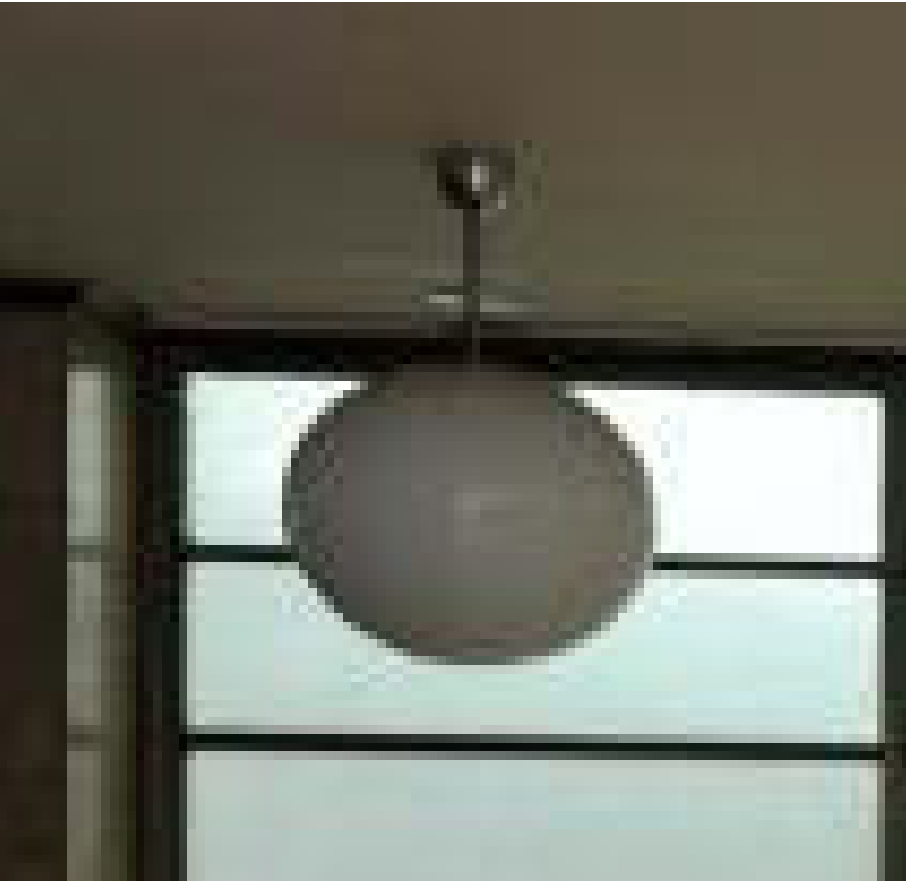
Decorative coving to be inspected and refurbished as necessary and according to method statement. Entrance Hall coving as pictured is in general good condition and refurbishments are only to finishes.

Localised openings in existing ceiling to allow the introduction of new services. Located to reduce impact to existing ceiling and not within decorative coving.

Existing globe pendent are to be refurbished, relamped and reinstated in existing positions.

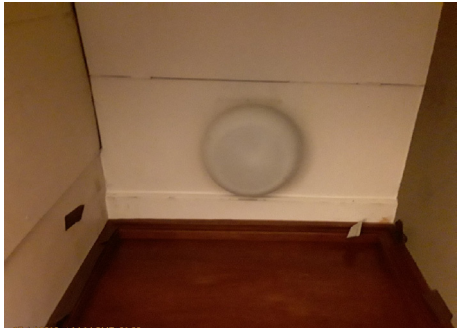
Existing lighting retained in concierge and Barrista with additional downlight to achieve required lux levels.
