Project  
Hornsey Town Hall

Drawing Title  
Joinery  
Reception Room G.2  
Receptions desk and joinery

Foyer

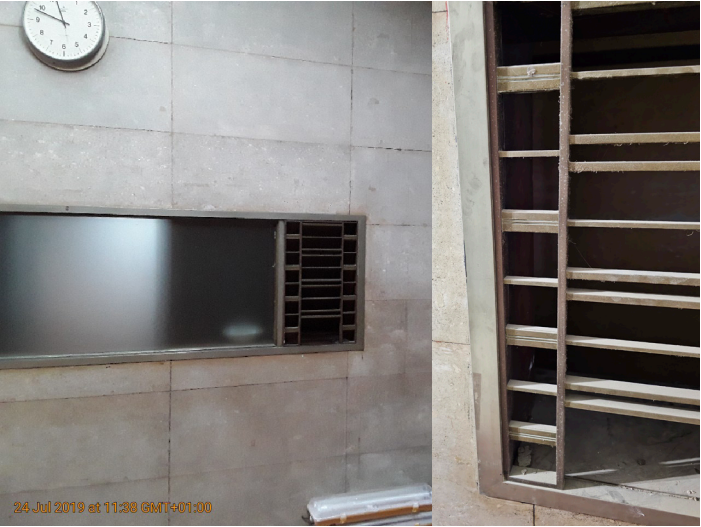
ALT-845 - Refurbishment Screen

Nickel plated open work screen for the box office it to be refurbished. Currently in good condition, the work undertaken will be a light clean to remove any surface soiling and straighten and discernible bowing or depressions in the openwork infill.

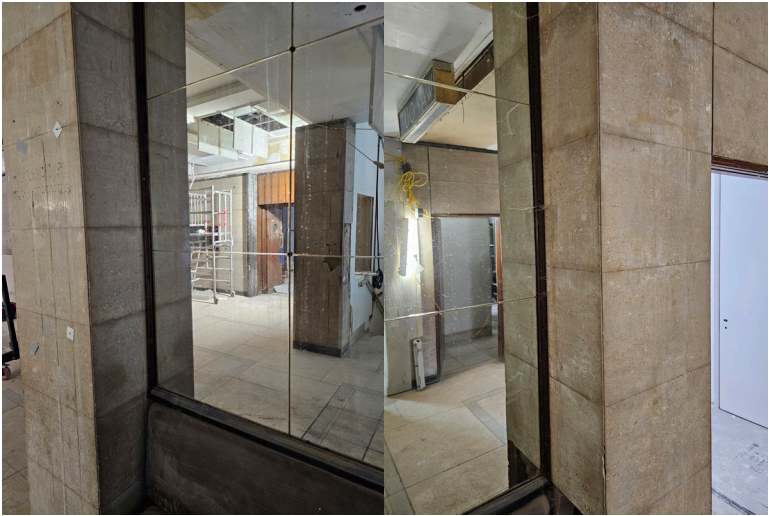
Entrance Hall Mirrors  
Existing mirrors with banquette seating below and bronze trims - in general good condition to be refurbished as method statement ALT-785 for mirrored wall and ALT-564 for seating below.

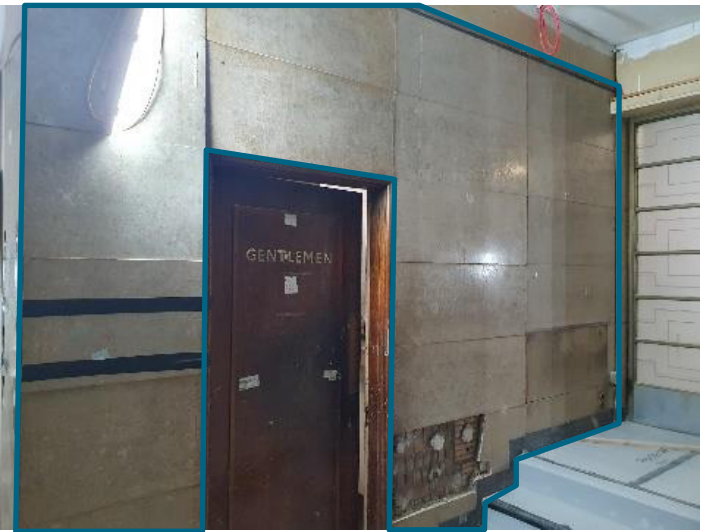
ALT-418 - Refurbishment Stone Work

The stonework around the gentlemen's lavatories and men's cloak room are to be salvaged for use elsewhere. The current condition of the stone work around the gentlemen's lavatories is dislodged and loose and requires it as a minimum to be removed and reinstalled (with some sections beyond repair). Similarly due to the relocation of the door opposite as the approved scheme a large new section of stone is required to fit into the previous opening. As the detailed method statement this stone highlighted with blue hatch is to be replaced with new matching stone and original stone salvaged for repairs elsewhere.

The remaining stone within the foyer is to be refurbished and repaired as the approved method statement. With example of condition and repair below.

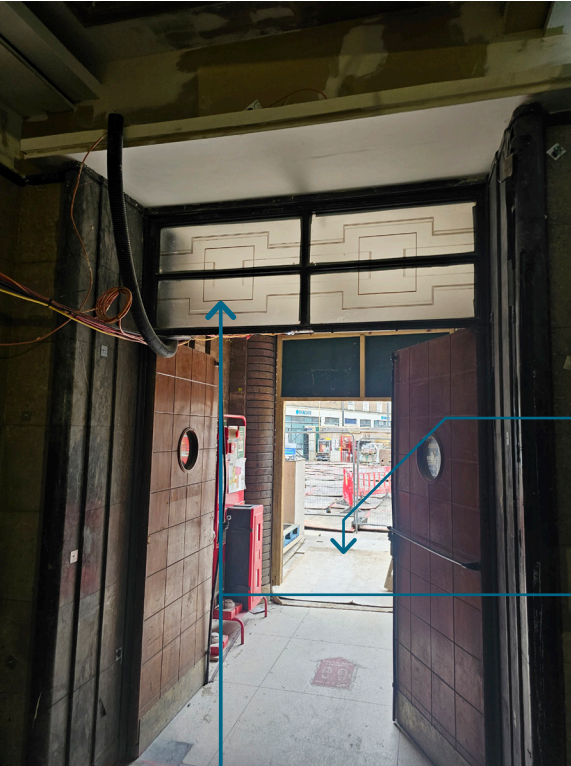
Existing skylight retained and refurbished  
New air-curtain above door in-front of skylight

New Crittall doors to match original design to replace replacement timber doors

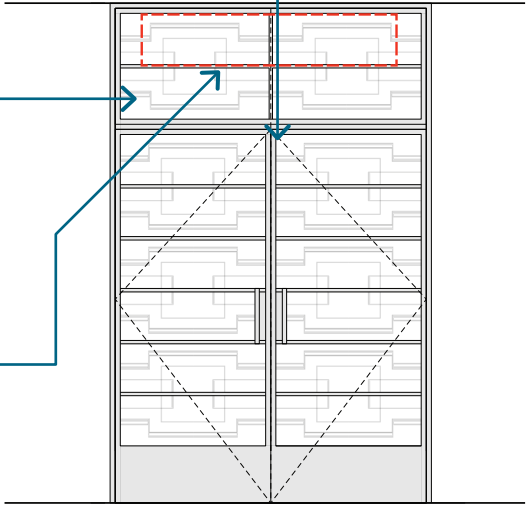
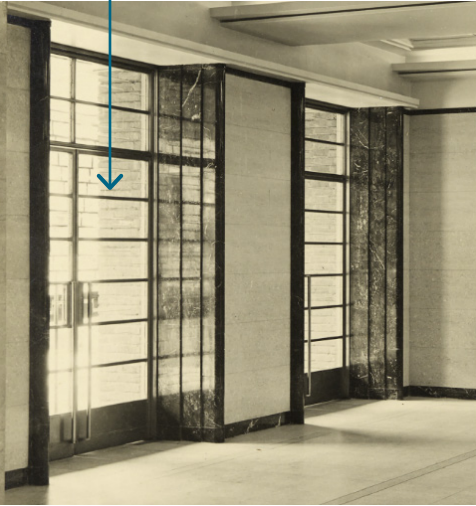
Ashburton Marble Features to door entrances, to be refurbished as method statement.

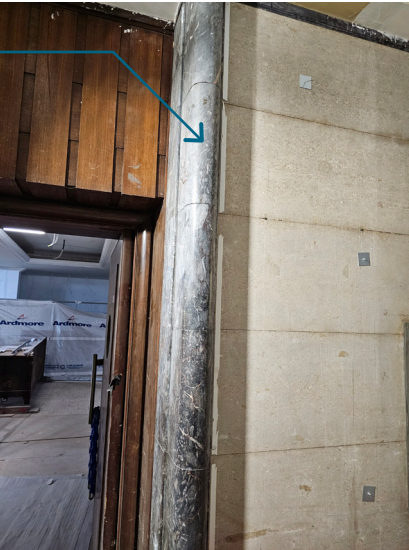
Cracked to edge of stones - to be repaired with resin infill by specialist

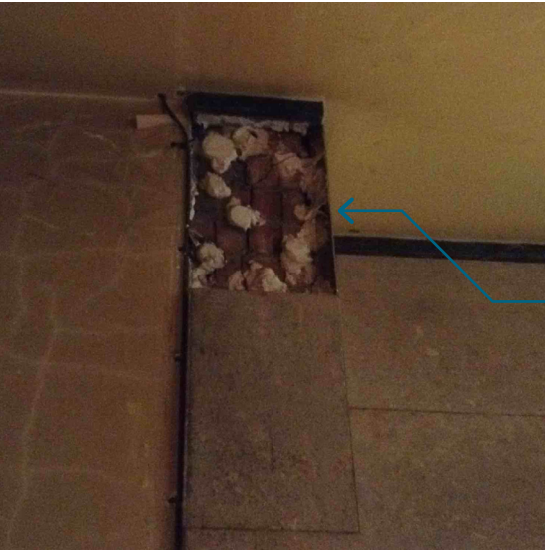
Missing stonework - to be replaced with salvaged stone

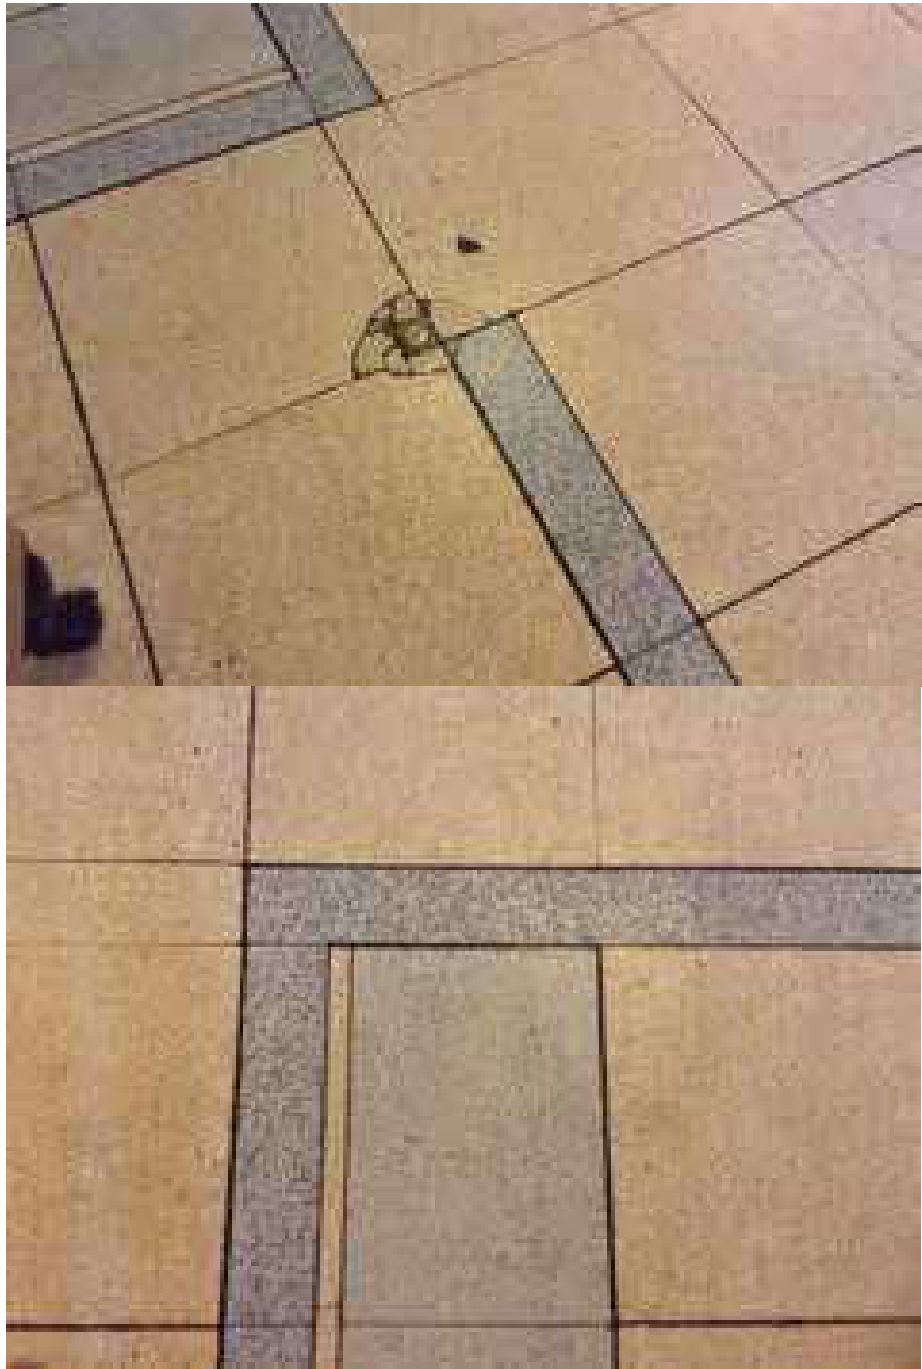
**Terrazzo Floor**  
The Foyer uses a mixture of pale blue and cream tiles. Localised areas contain mostly hairline cracks with some tiles showing larger sections of damage. The cracks are to be repaired and any tile beyond repair is to be replaced with a like-for-like finish as method statement ALT-411 and ALT-412

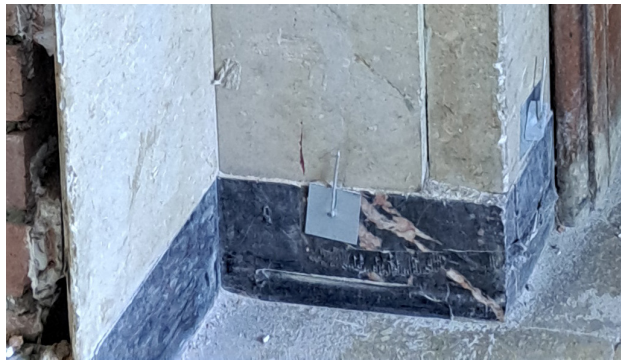
**Skirting**  
Ashburton Marble is used as a feature to skirting flush with the stone panelled walls. To be repaired as the method statement ALT-418.

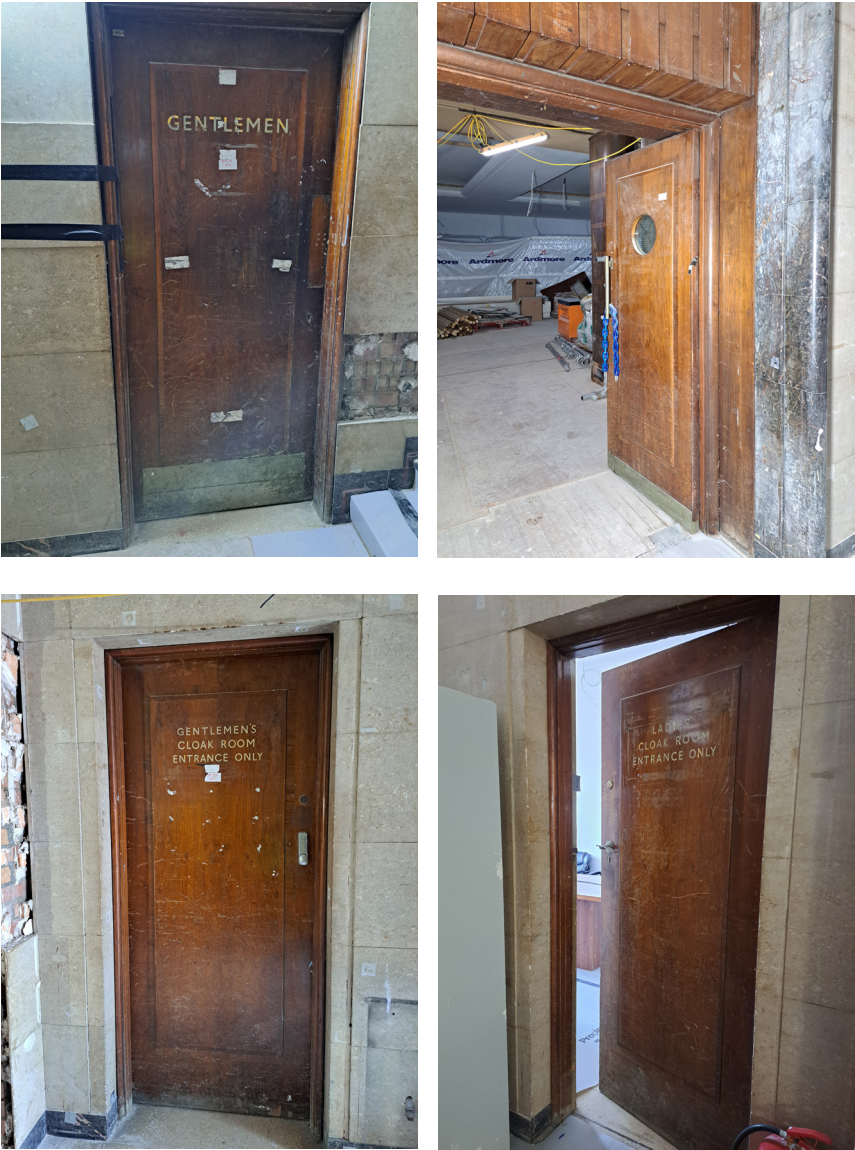
**Internal Doors**  
All the original internal doors have been retained and are to be refurbished as the relevant method statement ALT-573
