Treeworks Application

43 Langdon Park Road, London N6 5PT

17 September 2024

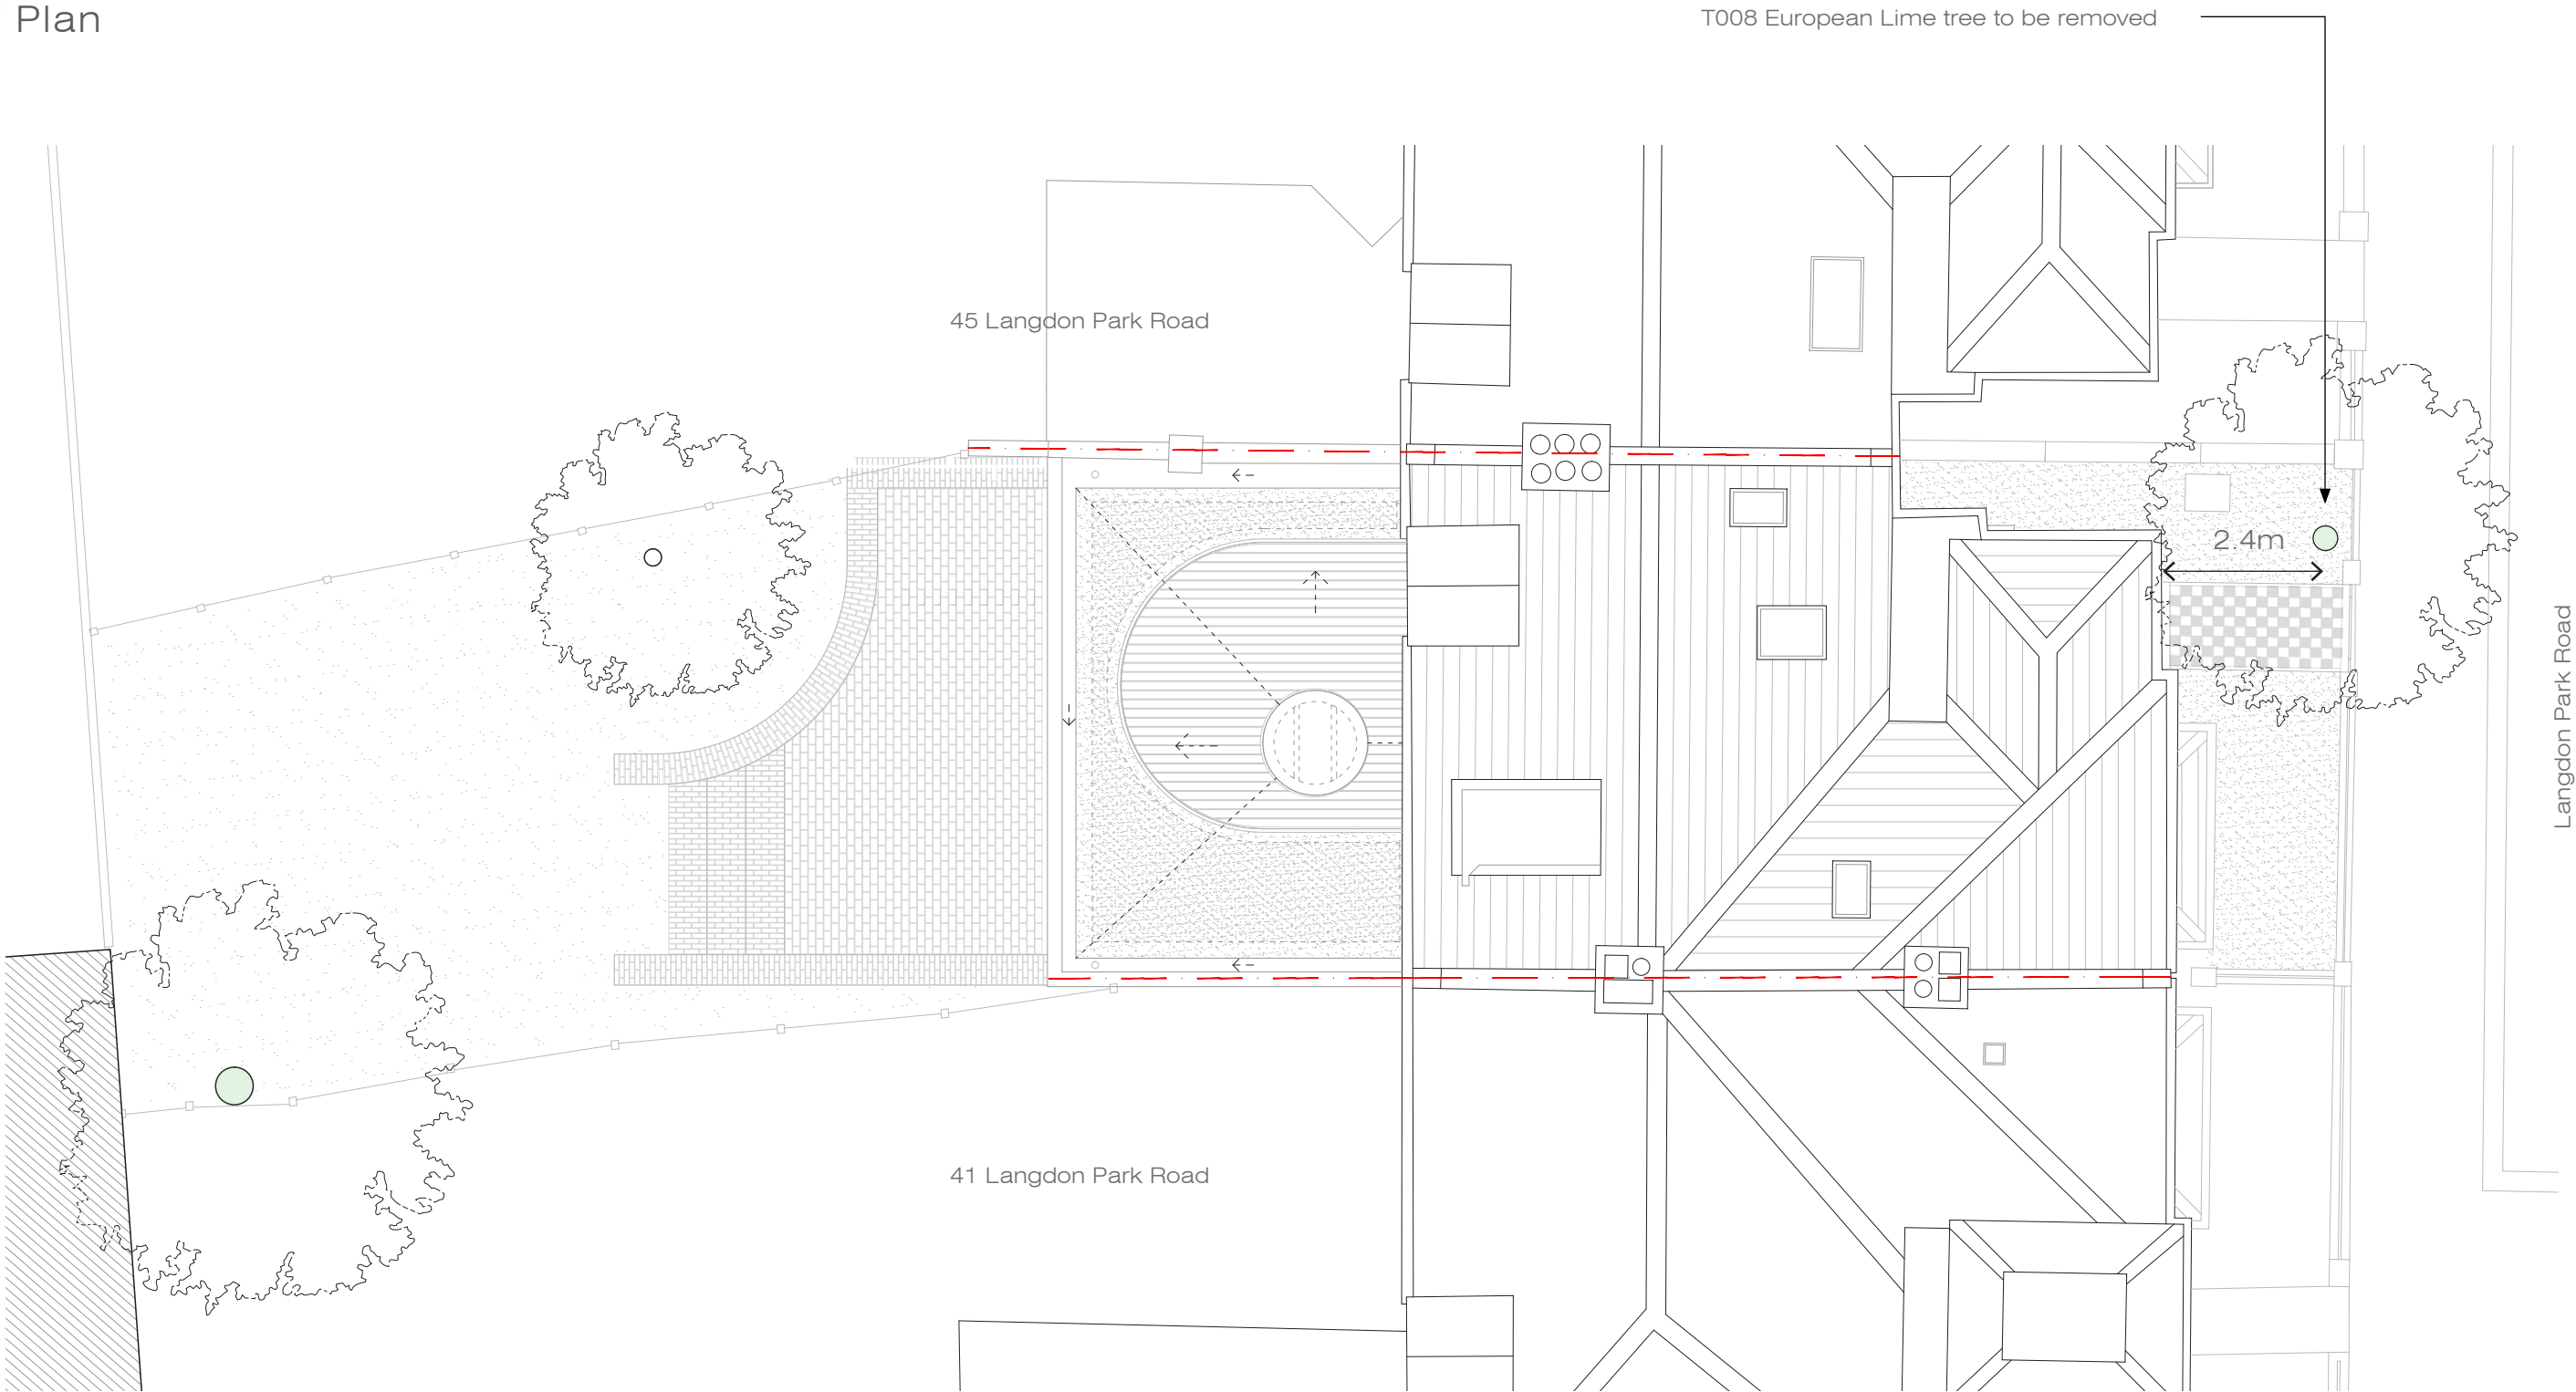
Roof Plan

The lime tree together with its root system are within influencing distance of the front of the house, 2.4 metres, and close to the boundary of the neighbouring property at 45 Langdon Park Road: see plan on page 4 and photos on page 6.

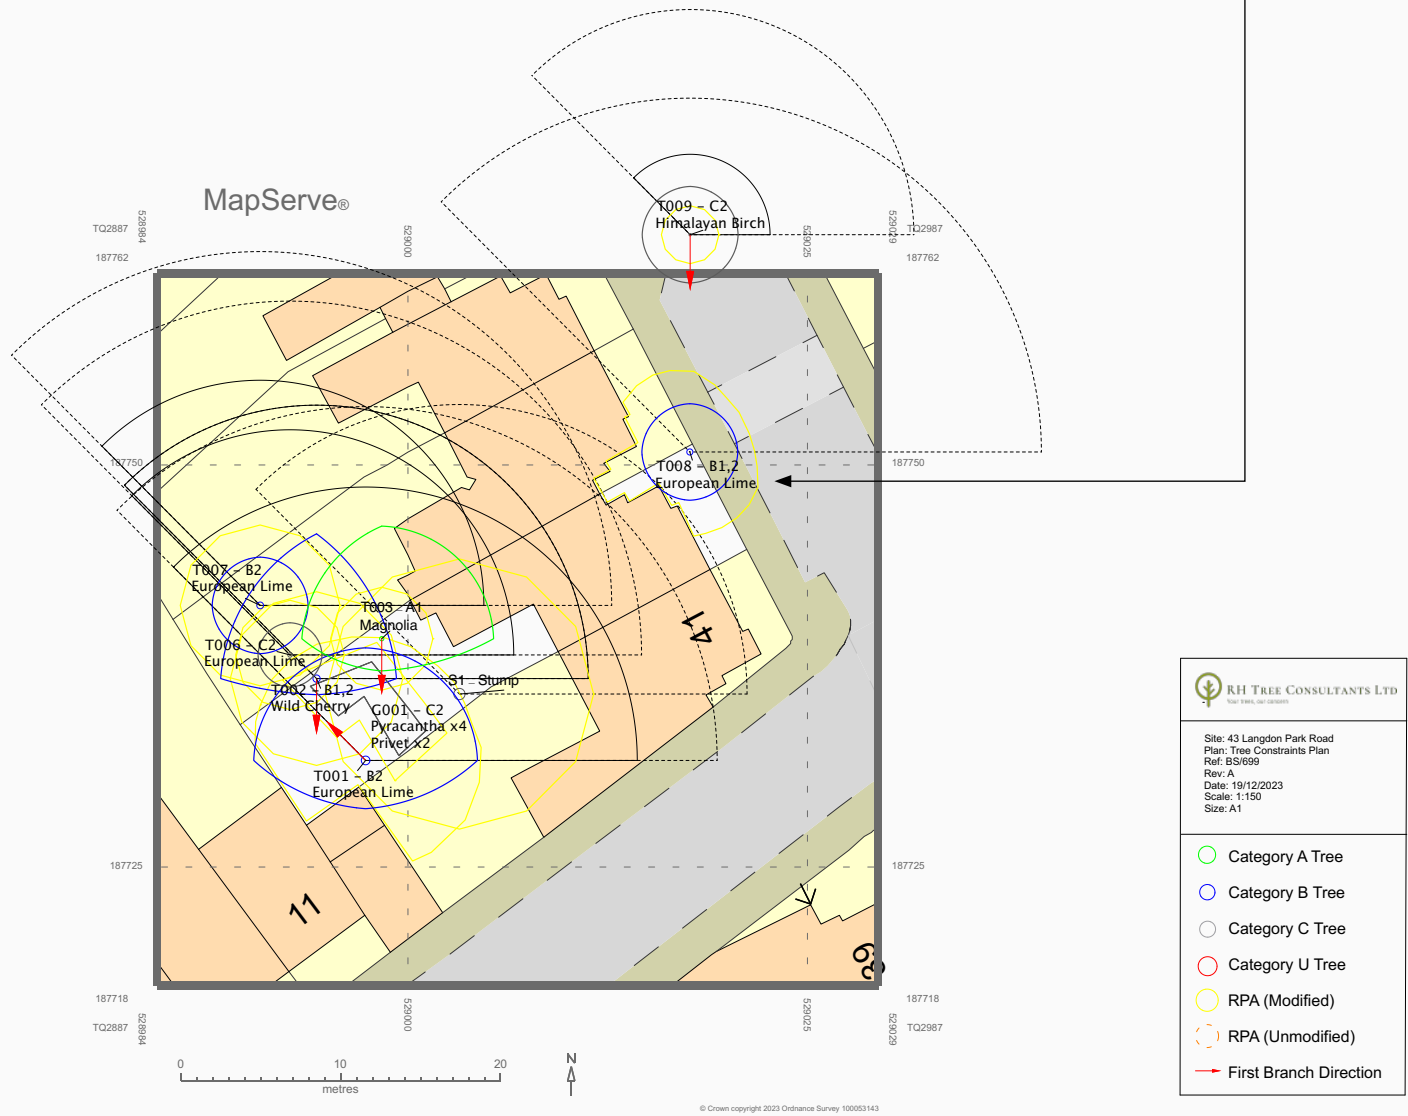
The roots are currently interfering with foul drainage pipes and undermining the hard surfaces and the front boundary brick wall. They have the potential to interfere with the foundations of the house at 43 Langdon Park Road causing structural damage. The clay soil type exacerbates this risk due to the shrink and swell caused by the tree roots.

Patches of various mortar colours in the front brick boundary wall indicate that the brickwork wall has required repointing likely where the tree has caused damage.

T008 European Lime tree in close proximity to the property, at front boundary wall of 43 and close to boundary with 45 Langdon Park Road. This application proposes to remove the tree to avoid current and future structural damage to the property, drainage and boundaries.

Given the interference with drainage, the proximity of the tree to the front of the house, the clay soil type, and that the tree may be expected to grow yet, it is proposed that the tree be removed to avoid future destabilisation and remedial works to the house, its foundations, drainage pipework, hard surfaces and boundary walls, and potentially, the neighbouring property.

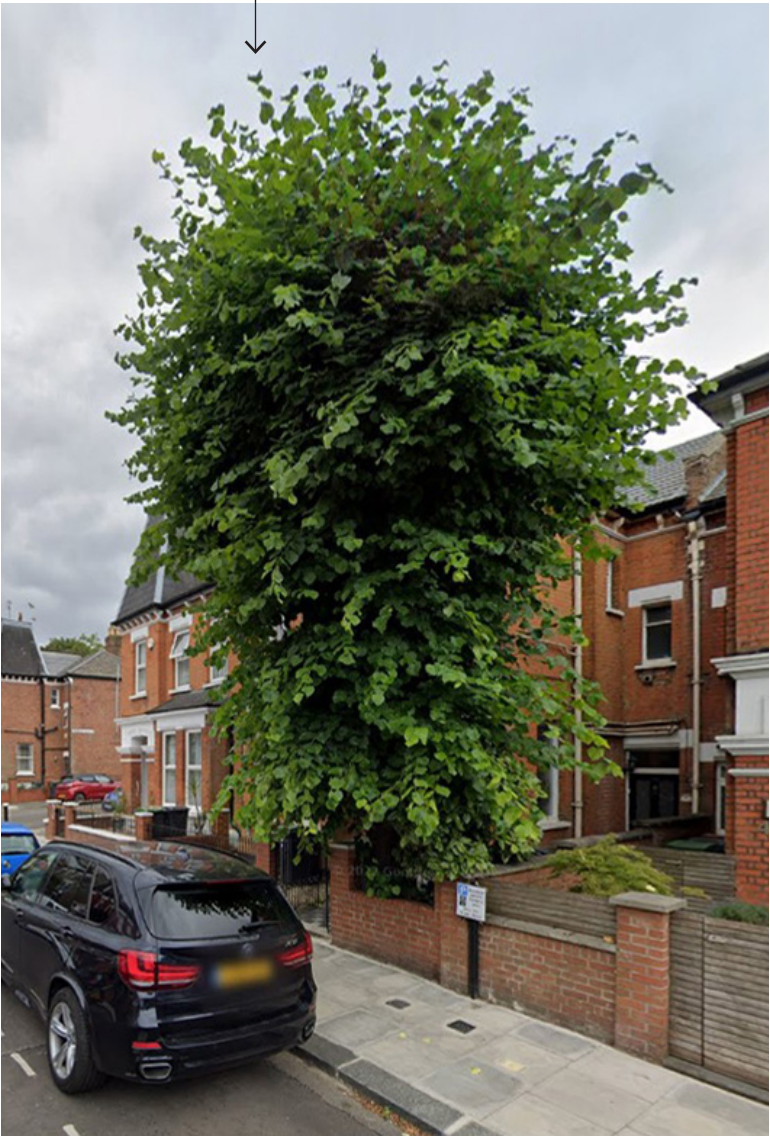
View south of 43 Langdon Park Road front and adjoining garden of 45 Langdon Park Road. Lime tree sited 2.4m from front of property.
