**Application for Approval of Details Reserved by Condition  
Discharge of Condition 4 – Specification of brickwork to South boundary wall.  
Planning Application Reference: HGY/2025/2929**

## **1. Purpose and Scope of Report**

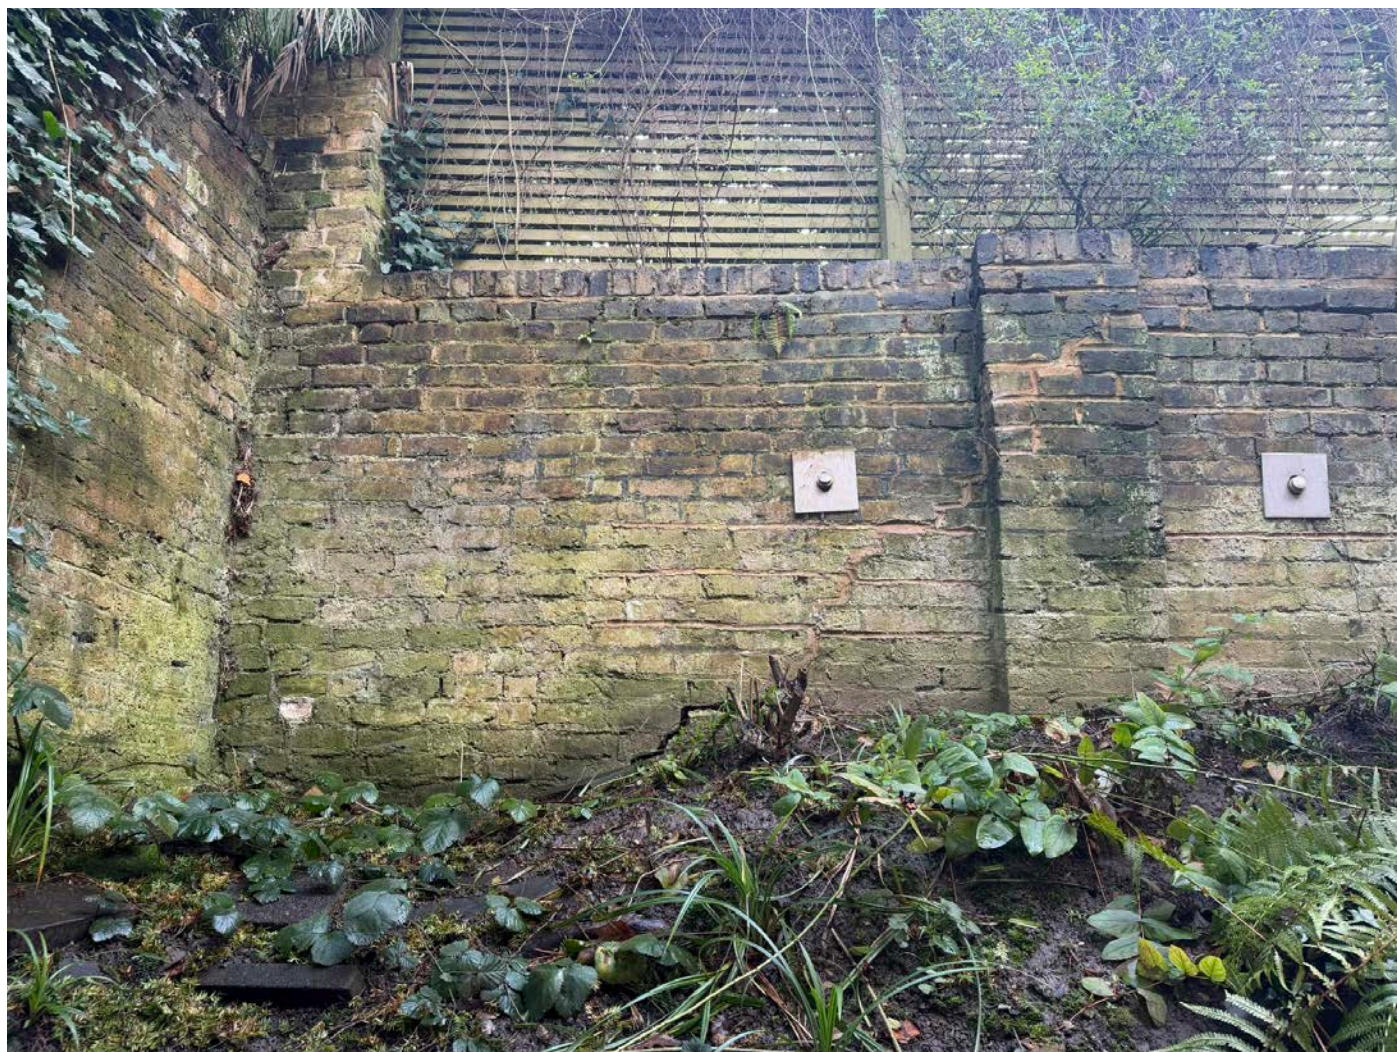
Photograph A – Uncleaned section of existing boundary wall.

Given the existing walls had extensive algae growth (Photograph A), a large section of wall was cleaned so as to enable an appropriate match in texture and colour.

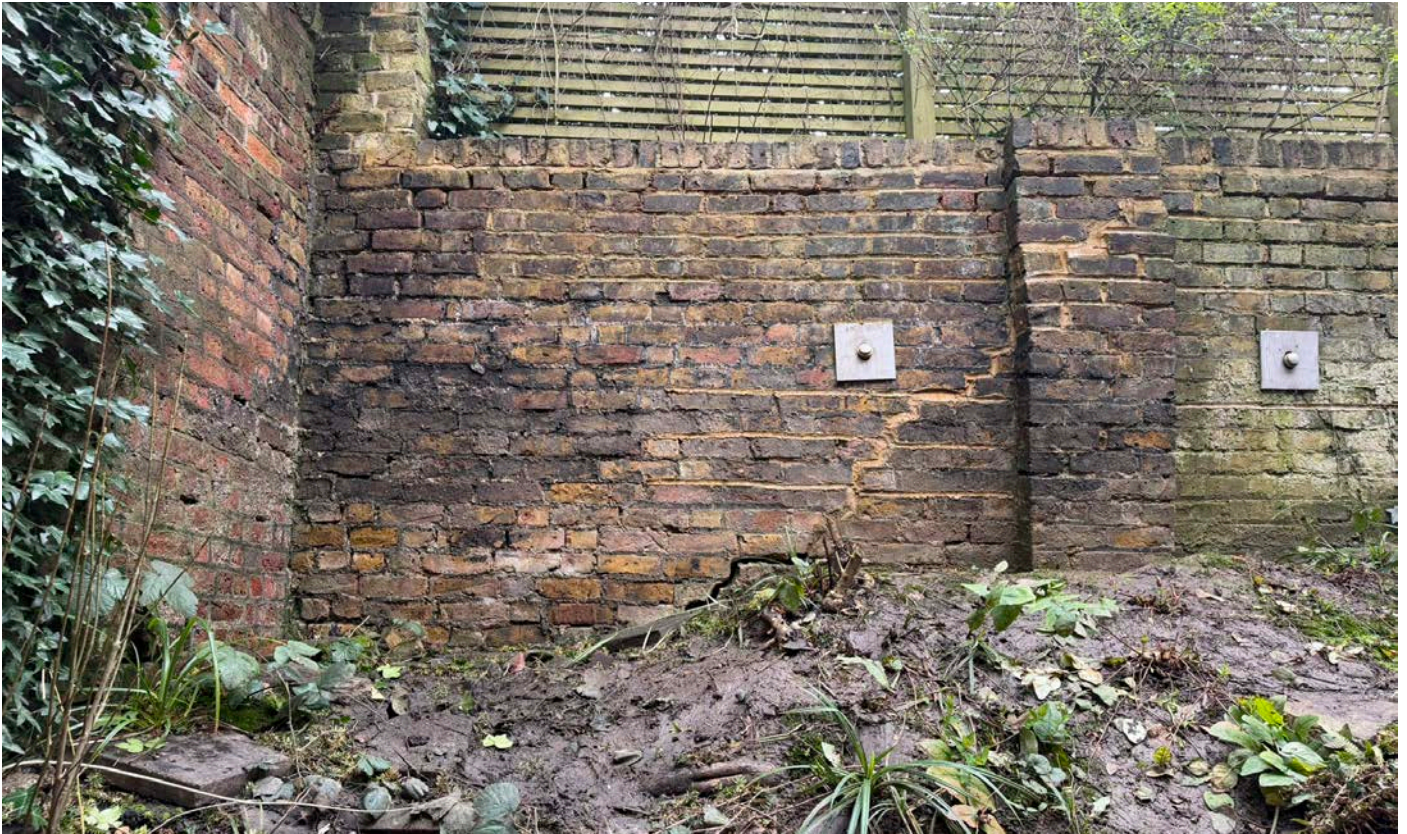
*Photograph B - Cleaned section of existing boundary wall in a wet state.*

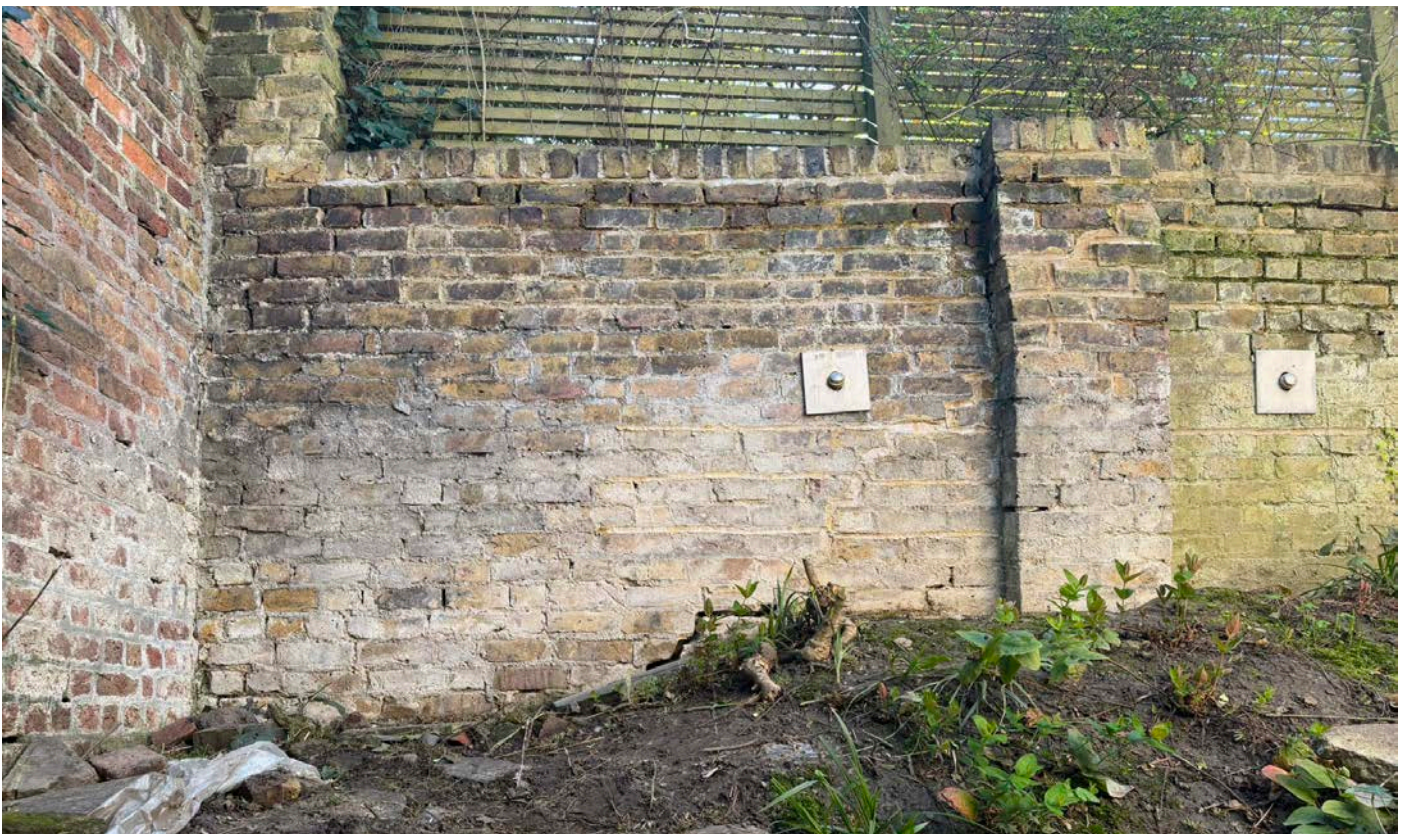
Following cleaning of the boundary wall to remove algae, significant efflorescence was observed on the lower half face of the existing bricks, particularly in a dry state (Photograph C). This efflorescence is likely caused by soluble salts migrating through the brickwork from the retained earth and groundwater behind the wall. It is a symptom of moisture-related deterioration and is not an inherent characteristic of the bricks themselves, nor a feature of the wall's heritage significance.

*Photograph C - Cleaned section of existing boundary wall in a dry state.*

For these reasons, the brick selection and tinting process documented in this report was carried out against sections of the wall that had been cleaned and from which efflorescence had been removed, in order to establish the true colour and character of the existing bricks. Where efflorescence could not be fully removed despite repeated cleaning, those areas were wetted to suppress the surface salts and reveal the underlying brick colour (Photograph F). This approach seeks to ensure that the proposed replacement bricks are matched to the genuine material character of the existing wall, consistent with Historic England's published principles and the requirements of Policies DM1 and DM9 of the Development Management DPD 2017.

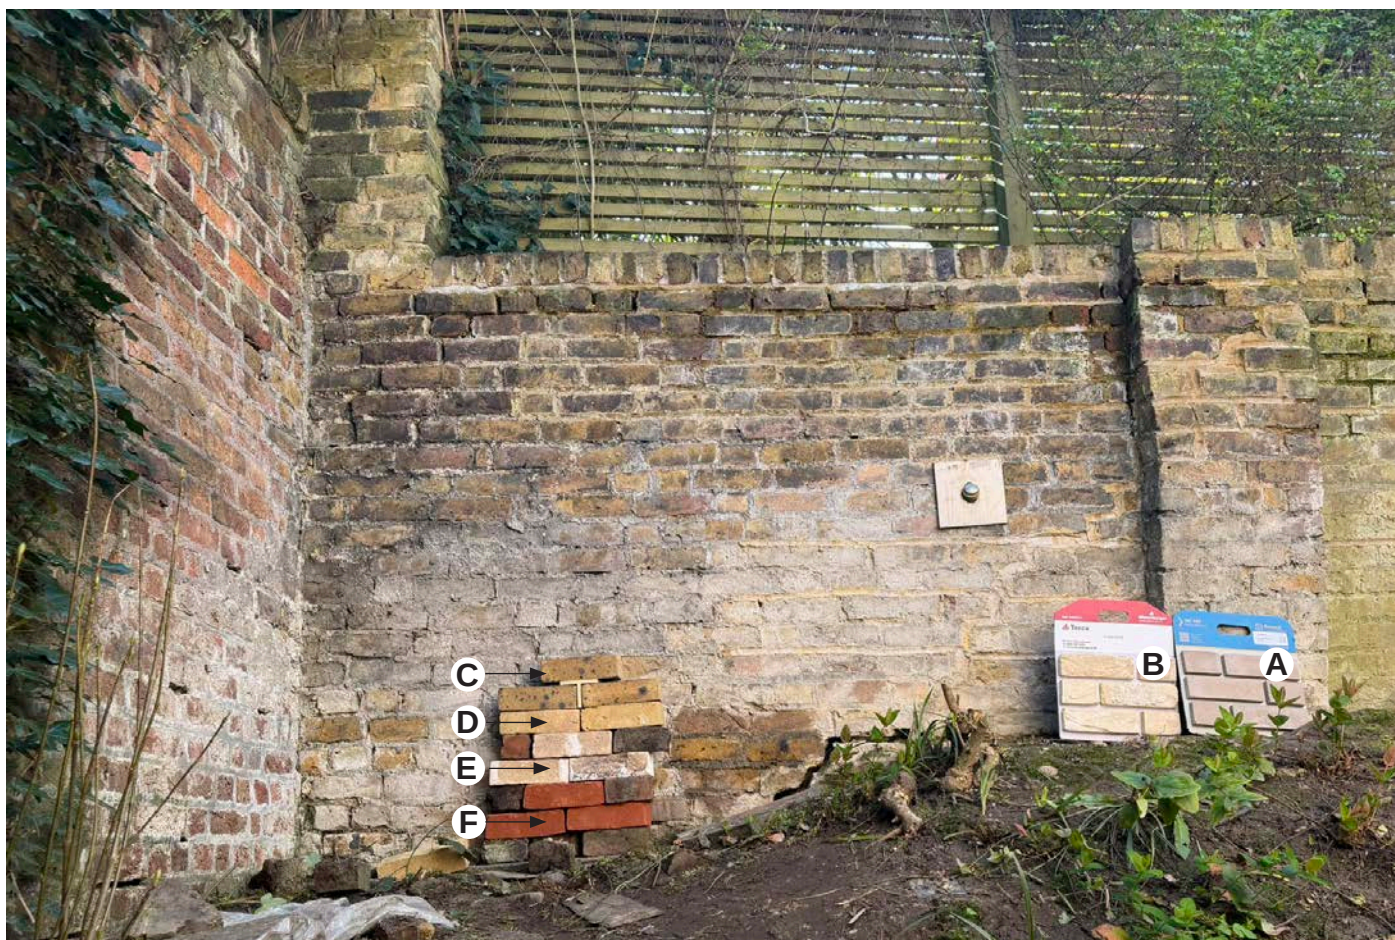
*Photograph D – Cleaned section of existing boundary wall in a dry state.*

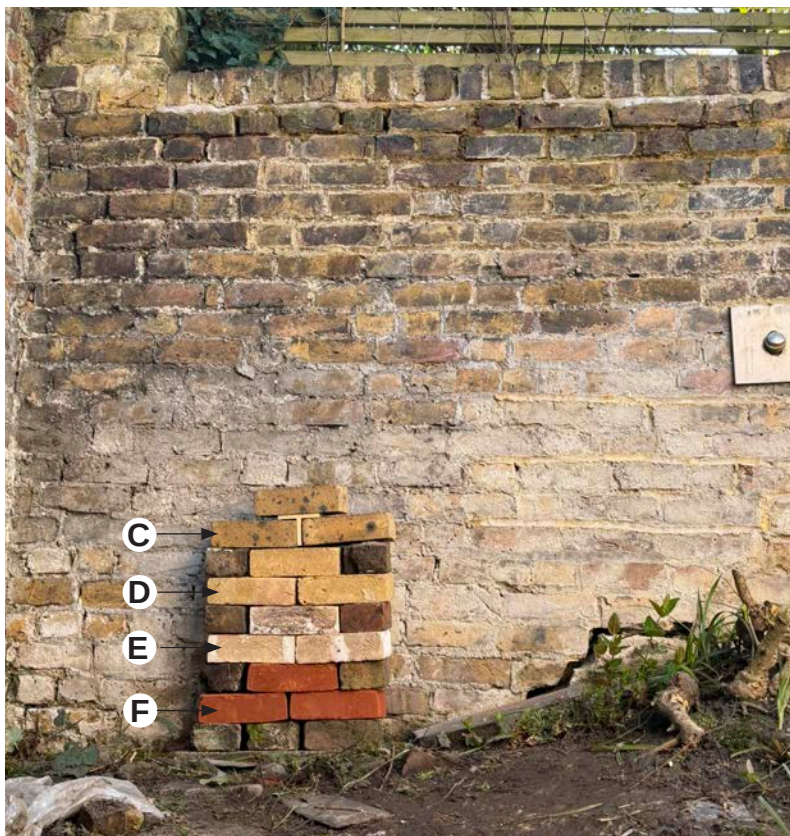
*Photograph E - Shortlisted bricks against the dry wall.  
Note some disregarded half bricks were used to support the wall to the sides.*

Was a good match to some of the existing bricks as shown in the photographs, particularly when efflorescence was removed. The upper portion of existing bricks however exhibited a much stronger dark weathered appearance, therefore brick tinting was considered to overcome this and is discussed later in this report.

The Danehill Yellow is therefore proposed as a replacement brick if additional bricks are needed in the replacement boundary wall. The Product Technical Information Sheet is included overleaf.

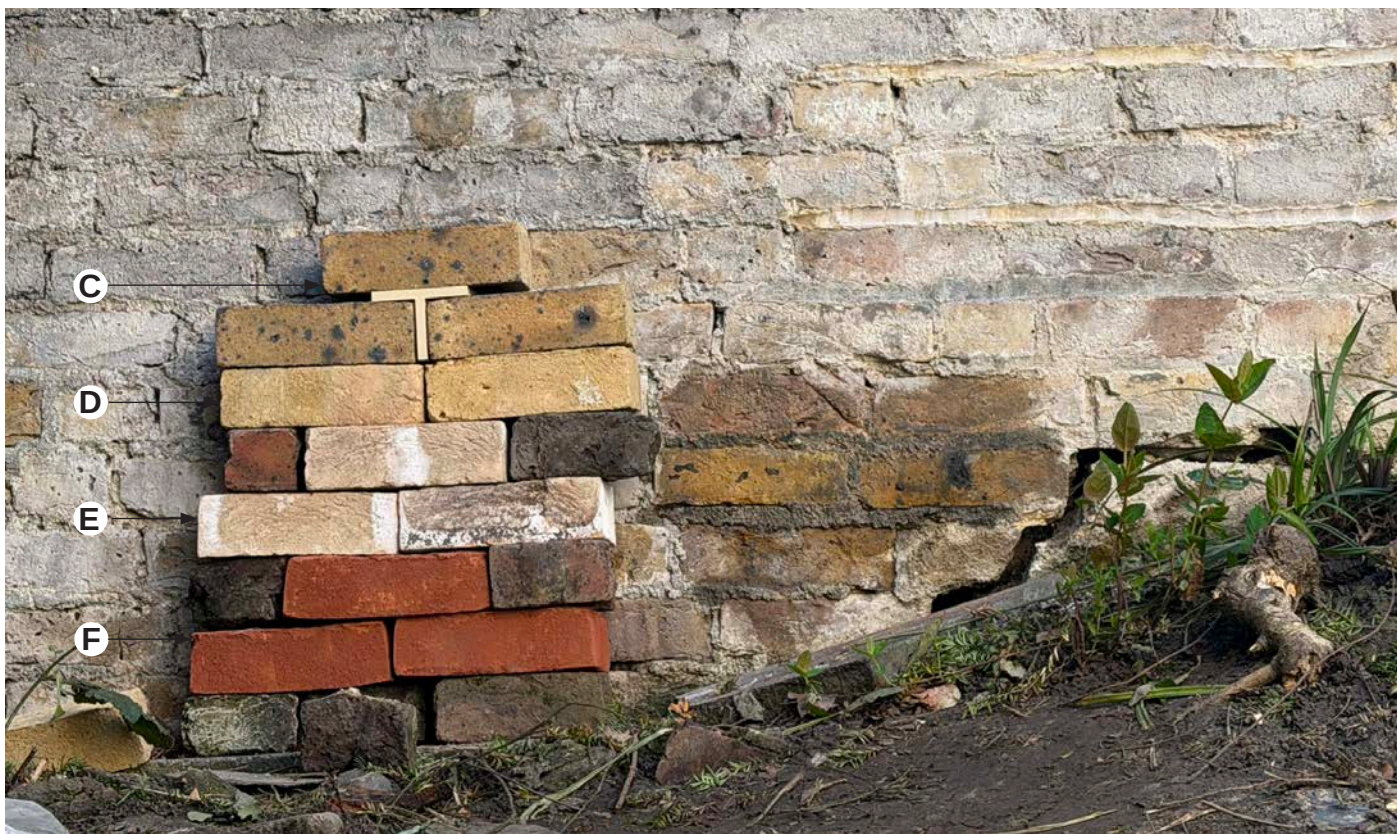
*Photograph F - Closeup of Shortlisted bricks also showing a wetted section of the existing wall to remove efflorescence.*

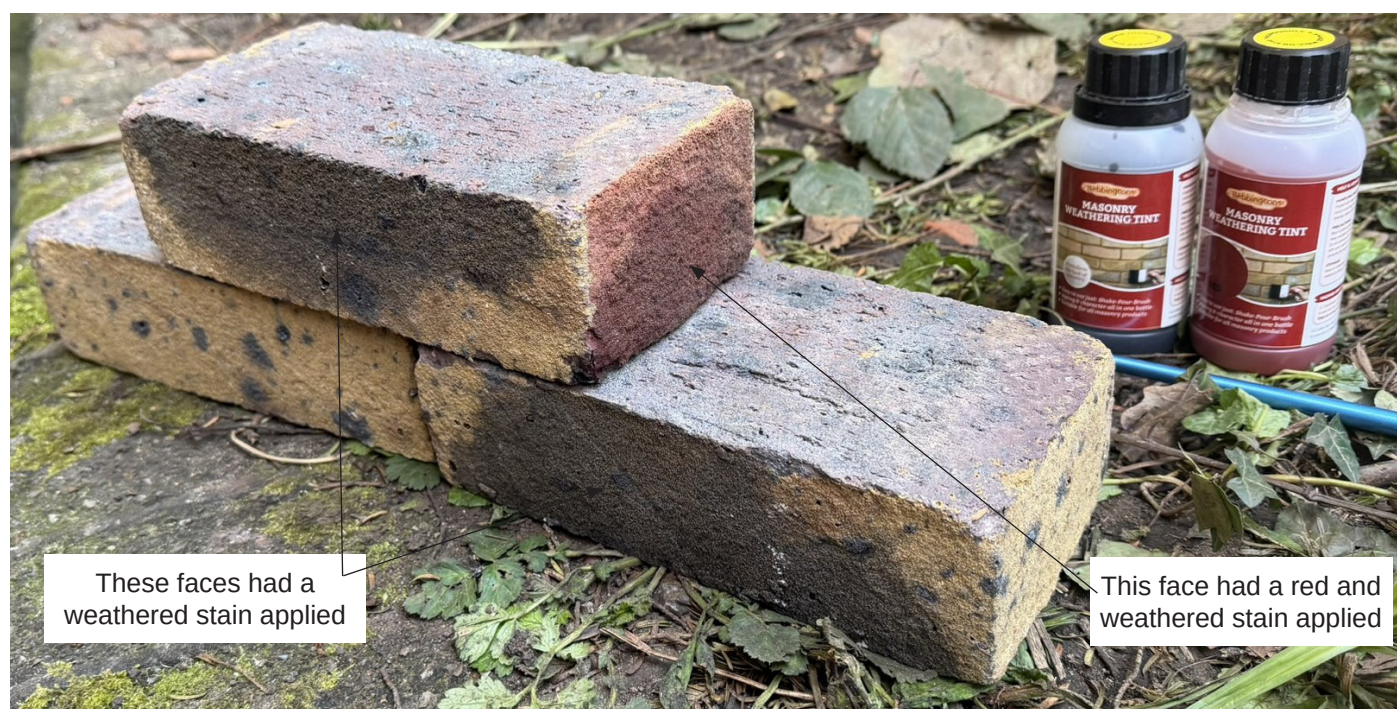
*Photograph G – Use of brick tinting to create a better match*

As noted above, brick tinting was considered to match the Michelmersh Danehill Yellows to the nearest existing bricks, a weathered tint and a red tint type were used from Bebbingtons to build up a different colour as shown below. The tinting is permanent and weather resistant and allows fine adjustment to account for specific nuances in combinations of reclaimed and new bricks.

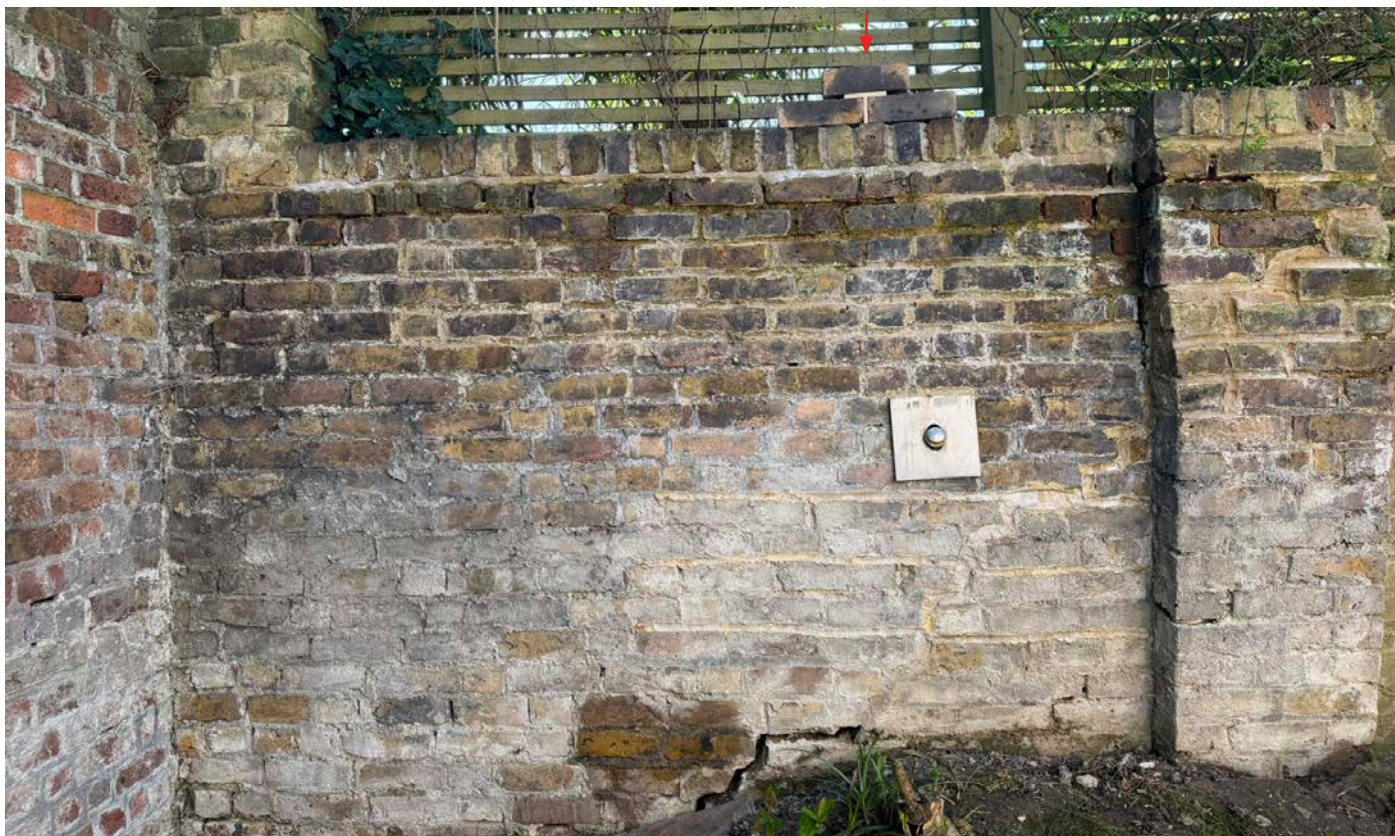
*Photograph H - Photograph of tinted Danehill Yellows at the top of the boundary wall*

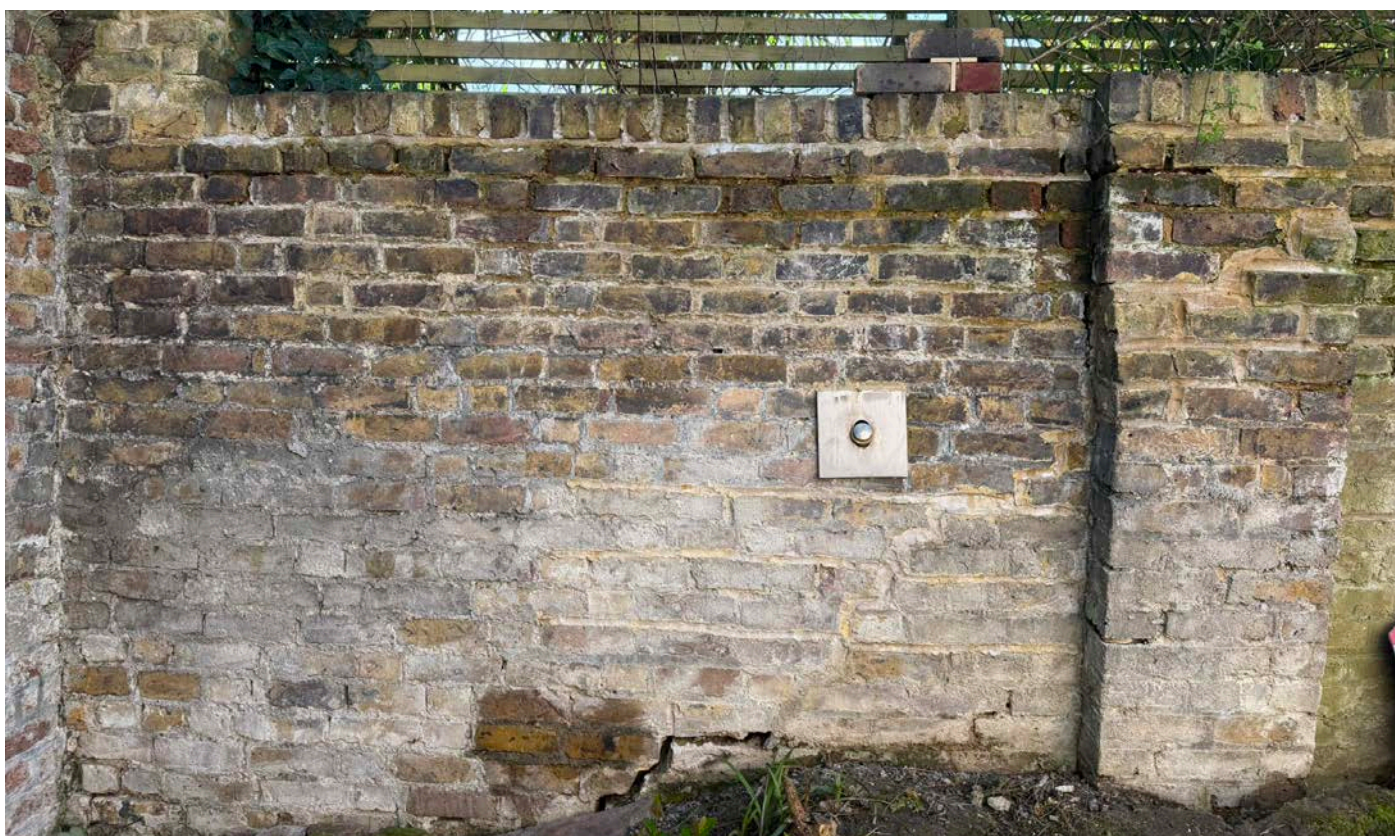
*Photograph J - Photograph of tinted Danehill Yellows at the top of the boundary wall with a red half brick test*

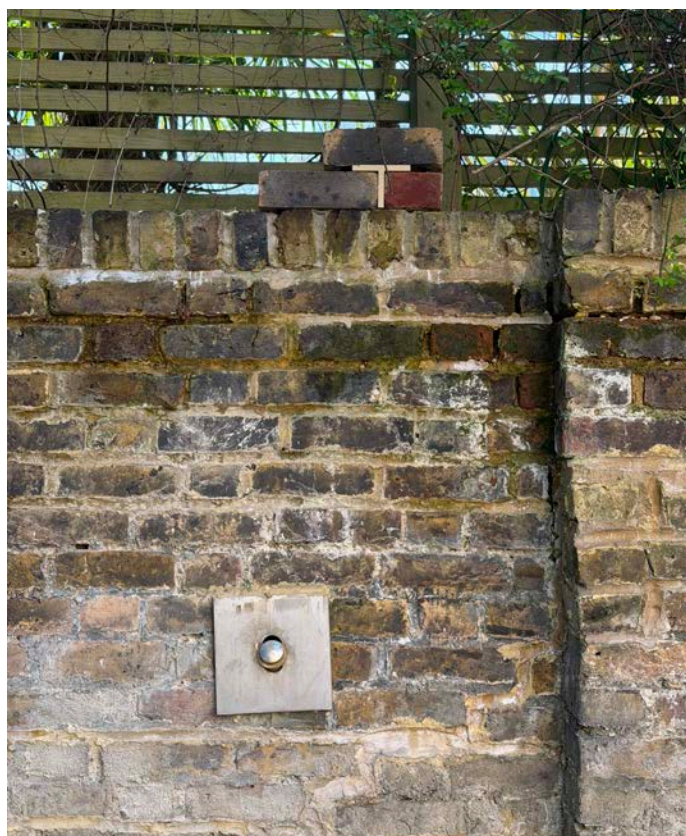
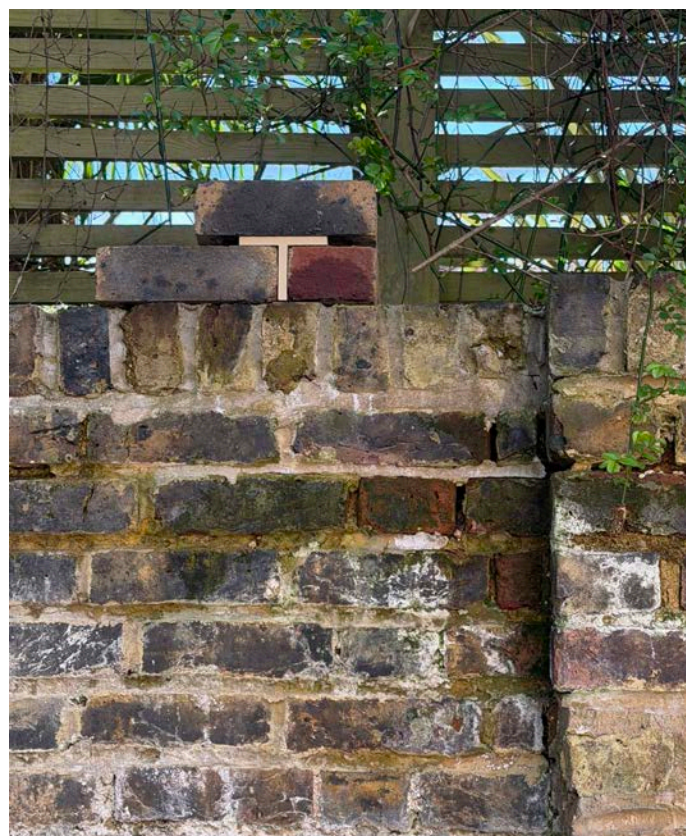
*Photograph K Closeups of tinted Danehill Yellow Bricks, the right photo red has been further stained compared to the left photo.*

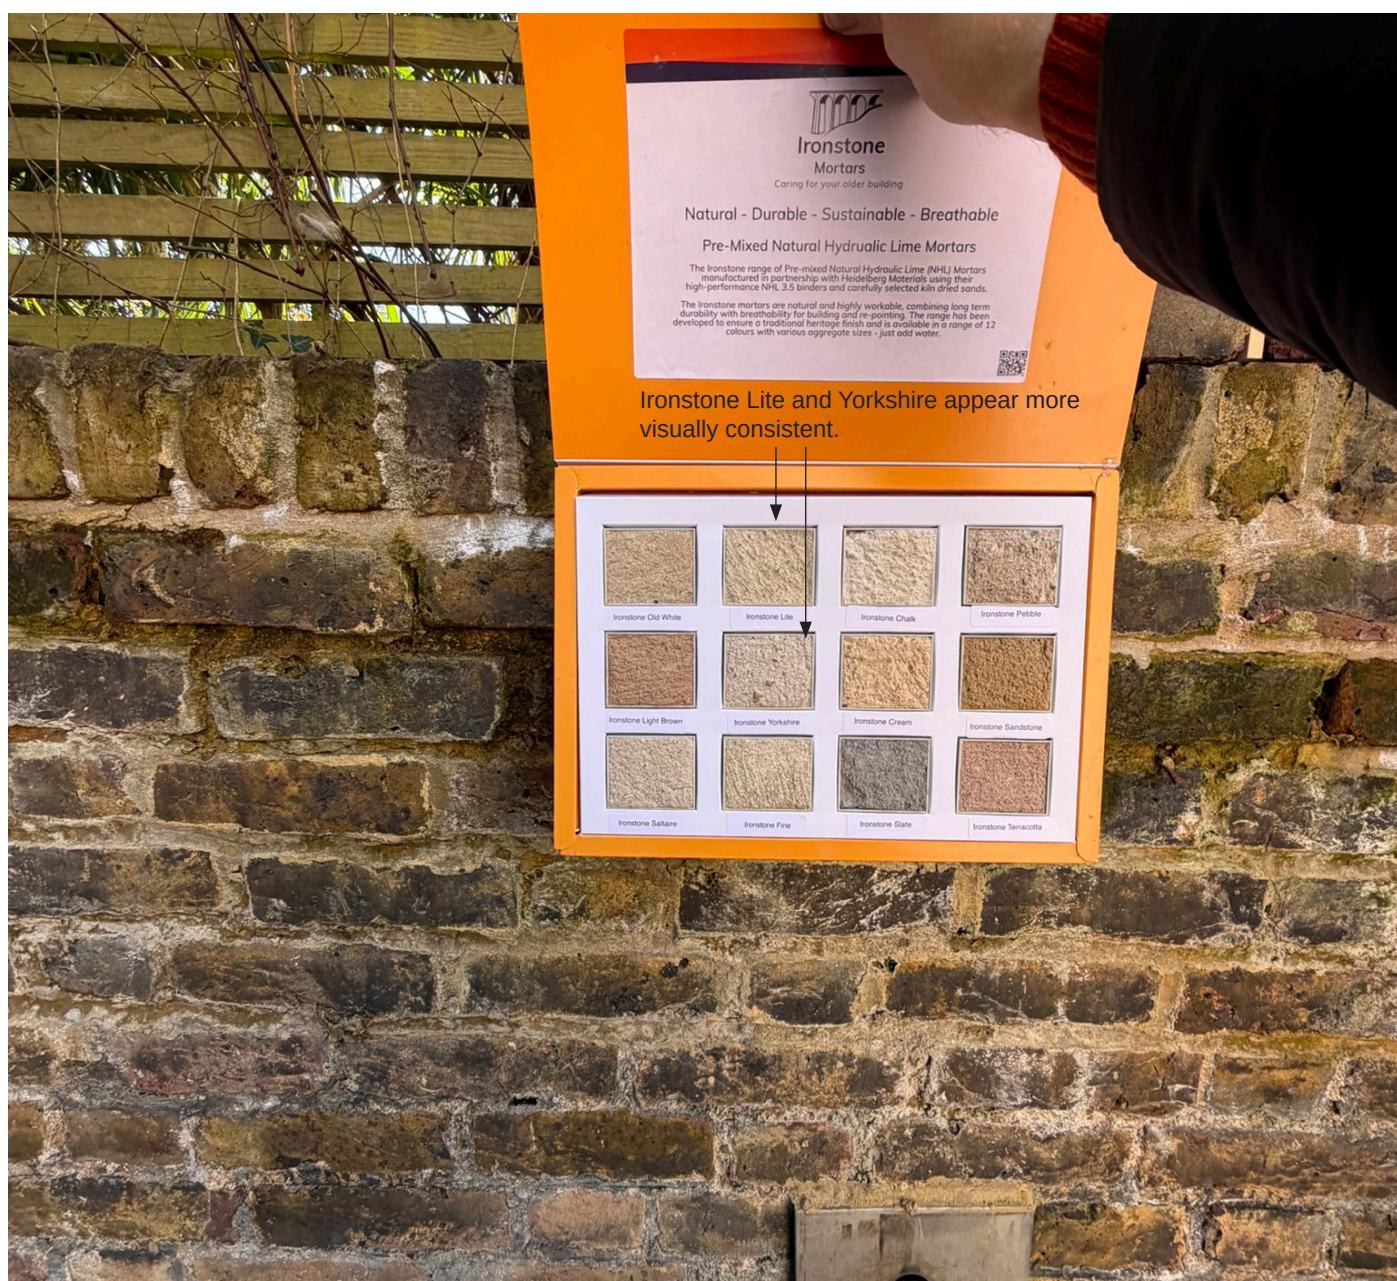
These mortar mixes are shown against the existing wall in Photograph L. The existing walls exhibit significant mortar joint degradation, dirt and staining, it is also evident that a poor mortar match was made for the original repairs given that its colour is a significant contrast to the existing wall (Photographs A and B) demonstrate this. Analysis of sections of the cleaned wall suggest that the predominant colour of mortar is a light white yellow colour, it was therefore concluded that a suitable matching colour of mortar to this be proposed.

*Photograph L - Comparison of mortar in upper wall with example pre-mixed NHL 3.5 Lime mortars.*

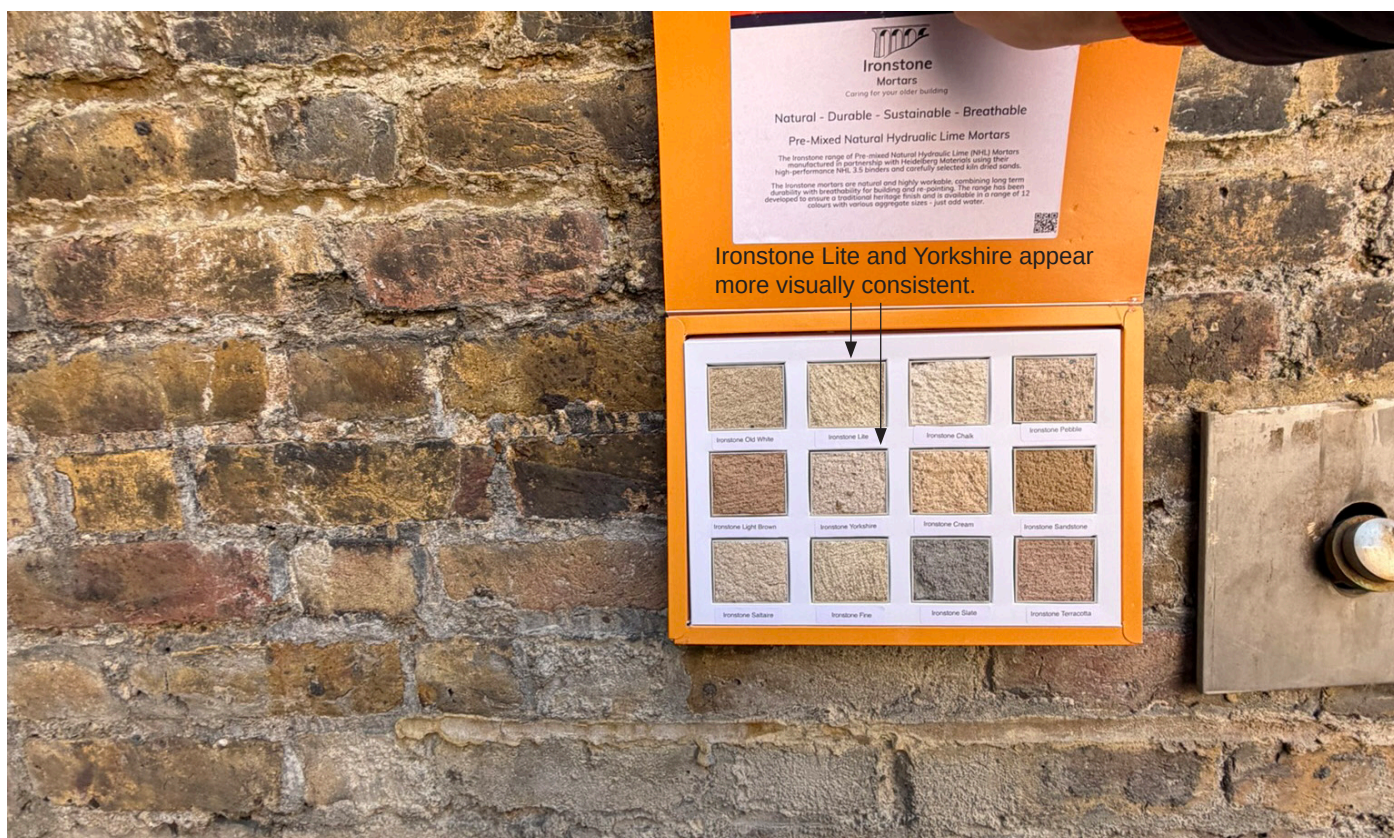
Photograph M Comparison of mortar in lower wall with example pre-mixed NHL 3.5 Lime mortars.

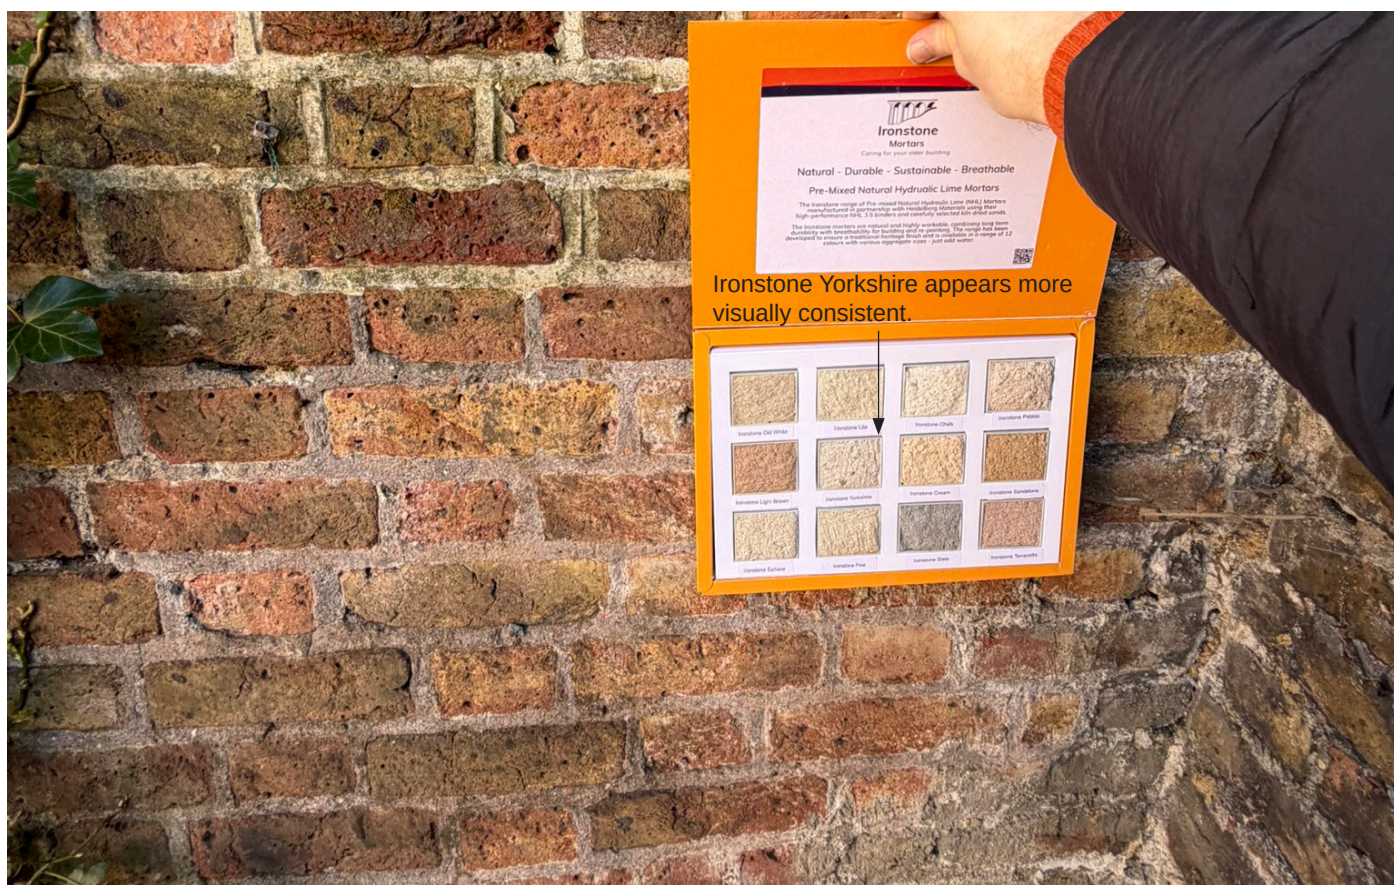
Photograph N Comparison of mortar in underpinned wall perpendicular to the South boundary wall to be rebuilt.

On inspection it is evident that currently available lime mortar mixes can achieve a good match. Wormersley's provide a match classed as 'Ironstone Lite' and 'Ironstone Yorkshire' that look similar to the existing, however when compared with the adjacent underpinned wall the 'Ironstone Yorkshire' looks like a more consistent match throughout.

It is therefore proposed that an NHL 3.5 mortar similar to the Ironstone Yorkshire be used for the rebuilding of the wall using a flush pointing technique more commonly consistent with the age of the wall and also evidenced in some of the better preserved sections of the adjacent boundary wall as shown in Photograph N.
