**Project:** 26\_5837\_02\_49  
**Site:** 63 Sheldon Avenue, London, N6 4NH  
**Client:** Hamid Ipakchi

| Report Type: | Arboricultural Impact Assessment & Method Statement |
| Site Address: | 63 Sheldon Avenue, London, N6 4NH |

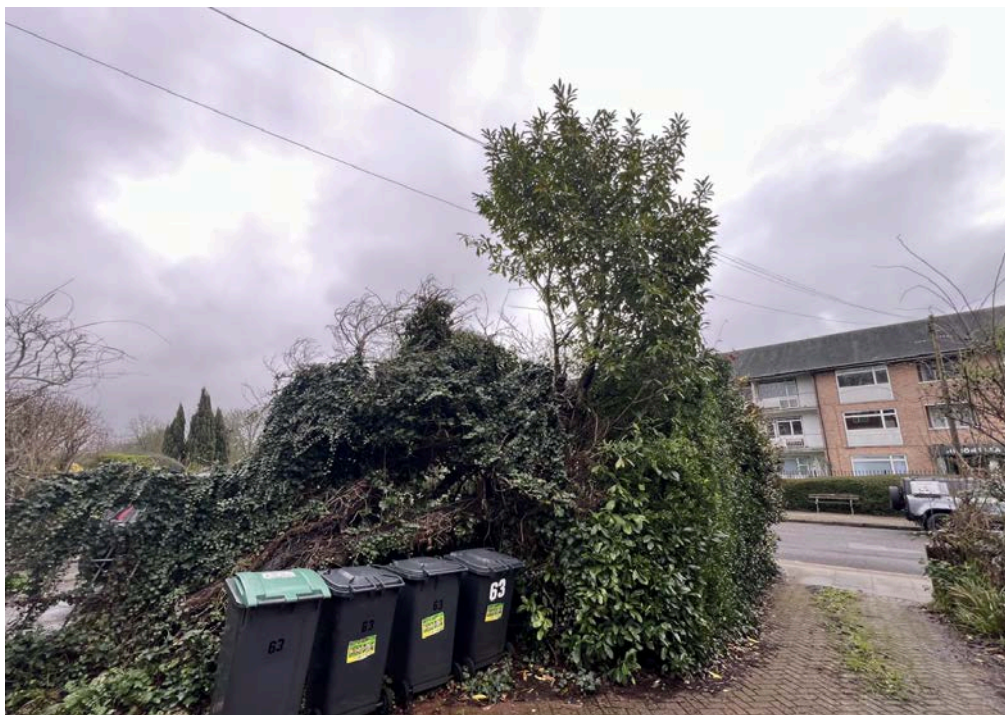
*Photographic plate showing T5 (left), T6 (centre) and H1 (right). (ROAVR, 2026)*

T5 (Lawson Cypress) is categorised as U. The tree is dead, windblown and exhibits stem decay, fungal brackets and significant deadwood. It has a life expectancy of less than 10 years and is unsuitable for retention.

H1, a young linear group comprising Japanese Spindle and Holly, is categorised as C2. It is in fair condition and provides limited collective amenity value.

T5 and T6 are in direct conflict with the proposed permeable driveway and will require removal to facilitate the development. Their removal is arboriculturally acceptable given their category grading and limited constraint value. H1 will be retained within a border to the side of the drive. The tree assessment plan shows a minor root protection area conflict, however the overgrown nature of the site means that accurate positioning of H1 was not possible, no significant root protection area conflict is anticipated.

| Tree Number | Species | Age Class | DBH | Height (crown height) | N | E | S | W | Condition | Life Expectancy | Physical Description | Comments | Managment Recommendations | RPA offset from stem. | Category Rating |
|---|---|---|---|---|---|---|---|---|---|---|---|---|---|---|---|
| T5 | <i>Chamaecyparis lawsoniana</i> (Lawson Cypress) | M | 250,300 | 5(1) | 1 | 3.5 | 3.5 | 1 | Dead | <10 | Windblown. | Dead. Ivy on tree. Decay present on stem. Fungal brackets visible on stem. Major deadwood in crown. | None | 4.69 | U |

Trees T5, T6, T8 and T9 shall be removed prior to the commencement of development. Removals shall be undertaken using sectional dismantling techniques where required to avoid damage to adjacent retained trees. Stumps shall be ground out only where this does not affect retained RPAs.

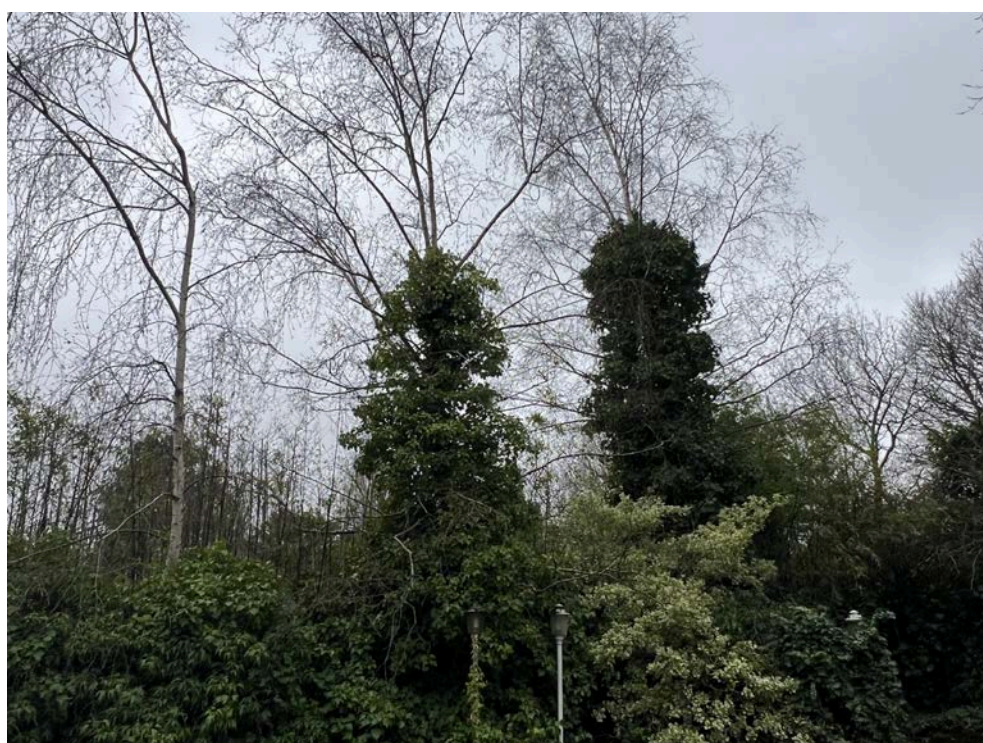
*Photographic plate showing T8 (left) and T10 (right). (ROAVR, 2026)*

T8 is in direct conflict with the proposed patio and will require removal to accommodate the development footprint.

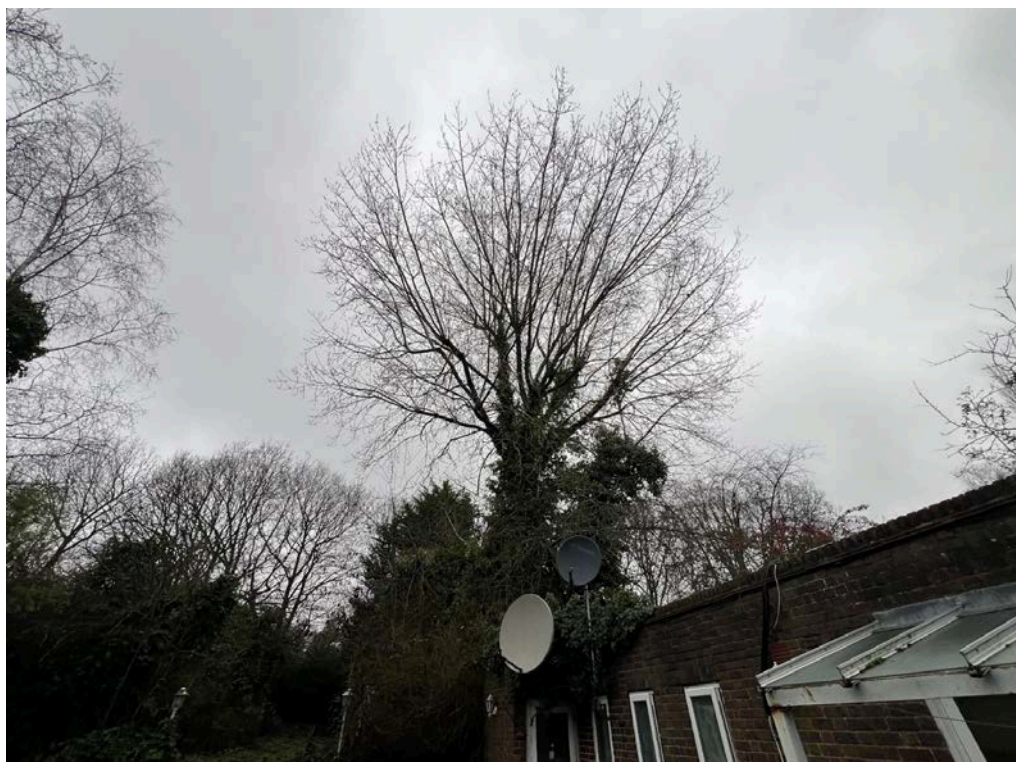
*Photographic plate showing T24 (centre). (ROAVR, 2026)*

A number of large off-site trees make a strong contribution to local amenity. T13–T19 (Common Oak) and T24 (Grey Poplar) are categorised as A1. These trees are in good condition with an estimated life expectancy of 40+ years. Although undergrowth restricted detailed stem inspection, no significant defects were identified from ground level. These trees provide high public amenity value and form a prominent landscape feature.

T24 is a high quality tree and forms a significant constraint. There is minor RPA encroachment associated with the proposed basement, but can be retained with careful hand excavation. The excavation method must avoid over excavation or battering back to prevent root damage to retained trees.
