## 28 Wood Lane, N6 5UB Proposed Window Upgrades - Cover Letter 23.03.2025

# 1. Introduction

This supplementary document has been prepared in support of a planning application for works to 28 Wood Lane (ref: PP-14585948, it specifically provides further detail on the repair, restoration and upgrading of the windows in response to dialogue with Haringey Conservation during application stage. This should be read alongside the accompanying window condition report, which sets out in detail the findings of specialist surveys carried out by two independent heritage window contractors in March 2025. As well as, the proposed window schedule.

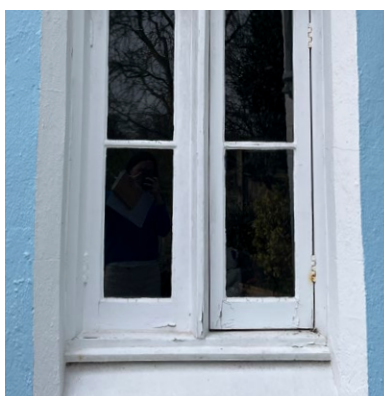
The rear elevation is south-east facing, leaving it prone to excess solar exposure and driven rainfall. The surveyors noted that the condition of the cills in particular has been compounded by the application of incorrect paint during previous maintenance cycles, which has cracked and burst where water has pooled on the surface, leaving the underlying timber exposed to moisture ingress and actively accelerating decay.

WLG.010 (REAR)  
Lower Ground Floor Living Room  
Poor external condition

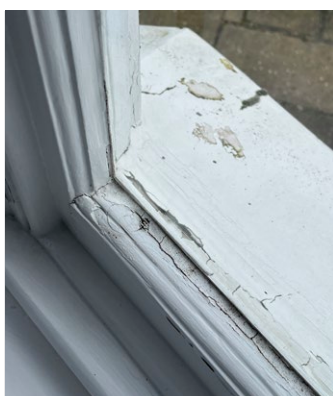
WUG.10 (REAR)  
Upper Ground Floor Bay Window  
Poor external condition

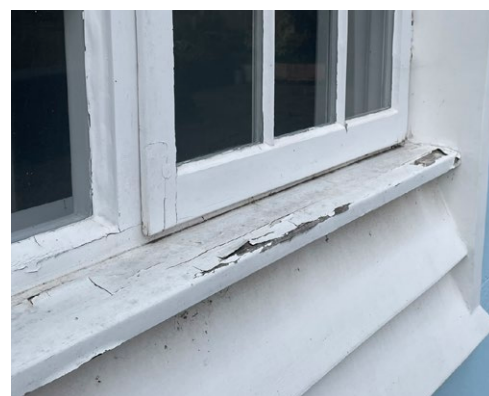
WUG.08 (REAR)  
Kitchen Window  
Poor external condition

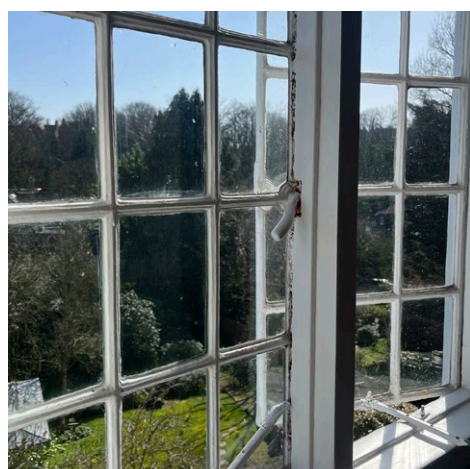
The Crittal windows present the most advanced stages of deterioration, with corrosion evident around the lock and handle fittings and, in some instances, holes in the glass panes themselves. By contrast, the windows on the front elevation are generally in good condition, showing only limited signs of weathering on the exterior.

WFF.03 (REAR)  
First Floor Bedroom  
Very poor condition

| | | | Frame condition (general): Very poor | |
| | | | External condition (e.g. sills / finishes): Very poor | |

| WFF.03 | Rear Elevation<br>Bedroom | Operable steel crittal window | Size (structural opening): 1100 x 1000mm | <b>Replacement of crittal window</b><br>New casement window made with PEFC Sapele glazed with slimline double glazing. |

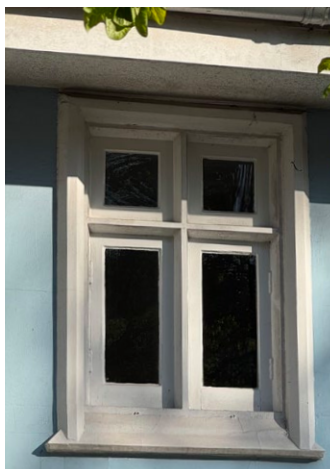
WFF.01 (FRONT)  
Stair  
Good internal and external condition

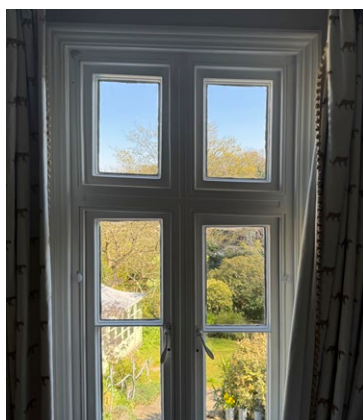
WUF.012 (REAR)  
Upper Ground Floor Nursery  
Transom not level

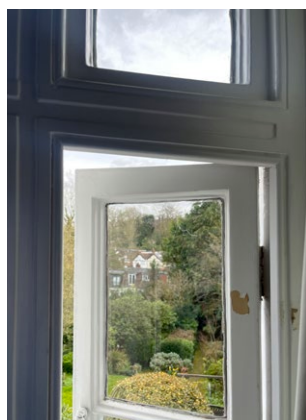
Casement has been replaced  
to fit within distorted opening

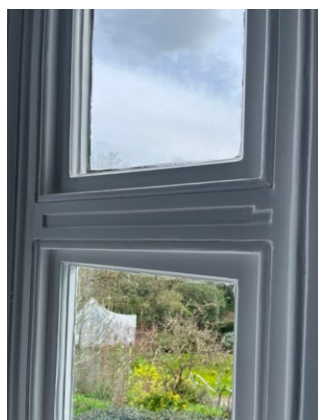
WUG.10 (REAR)  
Upper Ground Floor Bay Window  
Transom not level and replacement  
casement

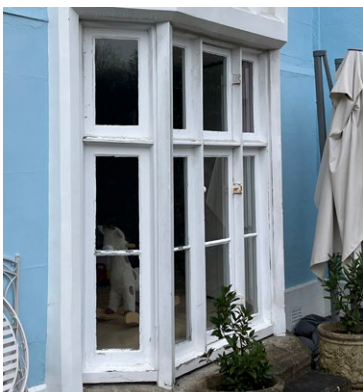
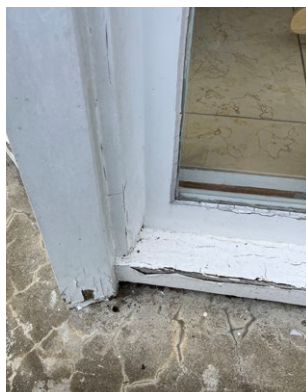
The lower ground floor bay window presents the most serious case on the property. The structural posts at the base of the bay have been subjected to the combined effects of sinking and rot, leaving them significantly compromised. The surveyors are clear that immediate attention is required to stabilise the structure and prevent further deterioration or collapse. It was also noted that the original operable casements in this bay cannot function as intended until the alignment is addressed. The planned works to the interior of the building and specifically the lower ground floor provide the ideal opportunity to remedy the structural failings of the bay window and arrest structural movement. While works are ongoing - damaged sections of timber can be cut away and replaced with suitable matching hardwood.

WLG.011 (REAR)  
Lower Ground Floor Bay Window  
Structural post is splitting and  
rotting

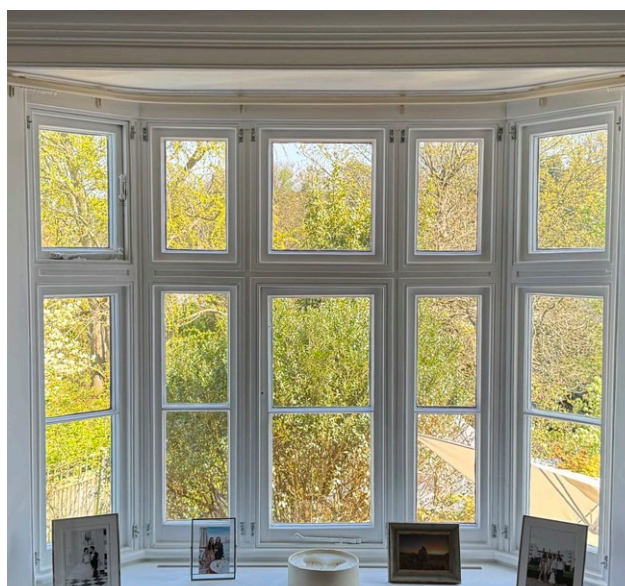
The condition surveys identified evidence of fixings added by previous owners across a number of windows, either left prominently in place, as with the upper ground floor bay window, painted over as with the lower ground floor bay, or removed but leaving unfilled screw holes in the frame. These accretions detract from the character and appearance of the windows. Addressing and reinstating the frames formed part of the discussion with the window surveyors and will be incorporated into the scope of works as part of the broader effort to reinstate the heritage character of the windows.

WUG.10 (REAR)  
Upper Ground Floor Bay Window  
Previous fixings left behind

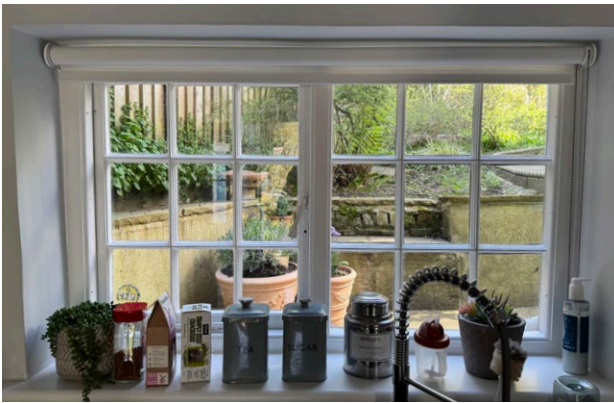
WL.G.01  
Kitchen

The front kitchen windows have been assessed by the surveyor as timber-framed replacements of Crittal windows - a conclusion supported by physical evidence in the frames as described in the condition survey. Their nine-pane-per-casement configuration presents particular practical difficulties for a glazing-only upgrade to double glazing within the existing frames.

Given that these are modern replacement windows rather than original historic fabric, and that they do not replicate the Crittal windows they replaced, their replacement is not considered to represent a loss of significance. The proposed replacement with heritage slimline timber frame double glazed units presents the opportunity to improve both the thermal performance and the visual coherence of the elevation, introducing a window more sympathetic to the character of the original building.

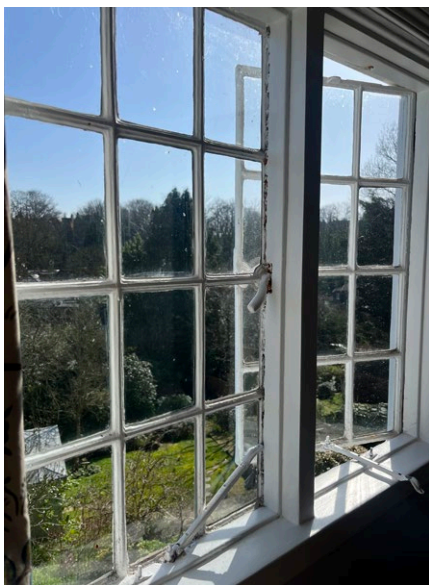
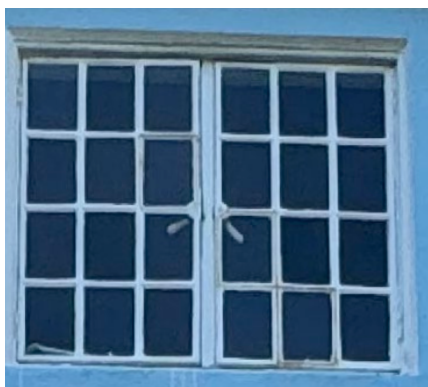
WFF.03 (REAR)  
First Floor Bedroom

As documented in the condition survey, the Crittal windows to the first floor bedroom, attic and lower ground floor bathroom are in a very poor state of repair, exhibiting late-stage corrosion. Inspection by the surveyor and advice from the heritage consultant determined that the surviving metal windows are steel framed, and are therefore likely to have been manufactured by Crittalls after approximately 1920 - indicating that these were later added openings or replacements of timber frame windows.

In addition to their physical condition, the original Crittal frames present a significant thermal performance liability. The absence of a thermal break in the steel frame means the frames become cold in low temperatures, encouraging condensation on both the glass and frame surfaces and contributing to the pattern of moisture-related deterioration observed across the rear elevation.

It is proposed to replace these windows with heritage slimline timber frame double glazed units, with detailing designed to be sympathetic to the character of the existing historic windows and to minimise any loss of historic character.

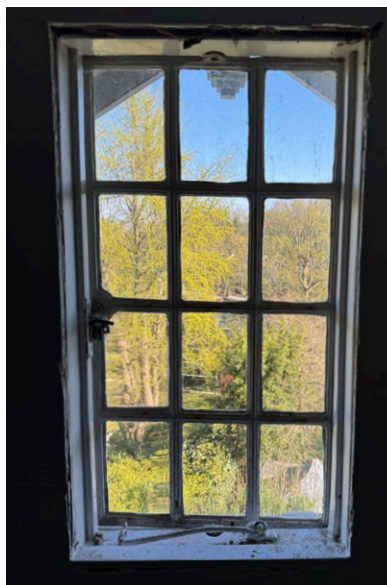
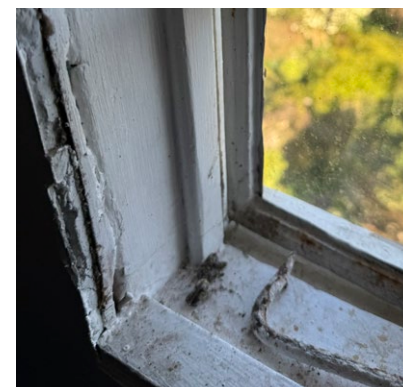
WA.01 (REAR)  
Attic

| | | | Frame condition (general): Very poor | |
| | | | External condition (e.g. sills / finishes): Very Poor | |

| WA.01 | Rear Elevation<br>Attic | Operable steel crittal window | Size (structural opening): 430 x 700mm | <b>Replacement of crittal window</b><br>New casement window made with PEFC Sapele glazed with slimline double glazing. |

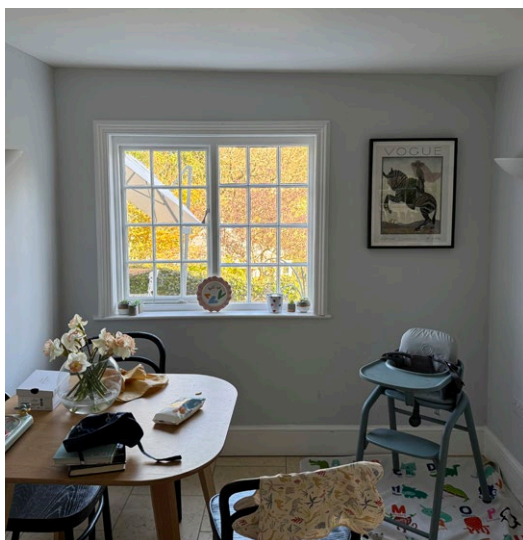
WL012  
Kitchen

Following thorough on-site discussion with the window surveyors, it was established that there was a high likelihood that the windows are modern timber-framed replacements of what were originally Crittal steel windows. The surveyor's assessment points to a number of clear indicators: the presence of infill holes in the surrounding frame where the original Crittal fixing points have been patched; a frame moulding profile that is inconsistent with both the Crittal windows they replaced and the original timber windows found elsewhere on the property; and the addition of supplementary framing introduced to make up the dimensions of the existing opening.

It is our view that this evidence materially affects the weight that should be given to the retention of these particular windows, and that their proposed removal in connection with the rear extension does not constitute the loss of historic fabric of significance. We trust that this careful assessment, informed by specialist heritage advice, provides the necessary context and reassurance to support this element of the proposed works.
