Project Bruce Castle

Drawing Typical Sash Window Repair Detail - Sheet 2  
Jamb Details

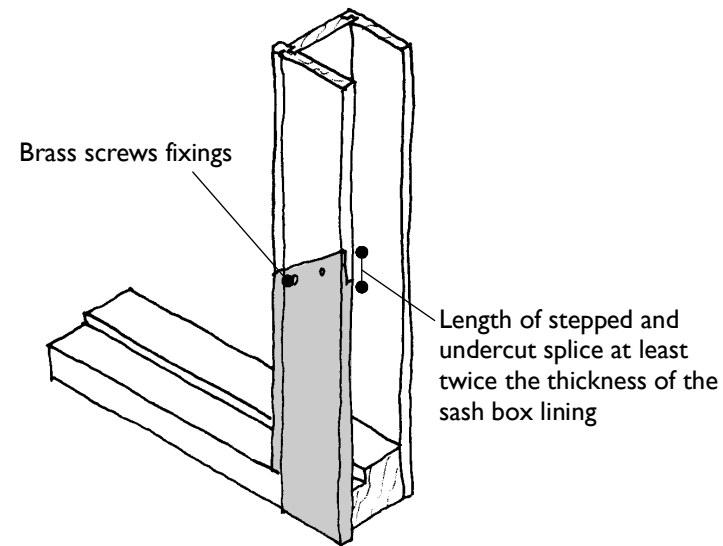
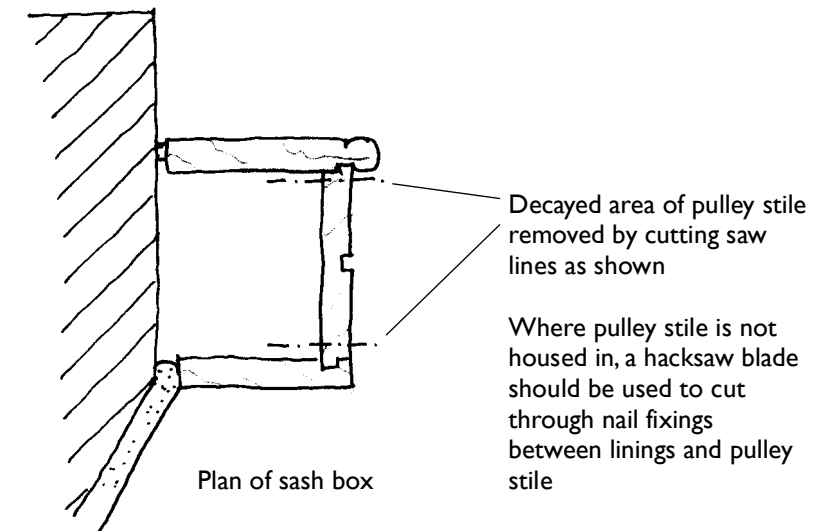
**Alternative detail**  
to that shown on the left
