Project Bruce Castle

Drawing Typical Sash Window Repair Detail - Sheet 1  
Cill and Sash Repairs

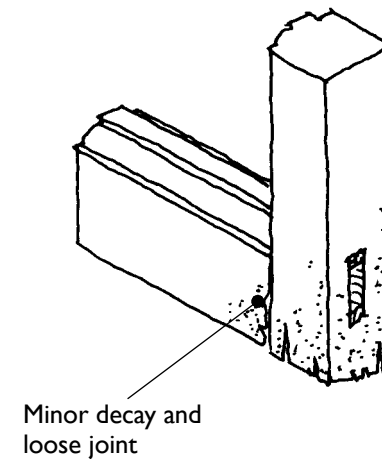
Minor decay and loose joint

This repair method does not apply where glass is removed from the sash. In this case repair joint by gluing. In the case of significant decay splice in timber repairs as shown on drawing titled *Bottom rail and sash repairs*.
