## **TREE DEVELOPMENT SURVEY AND REPORT**

**(BS5837:2012 ARBORICULTURAL IMPACT ASSESSMENT)**

| <b>SITE</b> | 15 Broadlands Road, Highgate, London. N6 4AE |
| <b>DATE</b> | 12 <sup>th</sup> January 2023 |

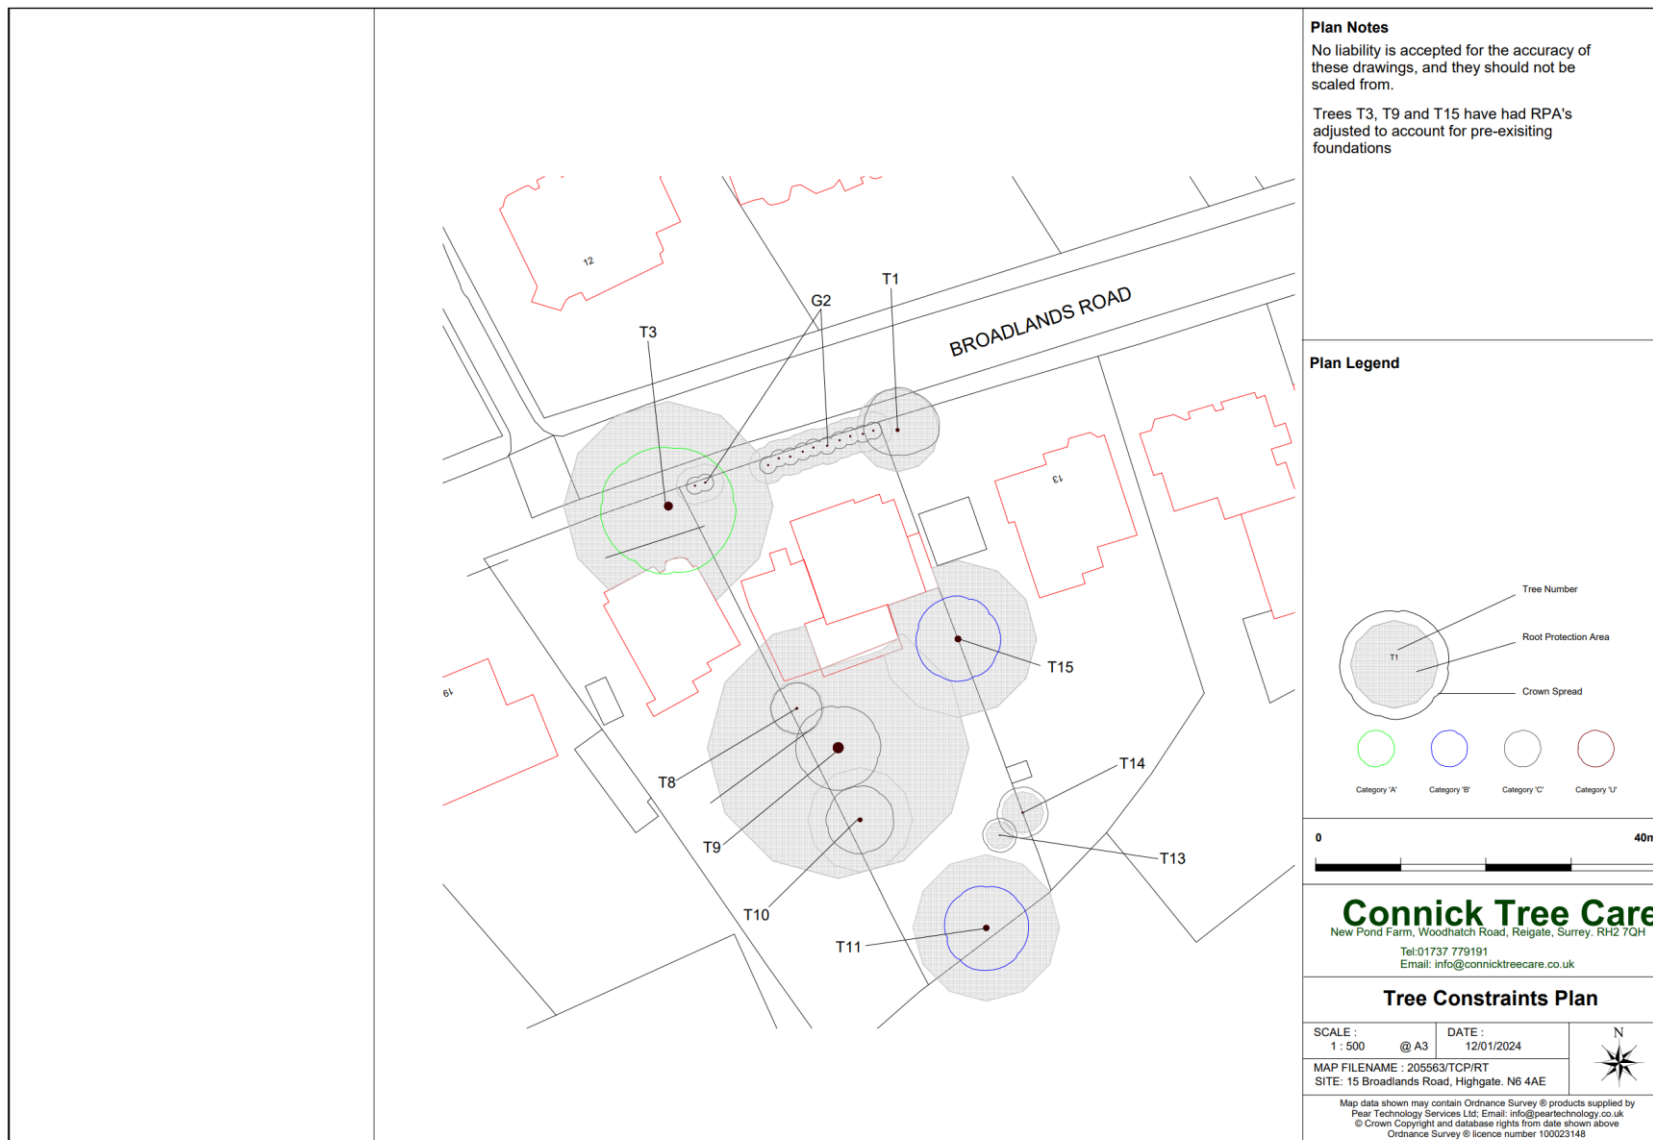
## APPENDIX II TREE CONSTRAINTS PLAN

Trees T3, T4, T5, T6, T7, T9, T15 have had the Root Protection area adjusted due to the presence of existing foundations.

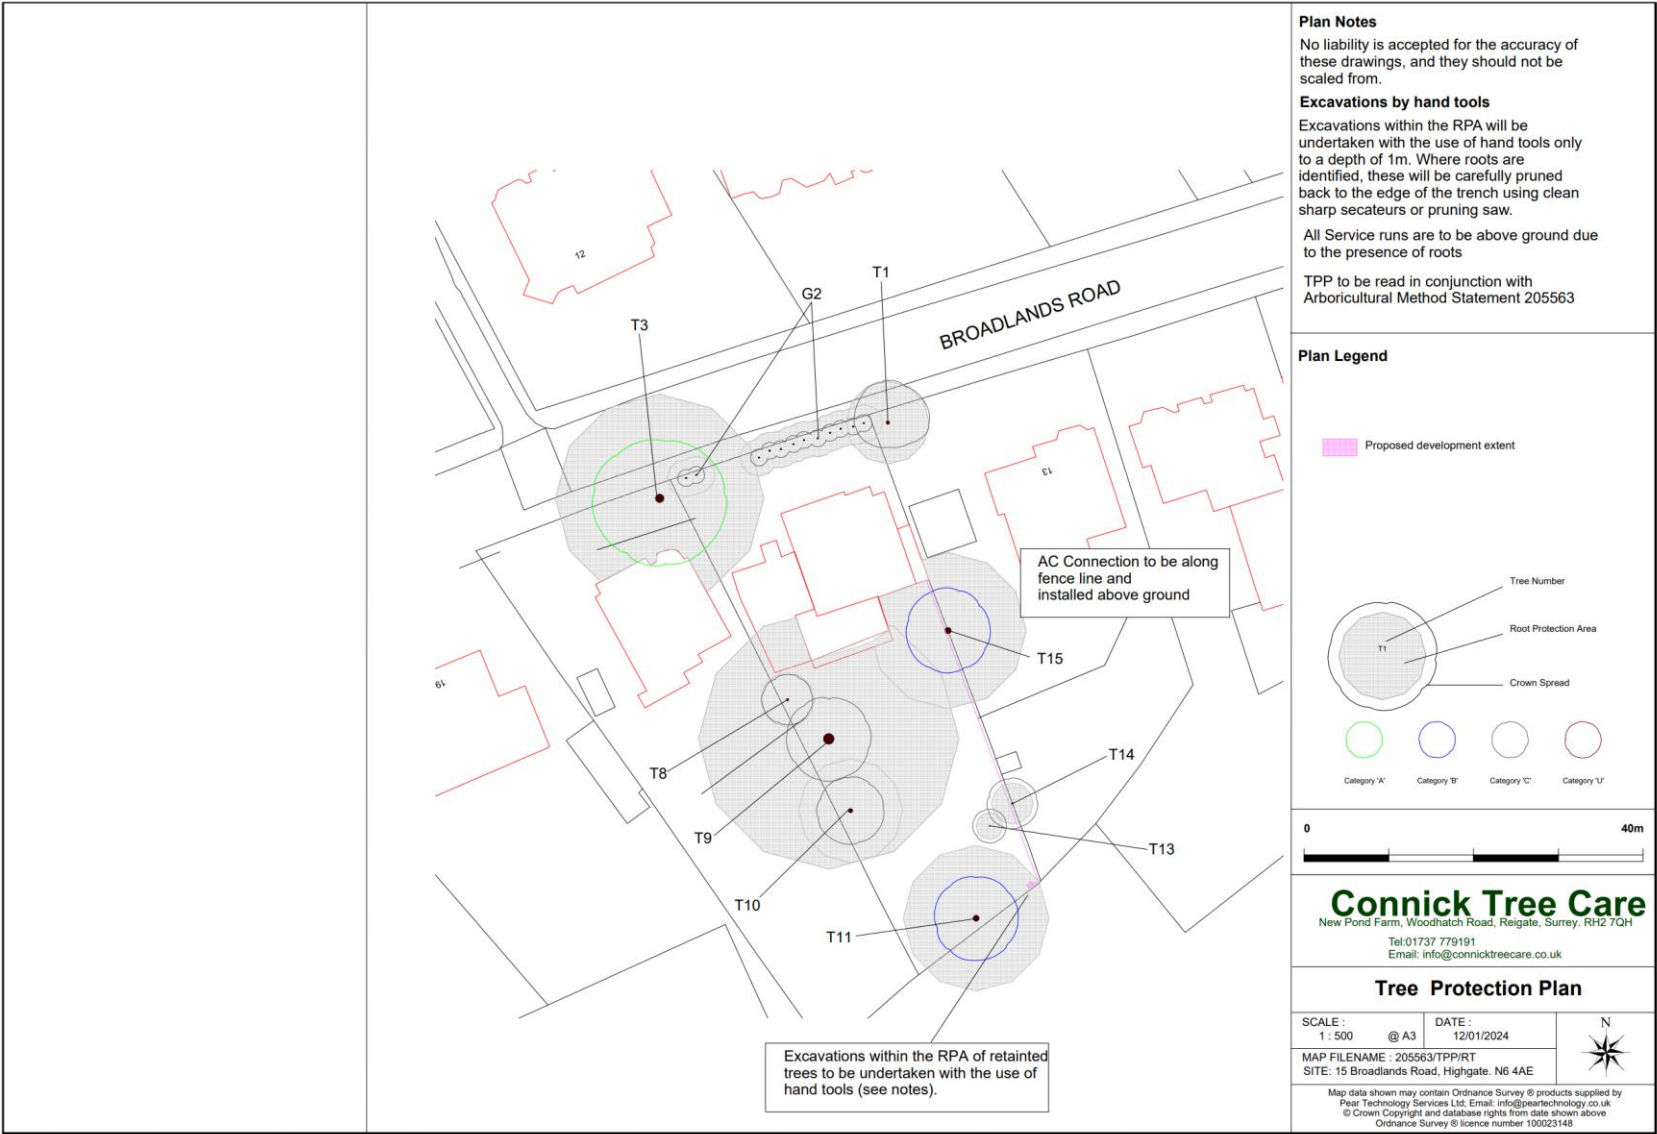
TREE PROTECTION PLAN

| Tree No. | Development Section | Total RPA m² | Impact of proposed development. |
|---|---|---|---|
| T11 | Concrete Pad | 221.7 | The proposed concrete pad will impact upon up to 0.62m² of the total minimum RPA equating to 0.28%. |

- 1 category 'B' tree recorded as T11 a mature Sycamore has been identified as having encroachments upon the RPA with the maximum impact of 0.28% .

The advice given above is a summary of the required precautions to ensure that the proposed development can be constructed with a minimal impact to all retained trees. The exact methods of construction required in and adjacent to the RPA of retained trees and a final Tree Protection Plan will be addressed within a separate Arboricultural Method Statement.
