## **Eade Road**

Otter and Water Vole Walkover and Ground Level Tree  
Assessment for Bats Report

2486124

**JANUARY 2024**

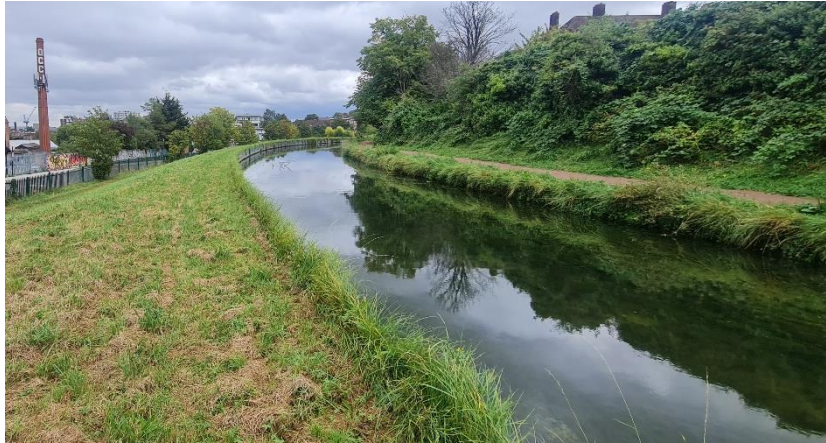
- 3.1.1 The canal piling along the northern and southern banks of the river means that there is no potential for otter holts within the site (Plate 1). The river does provide some potential for otter commuting and possibly feeding.

*Plate 1: Canal piling along river banks*

- 4.1.1 As there is some potential for commuting and feeding within the river, access for otter through the watercourse should be maintained throughout the works. Night time working and lighting of the river corridor should be avoided.

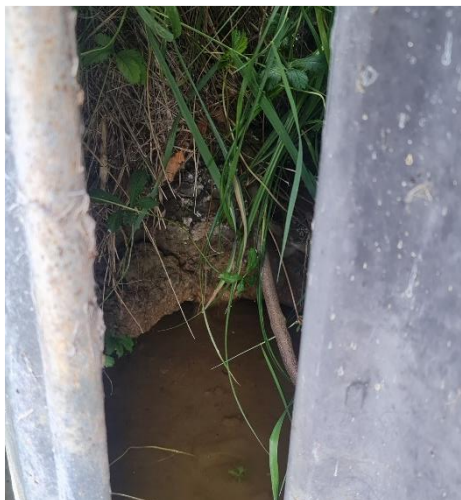
- 3.2.1 The canal piling along the banks of the river also mean that there is no opportunity for water voles to build burrows within the site. There are three areas at the western end of the site where there is a gap within the piling adjacent to a culvert (Plate 2). These were thoroughly checked for signs of use by water voles and none were found.

*Plate 2: Gap within canal piling at western end of site.*

- 3.2.2 The site is therefore classified as 'suitable but poor' as any potential burrowing opportunities are limited to the three small areas.

- 4.2.1 The gaps within the canal piling at the western end of the site should be resurveyed by a suitably qualified ecologist six weeks prior to works starting, and again two days prior to works starting. This is to ensure that no new water vole field signs are present, or any new activity within the three potential points where they could access the bank.

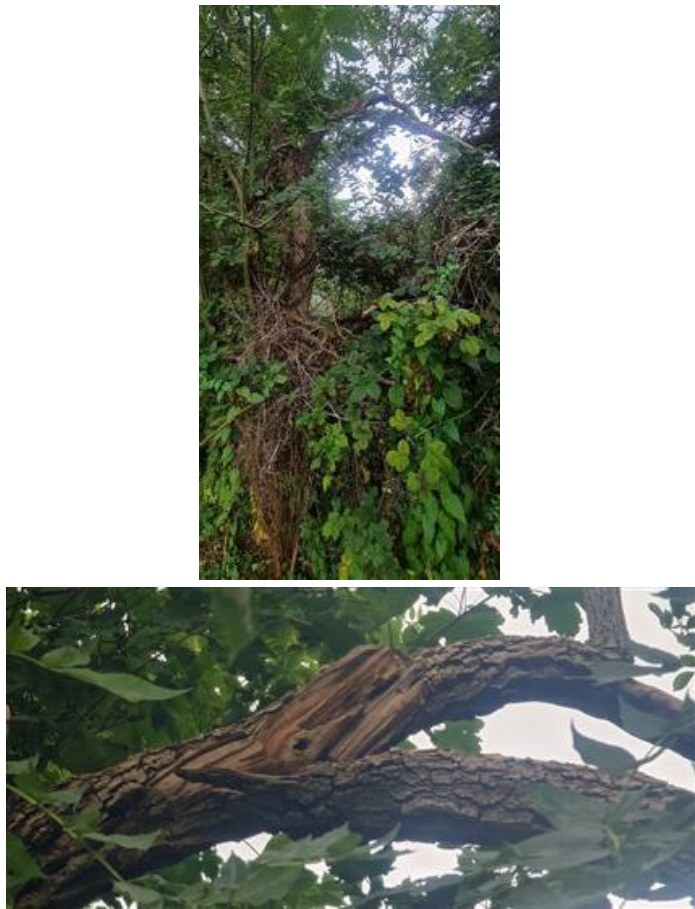
| Tree Reference | Photo | Description and indicative bat roost potential |
|---|---|---|
| T1 | | <p>A semi-mature tree (unrecorded species, possibly Black Walnut (<i>Juglans nigra</i>)) on the northern site boundary.</p> <p>Found to be in good overall condition with one recorded PRF.</p> <p>Hazard beam / longitudinal split in limb recorded, approximately 2.5m from ground. Feature is open to the elements as facing upwards.</p> <p><b>Low potential</b> for roosting bats.</p> |

- 4.3.1 All of the trees surveyed provided low potential for roosting bats. If any of these trees are to be directly affected by the works, for example the overhanging branches pruned to allow access to the river, then the identified features should be checked by a suitably experienced and level 2 bat licenced ecologist using an endoscope prior to works starting.

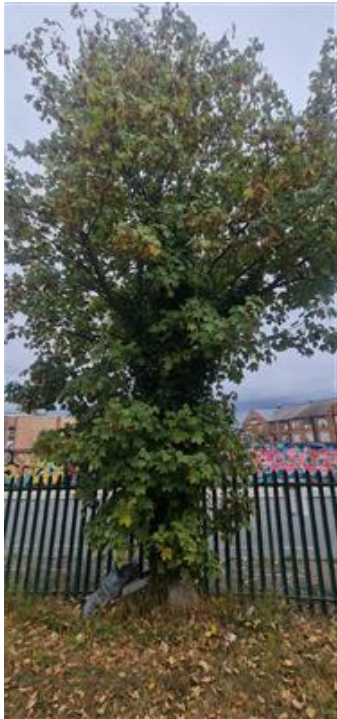
| Tree Reference | Photo | Description and indicative bat roost potential |
|---|---|---|
| T2 | | <p>A mature Sycamore (<i>Acer pseudoplatanus</i>) tree on the northern site boundary.</p> <p>Ivy preventing full inspection. Found to be in good overall condition with no PRFs present.</p> <p><b>Low potential</b> for roosting bats.</p> |

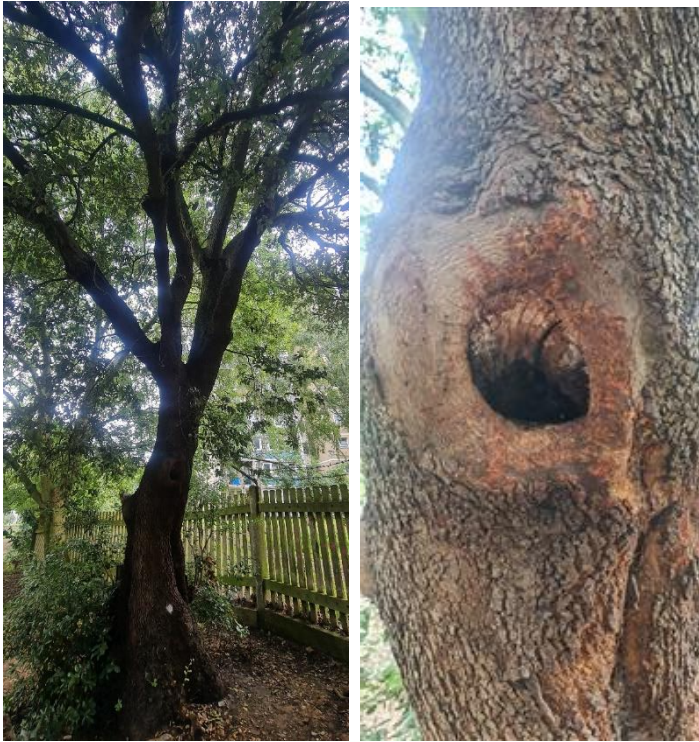
| Tree Reference | Photo | Description and indicative bat roost potential |
|---|---|---|
| T3 | | <p>A mature tree (unrecorded species) on the south western site boundary.</p> <p>Found to be in good overall condition with one recorded PRF.</p> <p>Pruning cut recorded on south west aspect of stem, approximately 1.5m above ground.</p> <p><b>Low potential</b> for roosting bats.</p> |

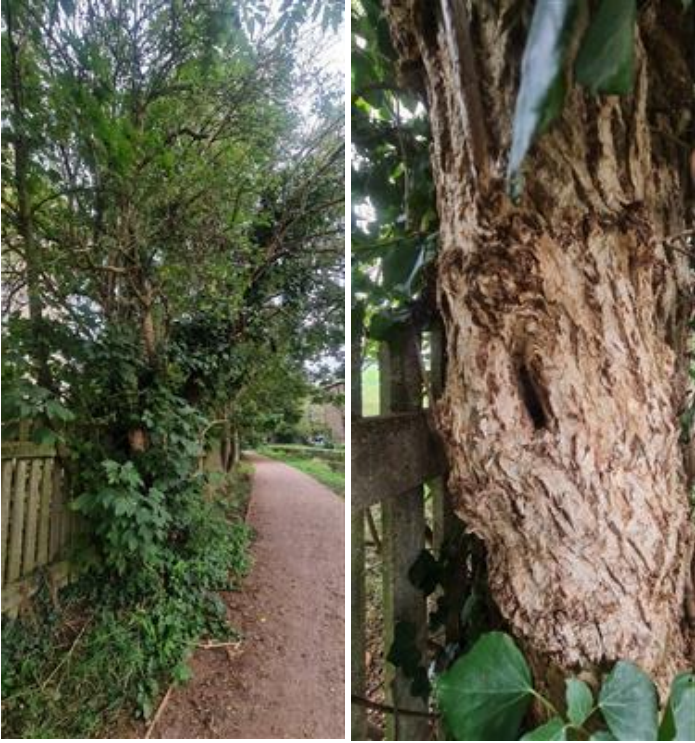
| Tree Reference | Photo | Description and indicative bat roost potential |
|---|---|---|
| T4 | | <p>A semi-mature (unrecorded species) of tree on the southern site boundary.</p> <p>Ivy preventing full inspection. Found to be in good overall condition with one PRF recorded.</p> <p>Small tearout recorded on western aspect of stem, approximately 1.5m from ground level.</p> <p><b>Low potential</b> for roosting bats.</p> |

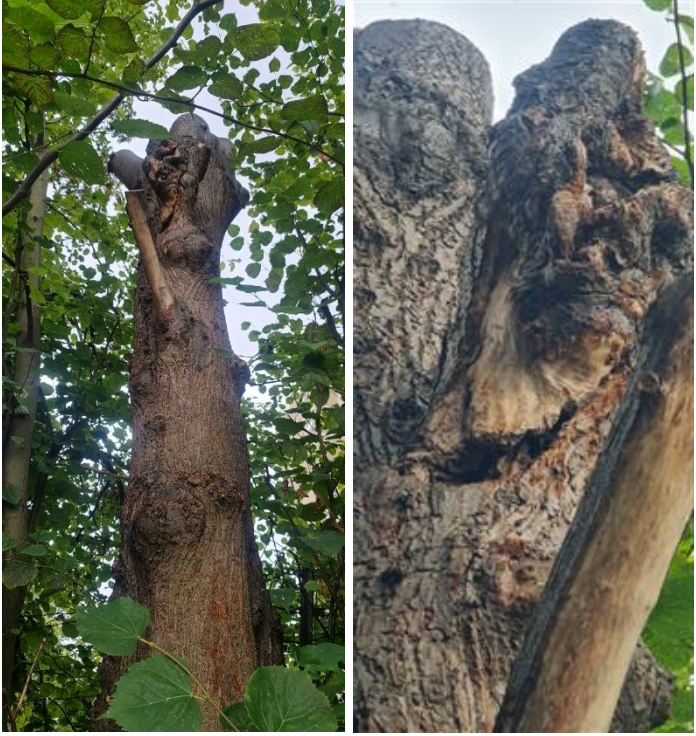
| Tree Reference | Photo | Description and indicative bat roost potential |
|---|---|---|
| T5 | | <p>A pollarded tree (unrecorded species) on the southern site boundary.</p> <p>One PRF recorded, located approximately 3m from ground level.</p> <p><b>Low potential</b> for roosting bats.</p> |

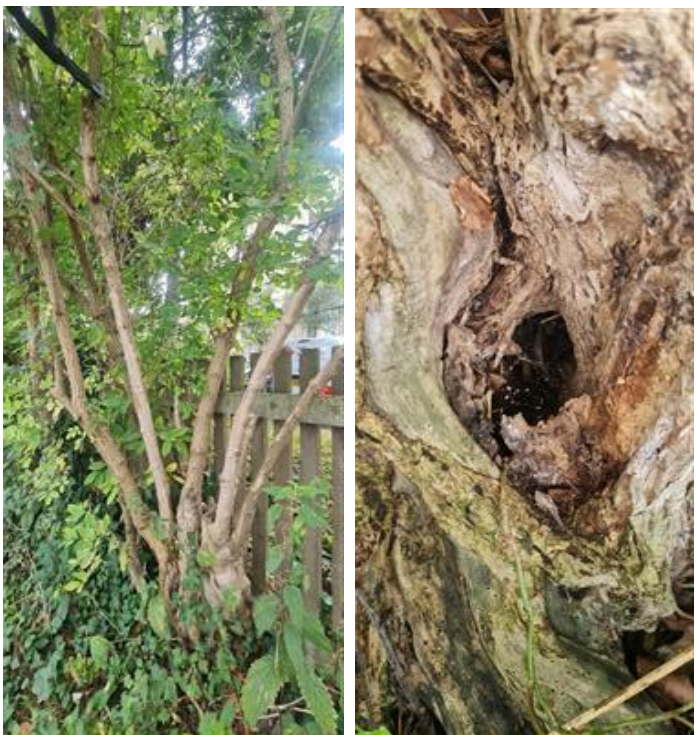
| Tree Reference | Photo | Description and indicative bat roost potential |
|---|---|---|
| T6 | | <p>A young Ash (<i>Fraxinus excelsior</i>) on the southern site boundary.</p> <p>Multi stemmed tree. Found to be in good overall condition with one PRF recorded.</p> <p>Rot hole recorded at the base of tree, cobwebs present in feature and ivy growing within.</p> <p><b>Low potential</b> for roosting bats.</p> |

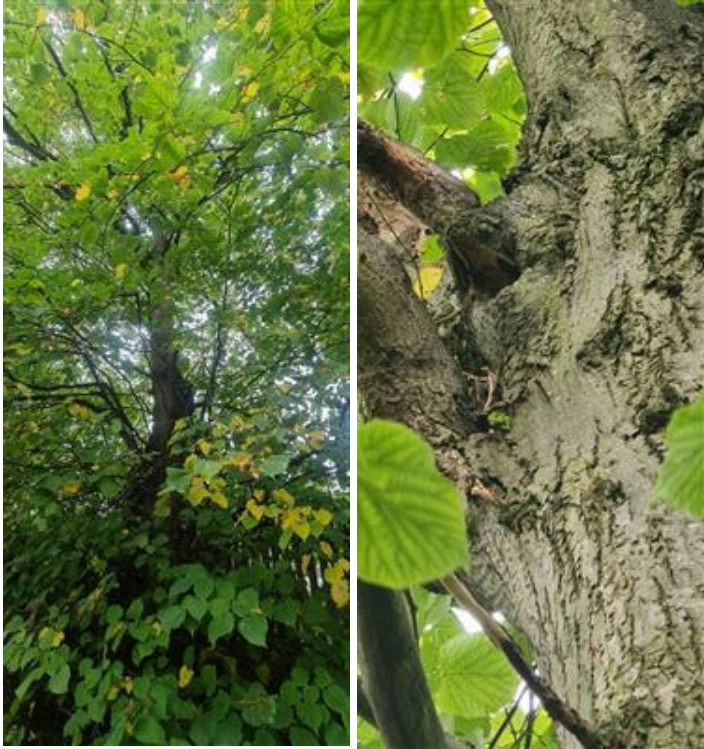
| Tree Reference | Photo | Description and indicative bat roost potential |
|---|---|---|
| T7 | | <p>An unrecorded species of tree on the southern site boundary.</p> <p>Found to be in good overall condition with one PRF recorded.</p> <p>Tear out recorded on northern aspect of stem, approximately 6m from ground level.</p> <p><b>Low potential</b> for roosting bats.</p> |

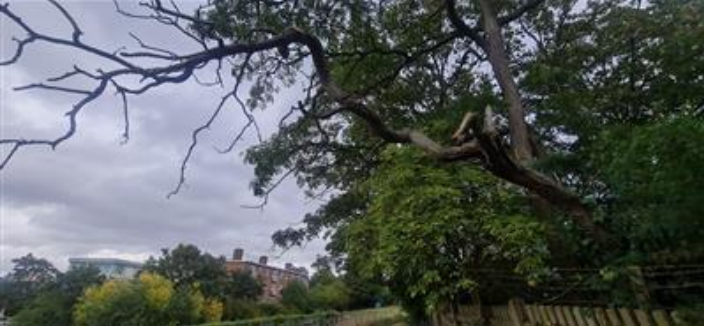
| Tree Reference | Photo | Description and indicative bat roost potential |
|---|---|---|
| T8 | | <p>A mature tree (unrecorded species) located outside of the southern site boundary.</p> <p>Potential feature identified in overhanging branch. Do not prune.</p> <p><b>Low potential</b> for roosting bats.</p> |

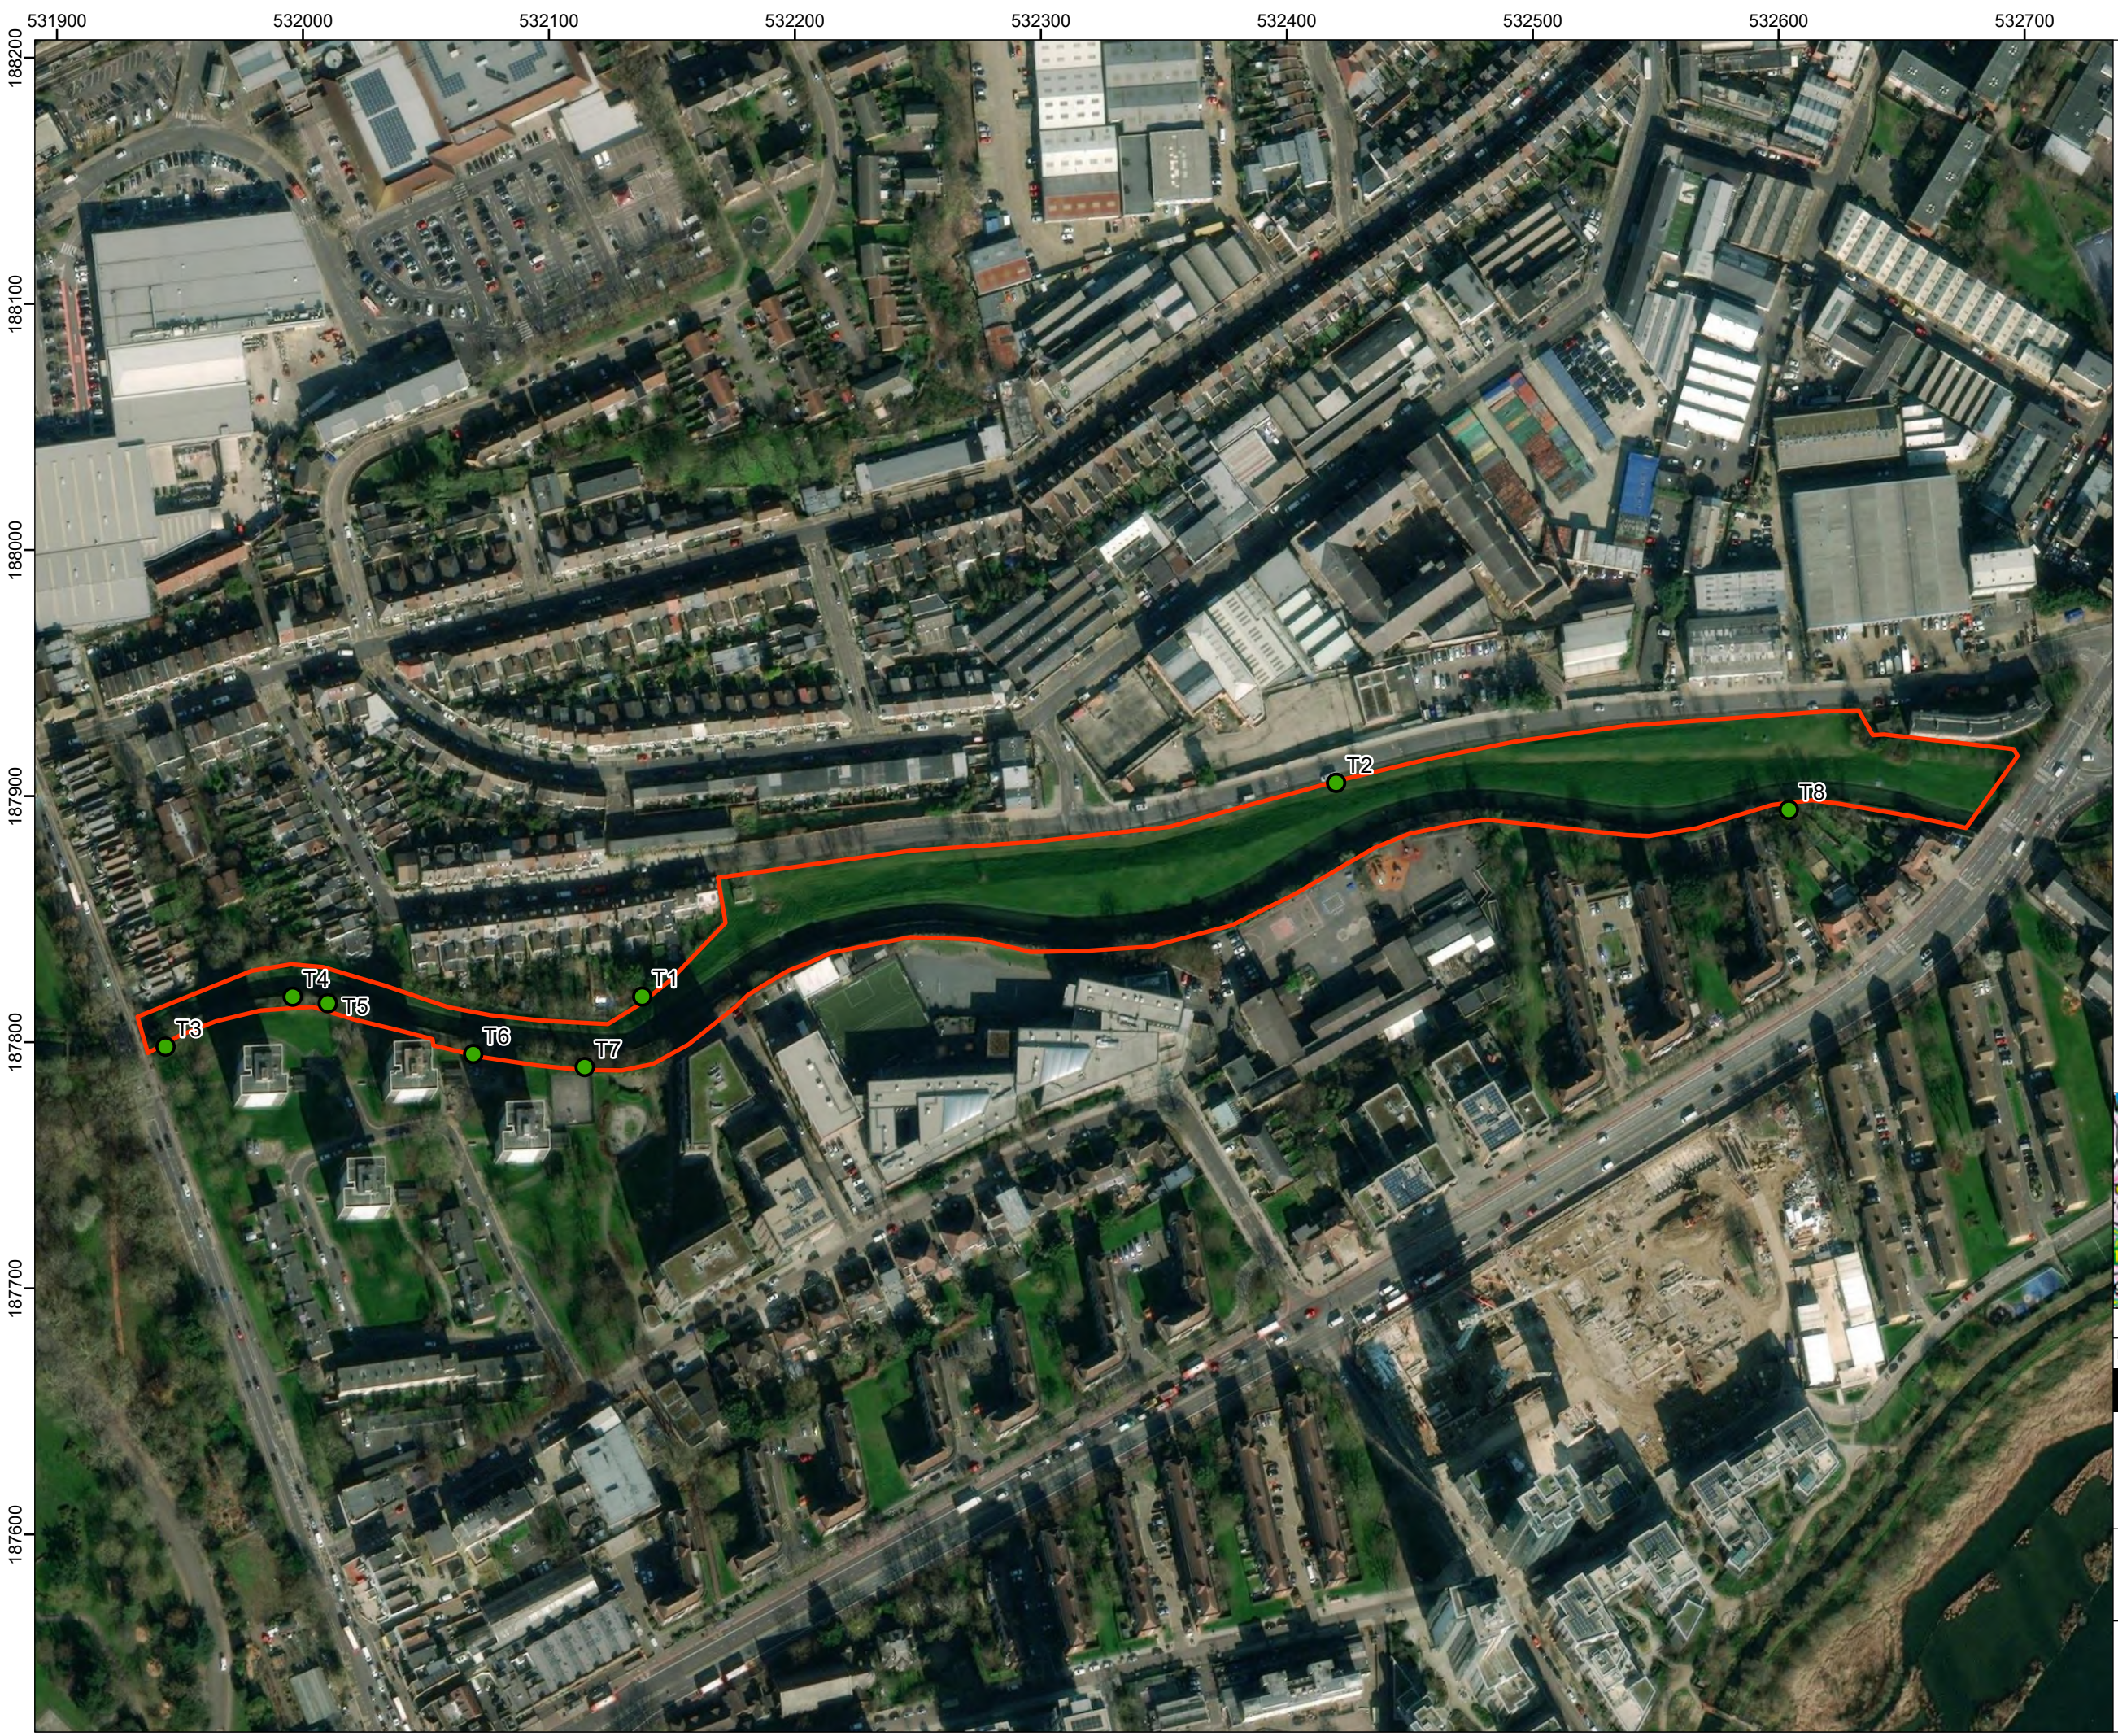
TITLE: Figure 2:  
GLTA Survey Results

- 3.3.1 A total of eight trees within and adjacent to the site were found to contain features which may provide suitable roosting locations for bats. The majority of these are located away from the proposed works, or had a limb overhanging the river which may need to be pruned to facilitate the works.
- 3.3.2 The results of the GLTA are summarised in Table 2 and displayed in Figure 2.
